## Structural Observation Report

24 Lincoln Way East – Massillon, OH

GPD Group is pleased to present this Observation Report from our visit to the retail/commercial property located at 24 Lincoln Way East (LWE), Massillon, Ohio on March 13, 2023.

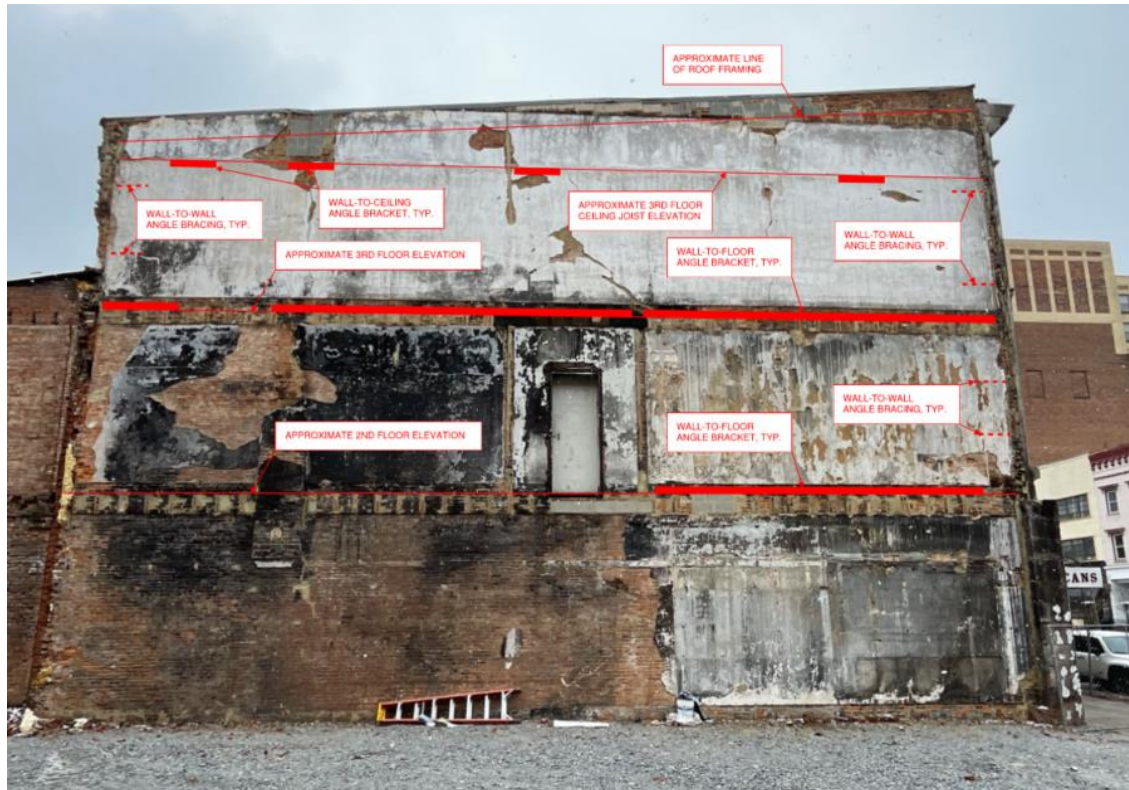
**Figure 2:** 24 LWE West Wall Elevation – Approximate Locations of Angle Brackets and Bracing.

The following general observations describe the components that were installed to stabilize the west wall of 24 LWE prior to demolition of the adjacent structure. Refer to Figure 2 for general locations of brackets and bracing at the west wall.

- Deteriorated and inconsistent masonry construction makes wall performance challenging to predict.
- No lateral support of the west wall appears to exist along the northern end of the second floor.

- No consistent lateral support of the west wall appears to exist at the third-floor ceiling.
- No lateral support of the west wall appears to exist at the roof level.

- Evaluate the basement wall for lateral earth pressure. After demolition, the adjacent basements of both 14 and 20 LWE were backfilled.
  - Develop connection details that will provide lateral support to the west wall. Multiple solutions could be developed.

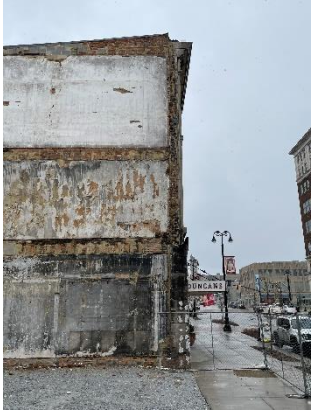
The now-exposed west wall, consisting of three-wythes of brick, is in poor-to-moderate condition. Despite recent masonry repairs after the January demolition (patching and filling of joist pockets, etc. on the 20 LWE side of the wall), wall cracks, voids, and penetrations remain in the wall. Additionally, the original bricks and mortar joints are in various states of deterioration.

| <p>Historical Photo of Original Construction – Looking North</p> | <p>Exterior – West Wall - Southwest Corner</p> |

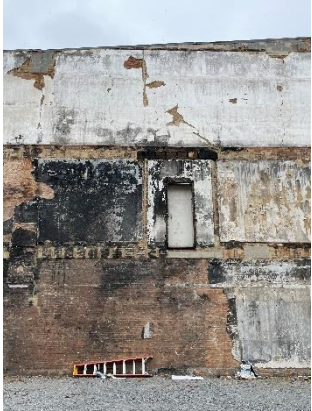
At the second floor, a doorway in the west wall, originally providing passage between 20 LWE and 24 LWE, remains unsecured.

| <p>Exterior – West Wall - Southwest Corner – Note Second Floor Doorway</p> | <p>Exterior – West Wall - Northwest Corner</p> |

- Install fall protection at the second-floor doorway in the west wall (e.g., permanently seal or provide a guardrail system).
- Due to the significant alterations to the building resulting from the demolition of approximately 50% of original construction, retain the services of a structural engineer to evaluate remaining gravity and lateral resisting systems to address compliance requirements of the current building code. This evaluation, at a minimum, will likely include the following:

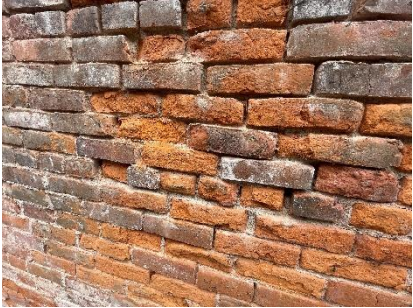
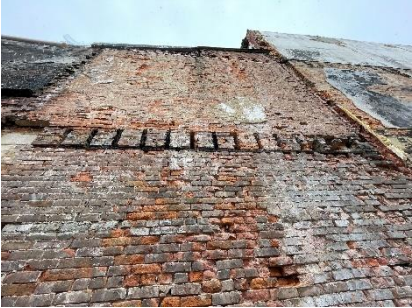
- Incomplete masonry repairs and weatherproofing presents opportunities for water intrusion into the building and continued masonry deterioration.

| <p>Exterior – West Wall Masonry Deterioration</p> | <p>Exterior – West Wall Masonry Deterioration</p> |

- Develop a comprehensive masonry repair and waterproofing program to minimize future water intrusion and masonry deterioration.

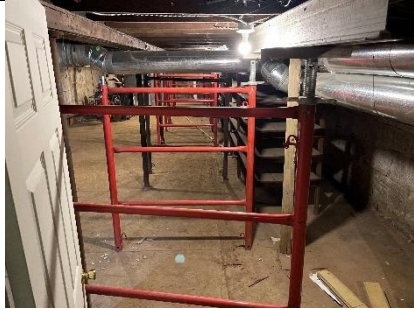
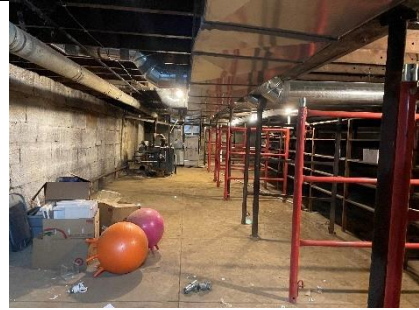
The temporary shoring, extending from basement floor slab to the third-floor ceiling framing, was installed parallel to, and approximately five-feet from, the west wall. Supplemental angle brackets and bracing were installed at the second floor, third floor, and third floor ceiling. No bracing was observed at the first floor or roof.

Basement – Temporary Shoring

- Until a more rigorous engineering analysis and repairs can be completed, it is recommended that shoring should be utilized in 24 LWE.
- Prior to completing a more in-depth evaluation of the remaining gravity and lateral resisting systems, as well as the stabilization bracing installed prior demolition, it is premature to assign remedial costs that will be required to bring the building up to code compliance.

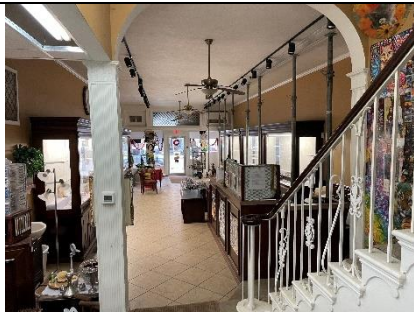
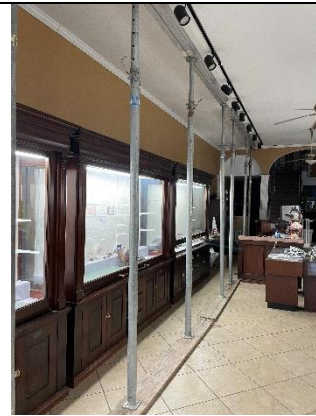
First Floor – Temporary Shoring

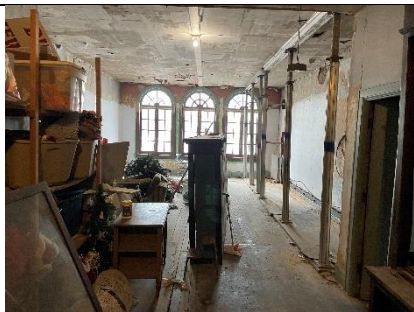
Second Floor – Temporary Shoring

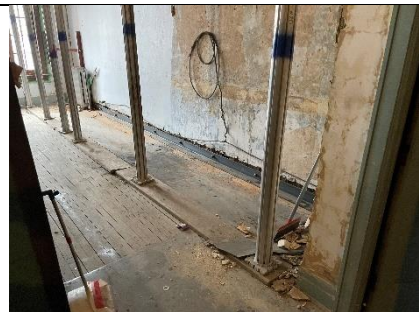
- A 20-foot length of steel angle framing was installed connecting the south end of the second-floor framing to both the east and west walls. Each angle was connected to the brick masonry with 3/4" diameter threaded rod and to the floor framing with what appeared to be 3/8" diameter lag screws. The spacing of the rods and screws were installed at approximately 2'-8" on-center. It is assumed that the threaded rods were installed utilizing a screen-tube adhesive system.
- Two horizontal steel angle bracing connecting the west wall and the south façade were installed equally spaced between the second and third floors. These braces were anchored to the masonry wall(s) with 3/4" diameter threaded rods similar to the steel angles along the floor.

- Like the adhesive anchors noted above, the resistance capacities of the lag screws used to connect the steel angles to the floor framing are unknown due to the unconfirmed screw size/length and the end/edge distances of the screws installed into the 2x narrow face of the wood joists.

Second Floor – Temporary Shoring and Floor-to-Wall Angle Bracket

- To make permanent use of installed angle brackets and braces, confirm in-situ adhesive anchor and lag screw demand-capacity ratios (e.g., pull tests for adhesive anchors).

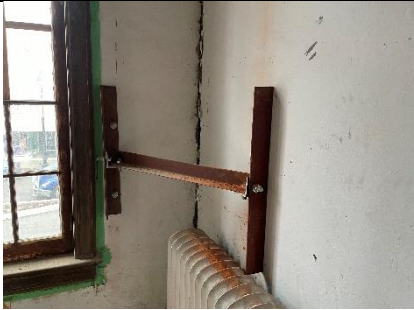
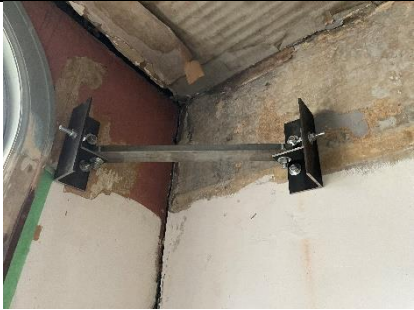
- Regardless of angle bracket and bracing locations, resistance capacity of the adhesive anchors used to connect steel components to the west and south walls is unknown. Factors contributing to the lack of reliability of the anchors includes the age, observed deterioration, and inconsistent nature of the in-situ masonry construction.

| <p>Second Floor – Wall-to-Wall Angle Bracing – Southwest Corner</p> | <p>Second Floor – Wall-to-Wall Angle Bracing – Southwest Corner</p> |

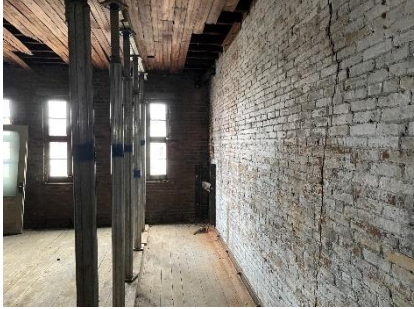
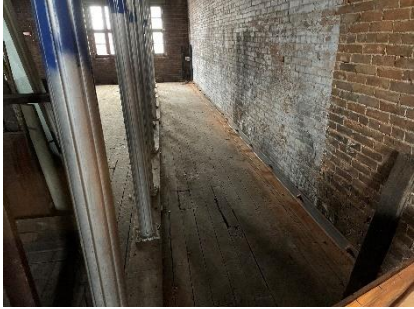
- Various lengths of steel angle framing were installed connecting the third-floor framing to both the east and west walls. The connection of the angles to the brick masonry and wood floor framing was similar to the connections as noted at the second floor.
- A series of horizontal steel angle brackets connecting north-south walls to east-west walls were installed between the third-floor and roof. Two braces were installed in both the northwest and southwest corners and a single brace was installed in the southeast corner.

| <p>Third Floor – Temporary Shoring and Floor-to-Wall Angle Bracket</p> | <p>Third Floor – Temporary Shoring and Floor-to-Wall Angle Bracket</p> |

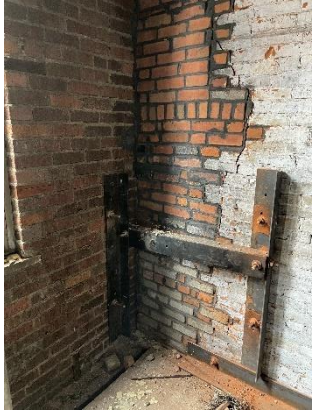
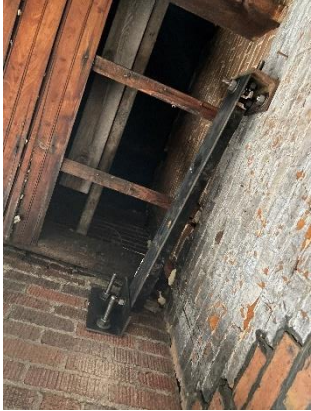
| <p>Third Floor – Wall-to-Wall Angle Bracing – Southwest Corner</p> | <p>Third Floor – Wall-to-Wall Angle Bracing – Southwest Corner</p> |

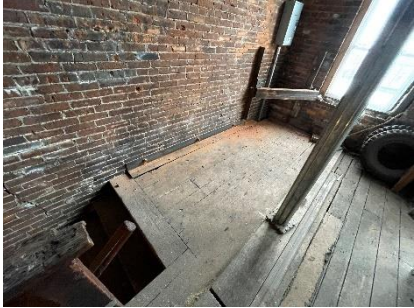
| <p>Third Floor – Temporary Shoring, Wall-to-Wall Angle Bracing, and Floor-to-Wall Angle Bracket – Northwest Corner</p> | <p>Third Floor Ceiling – Joist-to-Wall Angle Bracket</p> |

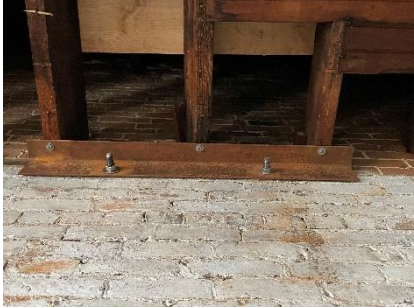
- Various lengths of steel angle framing were installed connecting the ceiling framing to both the east and west walls. The connection of the angles to the brick masonry and wood ceiling framing was similar to the connections as noted at the second floor.

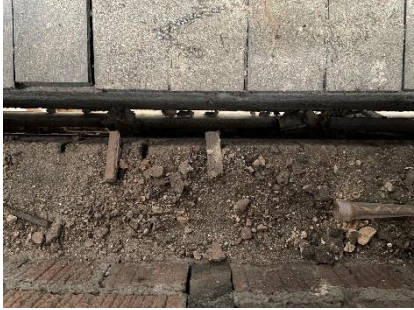
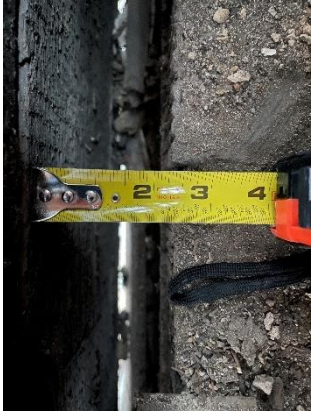
At the third floor, a separation between the floor framing and the south façade was observed.

- Except for the noted bracing at the intersections at the east and west walls, no continuous lateral support appears to exist at the south façade. As noted previously, a clear separation of the floor framing and the south façade was observed at the third floor.

| <p>Third Floor – Separation Between Third Floor Framing and South Façade</p> | <p>Third Floor – Separation Between Third Floor Framing and South Façade</p> |

- Develop connections (e.g., plated thru-bolts) to positively connect the masonry walls to the floor and roof framing.
  - Due to the observed separation, evaluate the existing lateral support of the south façade and develop repairs as required.
