C&K Industrial Services, Inc.  
5617 E. Schaaf Rd.  
Independence, Ohio 44131  
216-642-0055

## PACP Report with Pipe Run and Incident Snapshots

| Pipe segment ref.:<br><b>SNG-4-10</b> | Start date/time:<br><b>20220915 13:58</b> | Street:<br><b>ERIE ST</b> | City:<br><b>MASSILLON</b> | | | |
| Project name:<br><b>CITY OF MASSILLON</b> | Additional info: | | | | | |

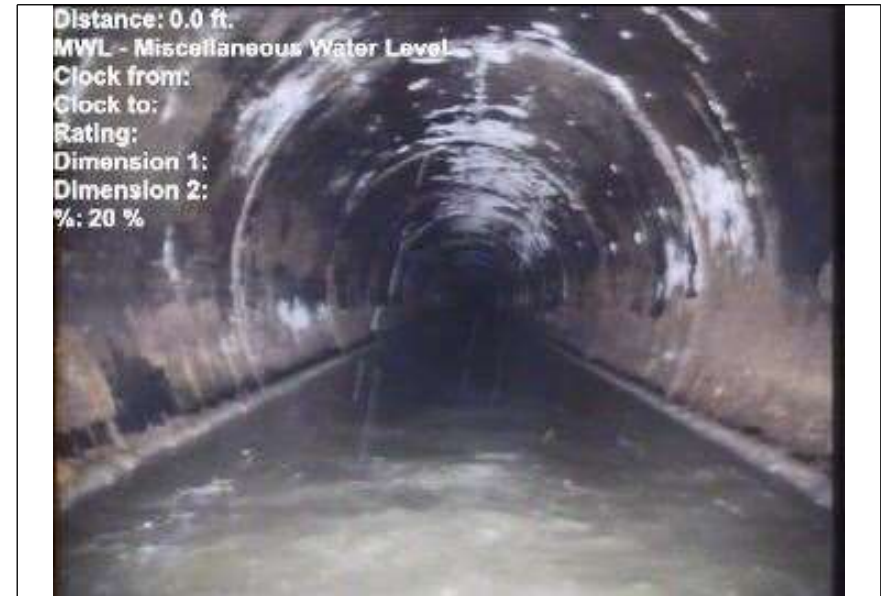
| Distance | Video Ref. | PACP Code | Continuous | S/M/L | Value Inches (mm) | | % | Joint | Circumferential Location | | Rating | Image Ref. | Remarks |
|---|---|---|---|---|---|---|---|---|---|---|---|---|---|
| 0.0 ft. | | MWL | | | | | 20 | <input type="checkbox"/> | / | | | CITY OF MASSILLON-AMH '1297 SR21'-AMH '1415 SR21'-MWL at 0.0 ft.JPG | |

At: 0 ft. MWL - Miscellaneous Water Level  
 Joint: No 20 %

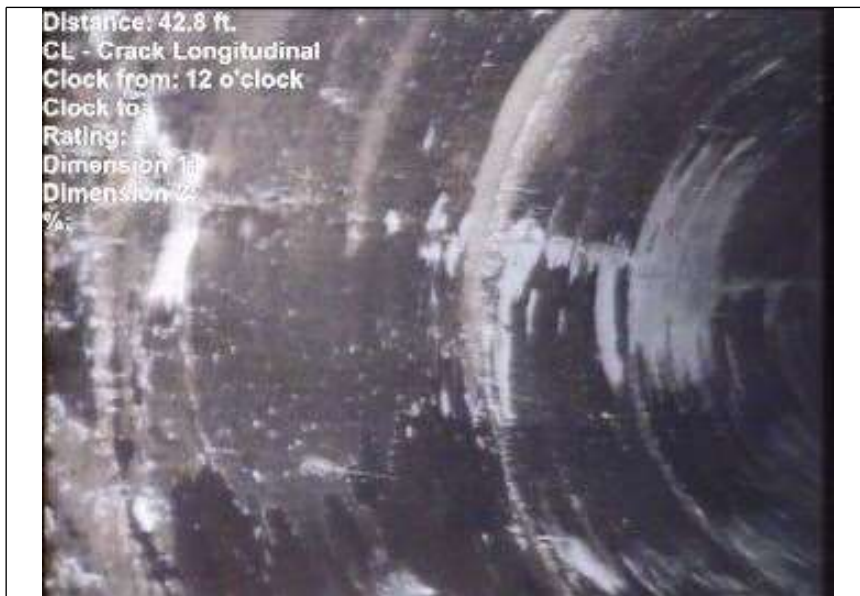
| Distance | Video Ref. | PACP Code | Continuous | S/M/L | Value Inches (mm) | | % | Joint | Circumferential Location | | Rating | Image Ref. | Remarks |
|---|---|---|---|---|---|---|---|---|---|---|---|---|---|
| 42.8 ft. | 00:03:57 | CL | S01 | | | | | <input type="checkbox"/> | 12 / | | 2 | CITY OF MASSILLON-AMH '1297 SR21'-AMH '1415 SR21'-CL at 42.8 ft.JPG | |

At: 42.8 ft. 12/ CL - Crack Longitudinal  
 Joint: No

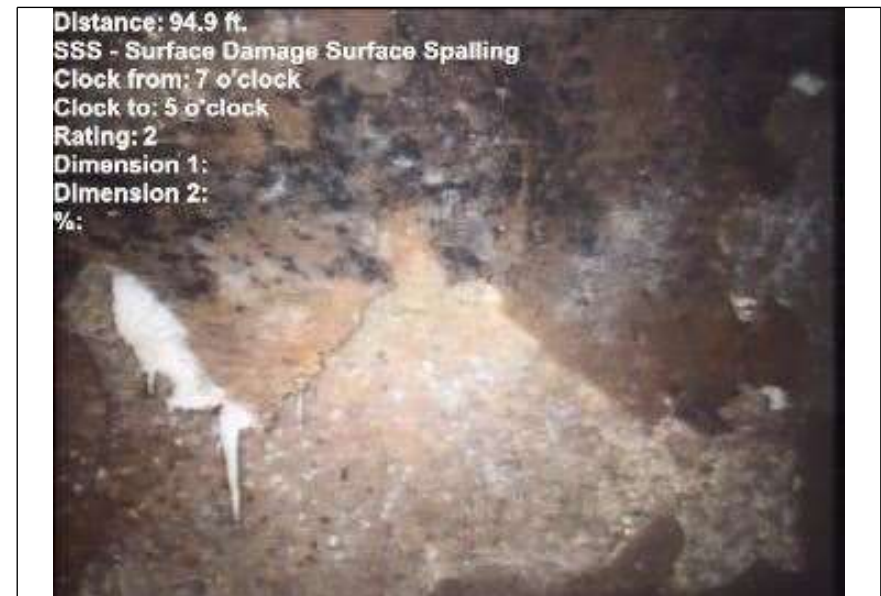
| Distance | Video Ref. | PACP Code | Continuous | S/M/L | Value Inches (mm) | | % | Joint | Circumferential Location | | Rating | Image Ref. | Remarks |
|---|---|---|---|---|---|---|---|---|---|---|---|---|---|
| 94.9 ft. | 00:06:02 | SSS | S02 | | | | | <input type="checkbox"/> | 7 / 5 | | 2 | CITY OF MASSILLON-AMH '1297 SR21'-AMH '1415 SR21'-SSS at 94.9 ft.JPG | |

At: 94.9 ft. 7/5 SSS - Surface Damage Surface Spalling  
 Joint: No

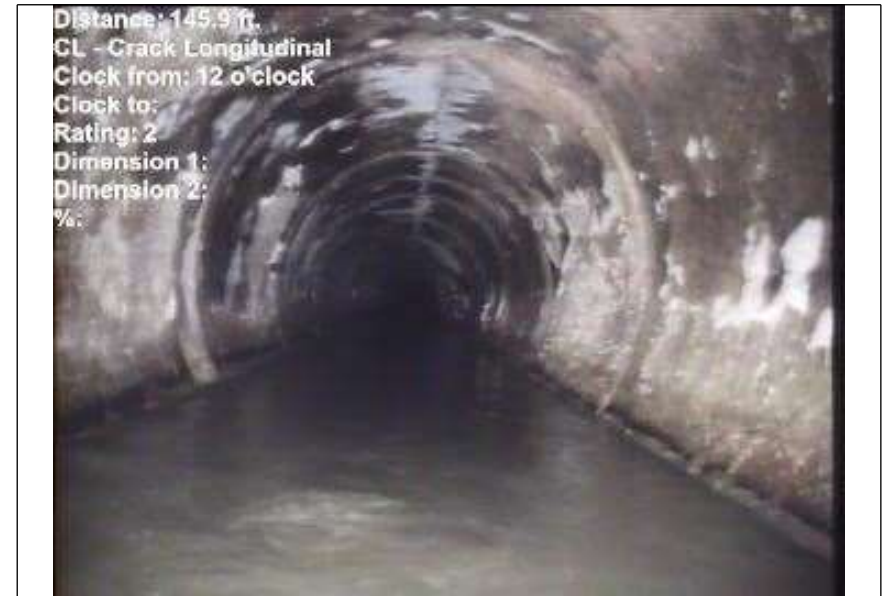
| Distance | Video Ref. | PACP Code | Continuous | S/M/L | Value Inches (mm) | | % | Joint | Circumferential Location | | Rating | Image Ref. | Remarks |
|---|---|---|---|---|---|---|---|---|---|---|---|---|---|
| 145.9 ft. | 00:07:49 | CL | S03 | | | | | <input type="checkbox"/> | 12 / | | 2 | CITY OF MASSILLON-AMH '1297 SR21'-AMH '1415 SR21'-CL at 145.9 ft.JPG | |

At: 145.9 ft. 12/. CL - Crack Longitudinal  
Joint: No

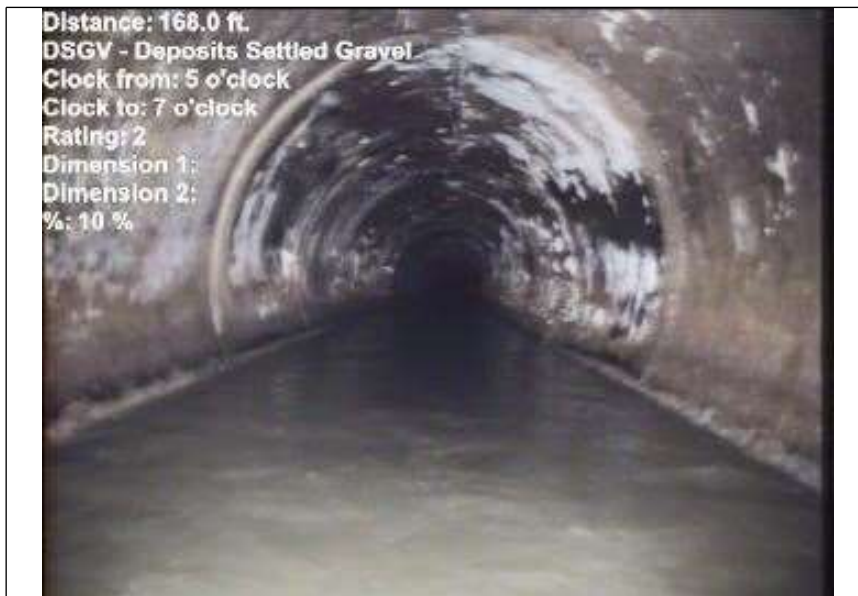
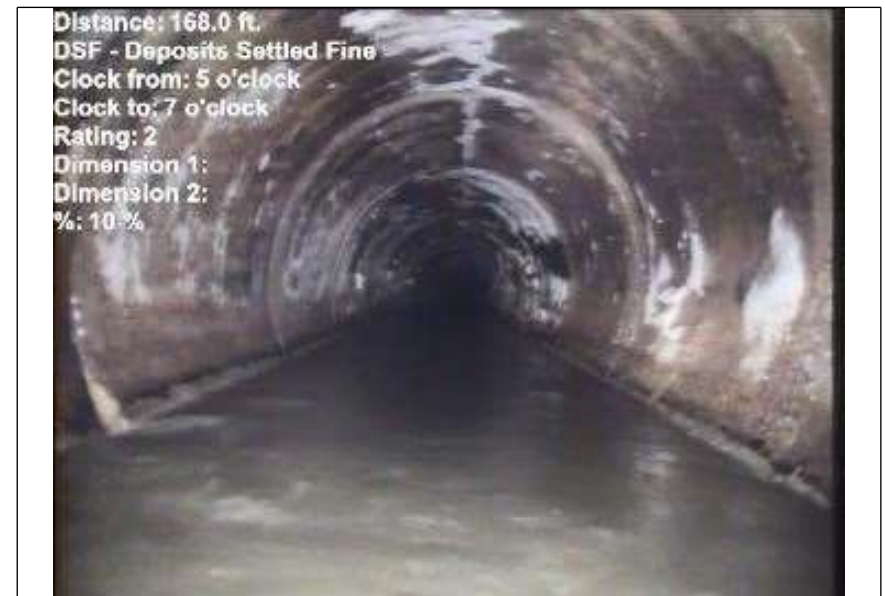
| Distance | Video Ref. | PACP Code | Continuous | S/M/L | Value Inches (mm) | | % | Joint | Circumferential Location | | Rating | Image Ref. | Remarks |
|---|---|---|---|---|---|---|---|---|---|---|---|---|---|
| 168.0 ft. | 00:08:29 | DSGV | S04 | | | | 10 | <input type="checkbox"/> | 5 / 7 | | 2 | CITY OF MASSILLON-AMH '1297 SR21'-AMH '1415 SR21'-DSGV at 168.0 ft.JPG | |

At: 168 ft. 5/7 DSGV - Deposits Settled Gravel  
Joint: No 10 %

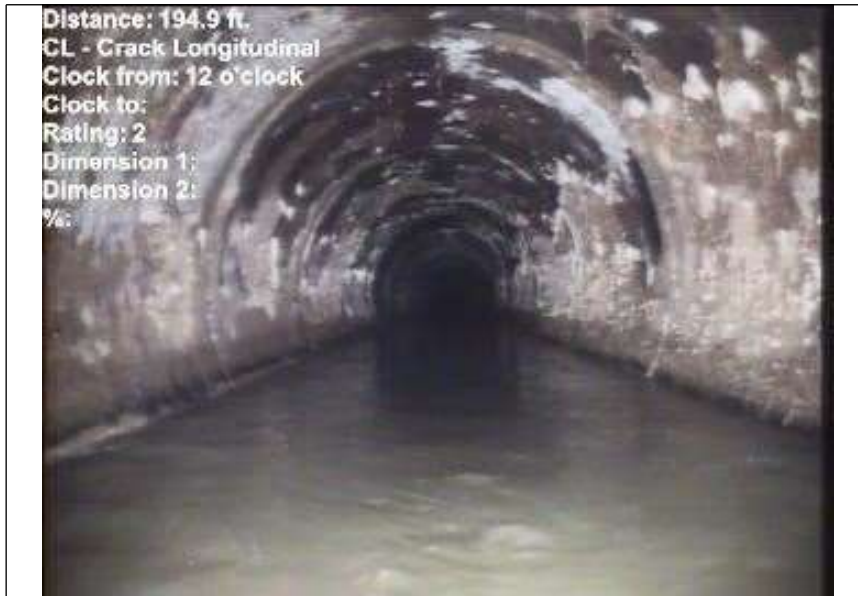
| Distance | Video Ref. | PACP Code | Continuous | S/M/L | Value Inches (mm) | | % | Joint | Circumferential Location | | Rating | Image Ref. | Remarks |
|---|---|---|---|---|---|---|---|---|---|---|---|---|---|
| 194.9 ft. | 00:10:24 | CL | F03 | | | | | <input type="checkbox"/> | 12 | / | 2 | CITY OF MASSILLON-AMH '1297 SR21'-AMH '1415 SR21'-CL at 194.9 ft.JPG | |

At: 194.9 ft. 12/. CL - Crack Longitudinal  
Joint: No

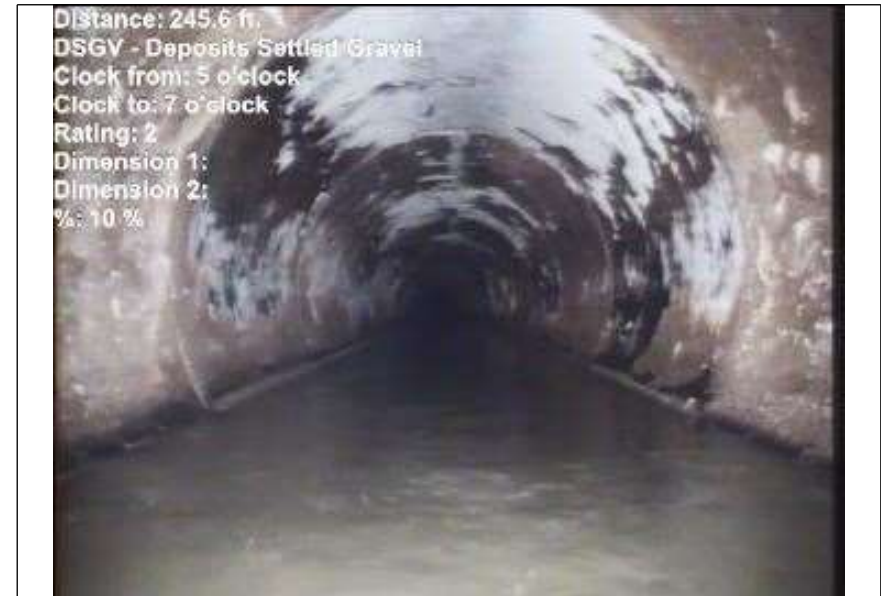
| Distance | Video Ref. | PACP Code | Continuous | S/M/L | Value Inches (mm) | | % | Joint | Circumferential Location | | Rating | Image Ref. | Remarks |
|---|---|---|---|---|---|---|---|---|---|---|---|---|---|
| 245.6 ft. | 00:11:23 | DSGV | F04 | | | | 10 | <input type="checkbox"/> | 5 | / 7 | 2 | CITY OF MASSILLON-AMH '1297 SR21'-AMH '1415 SR21'-DSGV at 245.6 ft.JPG | |

At: 245.6 ft. 5/7 DSGV - Deposits Settled Gravel  
Joint: No 10 %

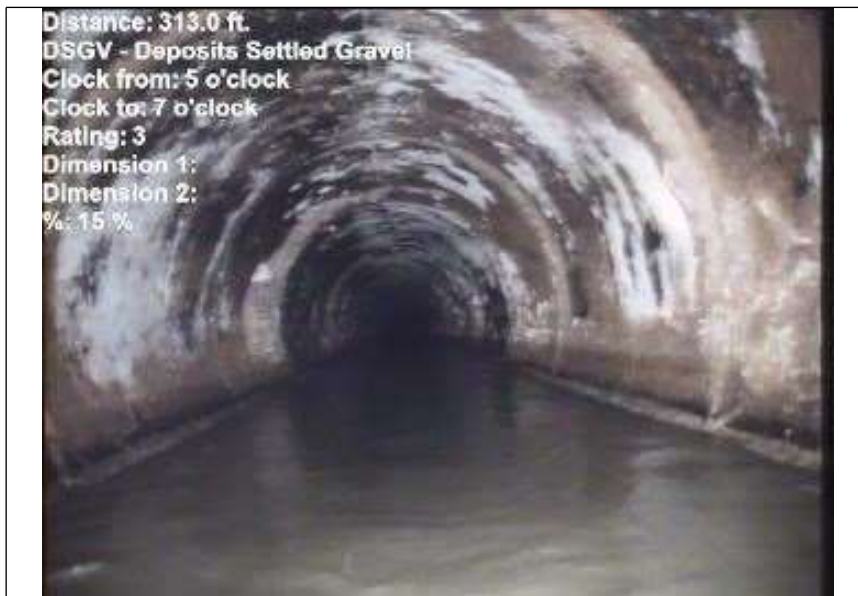
| Distance | Video Ref. | PACP Code | Continuous | S/M/L | Value Inches (mm) | | % | Joint | Circumferential Location | | Rating | Image Ref. | Remarks |
|---|---|---|---|---|---|---|---|---|---|---|---|---|---|
| 313.0 ft. | 00:12:41 | DSGV | S05 | | | | 15 | <input type="checkbox"/> | 5 | / 7 | 3 | CITY OF MASSILLON-AMH '1297 SR21'-AMH '1415 SR21'-DSGV at 313.0 ft.JPG | |

At: 313 ft. 5/7 DSGV - Deposits Settled Gravel  
Joint: No 15 %

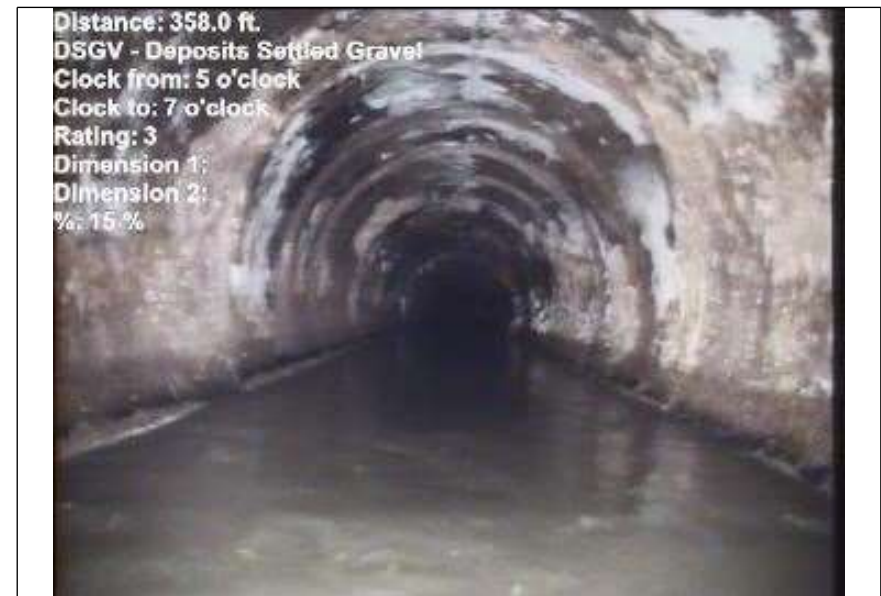
| Distance | Video Ref. | PACP Code | Continuous | S/M/L | Value Inches (mm) | | % | Joint | Circumferential Location | | Rating | Image Ref. | Remarks |
|---|---|---|---|---|---|---|---|---|---|---|---|---|---|
| 358.0 ft. | 00:13:50 | DSGV | F05 | | | | 15 | <input type="checkbox"/> | 5 | / 7 | 3 | CITY OF MASSILLON-AMH '1297 SR21'-AMH '1415 SR21'-DSGV at 358.0 ft.JPG | |

At: 358 ft. 5/7 DSGV - Deposits Settled Gravel  
Joint: No 15 %

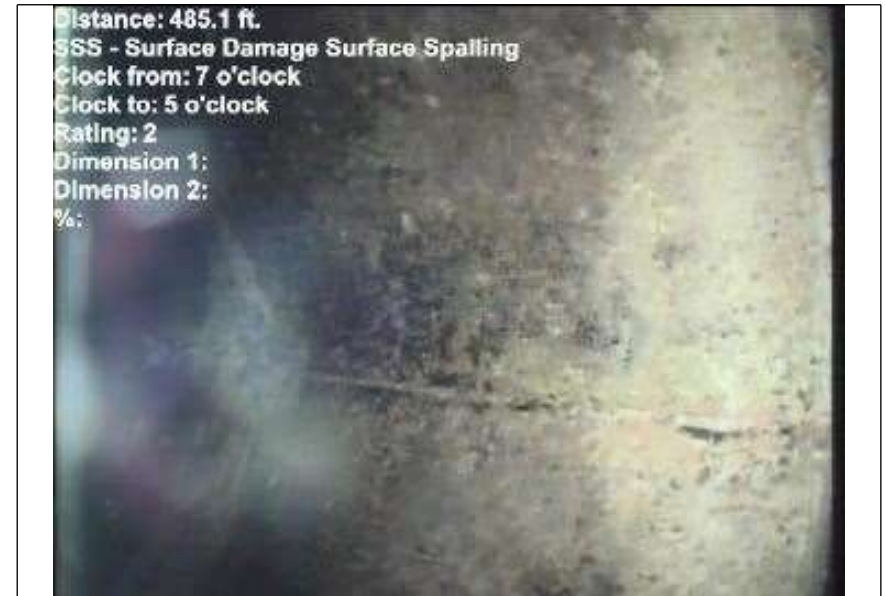
| Distance | Video Ref. | PACP Code | Continuous | S/M/L | Value Inches (mm) | | % | Joint | Circumferential Location | | Rating | Image Ref. | Remarks |
|---|---|---|---|---|---|---|---|---|---|---|---|---|---|
| 485.1 ft. | 00:16:43 | SSS | F02 | | | | | <input type="checkbox"/> | 7 | / 5 | 2 | CITY OF MASSILLON-AMH '1297 SR21'-AMH '1415 SR21'-SSS at 485.1 ft.JPG | |

At: 485.1 ft. 7/5 SSS - Surface Damage Surface Spalling  
Joint: No
