## PACP Report with Pipe Run and Incident Snapshots

| Pipe segment ref.:<br><b>SNG-4-3</b> | Start date/time:<br><b>20220916 11:06</b> | Street:<br><b>BIG INDIAN DR</b> | City:<br><b>MASSILLON</b> | | | |
| Project name:<br><b>CITY OF MASSILLON</b> | Additional info: | | | | | |

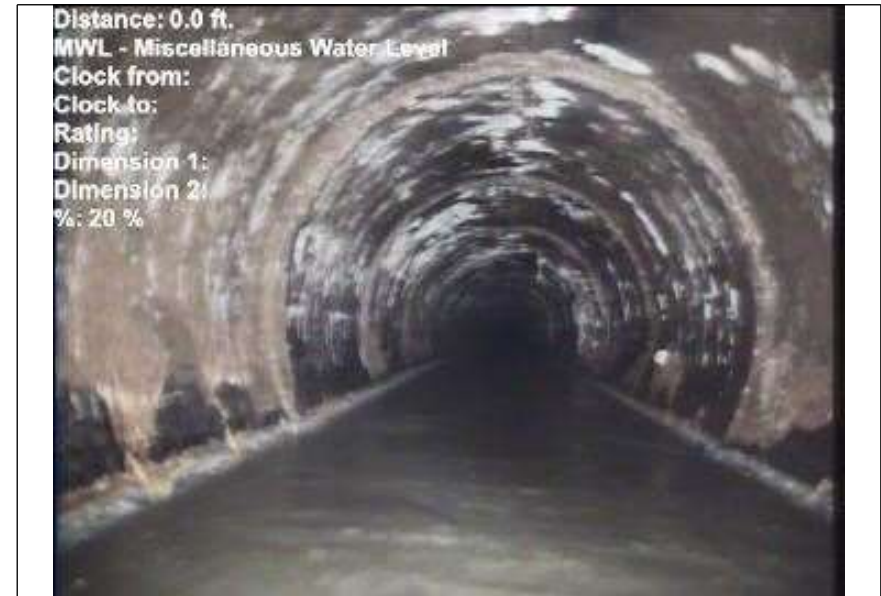
| Distance | Video Ref. | PACP Code | Continuous | S/M/L | Value Inches (mm) | | % | Joint | Circumferential Location | | Rating | Image Ref. | Remarks |
|---|---|---|---|---|---|---|---|---|---|---|---|---|---|
| 0.0 ft. | | MWL | | | | | 20 | <input type="checkbox"/> | / | | | CITY OF MASSILLON-AMH '2183 SR21'-AMH '2497 SR21'-MWL at 0.0 ft.JPG | |

At: 0 ft. MWL - Miscellaneous Water Level  
Joint: No 20 %

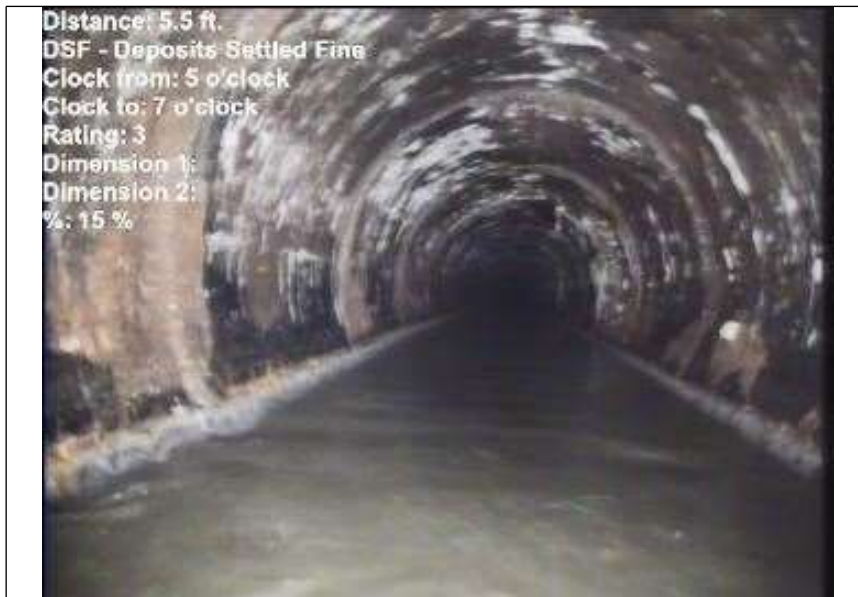
| Distance | Video Ref. | PACP Code | Continuous | S/M/L | Value Inches (mm) | | % | Joint | Circumferential Location | | Rating | Image Ref. | Remarks |
|---|---|---|---|---|---|---|---|---|---|---|---|---|---|
| 5.5 ft. | 00:01:06 | DSF | S01 | | | | 15 | <input type="checkbox"/> | 5 / 7 | | 3 | CITY OF MASSILLON-AMH '2183 SR21'-AMH '2497 SR21'-DSF at 5.5 ft.JPG | |

At: 5.5 ft. 5/7 DSF - Deposits Settled Fine  
Joint: No 15 %

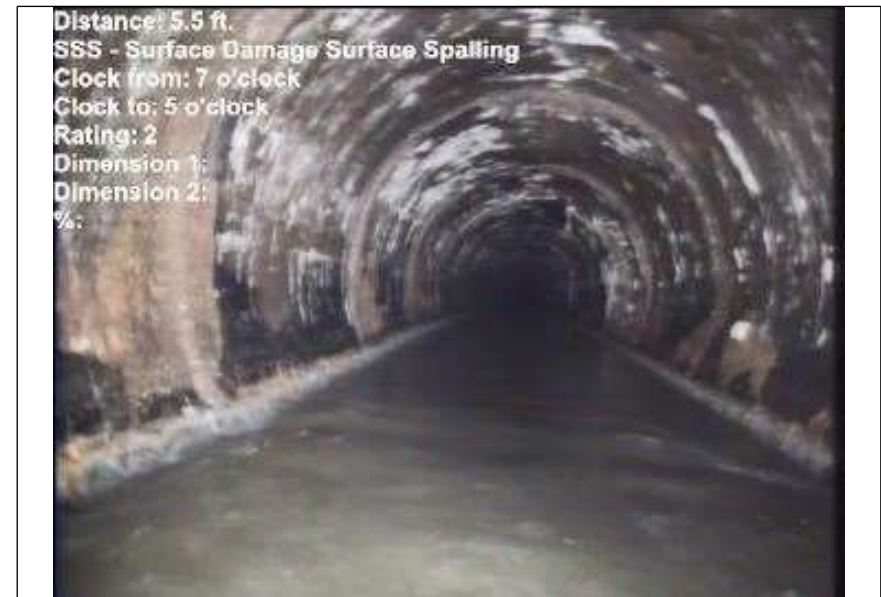
| Distance | Video Ref. | PACP Code | Continuous | S/M/L | Value Inches (mm) | | % | Joint | Circumferential Location | | Rating | Image Ref. | Remarks |
|---|---|---|---|---|---|---|---|---|---|---|---|---|---|
| 5.5 ft. | 00:01:32 | SSS | S02 | | | | | <input type="checkbox"/> | 7 / 5 | | 2 | CITY OF MASSILLON-AMH '2183 SR21'-AMH '2497 SR21'-SSS at 5.5 ft.JPG | |

At: 5.5 ft. 7/5 SSS - Surface Damage Surface Spalling  
Joint: No

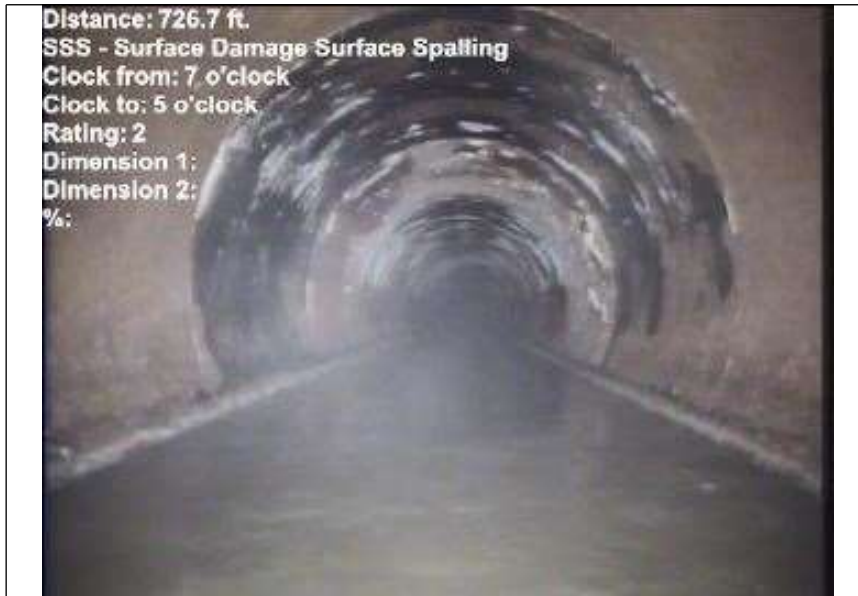
| Distance | Video Ref. | PACP Code | Continuous | S/M/L | Value Inches (mm) | | % | Joint | Circumferential Location | | Rating | Image Ref. | Remarks |
|---|---|---|---|---|---|---|---|---|---|---|---|---|---|
| 726.7 ft. | 00:20:50 | SSS | F02 | | | | | <input type="checkbox"/> | 7 / 5 | | 2 | CITY OF MASSILLON-AMH '2183 SR21'-AMH '2497 SR21'-SSS at 726.7 ft.JPG | |

At: 726.7 ft. 7/5 SSS - Surface Damage Surface Spalling  
Joint: No

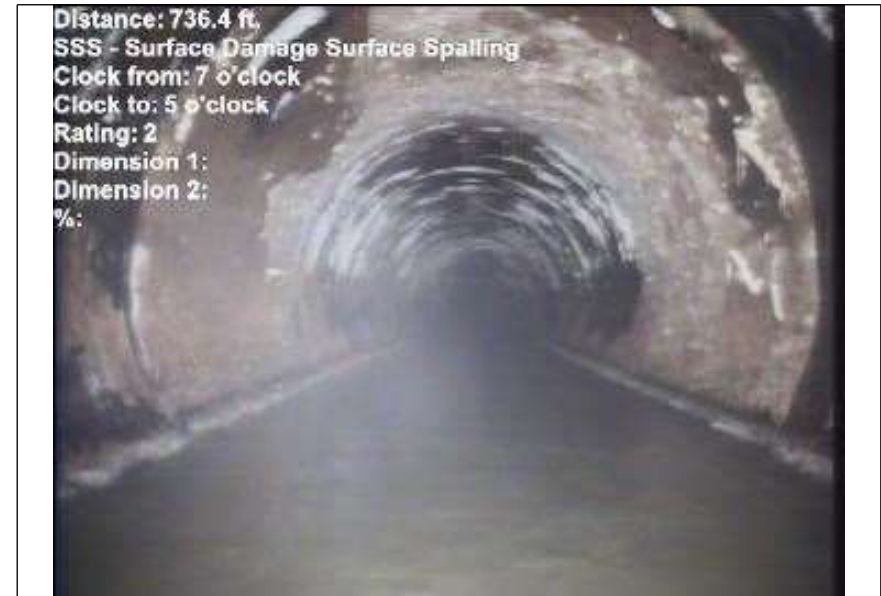
| Distance | Video Ref. | PACP Code | Continuous | S/M/L | Value Inches (mm) | | % | Joint | Circumferential Location | | Rating | Image Ref. | Remarks |
|---|---|---|---|---|---|---|---|---|---|---|---|---|---|
| 736.4 ft. | 00:21:20 | SSS | S03 | | | | | <input type="checkbox"/> | 7 / 5 | | 2 | CITY OF MASSILLON-AMH '2183 SR21'-AMH '2497 SR21'-SSS at 736.4 ft.JPG | |

At: 736.4 ft. 7/5 SSS - Surface Damage Surface Spalling  
Joint: No

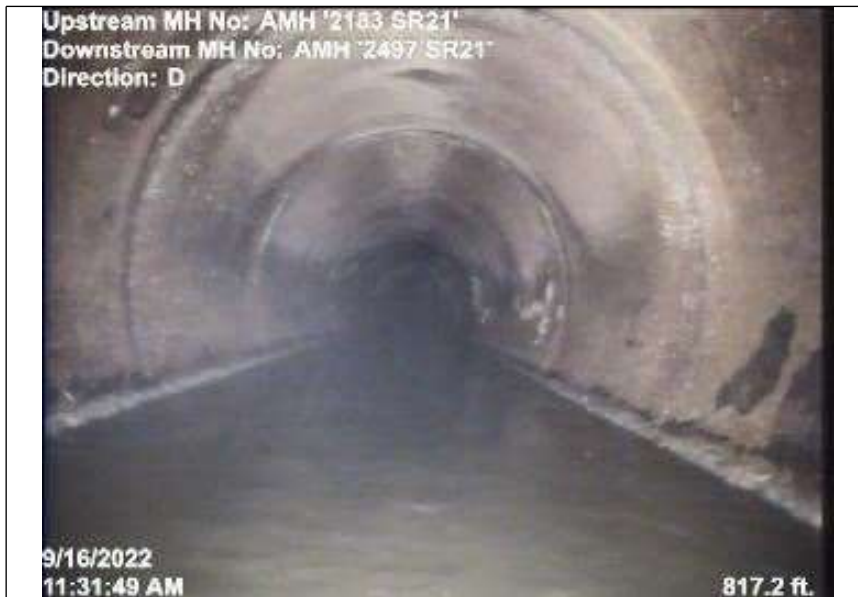
| Distance | Video Ref. | PACP Code | Continuous | S/M/L | Value Inches (mm) | | % | Joint | Circumferential Location | | Rating | Image Ref. | Remarks |
|---|---|---|---|---|---|---|---|---|---|---|---|---|---|
| 816.2 ft. | 00:24:36 | SSS | F03 | | | | | <input type="checkbox"/> | 7 / 5 | | 2 | CITY OF MASSILLON-AMH '2183 SR21'-AMH '2497 SR21'-SSS at 816.2 ft.JPG | |

At: 816.2 ft. 7/5 SSS - Surface Damage Surface Spalling  
Joint: No

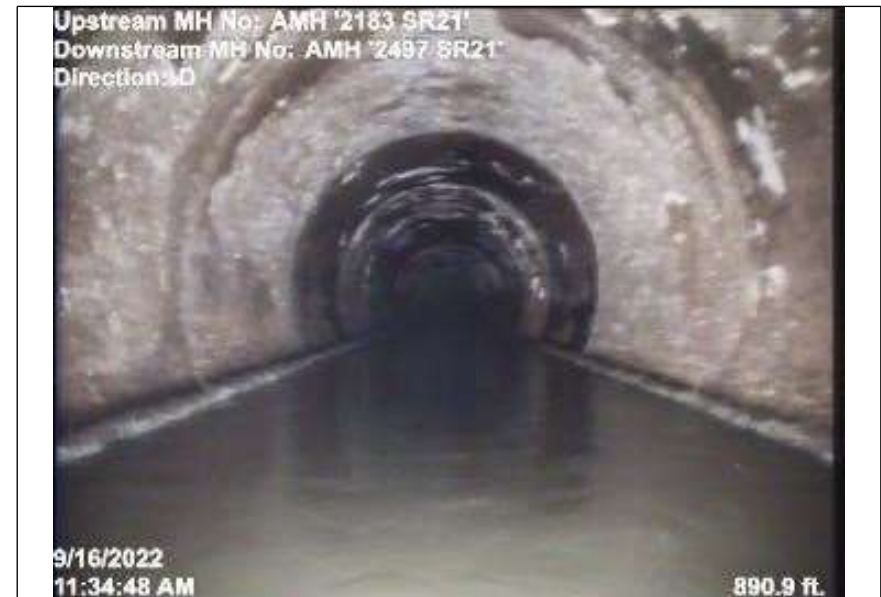
| Distance | Video Ref. | PACP Code | Continuous | S/M/L | Value Inches (mm) | | % | Joint | Circumferential Location | | Rating | Image Ref. | Remarks |
|---|---|---|---|---|---|---|---|---|---|---|---|---|---|
| 883.5 ft. | 00:27:23 | SSC | S04 | | | | | <input type="checkbox"/> | 7 | 5 | 1 | CITY OF MASSILLON-AMH '2183 SR21'-AMH '2497 SR21'-SSC at 883.5 ft.JPG | |

At: 883.5 ft. 7/5 SSC - Surface Spalling of Damage Coating  
Joint: No

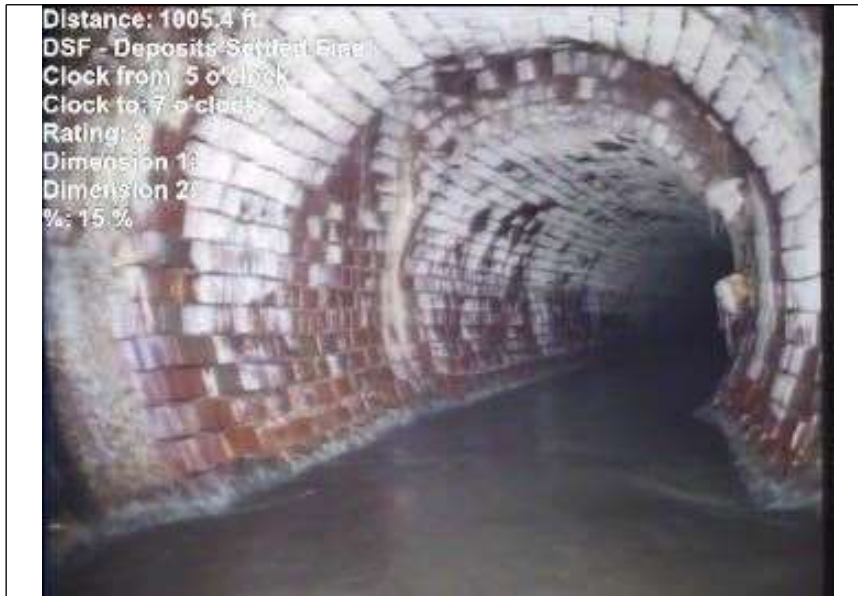
| Distance | Video Ref. | PACP Code | Continuous | S/M/L | Value Inches (mm) | | % | Joint | Circumferential Location | | Rating | Image Ref. | Remarks |
|---|---|---|---|---|---|---|---|---|---|---|---|---|---|
| 1,005.4 ft. | 00:31:45 | DSF | F01 | | | | 15 | <input type="checkbox"/> | 5 | 7 | 3 | CITY OF MASSILLON-AMH '2183 SR21'-AMH '2497 SR21'-DSF at 1_005.4 ft.JPG | |

At: 1005.4 ft. DSF - Deposits Settled Fine  
5/7

Joint: No 15 %

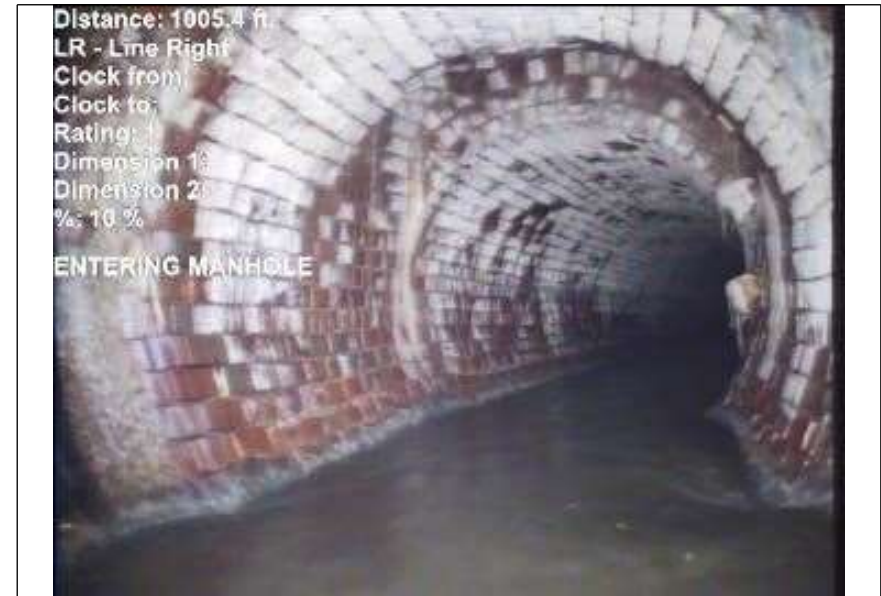
| Distance | Video Ref. | PACP Code | Continuous | S/M/L | Value Inches (mm) | | % | Joint | Circumferential Location | | Rating | Image Ref. | Remarks |
|---|---|---|---|---|---|---|---|---|---|---|---|---|---|
| 1,005.4 ft. | 00:31:59 | LR | | | | | 10 | <input type="checkbox"/> | / | | 1 | CITY OF MASSILLON-AMH '2183 SR21'-AMH '2497 SR21'-LR at 1_005.4 ft.JPG | ENTERING MANHOLE |

At: 1005.4 ft. LR - Line Right

Joint: No 10 % ENTERING MANHOLE

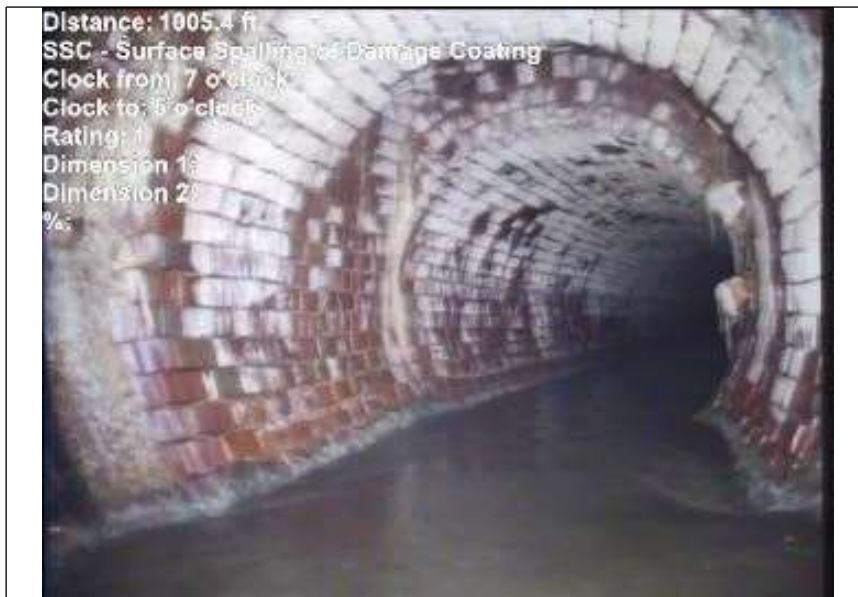
| Distance | Video Ref. | PACP Code | Continuous | S/M/L | Value Inches (mm) | | % | Joint | Circumferential Location | | Rating | Image Ref. | Remarks |
|---|---|---|---|---|---|---|---|---|---|---|---|---|---|
| 1,005.4 ft. | 00:31:52 | SSC | F04 | | | | | <input type="checkbox"/> | 7 | 5 | 1 | CITY OF MASSILLON-AMH '2183 SR21'-AMH '2497 SR21'-SSC at 1_005.4 ft.JPG | |

At: 1005.4 ft. SSC - Surface Spalling of Damage Coating  
7/5

Joint: No

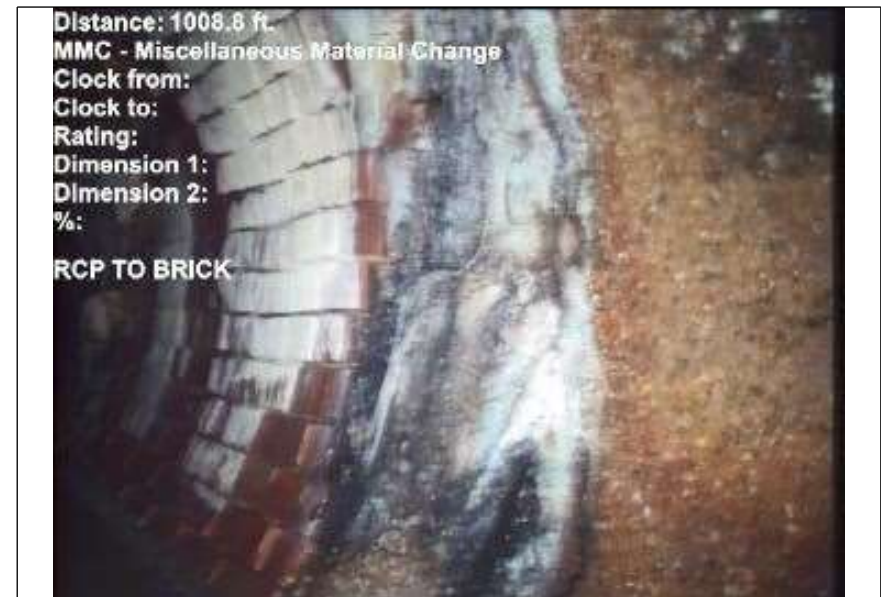
| Distance | Video Ref. | PACP Code | Continuous | S/M/L | Value Inches (mm) | | % | Joint | Circumferential Location | | Rating | Image Ref. | Remarks |
|---|---|---|---|---|---|---|---|---|---|---|---|---|---|
| 1,008.8 ft. | 00:33:06 | MMC | | | | | | <input type="checkbox"/> | / | | | CITY OF MASSILLON-AMH '2183 SR21'-AMH '2497 SR21'-MMC at 1_008.8 ft.JPG | RCP TO BRICK |

At: 1008.8 ft. MMC - Miscellaneous Material Change

Joint: No RCP TO BRICK
