C&K Industrial Services, Inc.  
5617 E. Schaaf Rd.  
Independence, Ohio 44131  
216-642-0055

## PACP Report with Pipe Run and Incident Snapshots

| Pipe segment ref.:<br><b>SNG-4-4</b> | Start date/time:<br><b>20220916 10:47</b> | Street:<br><b>BIG INDIAN DR</b> | City:<br><b>MASSILLON</b> | | | |
| Project name:<br><b>CITY OF MASSILLON</b> | Additional info: | | | | | |

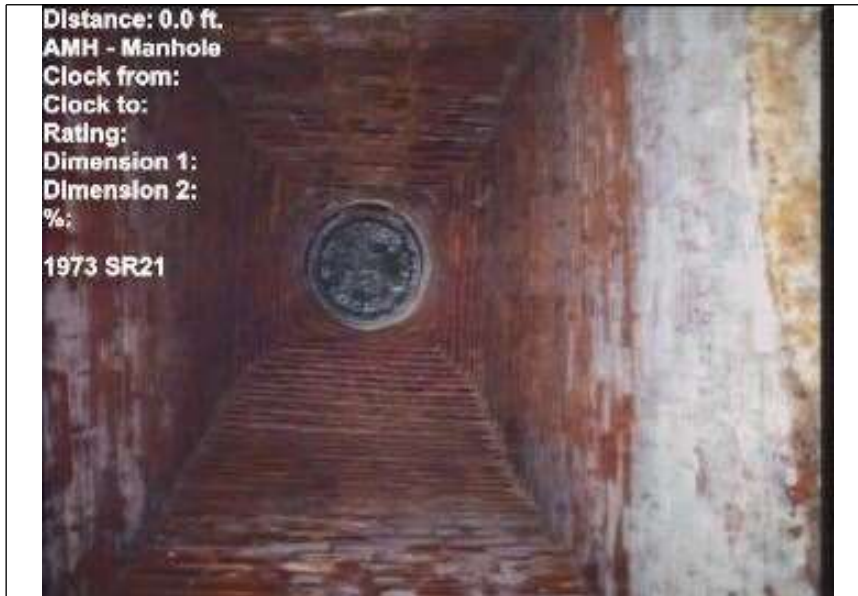
At: 0 ft. AMH - Manhole  
Joint: No 1973 SR21

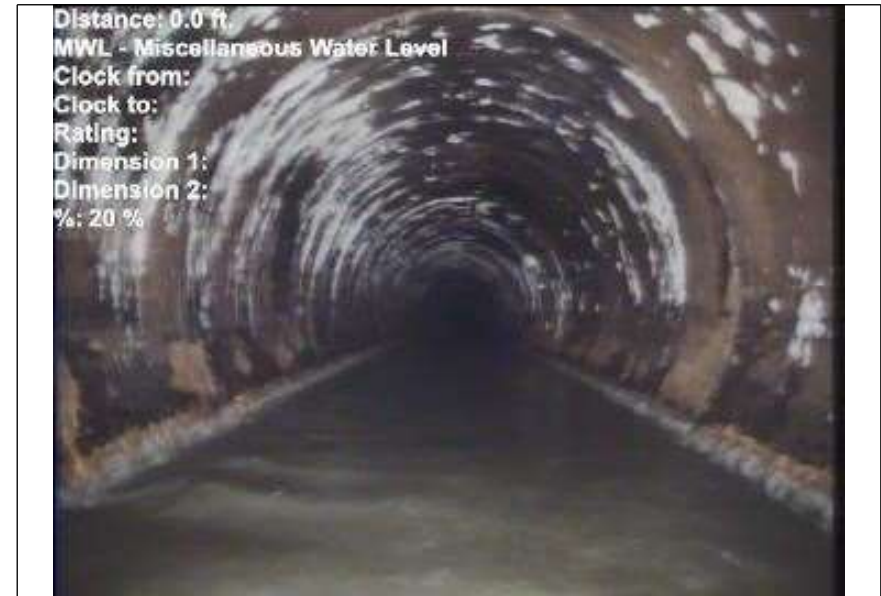
| Distance | Video Ref. | PACP Code | Continuous | S/M/L | Value Inches (mm) | | % | Joint | Circumferential Location | | Rating | Image Ref. | Remarks |
|---|---|---|---|---|---|---|---|---|---|---|---|---|---|
| 0.0 ft. | | MWL | | | | | 20 | <input type="checkbox"/> | / | | | CITY OF MASSILLON-AMH '1973 SR21'-AMH '2183 SR21'-MWL at 0.0 ft.JPG | |

At: 0 ft. MWL - Miscellaneous Water Level  
Joint: No 20 %

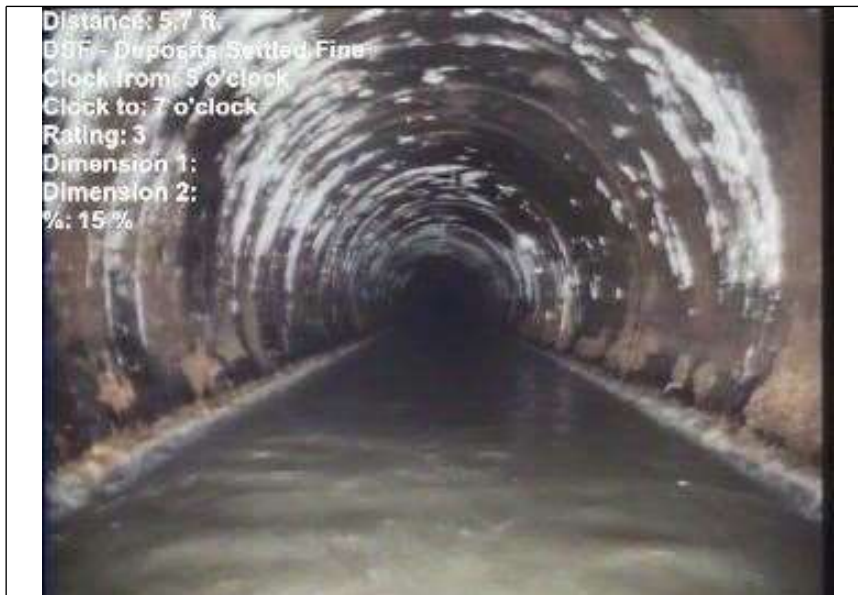
| Distance | Video Ref. | PACP Code | Continuous | S/M/L | Value Inches (mm) | | % | Joint | Circumferential Location | | Rating | Image Ref. | Remarks |
|---|---|---|---|---|---|---|---|---|---|---|---|---|---|
| 5.7 ft. | 00:01:26 | DSF | S01 | | | | 15 | <input type="checkbox"/> | 5 / 7 | | 3 | CITY OF MASSILLON-AMH '1973 SR21'-AMH '2183 SR21'-DSF at 5.7 ft.JPG | |

At: 5.7 ft. 5/7 DSF - Deposits Settled Fine  
Joint: No 15 %

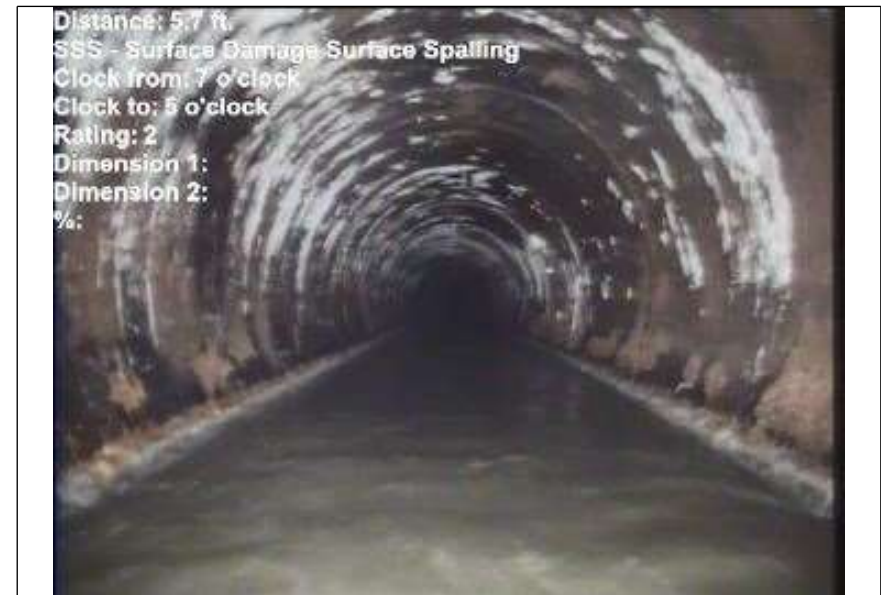
| Distance | Video Ref. | PACP Code | Continuous | S/M/L | Value Inches (mm) | | % | Joint | Circumferential Location | | Rating | Image Ref. | Remarks |
|---|---|---|---|---|---|---|---|---|---|---|---|---|---|
| 5.7 ft. | 00:01:52 | SSS | S02 | | | | | <input type="checkbox"/> | 7 / 5 | | 2 | CITY OF MASSILLON-AMH '1973 SR21'-AMH '2183 SR21'-SSS at 5.7 ft.JPG | |

At: 5.7 ft. 7/5 SSS - Surface Damage Surface Spalling  
Joint: No

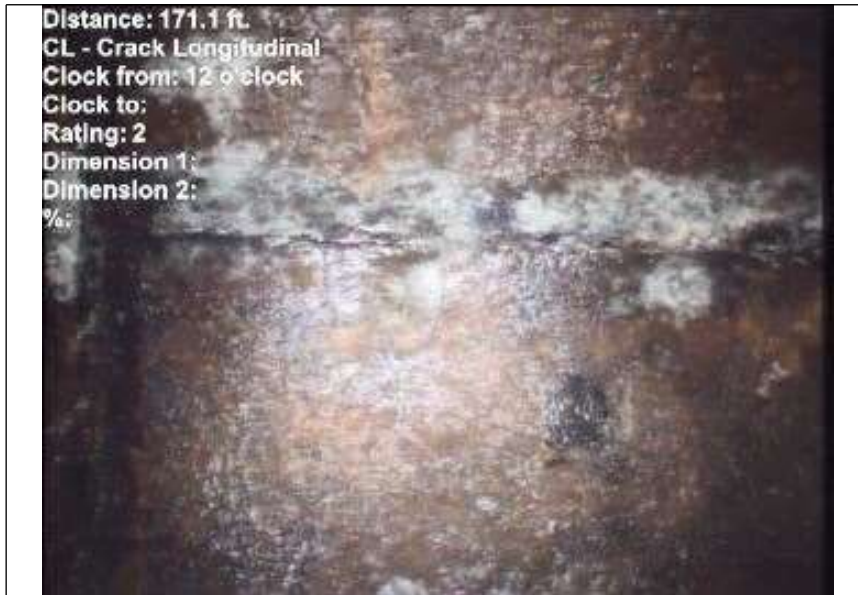
| Distance | Video Ref. | PACP Code | Continuous | S/M/L | Value Inches (mm) | | % | Joint | Circumferential Location | | Rating | Image Ref. | Remarks |
|---|---|---|---|---|---|---|---|---|---|---|---|---|---|
| 171.1 ft. | 00:06:08 | CL | S03 | | | | | <input type="checkbox"/> | 12 / | | 2 | CITY OF MASSILLON-AMH '1973 SR21'-AMH '2183 SR21'-CL at 171.1 ft.JPG | |

At: 171.1 ft. 12/. CL - Crack Longitudinal  
Joint: No

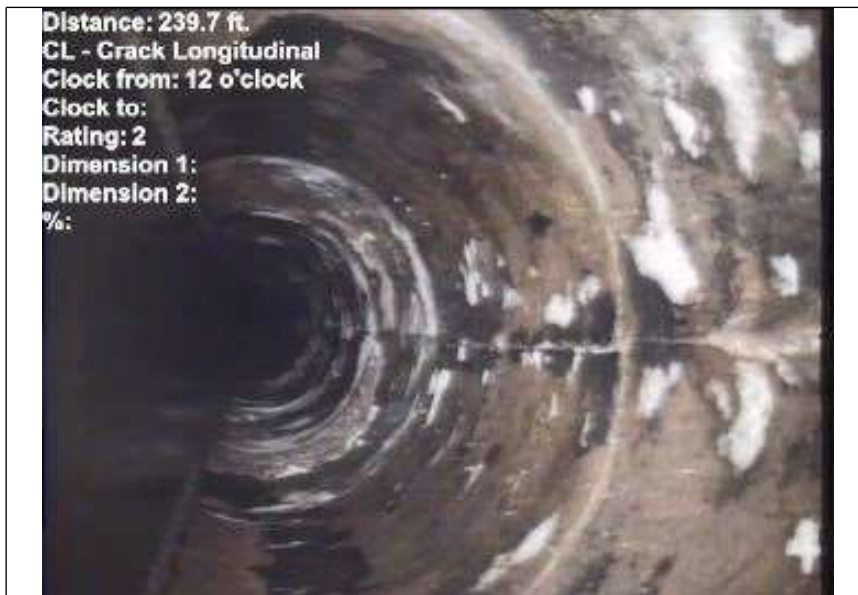
| Distance | Video Ref. | PACP Code | Continuous | S/M/L | Value Inches (mm) | | % | Joint | Circumferential Location | | Rating | Image Ref. | Remarks |
|---|---|---|---|---|---|---|---|---|---|---|---|---|---|
| 239.7 ft. | 00:08:46 | CL | S04 | | | | | <input type="checkbox"/> | 12 / | | 2 | CITY OF MASSILLON-AMH '1973 SR21'-AMH '2183 SR21'-CL at 239.7 ft.JPG | |

At: 239.7 ft. 12/. CL - Crack Longitudinal  
Joint: No

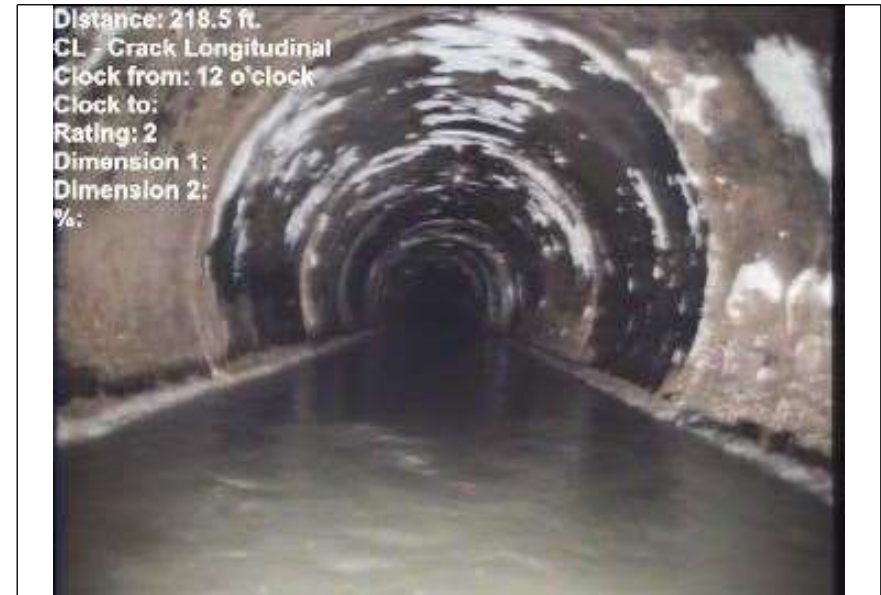
| Distance | Video Ref. | PACP Code | Continuous | S/M/L | Value Inches (mm) | | % | Joint | Circumferential Location | | Rating | Image Ref. | Remarks |
|---|---|---|---|---|---|---|---|---|---|---|---|---|---|
| 218.5 ft. | 00:07:39 | CL | F03 | | | | | <input type="checkbox"/> | 12 / | | 2 | CITY OF MASSILLON-AMH '1973 SR21'-AMH '2183 SR21'-CL at 218.5 ft.JPG | |

At: 218.5 ft. 12/. CL - Crack Longitudinal  
Joint: No

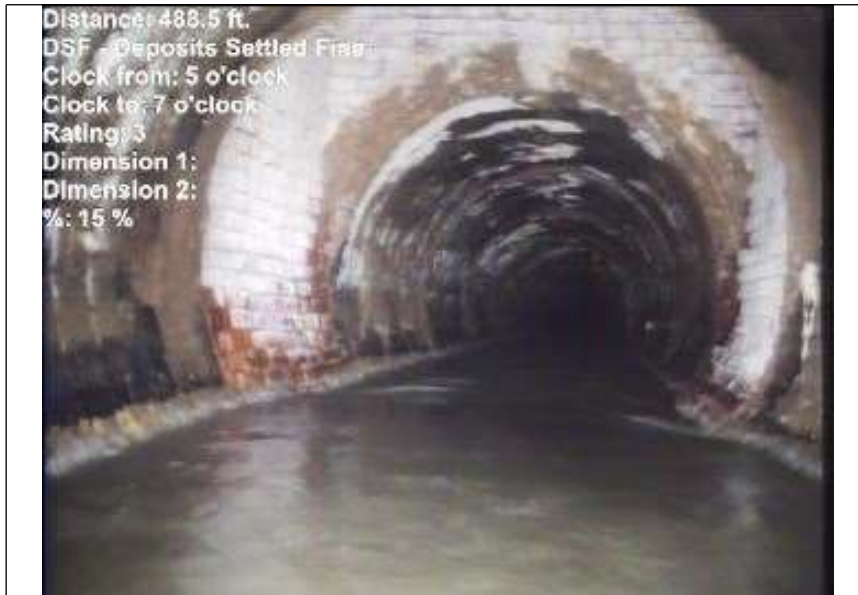
| Distance | Video Ref. | PACP Code | Continuous | S/M/L | Value Inches<br>(mm) | | % | Joint | Circumferential<br>Location<br>At/From To | | Rating | Image Ref. | Remarks |
|---|---|---|---|---|---|---|---|---|---|---|---|---|---|
| 488.5 ft. 00:14:44 | | DSF | F01 | | | | 15 | <input type="checkbox"/> | 5 | / 7 | 3 | CITY OF<br>MASSILLON-AMH<br>'1973 SR21'-AMH<br>'2183 SR21'-DSF at<br>488.5 ft.JPG | |

At: 488.5 ft. 5/7 DSF - Deposits Settled Fine

Joint: No 15 %

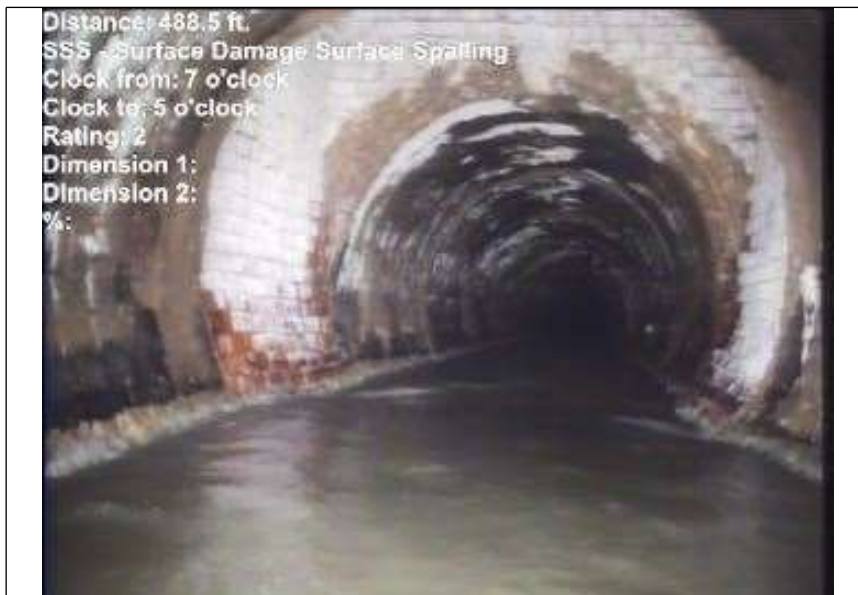
| Distance | Video Ref. | PACP Code | Continuous | S/M/L | Value Inches<br>(mm) | | % | Joint | Circumferential<br>Location<br>At/From To | | Rating | Image Ref. | Remarks |
|---|---|---|---|---|---|---|---|---|---|---|---|---|---|
| 488.5 ft. 00:14:51 | | SSS | F02 | | | | | <input type="checkbox"/> | 7 | / 5 | 2 | CITY OF<br>MASSILLON-AMH<br>'1973 SR21'-AMH<br>'2183 SR21'-SSS at<br>488.5 ft.JPG | |

At: 488.5 ft. 7/5 SSS - Surface Damage Surface Spalling

Joint: No

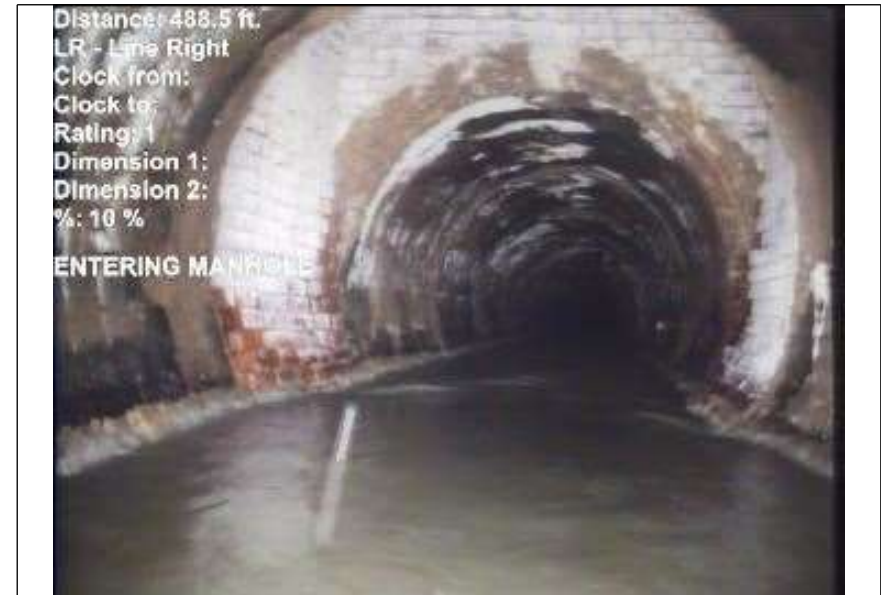
| Distance | Video Ref. | PACP Code | Continuous | S/M/L | Value Inches<br>(mm) | | % | Joint | Circumferential<br>Location<br>At/From To | | Rating | Image Ref. | Remarks |
|---|---|---|---|---|---|---|---|---|---|---|---|---|---|
| 488.5 ft. 00:14:59 | | LR | | | | | 10 | <input type="checkbox"/> | / | | 1 | CITY OF<br>MASSILLON-AMH<br>'1973 SR21'-AMH<br>'2183 SR21'-LR at<br>488.5 ft.JPG | ENTERING MANHOLE |

At: 488.5 ft. LR - Line Right

Joint: No 10 % ENTERING MANHOLE

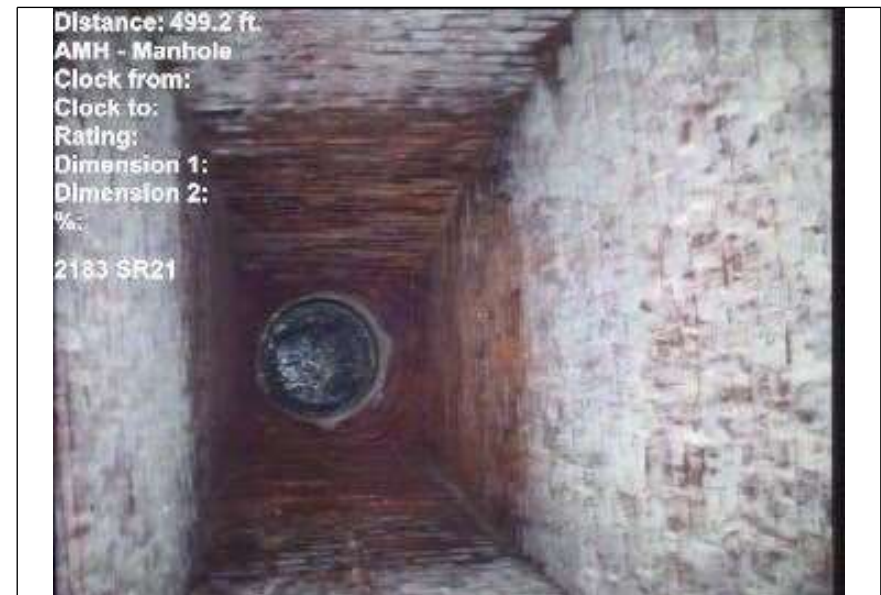
At: 499.2 ft. AMH - Manhole

Joint: No 2183 SR21
