## PACP Report with Pipe Run and Incident Snapshots

| Pipe segment ref.:<br><b>SNG-4-7</b> | Start date/time:<br><b>20220915 14:56</b> | Street:<br><b>ERIE ST</b> | City:<br><b>MASSILLON</b> | | | |
| Project name:<br><b>CITY OF MASSILLON</b> | Additional info: | | | | | |

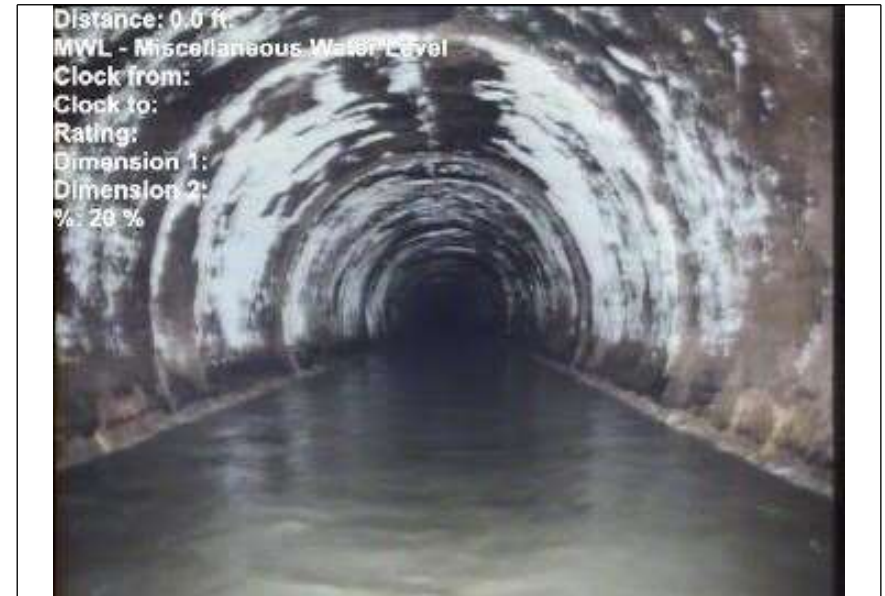
| Distance | Video Ref. | PACP Code | Continuous | S/M/L | Value Inches<br>(mm) | | % | Joint | Circumferential<br>Location<br>At/From To | | Rating | Image Ref. | Remarks |
|---|---|---|---|---|---|---|---|---|---|--|---|---|---|
| 0.0 ft. | | MWL | | | | | 20 | <input type="checkbox"/> | / | | | CITY OF<br>MASSILLON-AMH<br>'1623 SR21'-AMH<br>'1793 SR21'-MWL at<br>0.0 ft.JPG | |

At: 0 ft. MWL - Miscellaneous Water Level  
 Joint: No 20 %

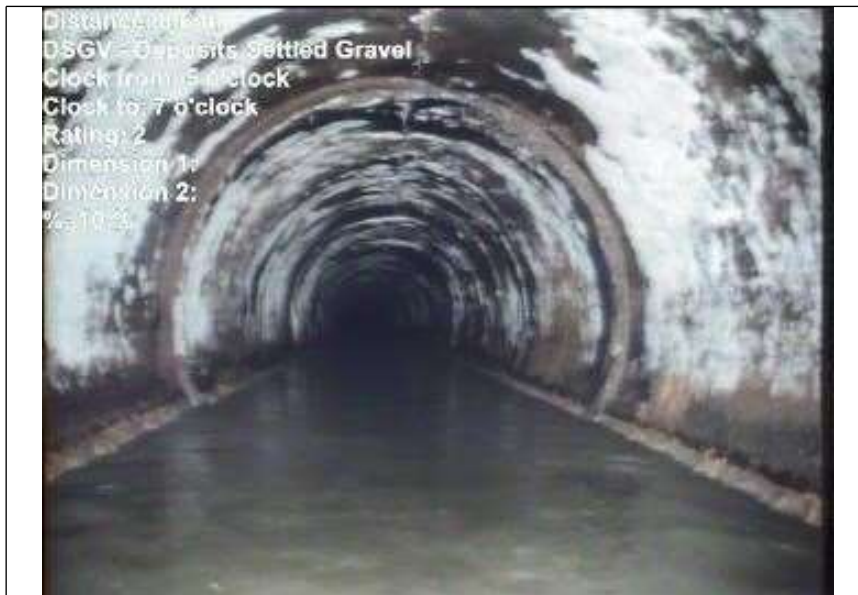
| Distance | Video Ref. | PACP Code | Continuous | S/M/L | Value Inches<br>(mm) | | % | Joint | Circumferential<br>Location<br>At/From To | | Rating | Image Ref. | Remarks |
|---|---|---|---|---|---|---|---|---|---|--|---|---|---|
| 8.6 ft. | 00:01:31 | DSGV | S01 | | | | 10 | <input type="checkbox"/> | 5 / 7 | | 2 | CITY OF<br>MASSILLON-AMH<br>'1623 SR21'-AMH<br>'1793 SR21'-DSGV at<br>8.6 ft.JPG | |

At: 8.6 ft. 5/7 DSGV - Deposits Settled Gravel  
 Joint: No 10 %

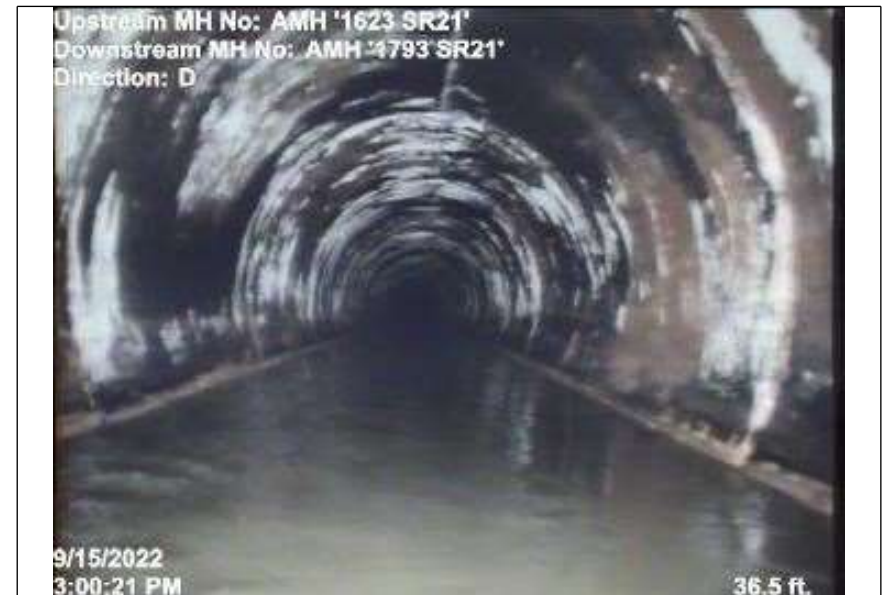
| Distance | Video Ref. | PACP Code | Continuous | S/M/L | Value Inches<br>(mm) | | % | Joint | Circumferential<br>Location<br>At/From To | | Rating | Image Ref. | Remarks |
|---|---|---|---|---|---|---|---|---|---|--|---|---|---|
| 32.9 ft. | 00:02:34 | DSGV | F01 | | | | 10 | <input type="checkbox"/> | 5 / 7 | | 2 | CITY OF<br>MASSILLON-AMH<br>'1623 SR21'-AMH<br>'1793 SR21'-DSGV at<br>32.9 ft.JPG | |

At: 32.9 ft. 5/7 DSGV - Deposits Settled Gravel  
 Joint: No 10 %

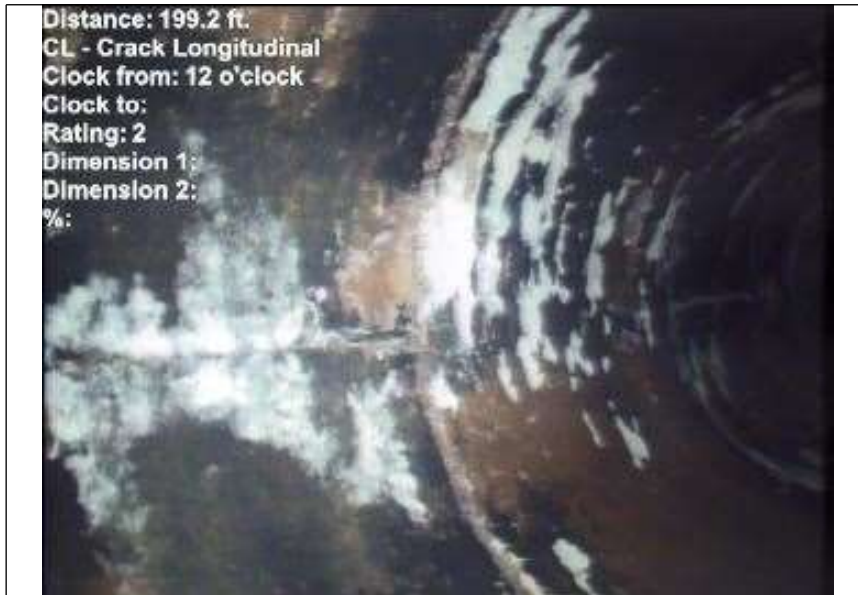
| Distance | Video Ref. | PACP Code | Continuous | S/M/L | Value Inches<br>(mm) | | % | Joint | Circumferential<br>Location<br>At/From To | | Rating | Image Ref. | Remarks |
|---|---|---|---|---|---|---|---|---|---|--|---|---|---|
| 199.2 ft. | 00:07:02 | CL | S02 | | | | | <input type="checkbox"/> | 12 / | | 2 | CITY OF<br>MASSILLON-AMH<br>'1623 SR21'-AMH<br>'1793 SR21'-CL at<br>199.2 ft.JPG | |

At: 199.2 ft. 12/. CL - Crack Longitudinal  
Joint: No

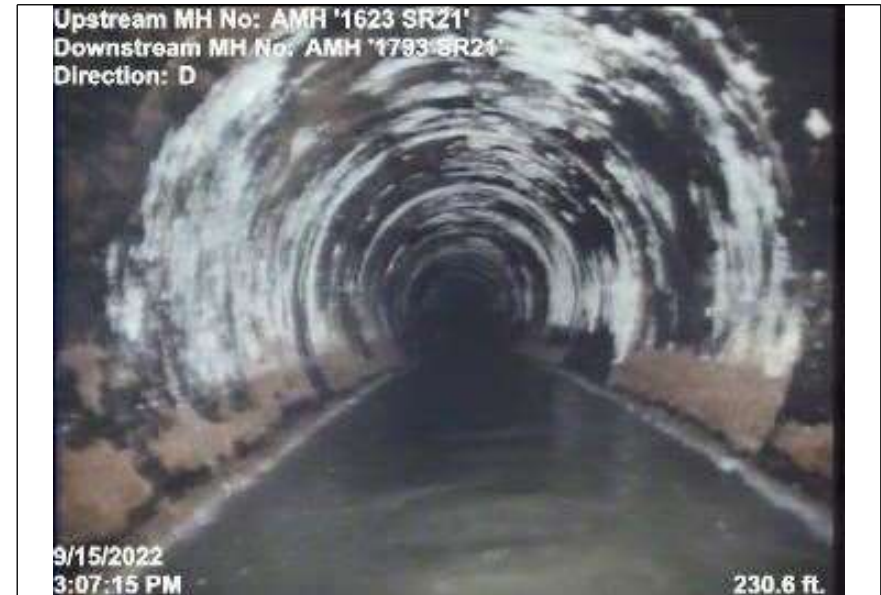
| Distance | Video Ref. | PACP Code | Continuous | S/M/L | Value Inches<br>(mm) | | % | Joint | Circumferential<br>Location<br>At/From To | | Rating | Image Ref. | Remarks |
|---|---|---|---|---|---|---|---|---|---|--|---|---|---|
| 227.0 ft. | 00:07:59 | CL | F02 | | | | | <input type="checkbox"/> | 12 / | | 2 | CITY OF<br>MASSILLON-AMH<br>'1623 SR21'-AMH<br>'1793 SR21'-CL at<br>227.0 ft.JPG | |

At: 227 ft. 12/. CL - Crack Longitudinal  
Joint: No

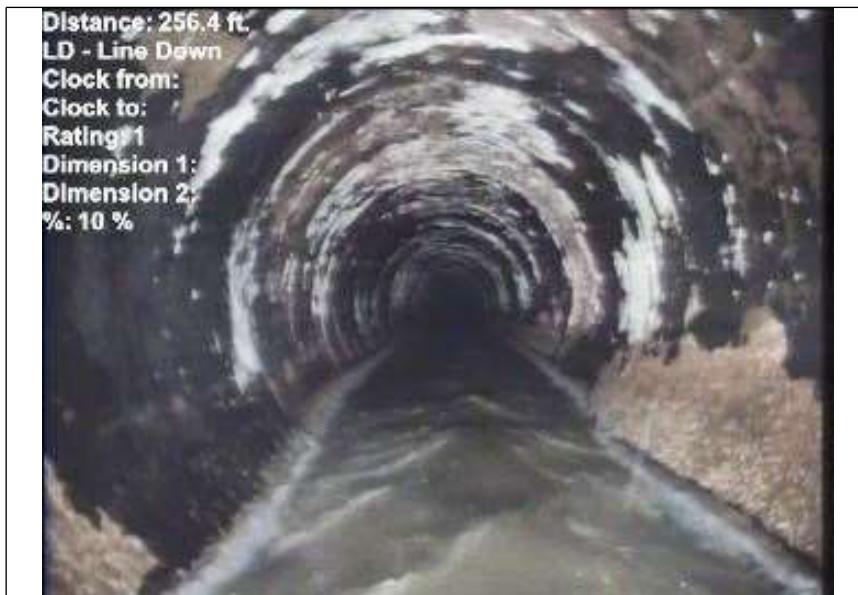
| Distance | Video Ref. | PACP Code | Continuous | S/M/L | Value Inches<br>(mm) | | % | Joint | Circumferential<br>Location<br>At/From To | | Rating | Image Ref. | Remarks |
|---|---|---|---|---|---|---|---|---|---|--|---|---|---|
| 256.4 ft. | 00:08:39 | LD | S03 | | | | 10 | <input type="checkbox"/> | / | | 1 | CITY OF<br>MASSILLON-AMH<br>'1623 SR21'-AMH<br>'1793 SR21'-LD at<br>256.4 ft.JPG | |

At: 256.4 ft. LD - Line Down  
Joint: No 10 %

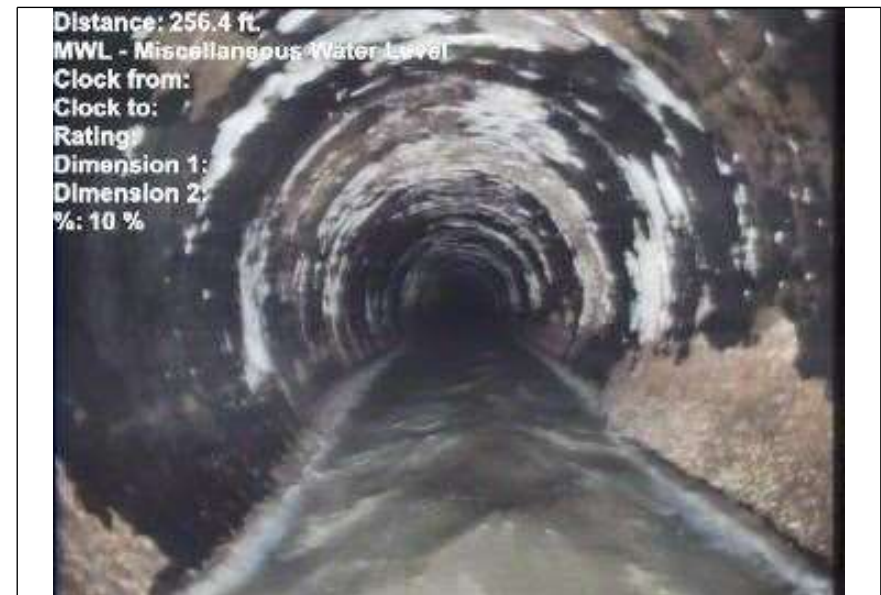
| Distance | Video Ref. | PACP Code | Continuous | S/M/L | Value Inches (mm) | | % | Joint | Circumferential Location | | Rating | Image Ref. | Remarks |
|---|---|---|---|---|---|---|---|---|---|---|---|---|---|
| 256.4 ft. | 00:08:58 | MWL | | | | | 10 | <input type="checkbox"/> | / | | | CITY OF MASSILLON-AMH '1623 SR21'-AMH '1793 SR21'-MWL at 256.4 ft.JPG | |

At: 256.4 ft. MWL - Miscellaneous Water Level  
Joint: No 10 %

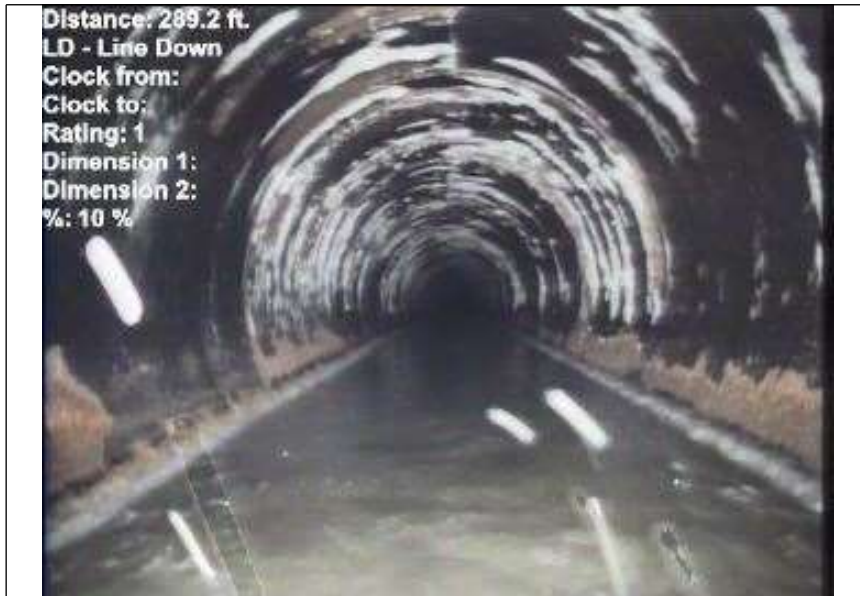
| Distance | Video Ref. | PACP Code | Continuous | S/M/L | Value Inches (mm) | | % | Joint | Circumferential Location | | Rating | Image Ref. | Remarks |
|---|---|---|---|---|---|---|---|---|---|---|---|---|---|
| 289.2 ft. | 00:10:21 | LD | F03 | | | | 10 | <input type="checkbox"/> | / | | 1 | CITY OF MASSILLON-AMH '1623 SR21'-AMH '1793 SR21'-LD at 289.2 ft.JPG | |

At: 289.2 ft. LD - Line Down  
Joint: No 10 %

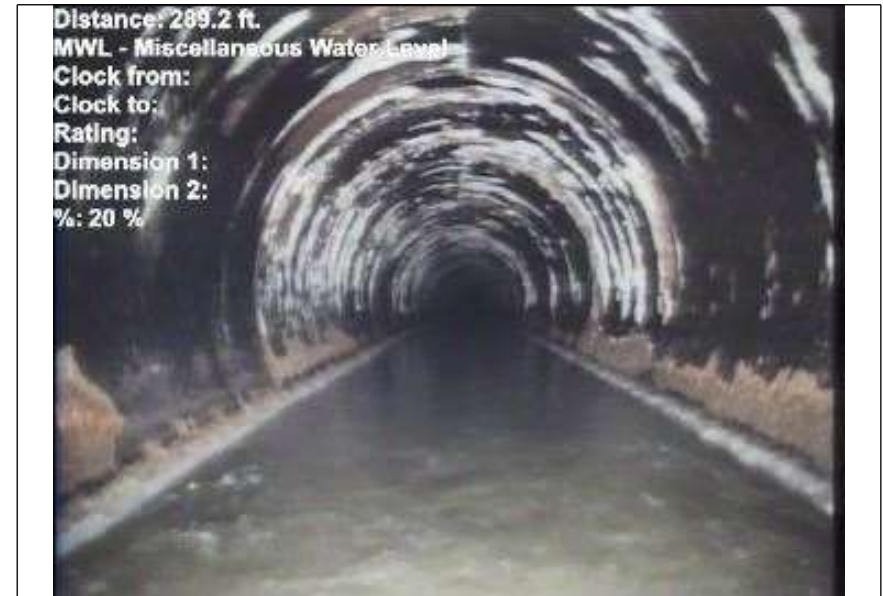
| Distance | Video Ref. | PACP Code | Continuous | S/M/L | Value Inches (mm) | | % | Joint | Circumferential Location | | Rating | Image Ref. | Remarks |
|---|---|---|---|---|---|---|---|---|---|---|---|---|---|
| 289.2 ft. | 00:09:57 | MWL | | | | | 20 | <input type="checkbox"/> | / | | | CITY OF MASSILLON-AMH '1623 SR21'-AMH '1793 SR21'-MWL at 289.2 ft.JPG | |

At: 289.2 ft. MWL - Miscellaneous Water Level  
Joint: No 20 %
