C&K Industrial Services, Inc.  
5617 E. Schaaf Rd.  
Independence, Ohio 44131  
216-642-0055

## PACP Report with Pipe Run and Incident Snapshots

| Pipe segment ref.:<br><b>SNG-4-9</b> | Start date/time:<br><b>20220915 14:20</b> | Street:<br><b>ERIE ST</b> | City:<br><b>MASSILLON</b> | | | |

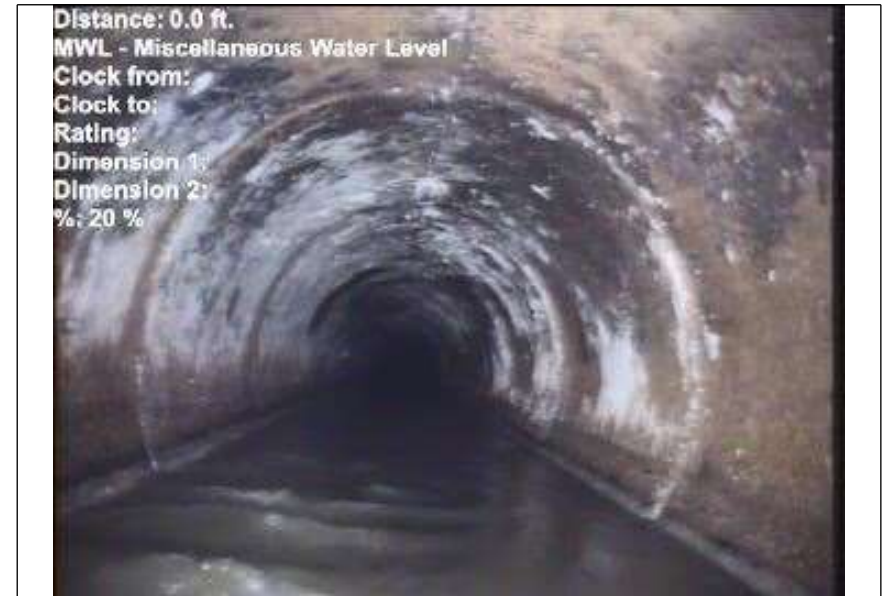
| Distance | Video Ref. | PACP Code | Continuous | S/M/L | Value Inches (mm) | | % | Joint | Circumferential Location | | Rating | Image Ref. | Remarks |
|---|---|---|---|---|---|---|---|---|---|---|---|---|---|
| 0.0 ft. | | MWL | | | | | 20 | <input type="checkbox"/> | / | | | CITY OF MASSILLON-AMH '1415 SR21'-AMH '1503 SR21'-MWL at 0.0 ft.JPG | |

At: 0 ft. MWL - Miscellaneous Water Level  
Joint: No 20 %

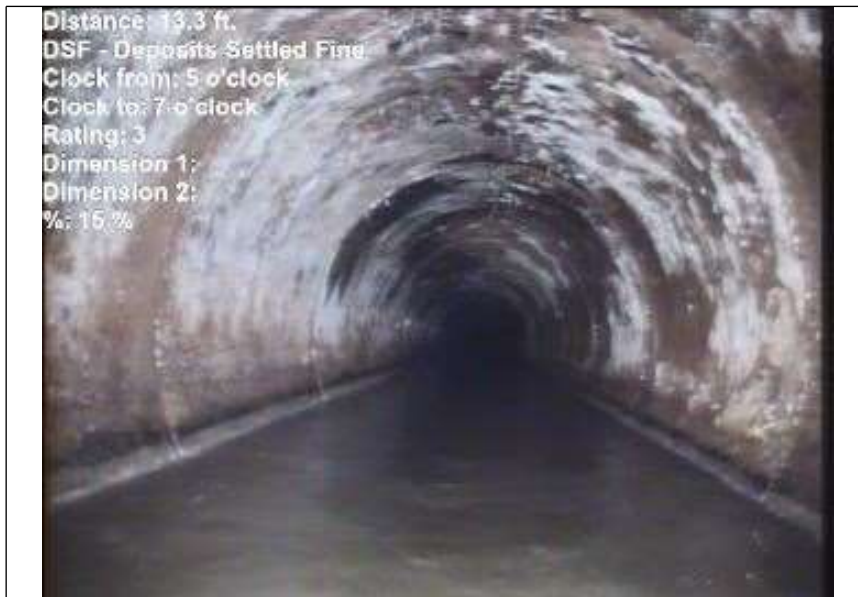
| Distance | Video Ref. | PACP Code | Continuous | S/M/L | Value Inches (mm) | | % | Joint | Circumferential Location | | Rating | Image Ref. | Remarks |
|---|---|---|---|---|---|---|---|---|---|---|---|---|---|
| 13.3 ft. | 00:01:10 | DSF | S01 | | | | 15 | <input type="checkbox"/> | 5 / 7 | | 3 | CITY OF MASSILLON-AMH '1415 SR21'-AMH '1503 SR21'-DSF at 13.3 ft.JPG | |

At: 13.3 ft. 5/7 DSF - Deposits Settled Fine  
Joint: No 15 %

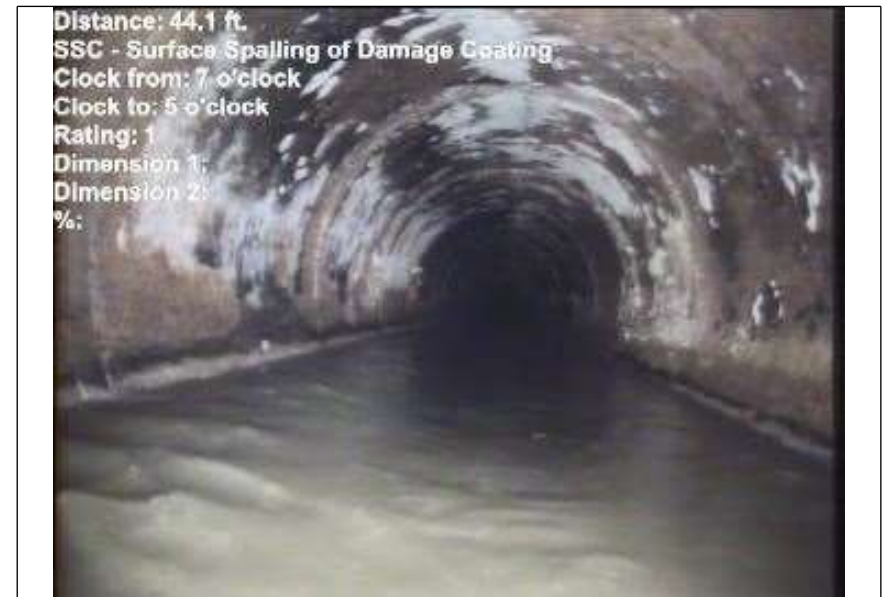
| Distance | Video Ref. | PACP Code | Continuous | S/M/L | Value Inches (mm) | | % | Joint | Circumferential Location | | Rating | Image Ref. | Remarks |
|---|---|---|---|---|---|---|---|---|---|---|---|---|---|
| 44.1 ft. | 00:02:16 | SSC | S02 | | | | | <input type="checkbox"/> | 7 / 5 | | 1 | CITY OF MASSILLON-AMH '1415 SR21'-AMH '1503 SR21'-SSC at 44.1 ft.JPG | |

At: 44.1 ft. 7/5 SSC - Surface Spalling of Damage Coating  
Joint: No

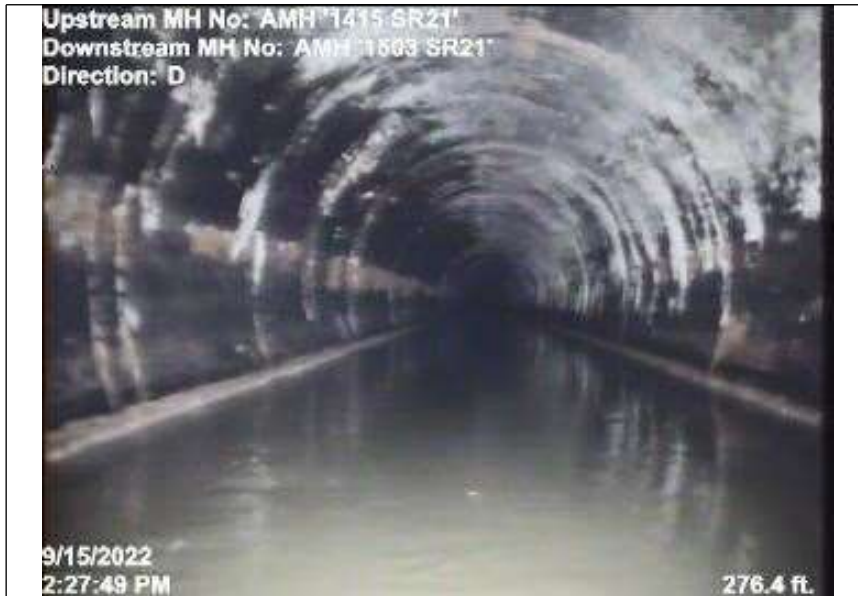
| Distance | Video Ref. | PACP Code | Continuous | S/M/L | Value Inches (mm) | | % | Joint | Circumferential Location | | Rating | Image Ref. | Remarks |
|---|---|---|---|---|---|---|---|---|---|---|---|---|---|
| 273.0 ft. | 00:06:20 | SSC | F02 | | | | | <input type="checkbox"/> | 7 / 5 | | 1 | CITY OF MASSILLON-AMH '1415 SR21'-AMH '1503 SR21'-SSC at 273.0 ft.JPG | |

At: 273 ft. 7/5 SSC - Surface Spalling of Damage Coating  
Joint: No

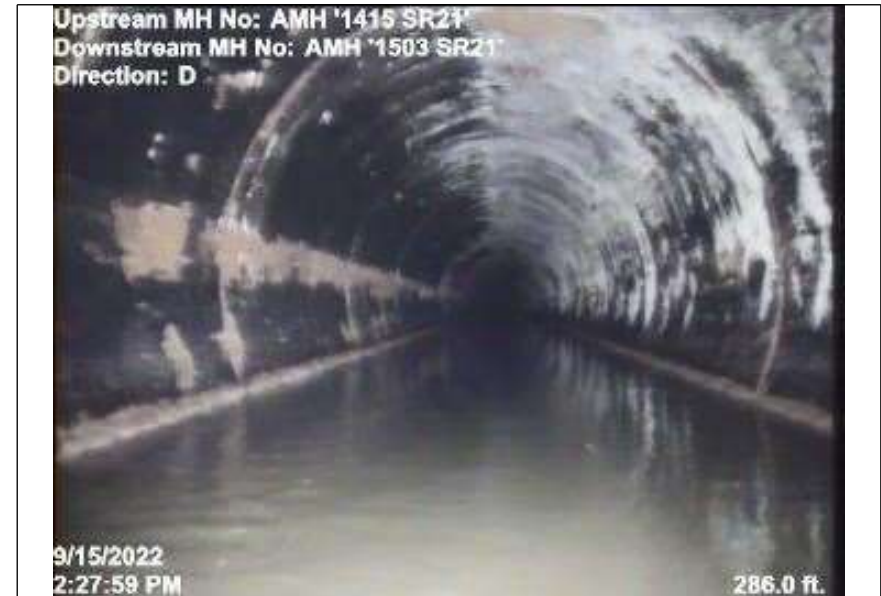
| Distance | Video Ref. | PACP Code | Continuous | S/M/L | Value Inches (mm) | | % | Joint | Circumferential Location | | Rating | Image Ref. | Remarks |
|---|---|---|---|---|---|---|---|---|---|---|---|---|---|
| 282.4 ft. | 00:06:30 | DSF | F01 | | | | 15 | <input type="checkbox"/> | 5 / 7 | | 3 | CITY OF MASSILLON-AMH '1415 SR21'-AMH '1503 SR21'-DSF at 282.4 ft.JPG | |

At: 282.4 ft. 5/7 DSF - Deposits Settled Fine  
Joint: No 15 %

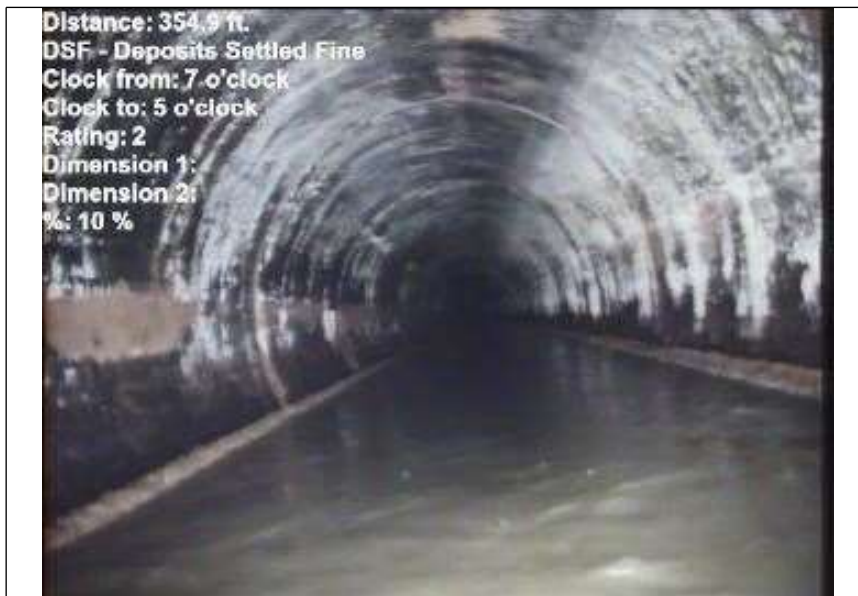
| Distance | Video Ref. | PACP Code | Continuous | S/M/L | Value Inches (mm) | | % | Joint | Circumferential Location | | Rating | Image Ref. | Remarks |
|---|---|---|---|---|---|---|---|---|---|---|---|---|---|
| 354.9 ft. | 00:08:03 | DSF | | | | | 10 | <input type="checkbox"/> | 7 / 5 | | 2 | CITY OF MASSILLON-AMH '1415 SR21'-AMH '1503 SR21'-DSF at 354.9 ft.JPG | |

At: 354.9 ft. 7/5 DSF - Deposits Settled Fine  
Joint: No 10 %

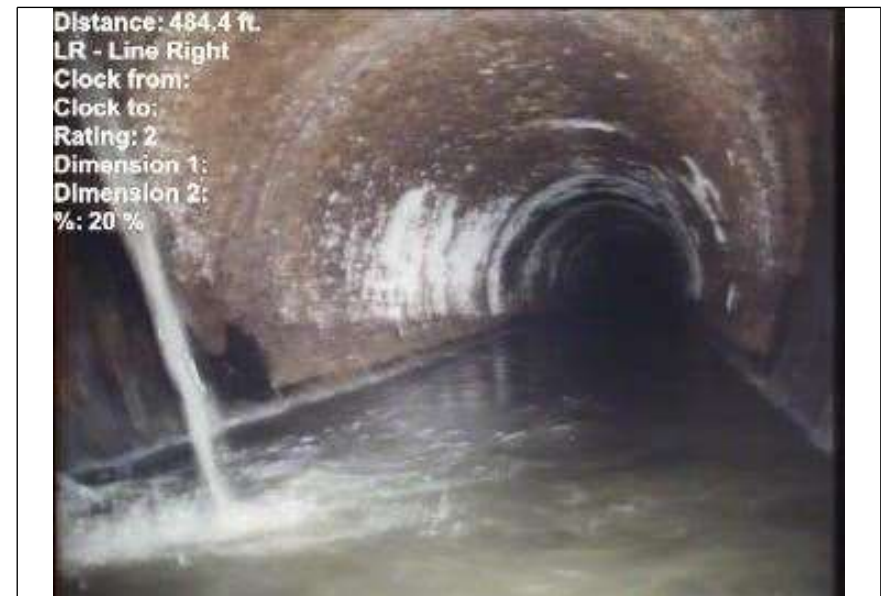
| Distance | Video Ref. | PACP Code | Continuous | S/M/L | Value Inches<br>(mm) | | % | Joint | Circumferential<br>Location<br>At/From To | | Rating | Image Ref. | Remarks |
|---|---|---|---|---|---|---|---|---|---|--|---|---|---|
| 484.4 ft. | 00:11:16 | LR | | | | | 20 | <input type="checkbox"/> | / | | 2 | CITY OF<br>MASSILLON-AMH<br>'1415 SR21'-AMH<br>'1503 SR21'-LR at<br>484.4 ft.JPG | |

At: 484.4 ft. LR - Line Right  
Joint: No 20 %
