| <b>Drainage Area</b> | | <b>Street</b> | TREMONT AVE |
| <b>Pipe Segment Ref.</b> | MASDCB001-MSADFT001 | <b>City</b> | MASSILON |

# PACP Inspection Report

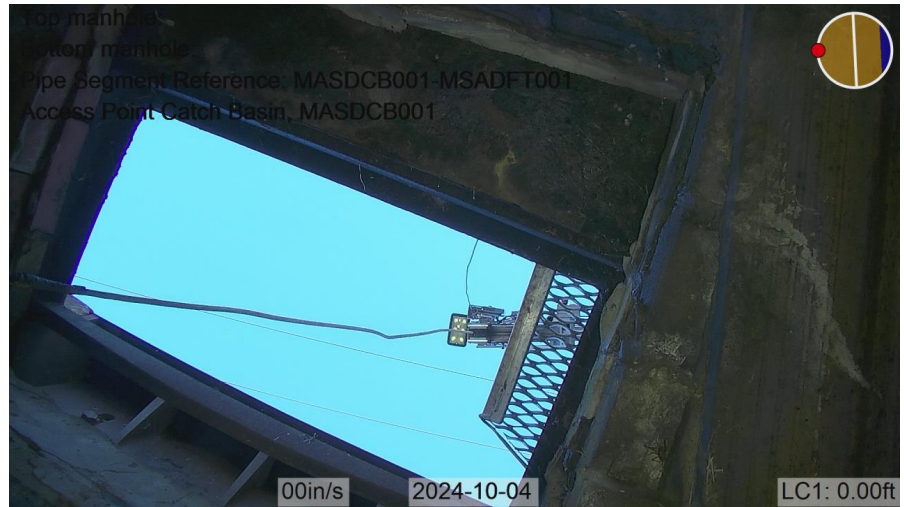
**Image Ref.** **001**

| Distance | Video Ref. | Code | Description | Cont. Defect | Value | | | Grade | Joint | Circumferential Location | | Image | Remarks |
|---|---|---|---|---|---|---|---|---|---|---|---|---|---|
| 0.00 | 00:00:04 | ACB | Access Point Catch Basin | | | | | | | | | 001 | MASDCB001 |

Access Point Catch Basin,  
MASDCB001

**Video** 00:00:04  
**Dist. downstream** 0.00 ft  
**Code** ACB  
**C. Location**

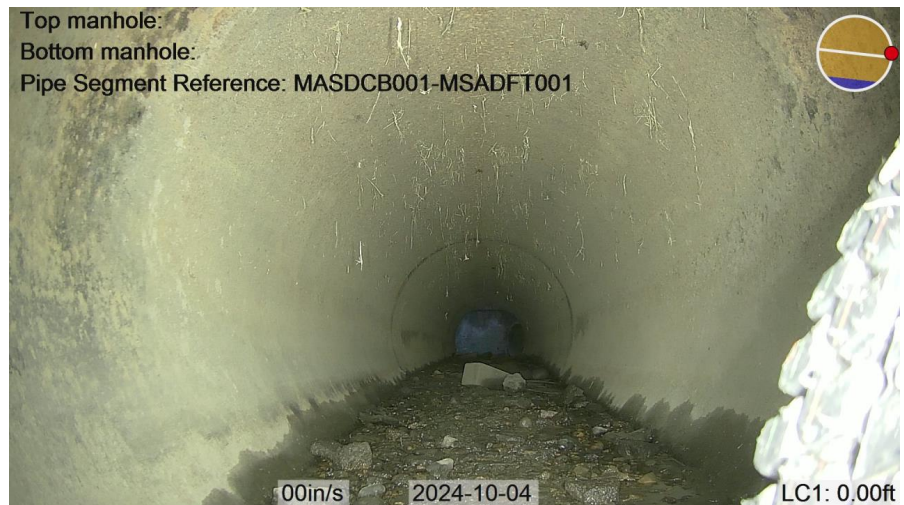
**Image Ref.** **002**

| Distance | Video Ref. | Code | Description | Cont. Defect | Value | | | Grade | Joint | Circumferential Location | | Image | Remarks |
|---|---|---|---|---|---|---|---|---|---|---|---|---|---|
| 0.00 | 00:00:29 | MWL | Miscellaneous Water Level | | | 5 | | | | | | 002 | |

Miscellaneous Water Level, Water  
level = 5 %

**Video** 00:00:29  
**Dist. downstream** 0.00 ft  
**Code** MWL  
**C. Location**

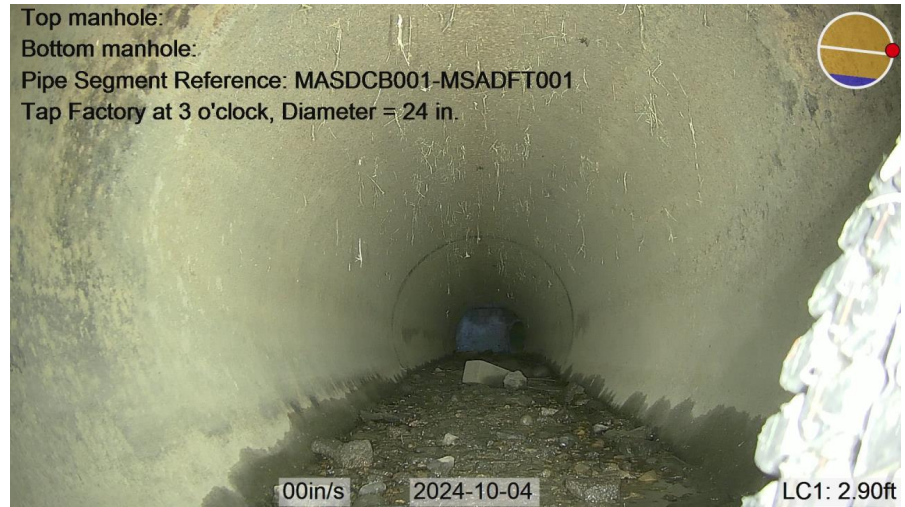
**Image Ref.** 003

| Distance | Video Ref. | Code | Description | Cont. Defect | Value | | | Grade | Joint | Circumferential Location | | Image | Remarks |
|---|---|---|---|---|---|---|---|---|---|---|---|---|---|
| 2.10 | 00:00:42 | TF | Tap Factory | | 24 | | | | | 03 | | 003 | |

Tap Factory at 3 o'clock, Diameter = 24 in.

**Video** 00:00:42  
**Dist. downstream** 2.10 ft  
**Code** TF  
**C. Location** 03

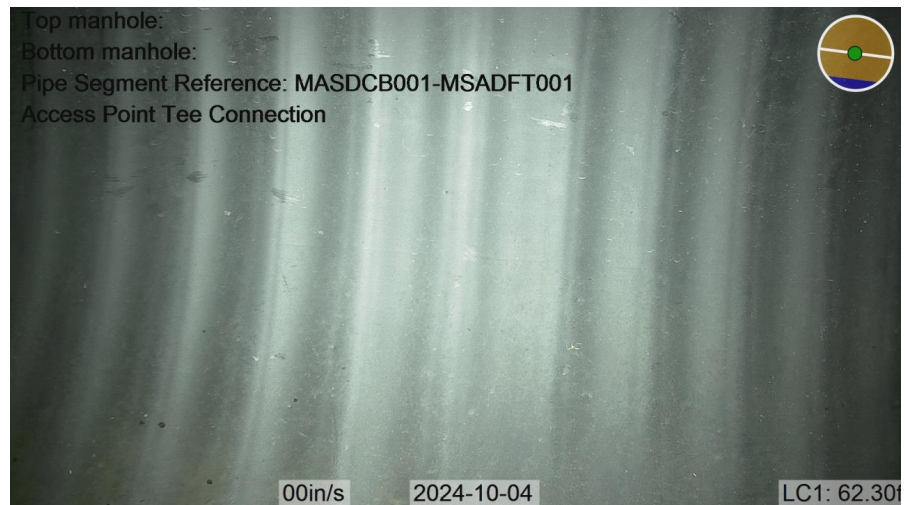
**Image Ref.** 004

| Distance | Video Ref. | Code | Description | Cont. Defect | Value | | | Grade | Joint | Circumferential Location | | Image | Remarks |
|---|---|---|---|---|---|---|---|---|---|---|---|---|---|
| 62.30 | 00:03:11 | ATC | Access Point Tee Connection | | | | | | | 06 | | 004 | |

Access Point Tee Connection

**Video** 00:03:11  
**Dist. downstream** 62.30 ft  
**Code** ATC  
**C. Location** 06
