# PACP Inspection Report

| <b>Drainage Area</b> | <b>Street</b> | TREMONT AVE |
| <b>Pipe Segment Ref.</b> MASDMH006-MASDMH005 | <b>City</b> | MASSILON |

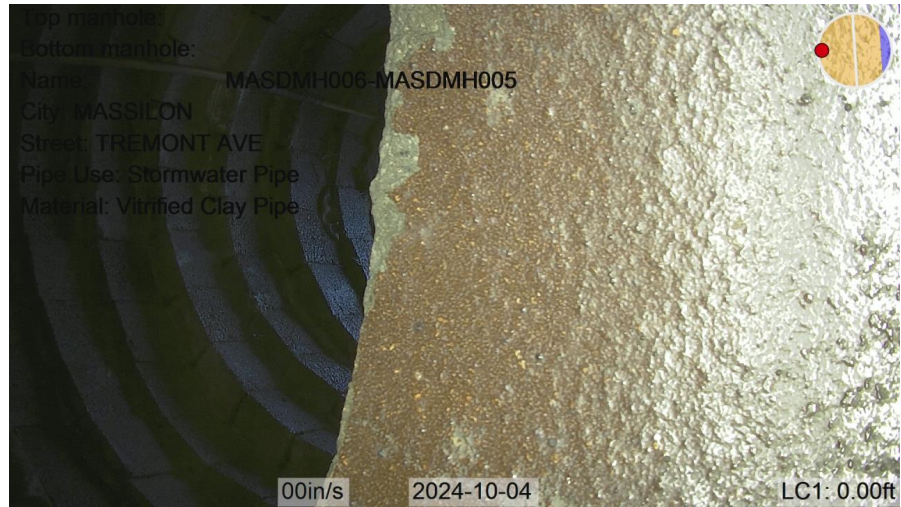
**Image Ref.** **028**

Access Point Manhole,  
MASDMH006

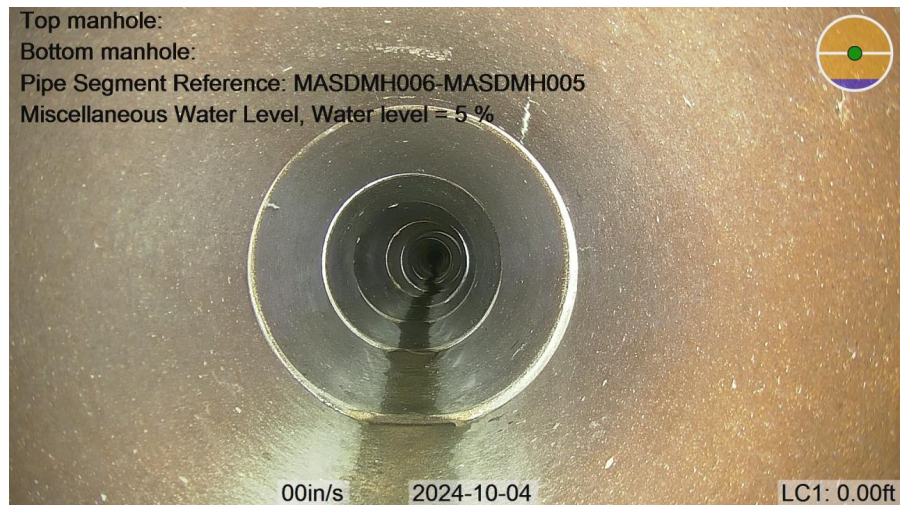
**Image Ref.** **029**

| Distance | Video Ref. | Code | Description | Cont. Defect | Value | | % | Grade | Joint | Circumferential Location | | Image | Remarks |
|---|---|---|---|---|---|---|---|---|---|---|---|---|---|
| 0.00 | 00:00:12 | MWL | Miscellaneous Water Level | | | | 5 | | | | | 029 | |

Miscellaneous Water Level, Water  
level = 5 %

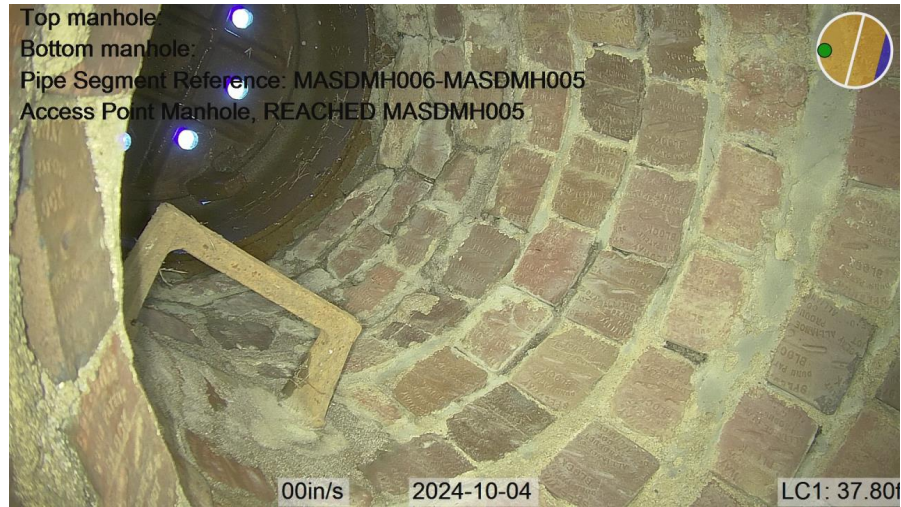
**Image Ref.** 030

Access Point Manhole, REACHED  
 MASDMH005
