| Drainage Area | | Street | TREMONT AVE |
| Pipe Segment Ref. | MASDMH005-MASDMH004 | City | MASSILON |

# PACP Inspection Report

| <b>Surveyed by</b> BRANDON LUERS | <b>Date</b> 10/4/2024 | <b>Weather</b> Dry - No precipitation during survey |

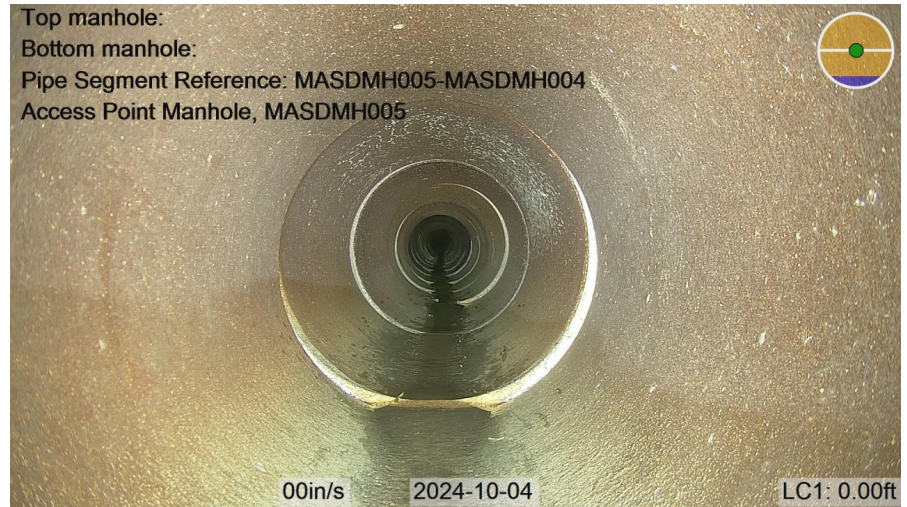
**Image Ref.**                      **031**

Access Point Manhole,  
MASDMH005

**Video**                              00:00:01  
**Dist. downstream**              0.00 ft  
**Code**                                AMH  
**C. Location**

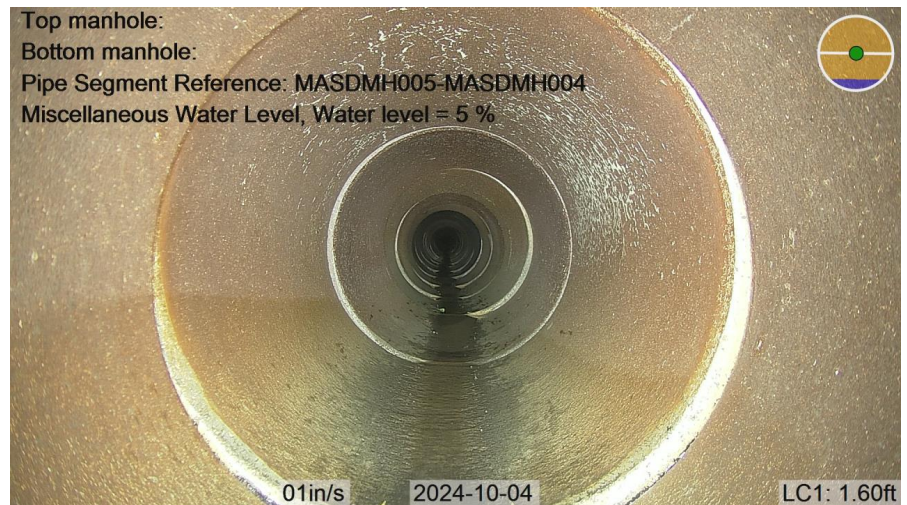
**Image Ref.**                      **032**

Miscellaneous Water Level, Water  
level = 5 %

**Video**                              00:00:02  
**Dist. downstream**              0.00 ft  
**Code**                                MWL  
**C. Location**

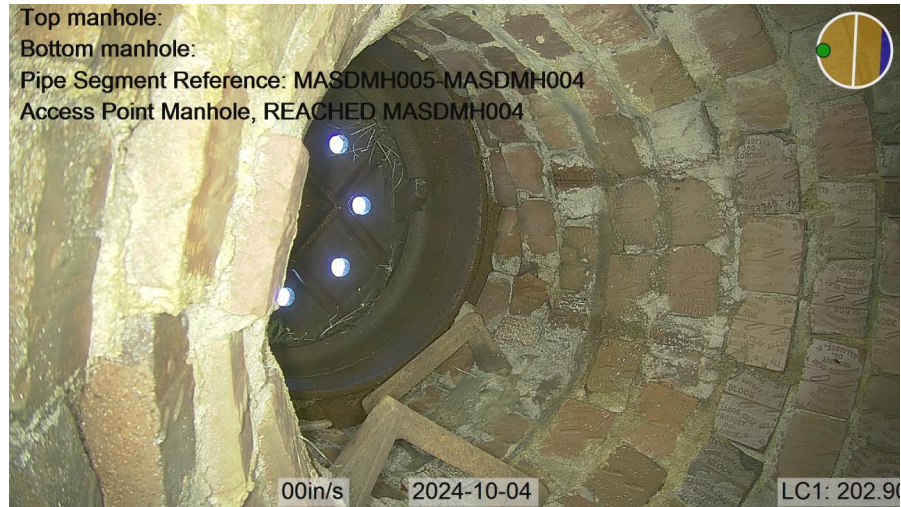
**Image Ref.** **033**

Access Point Manhole, REACHED  
MASDMH004

**Video** 00:03:39

**Dist. downstream** 202.90 ft
