| Drainage Area | | Street | TREMONT AVE |
| Pipe Segment Ref. | MASDMH004-MASDMH003 | City | MASSILON |

# PACP Inspection Report

| <b>Surveyed by</b> BRANDON LUERS | <b>Date</b> 10/4/2024 | <b>Weather</b> Dry - No precipitation during survey |

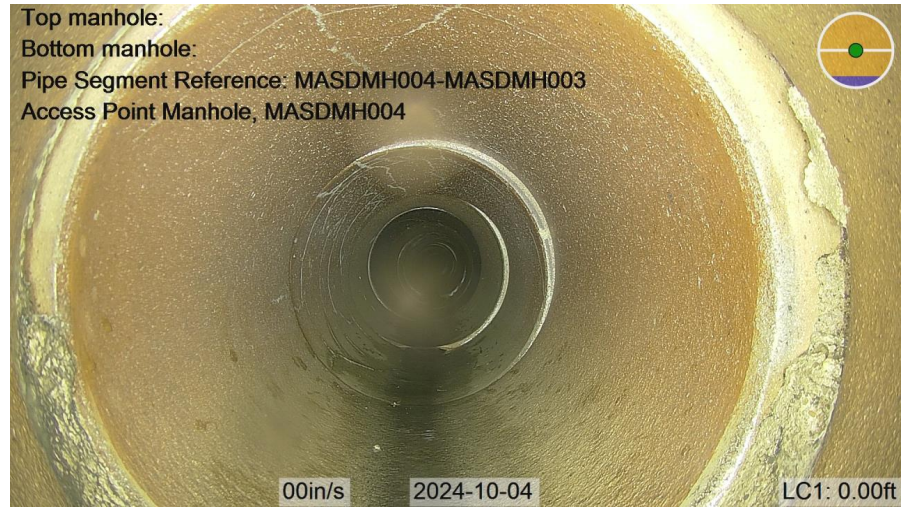
**Image Ref.**                      **034**

| Distance | Video Ref. | Code | Description | Cont. Defect | Value | | | Grade | Joint | Circumferential Location | | Image | Remarks |
|---|---|---|---|---|---|---|---|---|---|---|---|---|---|
| 0.00 | 00:00:01 | AMH | Access Point Manhole | | | | | | | | | 034 | MASDMH004 |

Access Point Manhole,  
MASDMH004

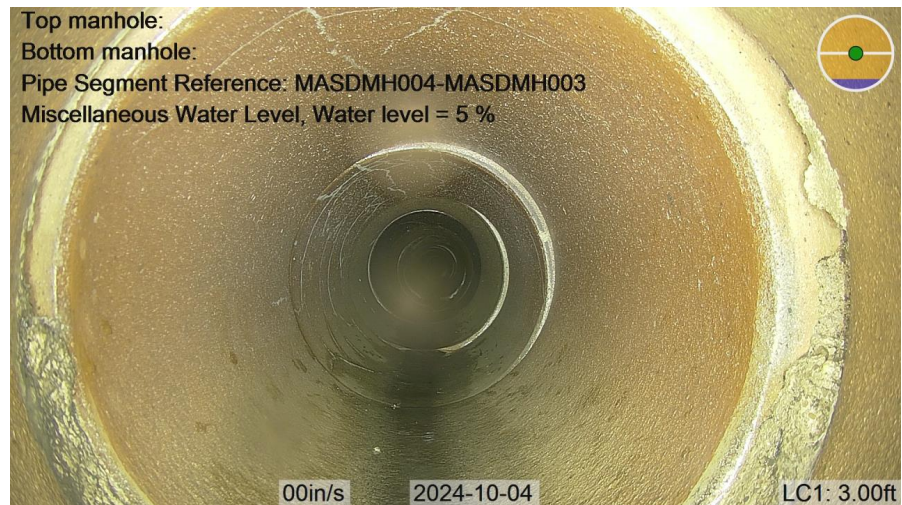
**Image Ref.**                      **035**

| Distance | Video Ref. | Code | Description | Cont. Defect | Value | | | Grade | Joint | Circumferential Location | | Image | Remarks |
|---|---|---|---|---|---|---|---|---|---|---|---|---|---|
| 0.00 | 00:00:02 | MWL | Miscellaneous Water Level | | | 5 | | | | | | 035 | |

Miscellaneous Water Level, Water  
level = 5 %

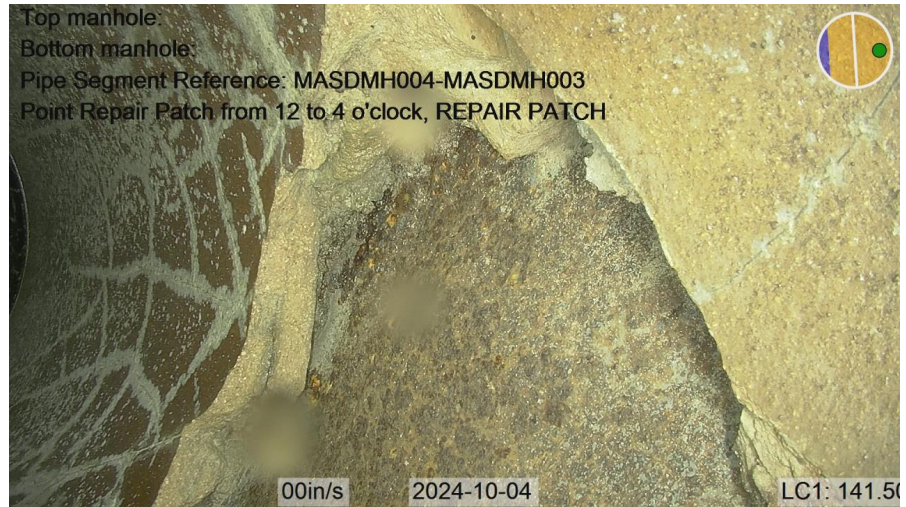
**Image Ref.** 036

| Distance | Video Ref. | Code | Description | Cont. Defect | Value | | | Grade | Joint | Circumferential Location | | Image | Remarks |
|---|---|---|---|---|---|---|---|---|---|---|---|---|---|
| 141.50 | 00:02:44 | RPP | Point Repair Patch | | | | | | | 12 | 04 | 036 | REPAIR PATCH |

Point Repair Patch from 12 to 4 o'clock, REPAIR PATCH

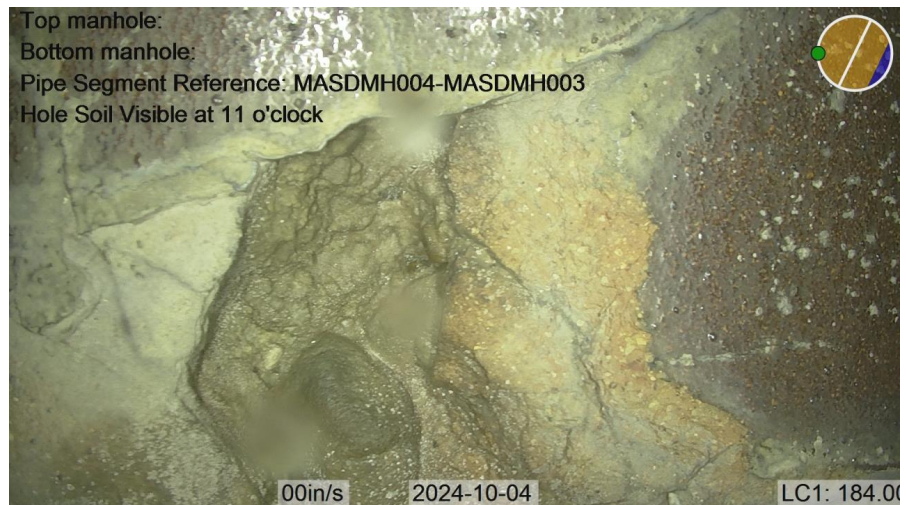
**Image Ref.** 037

| Distance | Video Ref. | Code | Description | Cont. Defect | Value | | | Grade | Joint | Circumferential Location | | Image | Remarks |
|---|---|---|---|---|---|---|---|---|---|---|---|---|---|
| 184.00 | 00:03:44 | HSV | Hole Soil Visible | | | | ST5 | | | 11 | | 037 | |

Hole Soil Visible at 11 o'clock, S:5

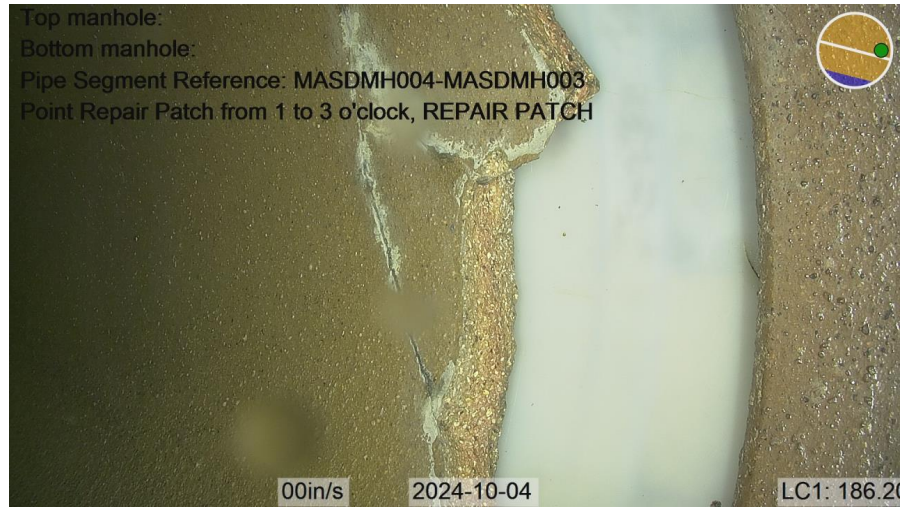
**Image Ref.** **038**

| Distance | Video Ref. | Code | Description | Cont. Defect | Value | | | Grade | Joint | Circumferential Location | | Image | Remarks |
|---|---|---|---|---|---|---|---|---|---|---|---|---|---|
| 186.20 | 00:03:58 | RPP | Point Repair Patch | | | | | | | 01 | 03 | 038 | REPAIR PATCH |

Point Repair Patch from 1 to 3  
o'clock, REPAIR PATCH

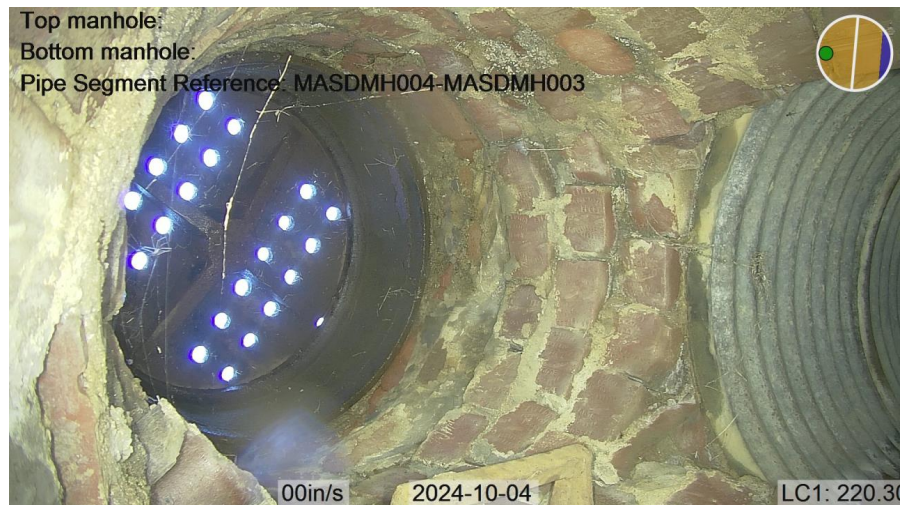
**Image Ref.** **039**

| Distance | Video Ref. | Code | Description | Cont. Defect | Value | | | Grade | Joint | Circumferential Location | | Image | Remarks |
|---|---|---|---|---|---|---|---|---|---|---|---|---|---|
| 220.30 | 00:04:48 | AMH | Access Point Manhole | | | | | | | | | 039 | REACHED MASDMH003 |

Access Point Manhole, REACHED  
MASDMH003
