| Pipe Segment Ref. MASDMH003-MASDMH002 | City | MASSILON |

# PACP Inspection Report

| <b>Surveyed by</b> BRANDON LUERS | <b>Date</b> 10/4/2024 | <b>Weather</b> Dry - No precipitation during survey |

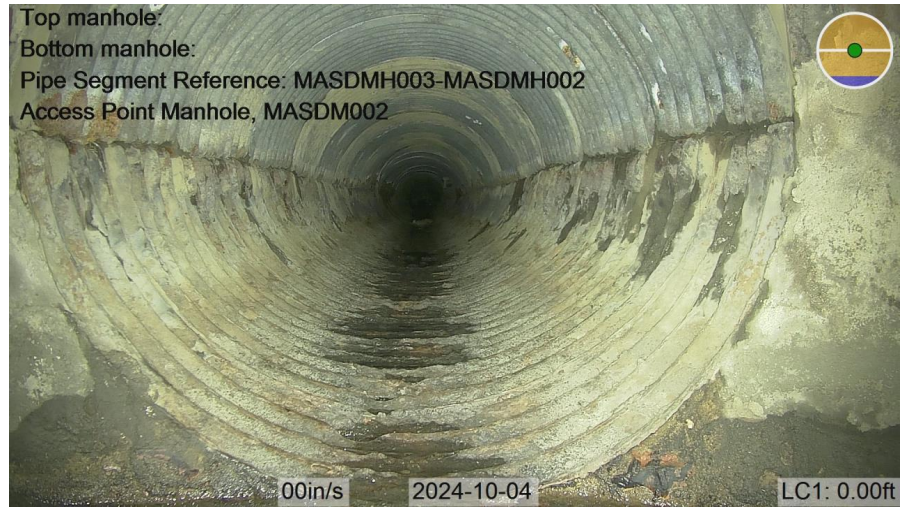
**Image Ref.** **024**

Access Point Manhole, MASDM002

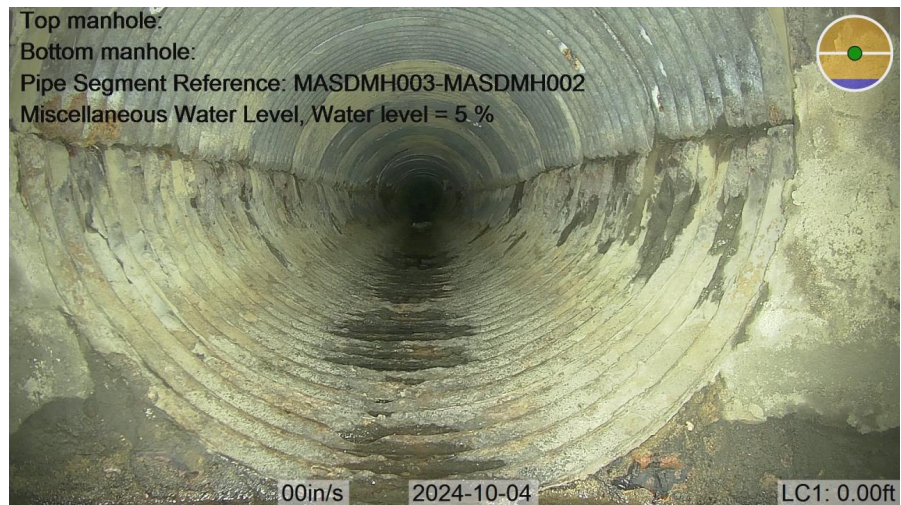
**Image Ref.** **025**

Miscellaneous Water Level, Water level = 5 %

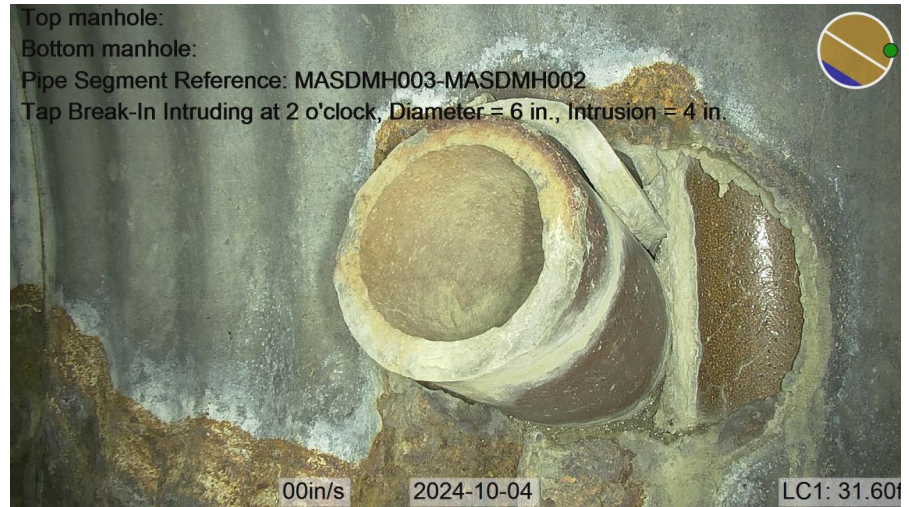
**Image Ref.** 026

| Distance | Video Ref. | Code | Description | Cont. Defect | Value | | Grade | Joint | Circumferential Location | | Image | Remarks | |
|---|---|---|---|---|---|---|---|---|---|---|---|---|---|
| 31.60 | 00:01:35 | TBI | Tap Break-In Intruding | | 6 | 4 | | | 02 | | 026 | | |

Tap Break-In Intruding at 2 o'clock,  
Diameter = 6 in., Intrusion = 4 in.

**Video** 00:01:35  
**Dist. upstream** 31.60 ft  
**Code** TBI  
**C. Location** 02

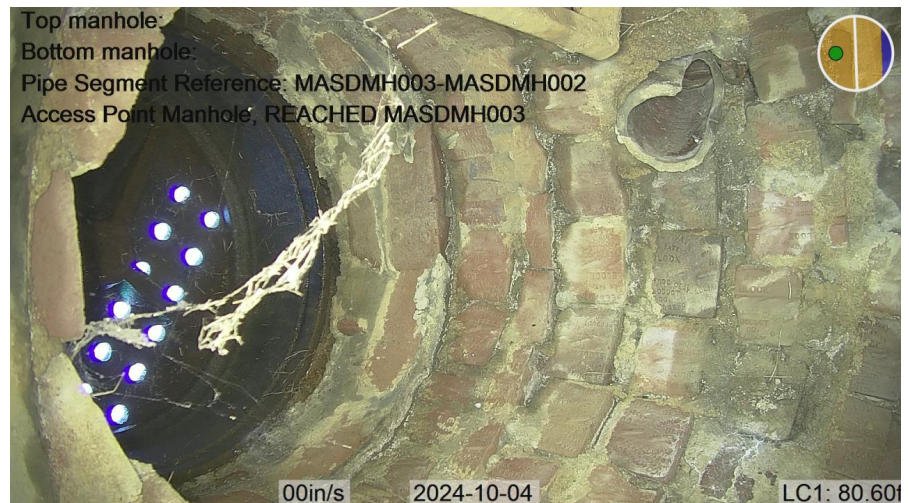
**Image Ref.** 027

Access Point Manhole, REACHED  
MASDMH003
