| <b>Drainage Area</b> | | <b>Street</b> | TREMONT AVE |
| <b>Pipe Segment Ref.</b> | MASDMH002-MASDMH001 | <b>City</b> | MASSILON |

# PACP Inspection Report

| <b>Surveyed by</b> BRANDON LUERS | <b>Date</b> 10/4/2024 | <b>Weather</b> Dry - No precipitation during survey |

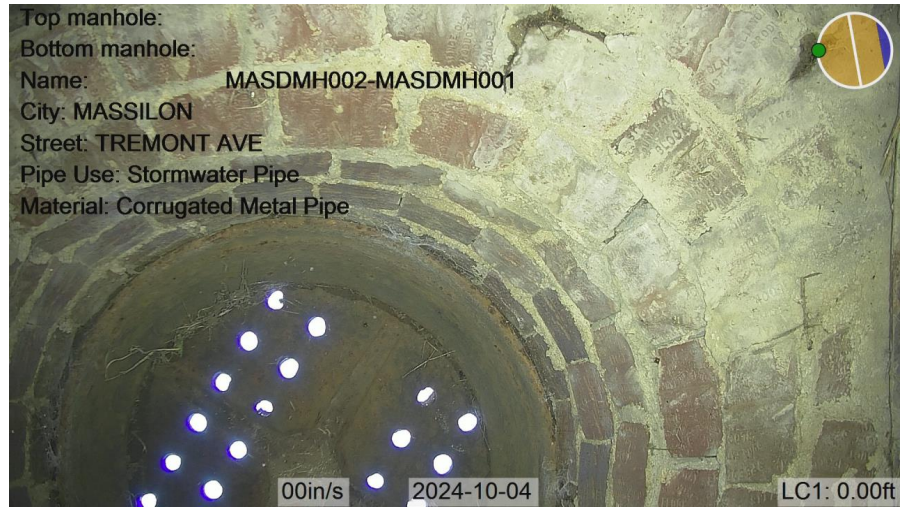
**Image Ref.** **014**

Access Point Manhole,  
MASDMH001

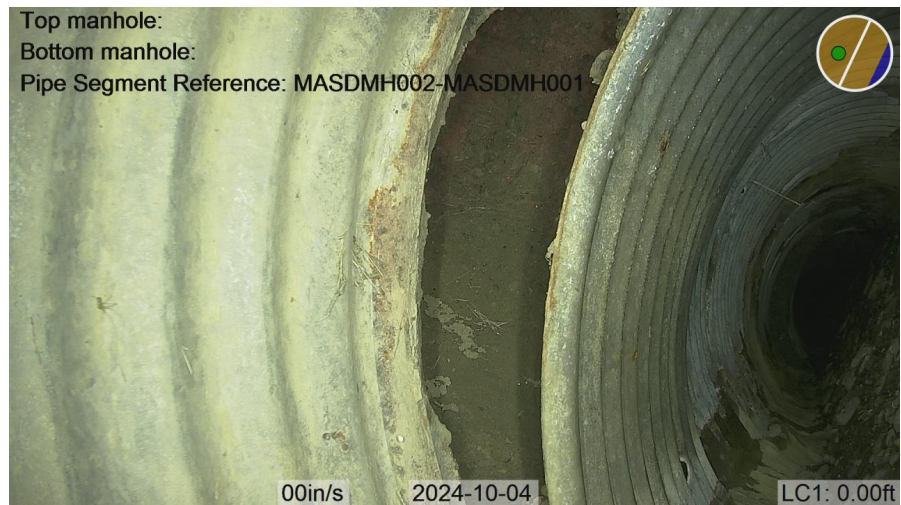
**Image Ref.** **015**

Miscellaneous Water Level, Water  
level = 5 %

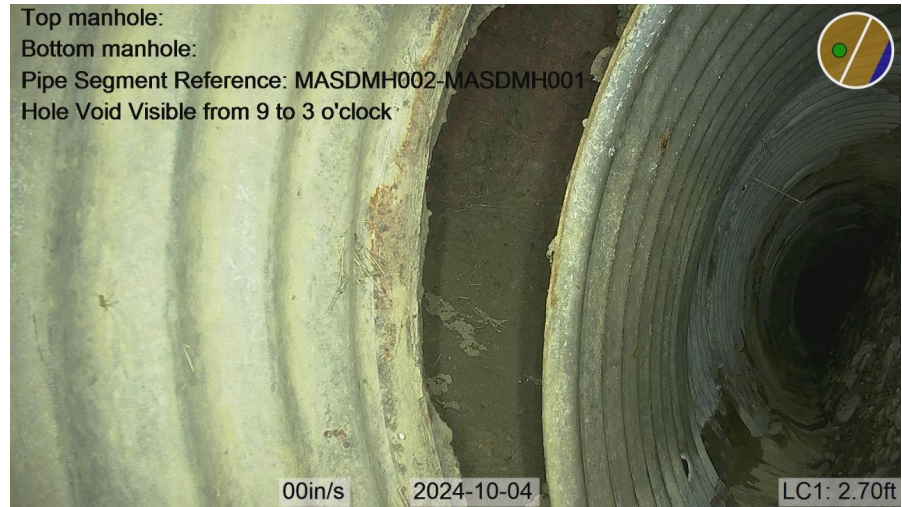
**Image Ref.** **016**

| Distance | Video Ref. | Code | Description | Cont. Defect | Value | | | Grade | Joint | Circumferential Location | | Image | Remarks |
|---|---|---|---|---|---|---|---|---|---|---|---|---|---|
| 2.70 | 00:00:26 | HVV | Hole Void Visible | | | | ST5 | | 09 | 03 | | 016 | |

Hole Void Visible from 9 to 3 o'clock, S:5

**Video** 00:00:26  
**Dist. upstream** 2.70 ft  
**Code** HVV  
**C. Location** 09 - 03

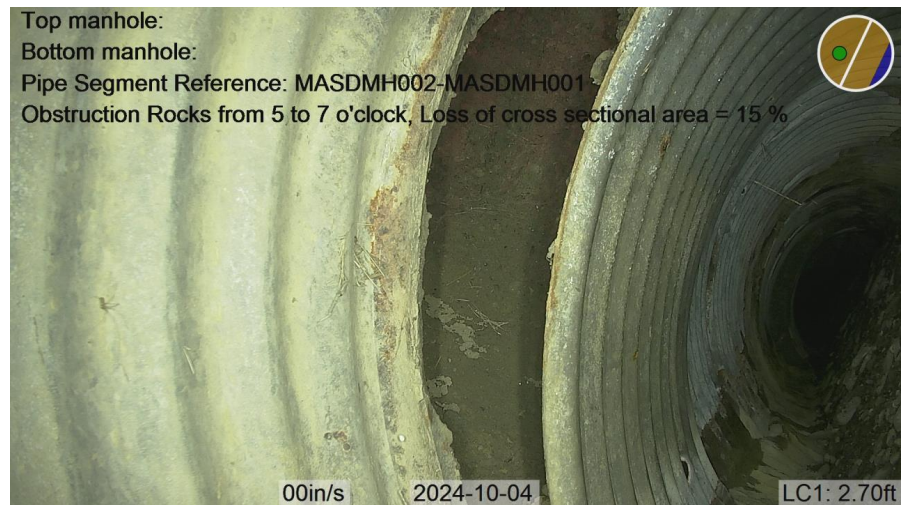
**Image Ref.** **017**

| Distance | Video Ref. | Code | Description | Cont. Defect | Value | | | Grade | Joint | Circumferential Location | | Image | Remarks |
|---|---|---|---|---|---|---|---|---|---|---|---|---|---|
| 2.70 | 00:00:28 | OBR | Obstruction Rocks | | | 15 | OM3 | | 05 | 07 | | 017 | |

Obstruction Rocks from 5 to 7 o'clock, Loss of cross sectional area = 15 %, OM:3

**Video** 00:00:28  
**Dist. upstream** 2.70 ft  
**Code** OBR  
**C. Location** 05 - 07

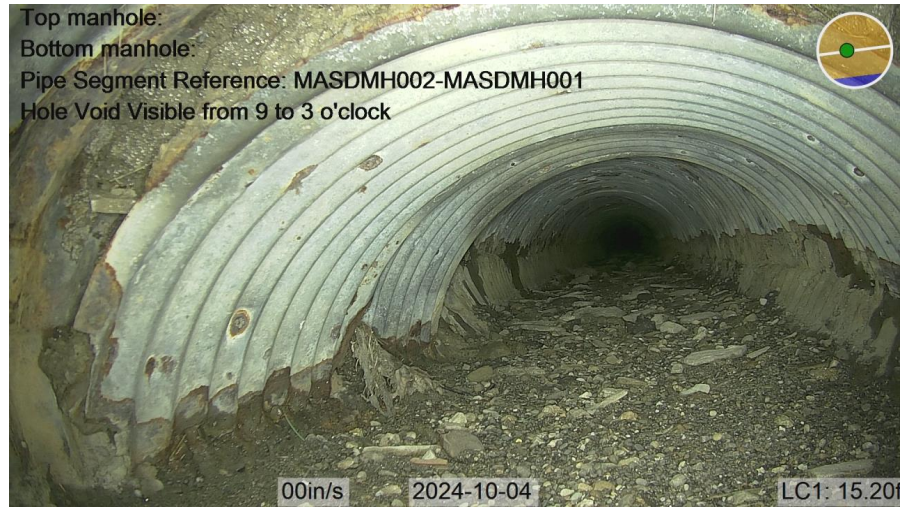
**Image Ref.** **018**

| Distance | Video Ref. | Code | Description | Cont. Defect | Value | | | Grade | Joint | Circumferential Location | | Image | Remarks |
|---|---|---|---|---|---|---|---|---|---|---|---|---|---|
| 15.20 | 00:00:51 | HVV | Hole Void Visible | | | | ST5 | | 09 | 03 | | 018 | |

Hole Void Visible from 9 to 3 o'clock, S:5

**Video** 00:00:51  
**Dist. upstream** 15.20 ft  
**Code** HVV  
**C. Location** 09 - 03

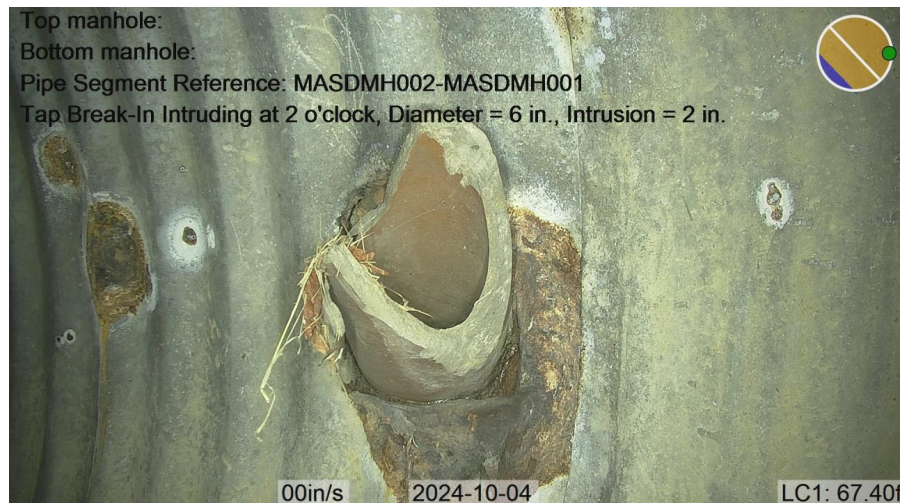
**Image Ref.** **019**

| Distance | Video Ref. | Code | Description | Cont. Defect | Value | | | Grade | Joint | Circumferential Location | | Image | Remarks |
|---|---|---|---|---|---|---|---|---|---|---|---|---|---|
| 67.40 | 00:02:01 | TBI | Tap Break-In Intruding | | 6 | 2 | | | 02 | | | 019 | |

Tap Break-In Intruding at 2 o'clock, Diameter = 6 in., Intrusion = 2 in.

**Video** 00:02:01  
**Dist. upstream** 67.40 ft  
**Code** TBI  
**C. Location** 02

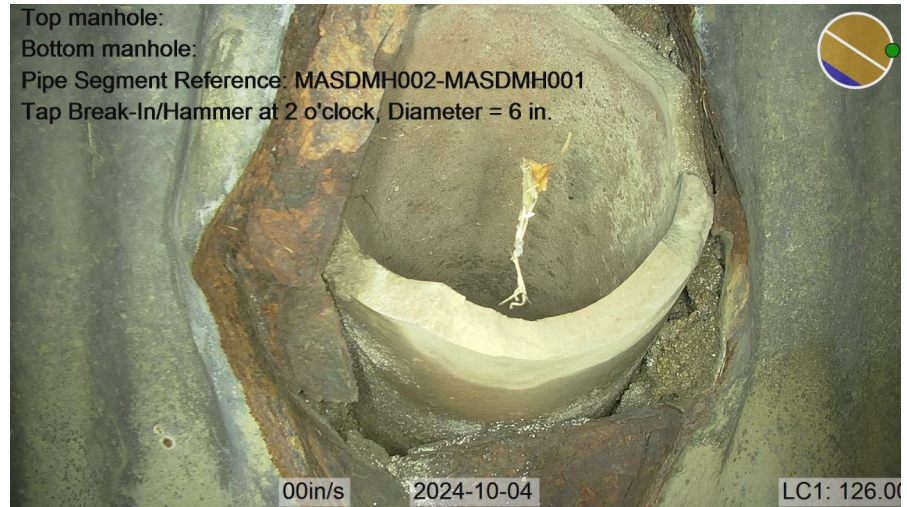
**Image Ref.** **020**

| Distance | Video Ref. | Code | Description | Cont. Defect | Value | | | Grade | Joint | Circumferential Location | | Image | Remarks |
|---|---|---|---|---|---|---|---|---|---|---|---|---|---|
| 126.00 | 00:03:21 | TB | Tap Break-In/Hammer | | 6 | | | | 02 | | | 020 | |

Tap Break-In/Hammer at 2 o'clock,  
Diameter = 6 in.

**Video** 00:03:21  
**Dist. upstream** 126.00 ft  
**Code** TB  
**C. Location** 02

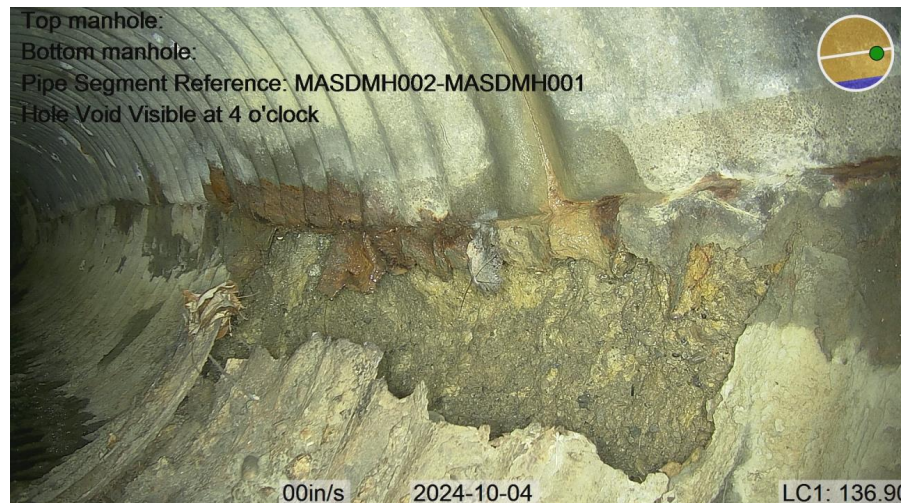
**Image Ref.** **021**

| Distance | Video Ref. | Code | Description | Cont. Defect | Value | | | Grade | Joint | Circumferential Location | | Image | Remarks |
|---|---|---|---|---|---|---|---|---|---|---|---|---|---|
| 136.90 | 00:03:39 | HVV | Hole Void Visible | | | | ST5 | | 04 | | | 021 | |

Hole Void Visible at 4 o'clock, S:5

**Video** 00:03:39  
**Dist. upstream** 136.90 ft  
**Code** HVV  
**C. Location** 04

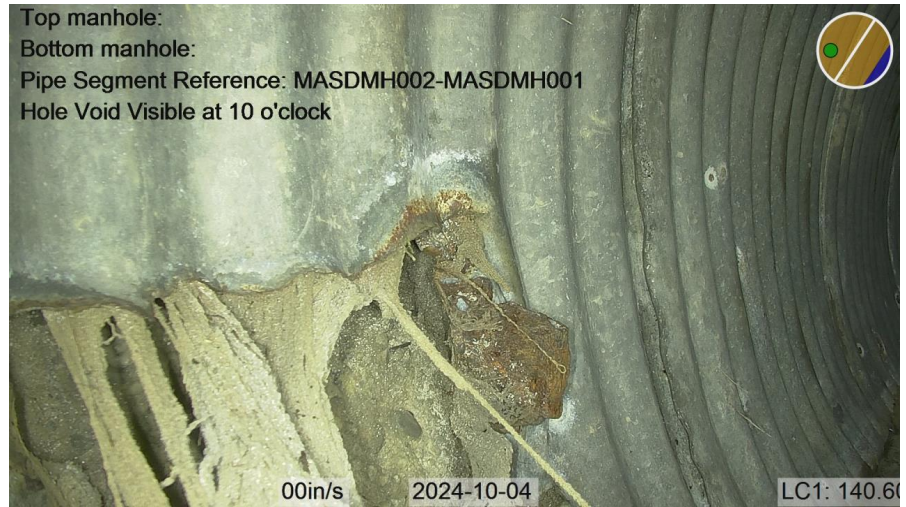
**Image Ref.** 022

| Distance | Video Ref. | Code | Description | Cont. Defect | Value | | | Grade | Joint | Circumferential Location | | Image | Remarks |
|---|---|---|---|---|---|---|---|---|---|---|---|---|---|
| 140.60 | 00:03:52 | HVV | Hole Void Visible | | | | ST5 | | 10 | | | 022 | |

Hole Void Visible at 10 o'clock, S:5

**Video** 00:03:52  
**Dist. upstream** 140.60 ft  
**Code** HVV  
**C. Location** 10

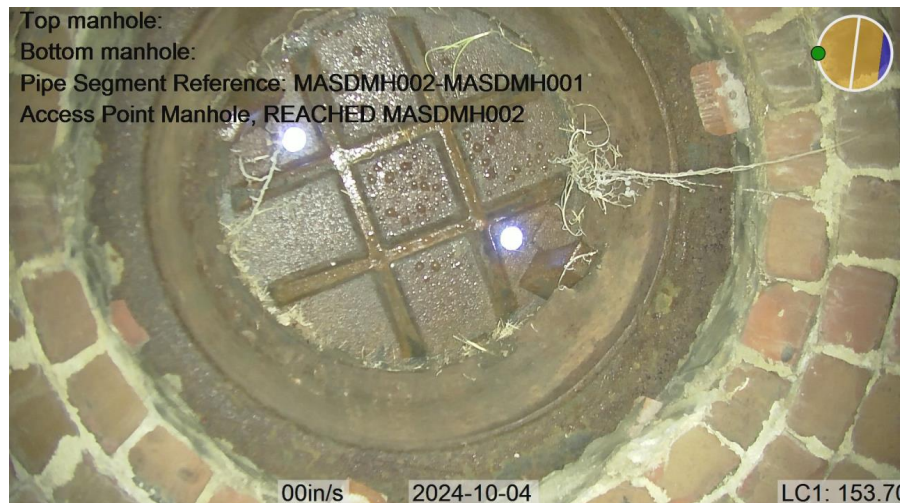
**Image Ref.** 023

Access Point Manhole, REACHED  
MASDMH002
