| Drainage Area | Street | TREMONT AVE |
| Pipe Segment Ref. MASDMH001-MASDCB001 | City | MASSILON |

# PACP Inspection Report

| <b>Surveyed by</b> BRANDON LUERS | <b>Date</b> 10/4/2024 | <b>Weather</b> Dry - No precipitation during survey |

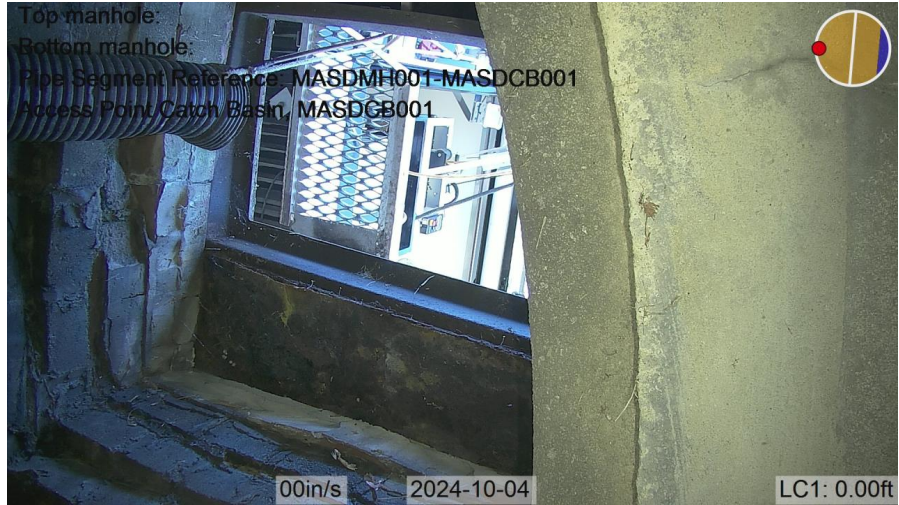
**Image Ref.** 005

Access Point Catch Basin,  
MASDCB001

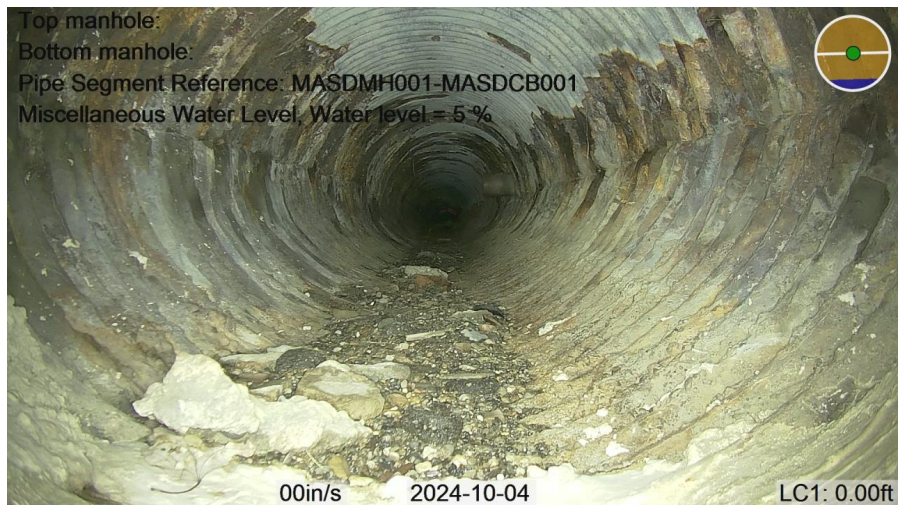
**Image Ref.** 006

Miscellaneous Water Level, Water  
level = 5 %

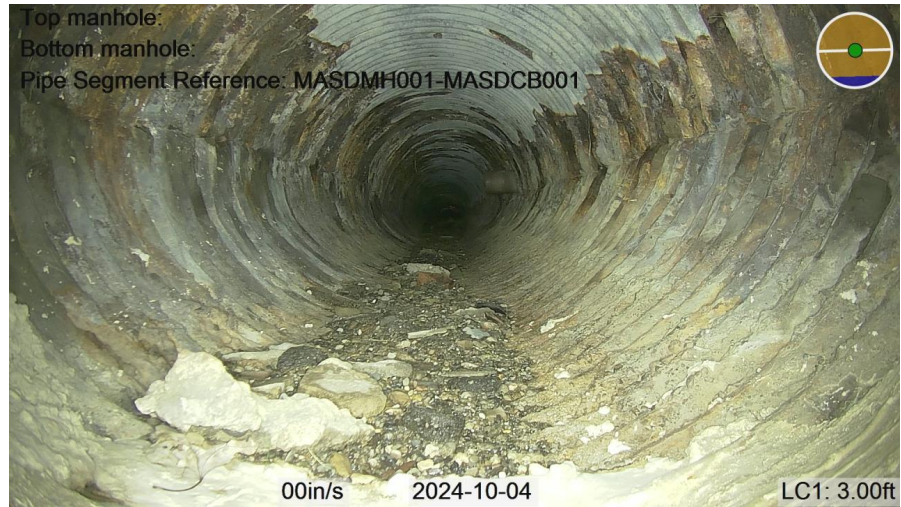
**Image Ref.** **007**

| | Dist. | Code | Picture | Video | Description |
|---|---|---|---|---|---|
| | 3.00 | MMC | 007 | 00:00:29 | Miscellaneous Material Change, RCP TO CMP |

Miscellaneous Material Change,  
RCP TO CMP

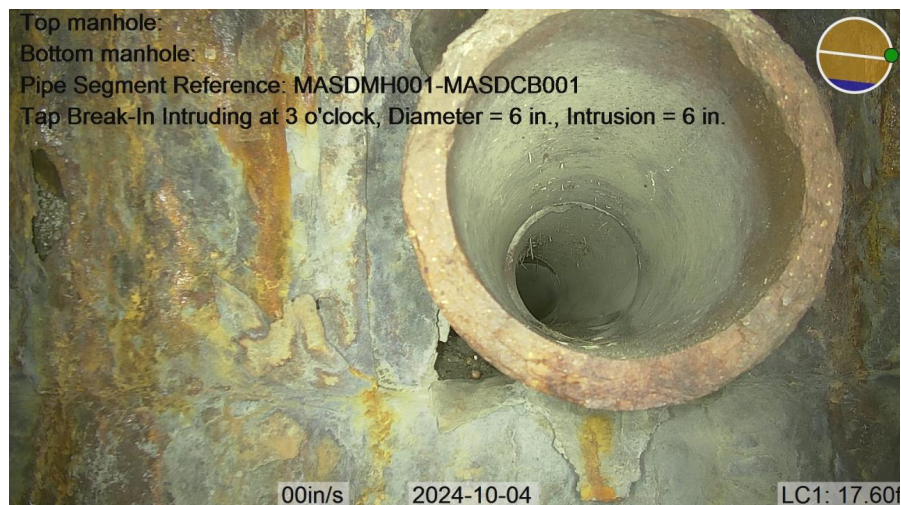
**Image Ref.** **008**

| | Dist. | Code | Picture | Video | Description |
|---|---|---|---|---|---|
| | 17.60 | TBI | 008 | 00:00:56 | Tap Break-In Intruding at 3 o'clock, Diameter = 6 in., Intrusion = 6 in. |

Tap Break-In Intruding at 3 o'clock,  
Diameter = 6 in., Intrusion = 6 in.

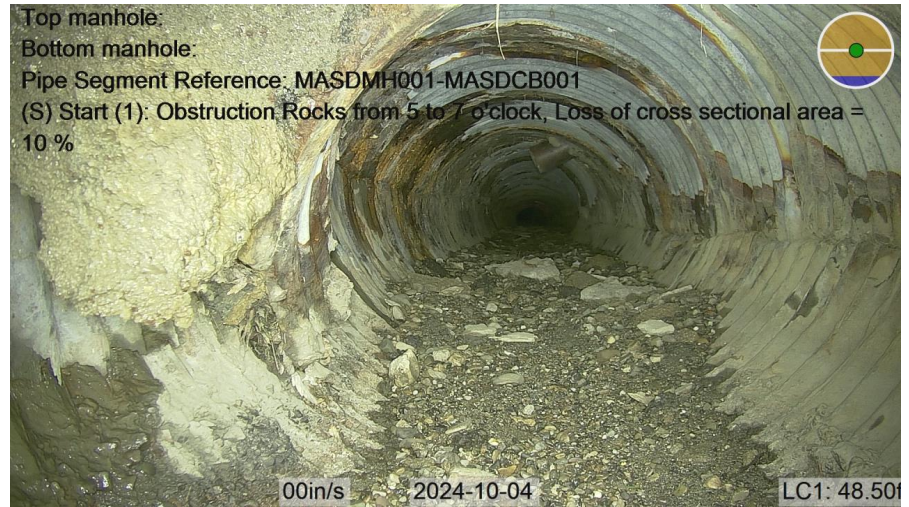
**Image Ref.** **009**

| | Dist. | Code | Picture | Video | Description |
|---|---|---|---|---|---|
| | 48.50 | OBR | 009 | 00:02:39 | Start (1): Obstruction Rocks from 5 to 7 o'clock, Loss of cross sectional area = 10 %, OM:2 |

Start (1): Obstruction Rocks from 5 to 7 o'clock, Loss of cross sectional area = 10 %, OM:2

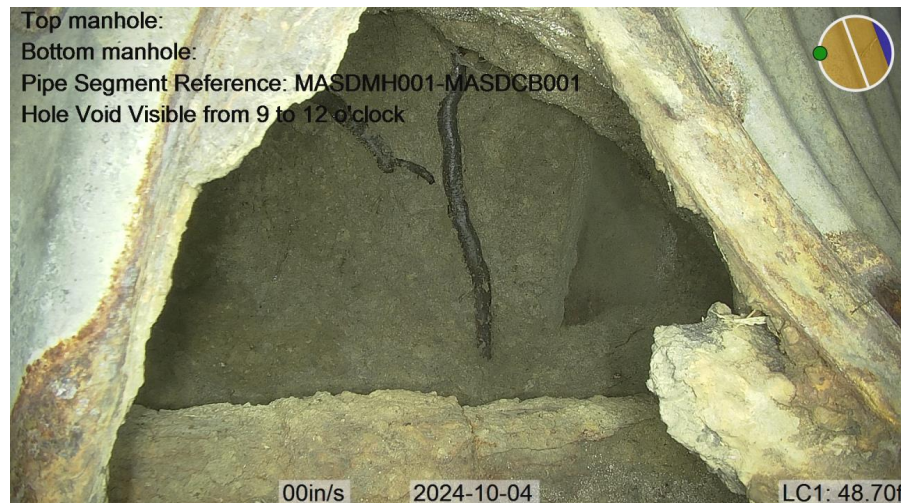
**Image Ref.** **010**

| | Dist. | Code | Picture | Video | Description |
|---|---|---|---|---|---|
| | 48.70 | HVV | 010 | 00:02:51 | Hole Void Visible from 9 to 12 o'clock, S:5 |

Hole Void Visible from 9 to 12 o'clock, S:5

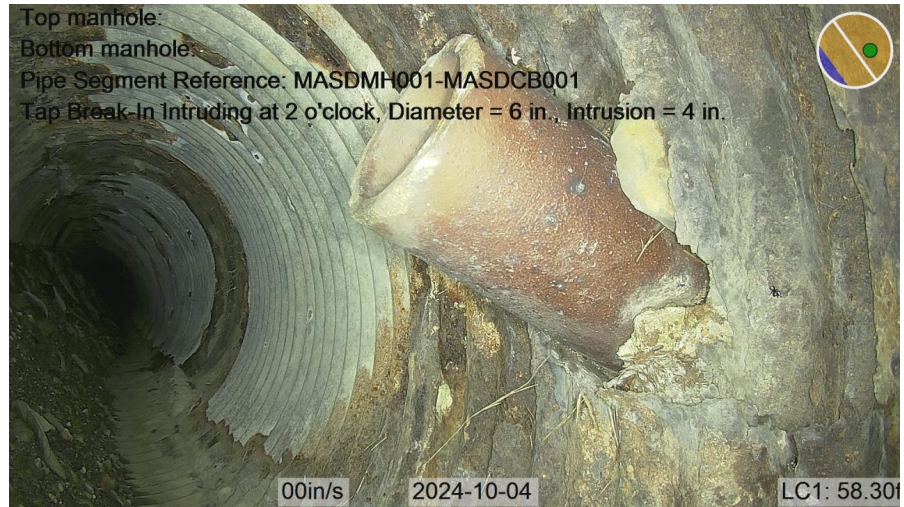
**Image Ref.** 011

| | Dist. | Code | Picture | Video | Description |
|---|---|---|---|---|---|
| | 58.30 | TBI | 011 | 00:03:28 | Tap Break-In Intruding at 2 o'clock, Diameter = 6 in., Intrusion = 4 in. |

Tap Break-In Intruding at 2 o'clock,  
Diameter = 6 in., Intrusion = 4 in.

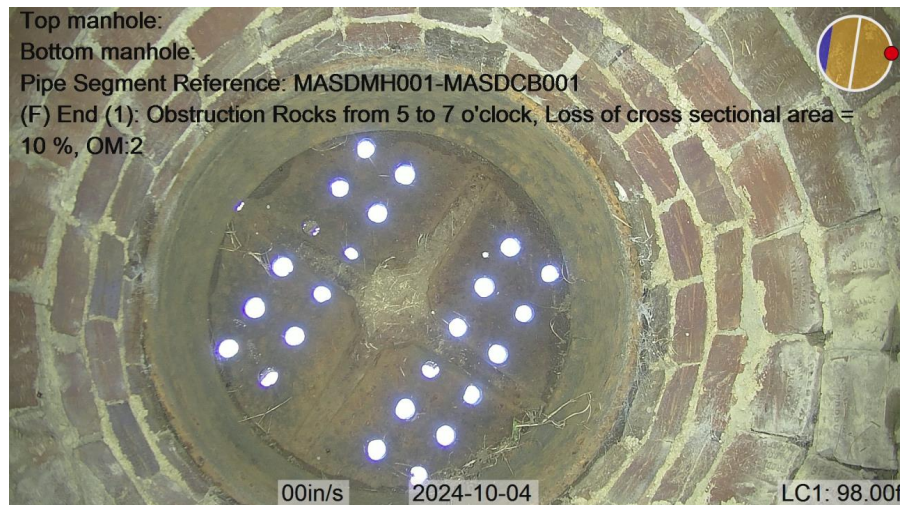
**Image Ref.** 012

| | Dist. | Code | Picture | Video | Description |
|---|---|---|---|---|---|
| | 98.00 | OBR | 012 | 00:04:16 | End (1): Obstruction Rocks from 5 to 7 o'clock, Loss of cross sectional area = 10 %, OM:2 |

End (1): Obstruction Rocks from 5  
to 7 o'clock, Loss of cross sectional  
area = 10 %, OM:2

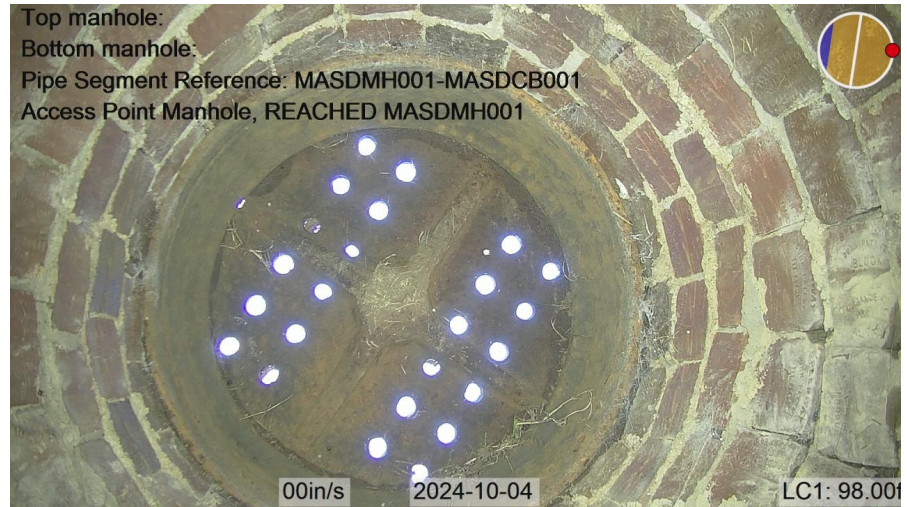
**Image Ref.** 013

Access Point Manhole, REACHED  
 MASDMH001
