| Drainage Area | Street | TREMONT AVE |

# PACP Inspection Report

| <b>Surveyed by</b> BRANDON LUERS | <b>Date</b> 10/4/2024 | <b>Weather</b> Dry - No precipitation during survey |

| <b>Pipe Segment Ref.</b> MASDCB002-MASDCB003 | <b>City</b> | MASSILON |

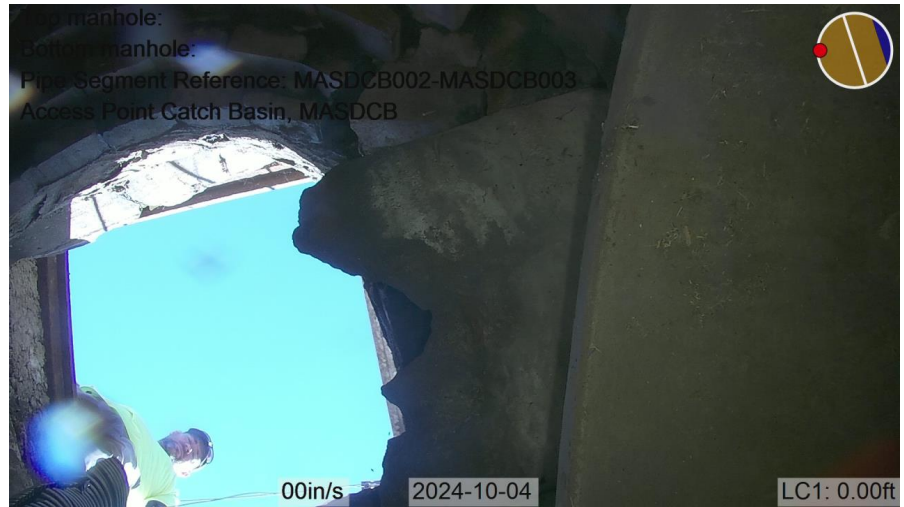
**Image Ref.** **040**

| Distance | Video Ref. | Code | Description | Cont. Defect | Value | | | Grade | Joint | Circumferential Location | | Image | Remarks |
|---|---|---|---|---|---|---|---|---|---|---|---|---|---|
| 0.00 | 00:00:03 | ACB | Access Point Catch Basin | | | | | | | | | 040 | MASDCB002 |

Access Point Catch Basin,  
MASDCB002

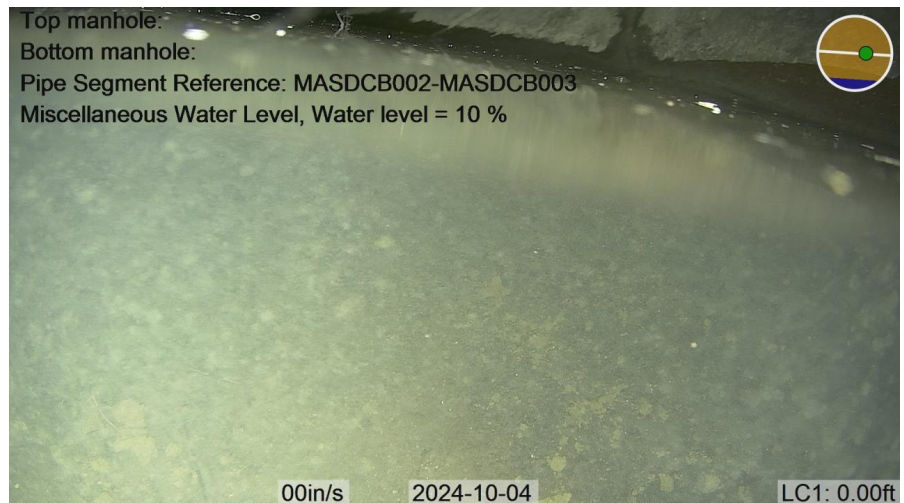
**Image Ref.** **041**

| Distance | Video Ref. | Code | Description | Cont. Defect | Value | | | Grade | Joint | Circumferential Location | | Image | Remarks |
|---|---|---|---|---|---|---|---|---|---|---|---|---|---|
| 0.00 | 00:00:08 | MWL | Miscellaneous Water Level | | | | 10 | | | | | 041 | |

Miscellaneous Water Level, Water  
level = 10 %

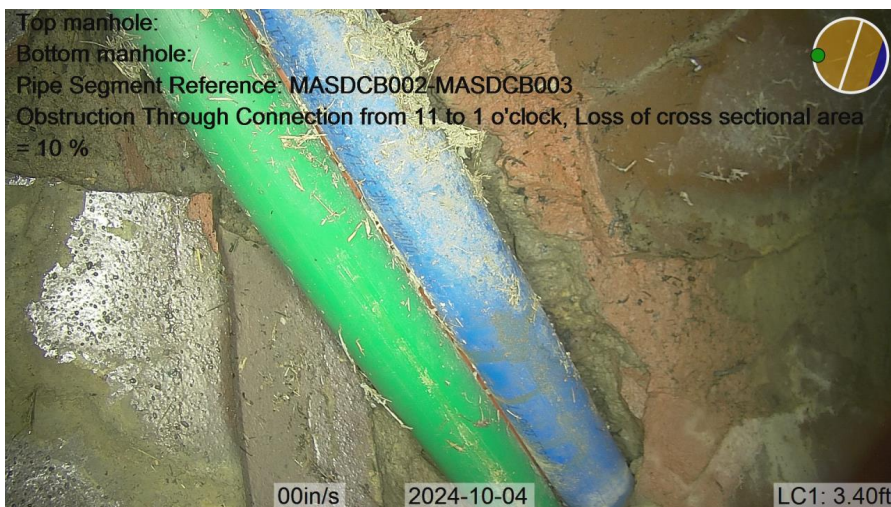
**Image Ref.** **042**

| Distance | Video Ref. | Code | Description | Cont. Defect | Value | | | Grade | Joint | Circumferential Location | | Image | Remarks |
|---|---|---|---|---|---|---|---|---|---|---|---|---|---|
| 1.90 | 00:00:22 | OBC | Obstruction Through Connection | | | | 10 | OM2 | | 11 | 01 | 042 | |

Obstruction Through Connection  
from 11 to 1 o'clock, Loss of cross  
sectional area = 10 %, OM:2

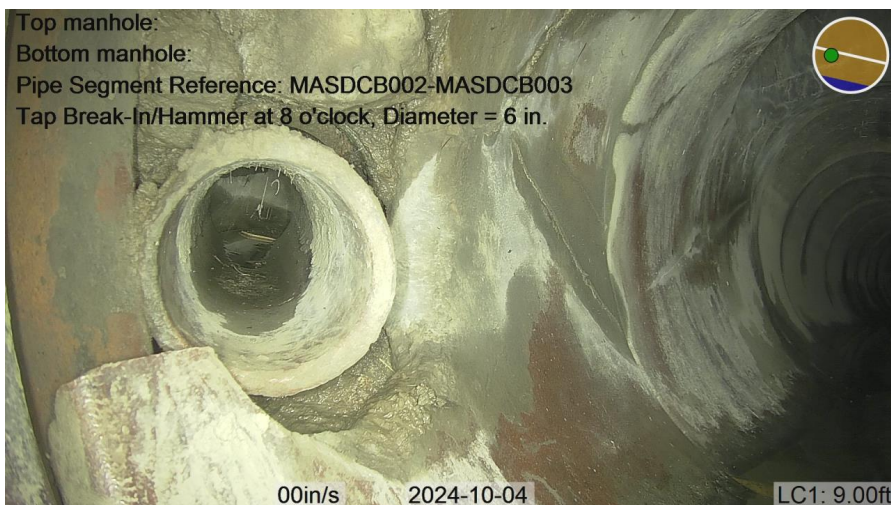
**Image Ref.** **043**

| Distance | Video Ref. | Code | Description | Cont. Defect | Value | | | Grade | Joint | Circumferential Location | | Image | Remarks |
|---|---|---|---|---|---|---|---|---|---|---|---|---|---|
| 9.00 | 00:00:35 | TB | Tap Break-In/Hammer | | 6 | | | | | 08 | | 043 | |

Tap Break-In/Hammer at 8 o'clock,  
Diameter = 6 in.

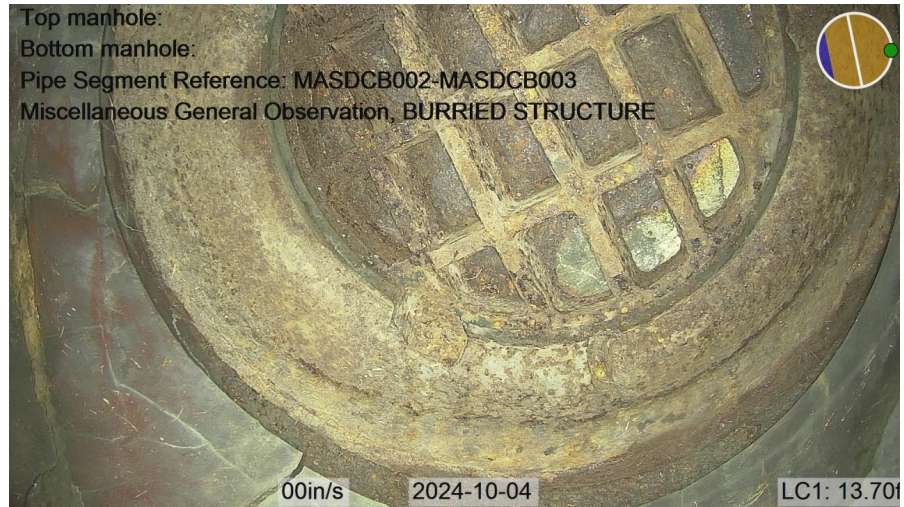
**Image Ref.** **044**

| Distance | Video Ref. | Code | Description | Cont. Defect | Value | | | Grade | Joint | Circumferential Location | | Image | Remarks |
|---|---|---|---|---|---|---|---|---|---|---|---|---|---|
| 13.70 | 00:00:58 | MGO | Miscellaneous General Observation | | | | | | | | | 044 | BURRIED STRUCTURE |

Miscellaneous General  
Observation, BURRIED  
STRUCTURE

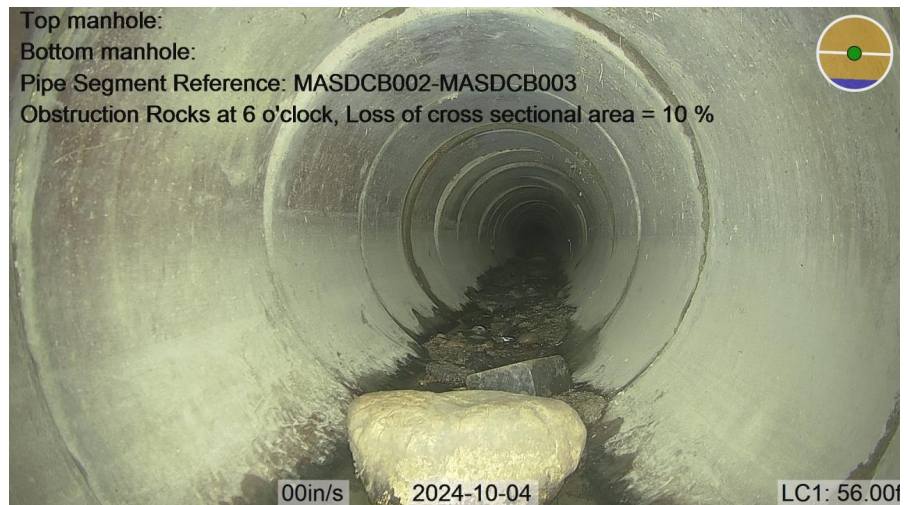
**Image Ref.** **045**

| Distance | Video Ref. | Code | Description | Cont. Defect | Value | | | Grade | Joint | Circumferential Location | | Image | Remarks |
|---|---|---|---|---|---|---|---|---|---|---|---|---|---|
| 55.90 | 00:01:40 | OBR | Obstruction Rocks | | | | 10 | OM2 | | 06 | | 045 | |

Obstruction Rocks at 6 o'clock, Loss  
of cross sectional area = 10 %,  
OM:2

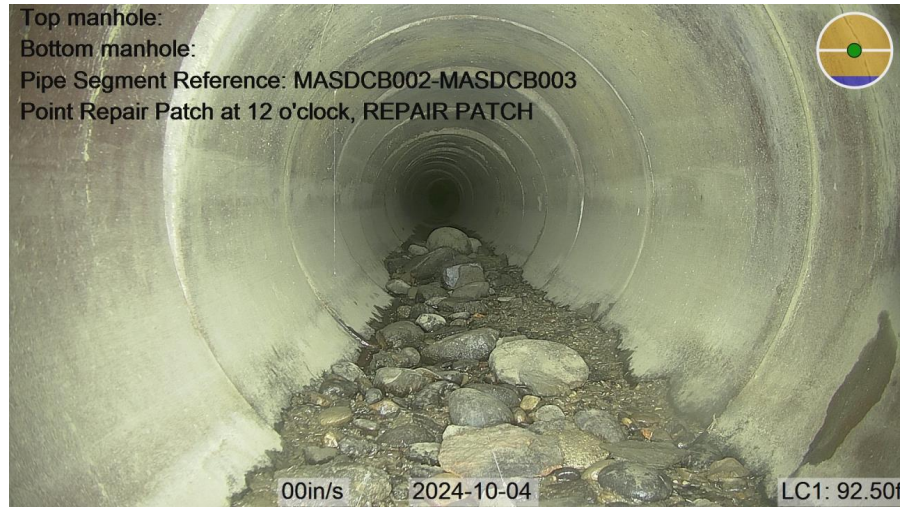
**Image Ref.** **047**

| Distance | Video Ref. | Code | Description | Cont. Defect | Value | | | Grade | Joint | Circumferential Location | | Image | Remarks |
|---|---|---|---|---|---|---|---|---|---|---|---|---|---|
| 92.50 | 00:05:01 | RPP | Point Repair Patch | | | | | | | 12 | | 047 | REPAIR PATCH |

Point Repair Patch at 12 o'clock,  
REPAIR PATCH

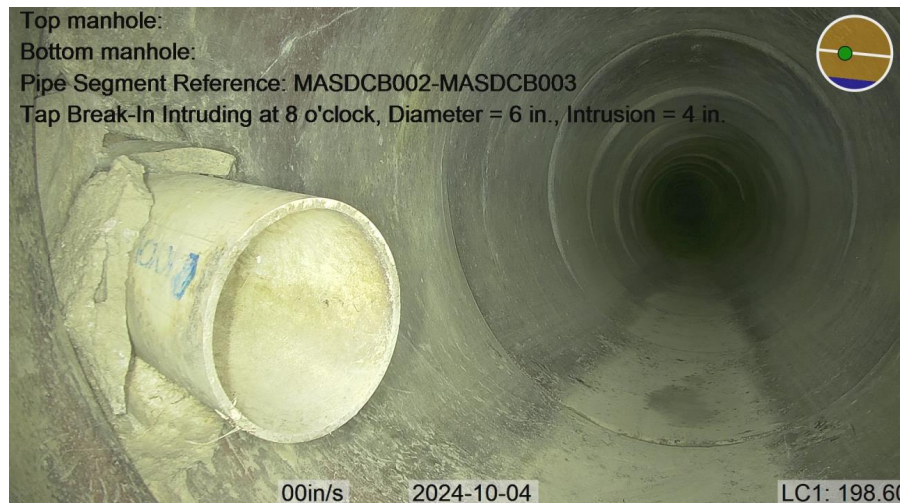
**Image Ref.** **048**

| Distance | Video Ref. | Code | Description | Cont. Defect | Value | | | Grade | Joint | Circumferential Location | | Image | Remarks |
|---|---|---|---|---|---|---|---|---|---|---|---|---|---|
| 198.60 | 00:06:51 | TBI | Tap Break-In Intruding | | 6 | 4 | | | | 08 | | 048 | |

Tap Break-In Intruding at 8 o'clock,  
Diameter = 6 in., Intrusion = 4 in.

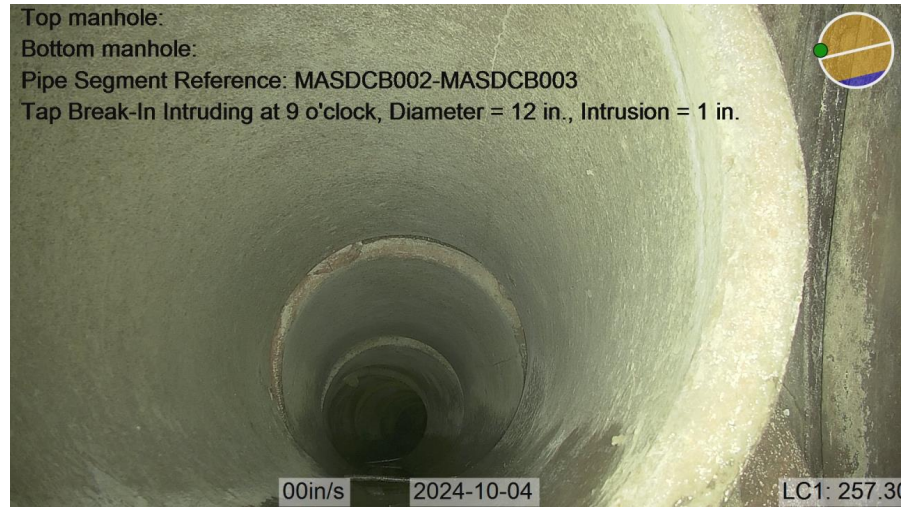
**Image Ref.** 049

| Distance | Video Ref. | Code | Description | Cont. Defect | Value | | | Grade | Joint | Circumferential Location | | Image | Remarks |
|---|---|---|---|---|---|---|---|---|---|---|---|---|---|
| 257.30 | 00:08:16 | TBI | Tap Break-In Intruding | | 12 | 1 | | | | 09 | | 049 | |

Tap Break-In Intruding at 9 o'clock,  
Diameter = 12 in., Intrusion = 1 in.

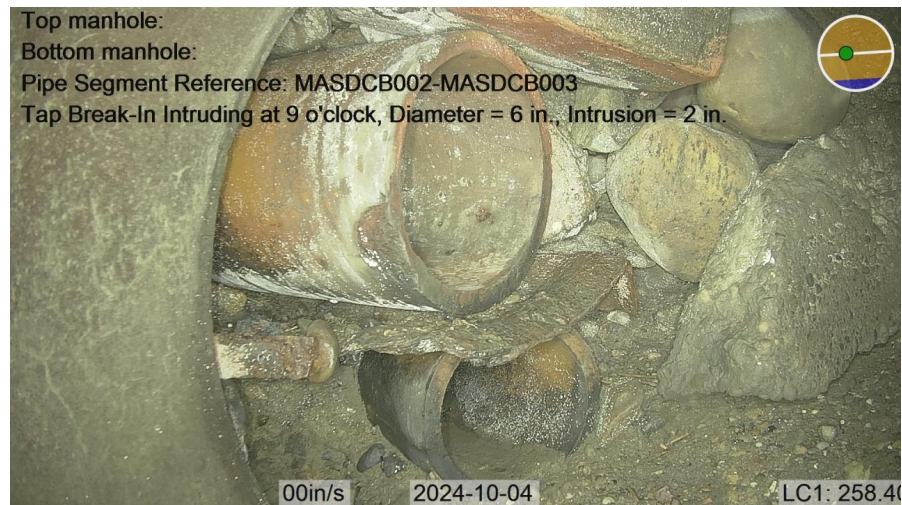
**Image Ref.** 050

| Distance | Video Ref. | Code | Description | Cont. Defect | Value | | | Grade | Joint | Circumferential Location | | Image | Remarks |
|---|---|---|---|---|---|---|---|---|---|---|---|---|---|
| 258.40 | 00:08:25 | TBI | Tap Break-In Intruding | | 6 | 2 | | | | 09 | | 050 | |

Tap Break-In Intruding at 9 o'clock,  
Diameter = 6 in., Intrusion = 2 in.

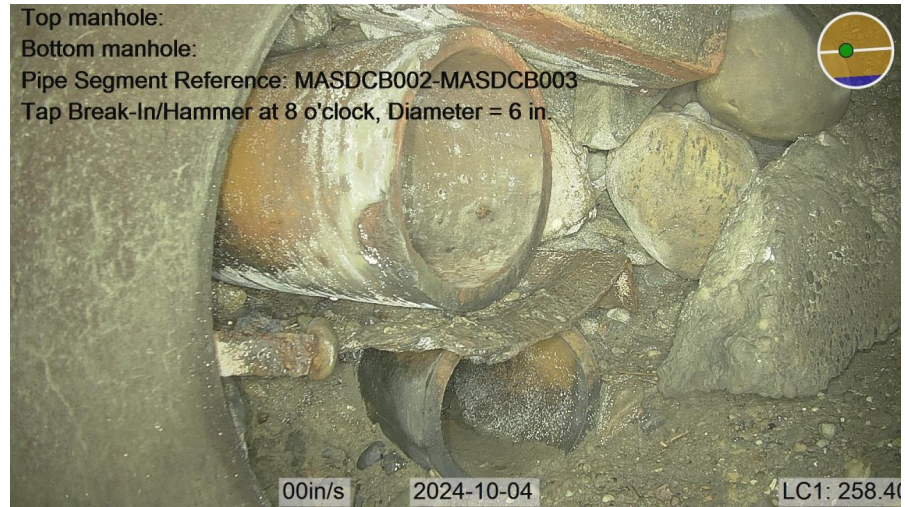
**Image Ref.** **051**

| Distance | Video Ref. | Code | Description | Cont. Defect | Value | | | Grade | Joint | Circumferential Location | | Image | Remarks |
|---|---|---|---|---|---|---|---|---|---|---|---|---|---|
| 258.40 | 00:08:28 | TB | Tap Break-In/Hammer | | 6 | | | | | 08 | | 051 | |

Tap Break-In/Hammer at 8 o'clock,  
Diameter = 6 in.

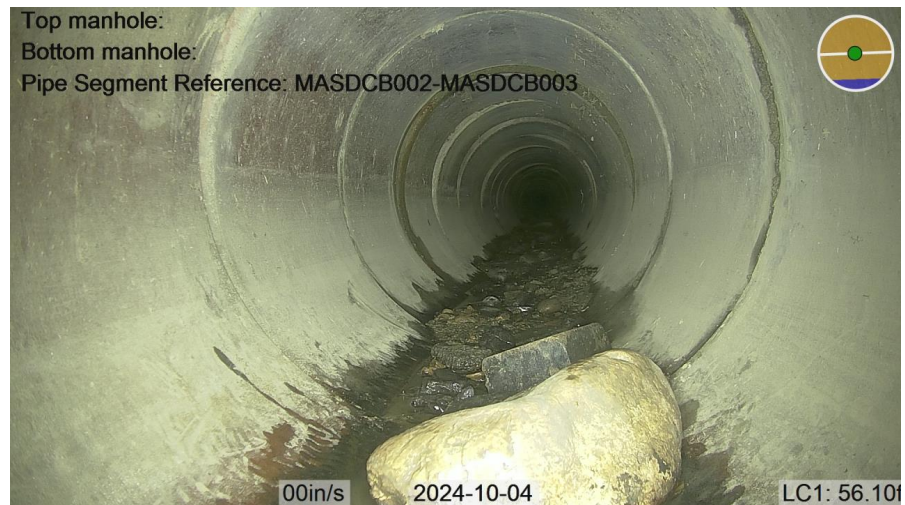
**Image Ref.** **046**

| Distance | Video Ref. | Code | Description | Cont. Defect | Value | | | Grade | Joint | Circumferential Location | | Image | Remarks |
|---|---|---|---|---|---|---|---|---|---|---|---|---|---|
| 259.00 | 00:03:06 | MSA | Miscellaneous Survey Abandoned | | | | | | | | | 046 | COULD NOT GO ANY FURTHER REACHED FITTING POINT |

Miscellaneous Survey Abandoned,  
COULD NOT GO ANY FURTHER  
REACHED FITTING POINT
