PHASE I  
ENVIRONMENTAL SITE  
ASSESSMENT  
SELECT PROPERTIES  
THIRD STREET NW  
MASSILLON, OHIO.

September 14, 1994

Berquist and Associates  
Massillon, Ohio

URS CONSULTANTS  
23355 Mercantile Road Cleveland, Ohio 44122  
j:\adm\berquist\5050600\reports\massprc.rpt

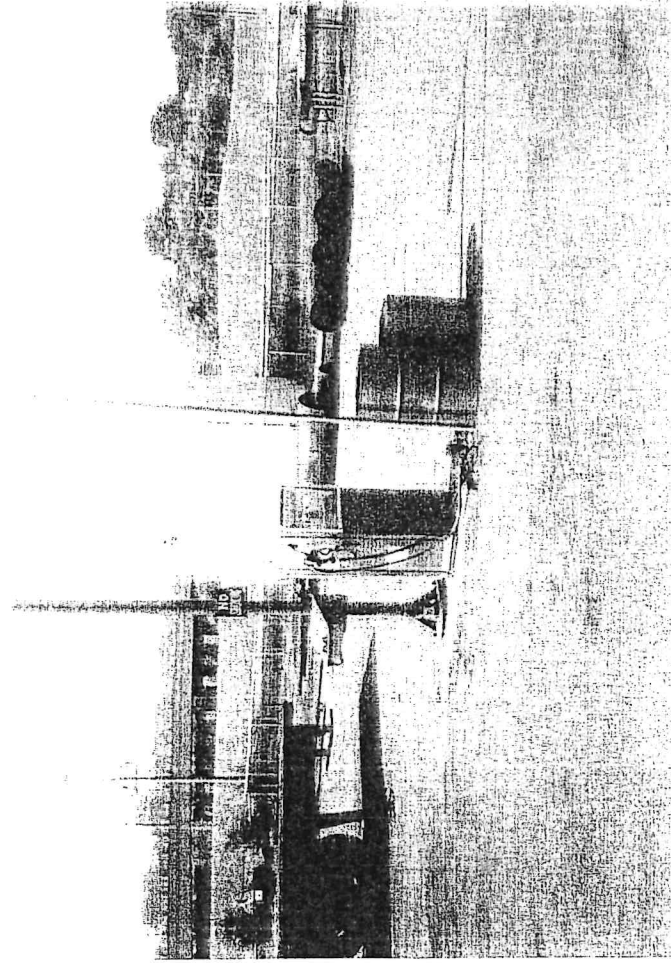
- A site walkover of the properties indicated a number of areas of concern on the Ohio Drilling Company main plant site. These areas are as follows:
  1. The presence of an UST located on the south side of the property.

Photograph 1 8/25/94  
Ohio Drilling Co. (ODC) Main Plant Note UST

Based on these conclusions, a Phase II Site Investigation is warranted and recommended for both the Ohio Drilling company main plant site and the Agathon ballfield. The Phase II study would include subsurface sampling at the UST and some areas of surface spillage at the Ohio Drilling site and select subsurface sampling at the Agathon ball field.

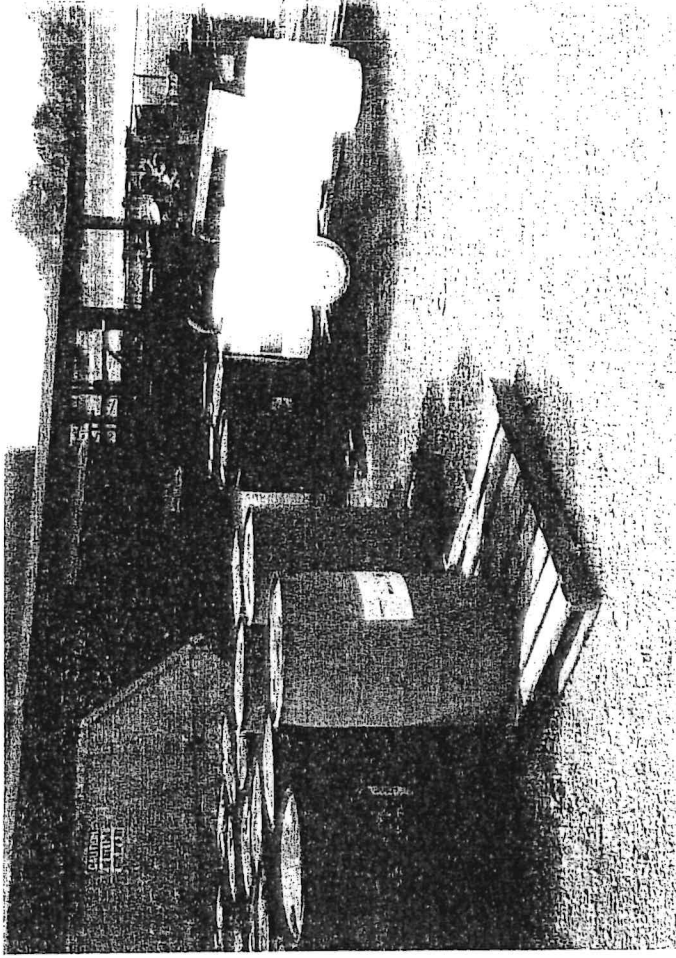
The northern section of the exterior of the building is also a gravel lined parking area which is primarily used to store pipe and drilling supplies. During the walkover one area was noted as having approximately 15 drums of muriatic acid (Hydrochloric acid) which is used in water well production. The acid is often used in the production of water wells however, it was noted that occasionally some of the acid is used onsite to clean parts. This was conveyed verbally by an employee who was present during the site walkover. The employee stated that the acid is used to clean parts in large plastic troughs. After use, the acid is neutralized with soda ash and discharged to the sewer system. Based on a review of the site conditions much of the acid apparently spills on the gravel lot and reacts with the stones. This is apparent from several localized areas of surface staining on the north lot in addition to many small oil surface staining areas found throughout the site (see Photographs 1-4, Appendix B).

Photograph 2 8/25/94  
ODC, Acid Storage, Note Surface Spillage

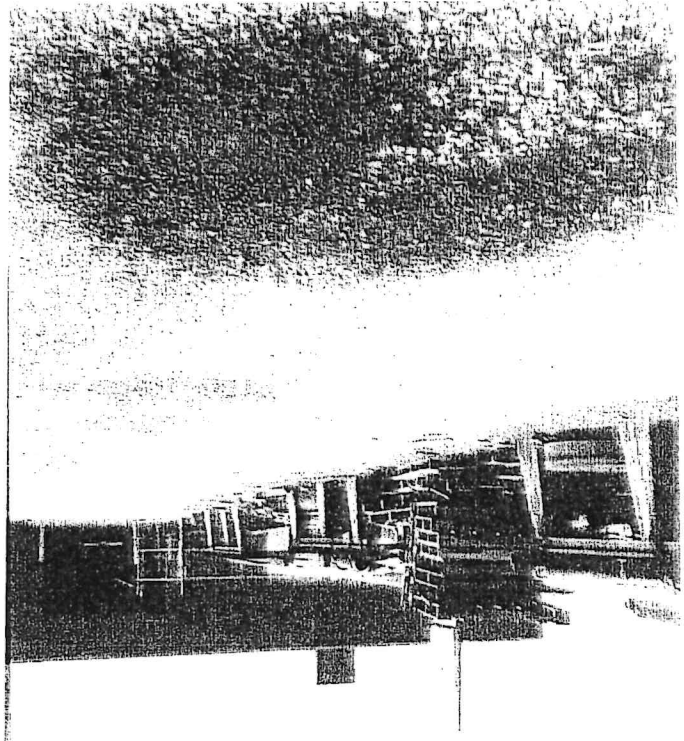
2. Stained surface soil, resulting from spilled hydraulic, lube and/or used motor oil and Muriatic Acid (Hydrochloric) exists on the north side of the facility.

Photograph 3 8/25/94  
ODC, Surface Oil Spillage

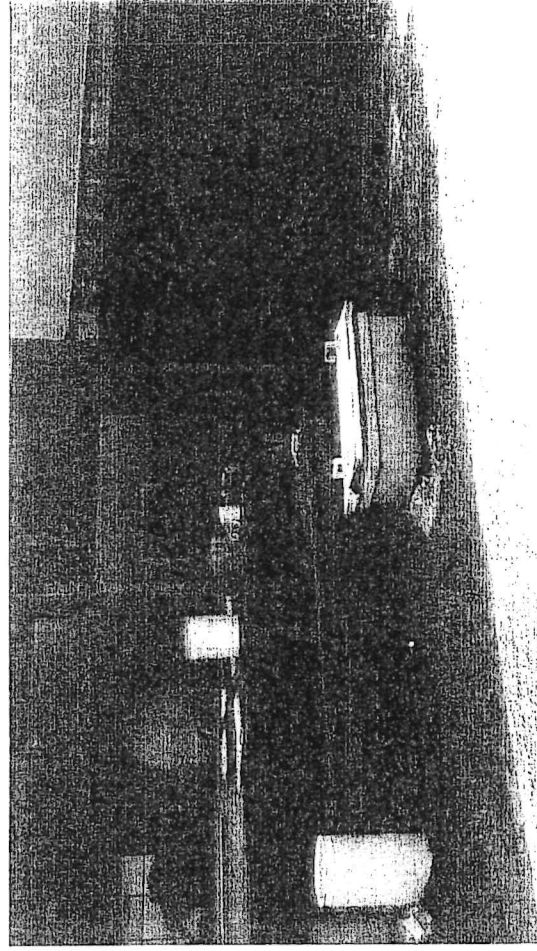
Photograph 4 8/25/94  
ODC, Parts Cleaning - Acid Trough

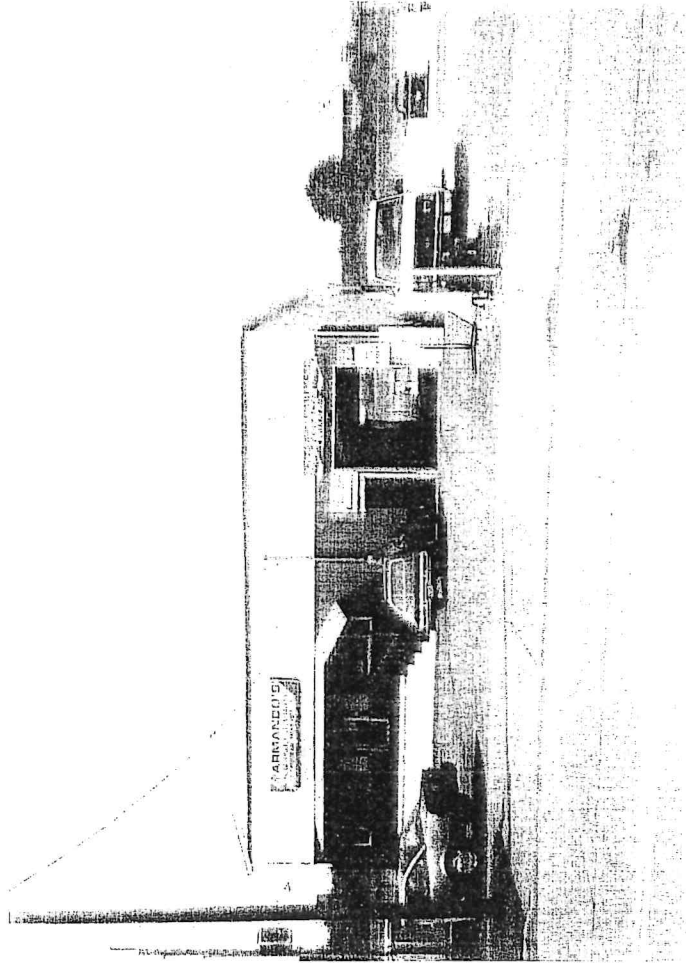
Photograph 5 8/25/94  
Armandos Fizza Building

A survey of both the interior and exterior of the Armandos pizza/Cork and Bottle beverage store building did not reveal any items of concern with respect to the potential for environmental contamination. One drum of an oil-like substance was found behind the building-however it was found to contain waste grease from the Pizza kitchen (see Photograph 5, Appendix B).

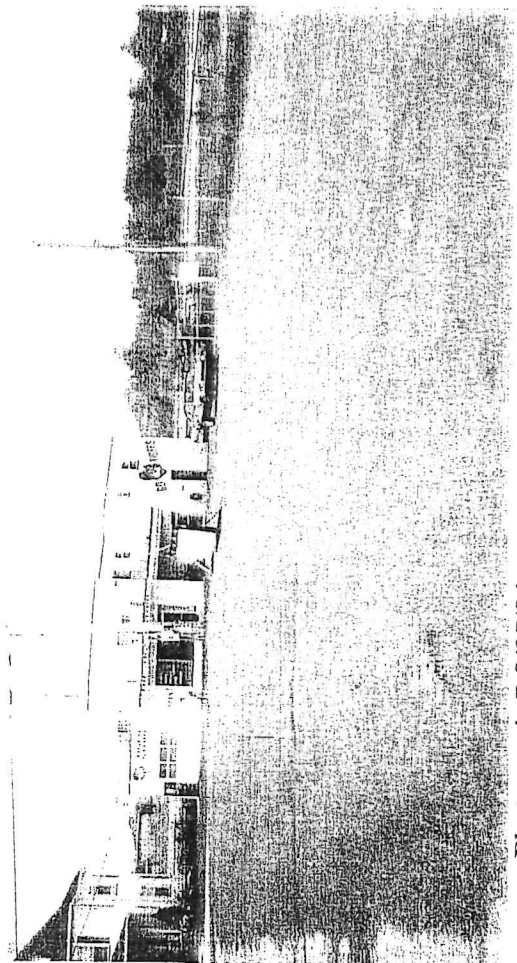
Photograph 7 8/25/94  
Tiger Store and Adjacent Residence

A review of exterior conditions at this residential home also did not indicate any problems or concerns with respect to environmental contamination (see Photograph 7, Appendix B).

The Tiger store is a two story wood frame structure situated in a paved parking lot. The building has the appearance of having residential quarters upstairs. The first floor is a retail sporting goods store with no noted items of concern (see Photograph 7, Appendix B).
