Massillon Levee Pipe Inspection  
Final Report  
February 4, 2010

Pipeline and Drainage Consultants  
Subsidiary of Spartan Construction

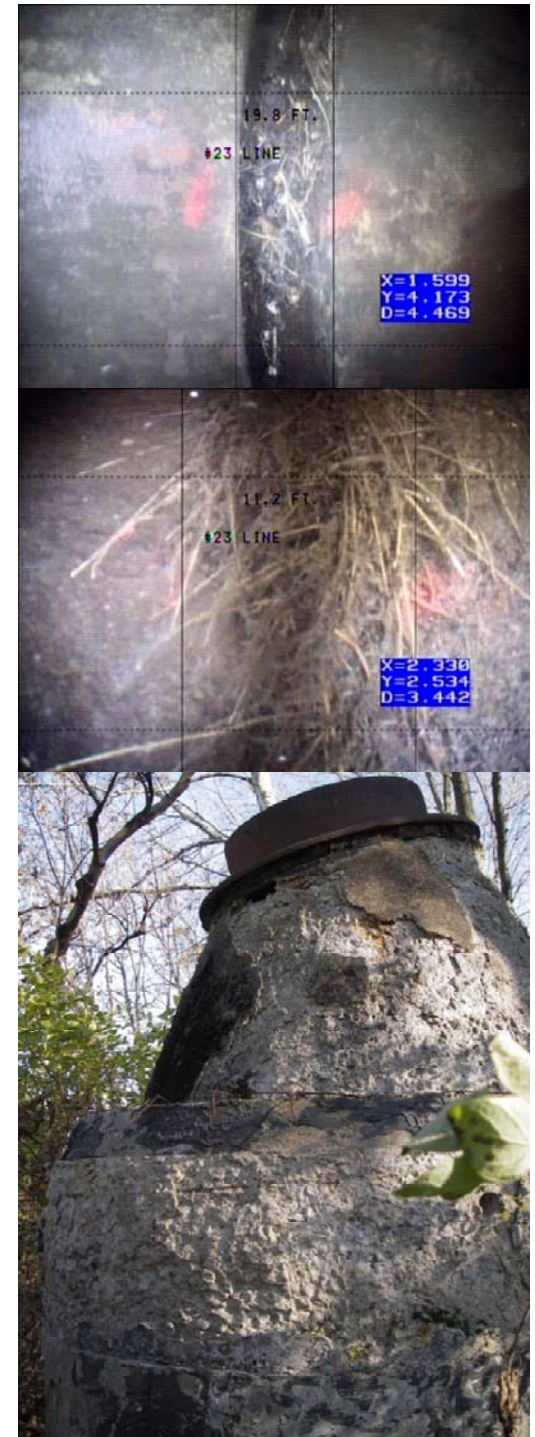
| Pipe #23 West of Rail Road | |
|---|---|
| 94.3ft | Approx. 2" joint separation right haunch |
| 103 ft | Manhole, significant deterioration |

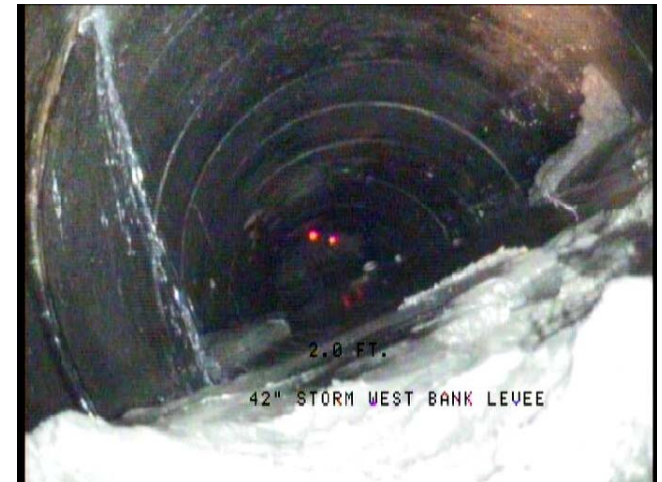
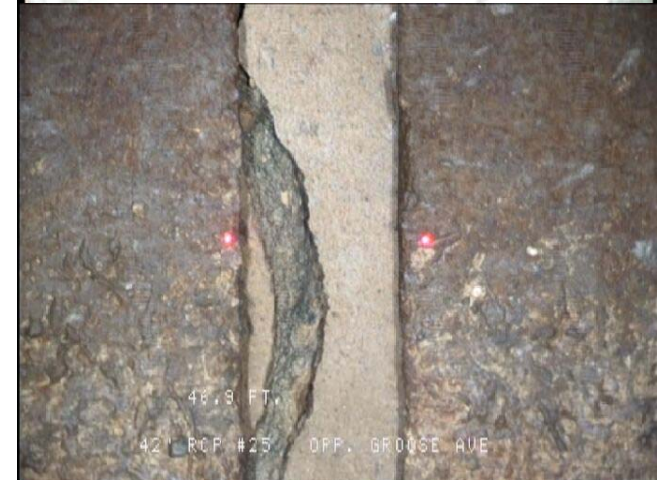
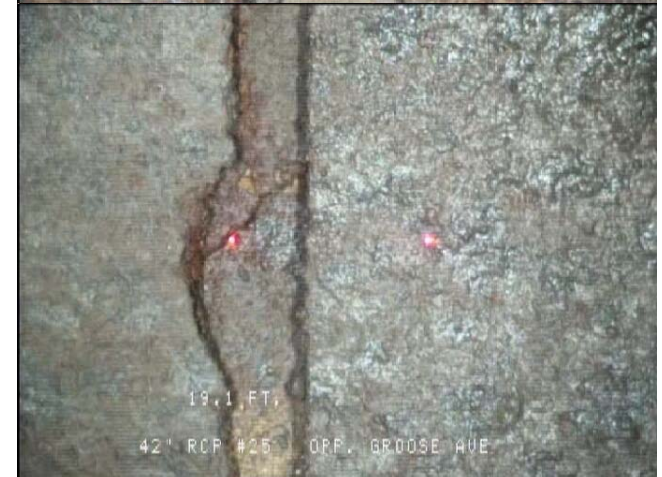
| Pipe #25 | |
|---|---|
| 46.9 ft | Gasket rolled |
| 78.9ft | Crack through bell |

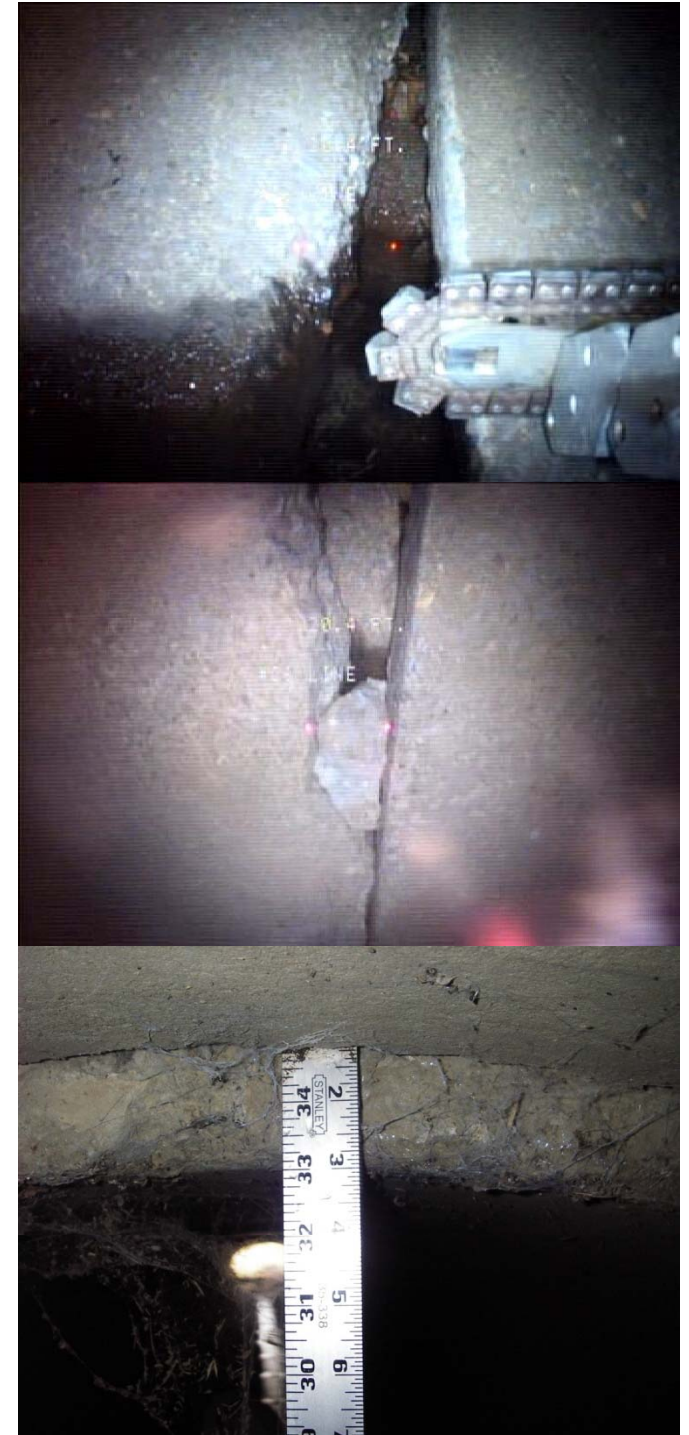
| Pipe # 26 | |
|---|---|
| 88ft | Spalled/broken invert/moisture present |
| 93ft | Large piece of headwall missing at invert of inlet approx. 36" across |

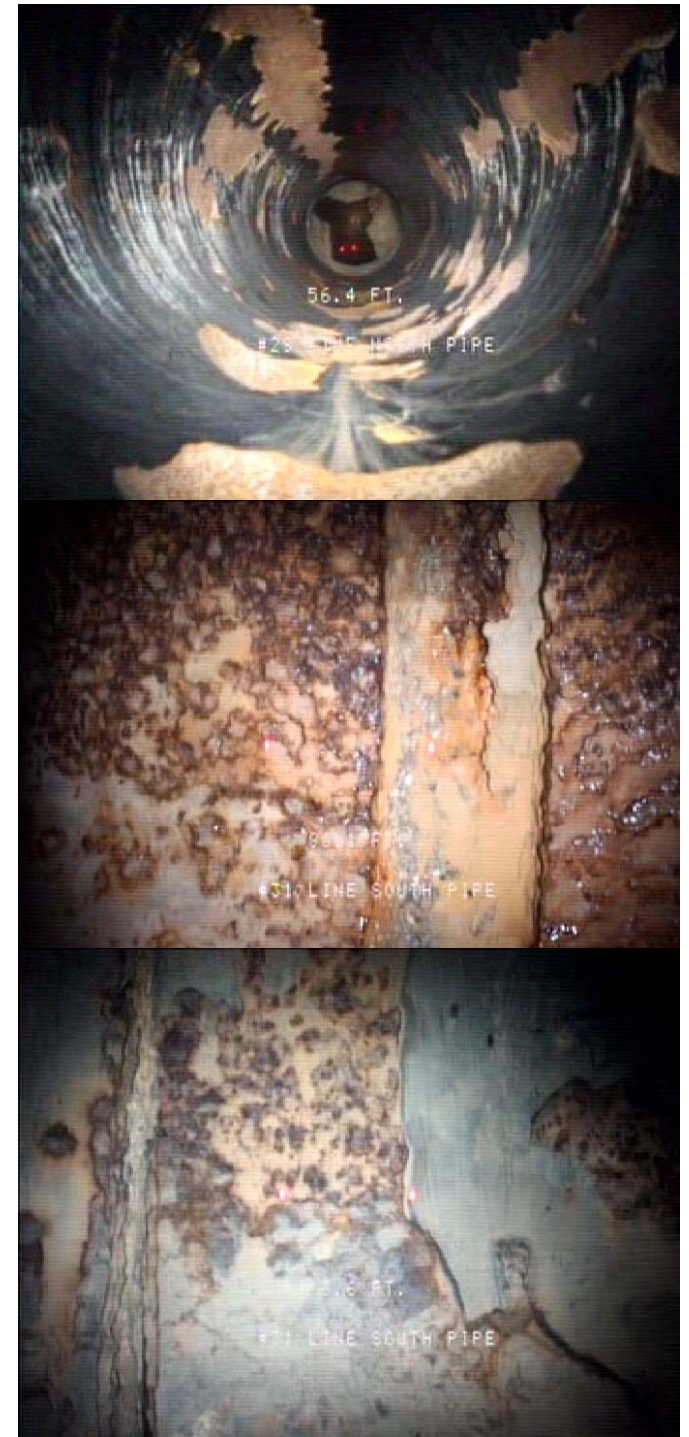
| Feet | Defect |
|---|---|
| 0-100 ft | All three pipes have moderate to severe corrosion at the joints. Bellies have formed in the flat areas of the pipe at the beginning and the end of the runs toward the pump station. Missing protective coating and corrosion was also noted in flat areas and sharp bends. It appears in some sections that point repairs have been made on the protective coating. Recommend air pressure testing to verify integrity of the joints. |

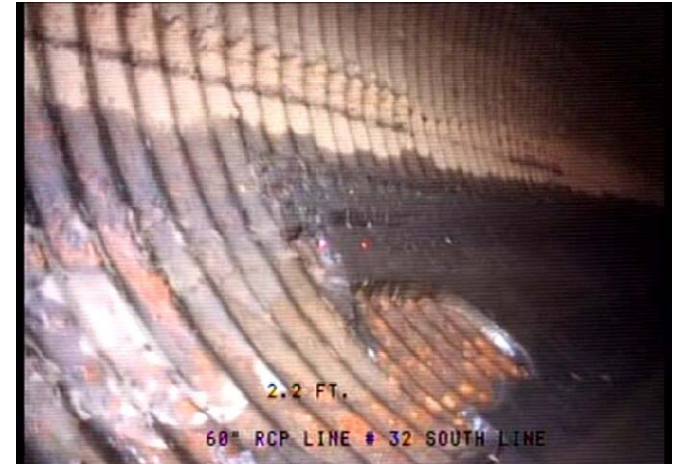
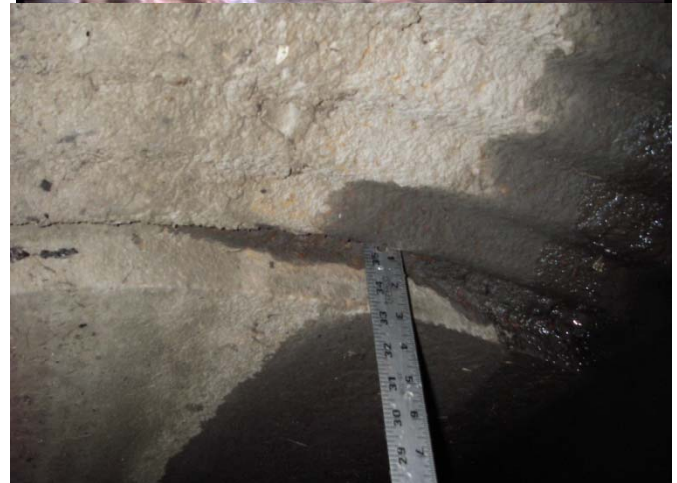
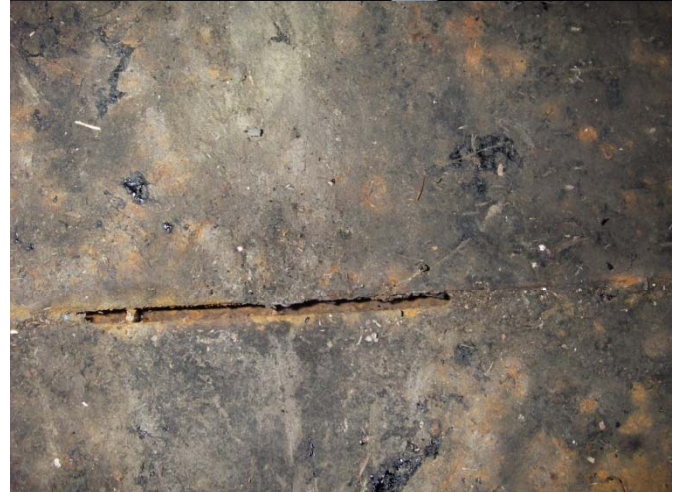
| Pipe # 32, Federal Avenue South Gravity | |
|---|---|
| 127ft | Approx. 1" joint separation, staining at 1:00 |
| 135ft | Gatewell |

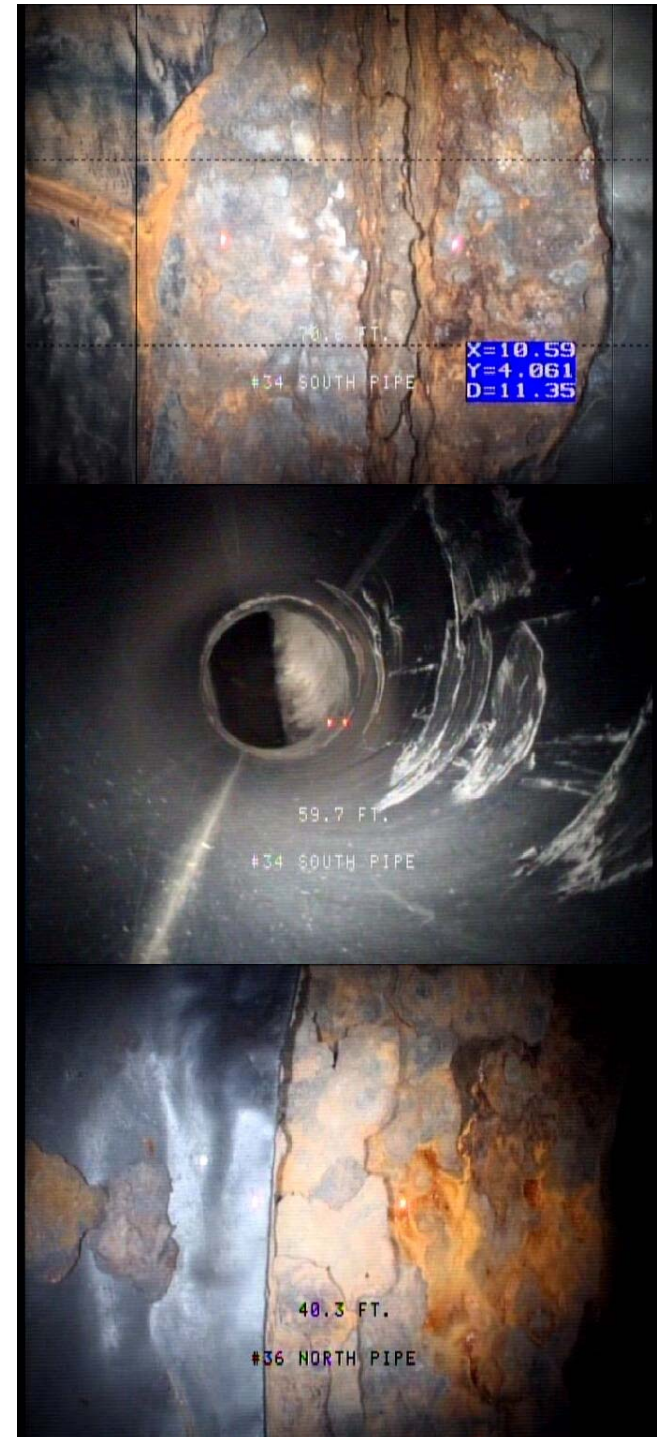
| Feet | Defect |
|---|---|
| 0-141 ft | <p>All three pipes have moderate to severe corrosion at the joints. Missing protective coating and corrosion was also noted in flat areas and sharp bends. It appears in some sections that point repairs have been made on the protective coating. Recommend air pressure testing to verify integrity of the joints.</p> <p>*Note: Pipe #35 has severe loss of lining from air-release valve to pump station on the downward grade section of pipe.</p> |

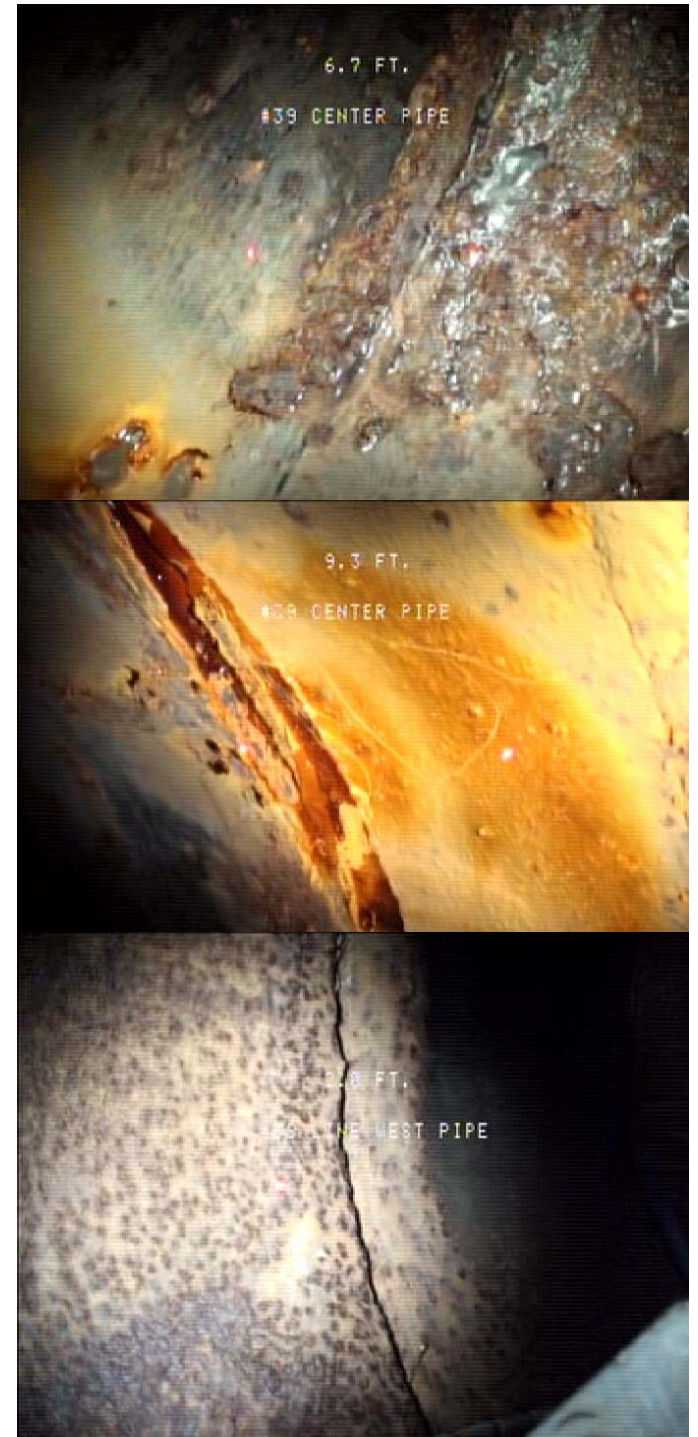
| Feet | Defect |
|---|---|
| 5, 10, 20 ft | <p>All three pipes have moderate to severe corrosion and rust at the joints and pipe walls. Missing protective coating was predominately around the haunches and inverts of the pipe. Recommend air pressure testing to verify integrity of the joints.</p> <p>*Note: Pipe #39 (center) at 9.3ft has a severe offset/separated joint with potential leakage.</p> |

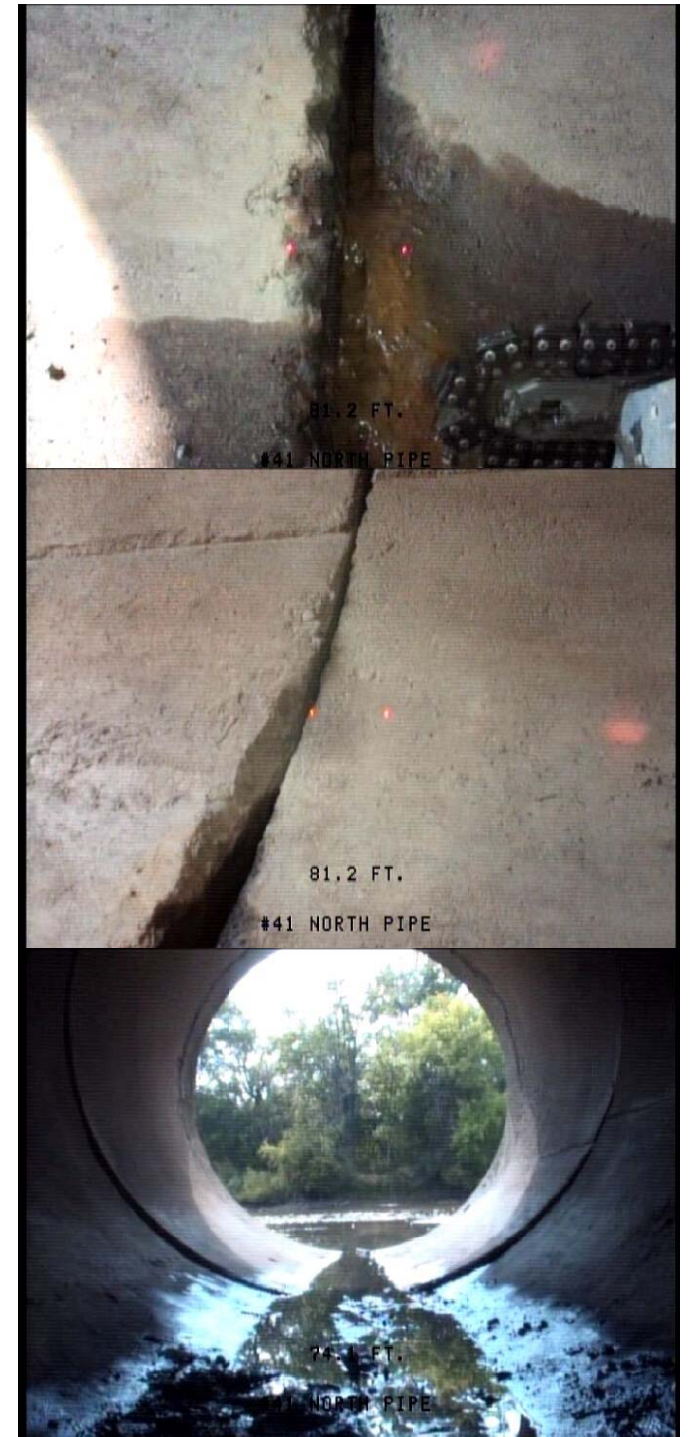
| Arch Avenue Box #41 | |
|---|---|
| 85ft | Spalling/ cracking at headwall |

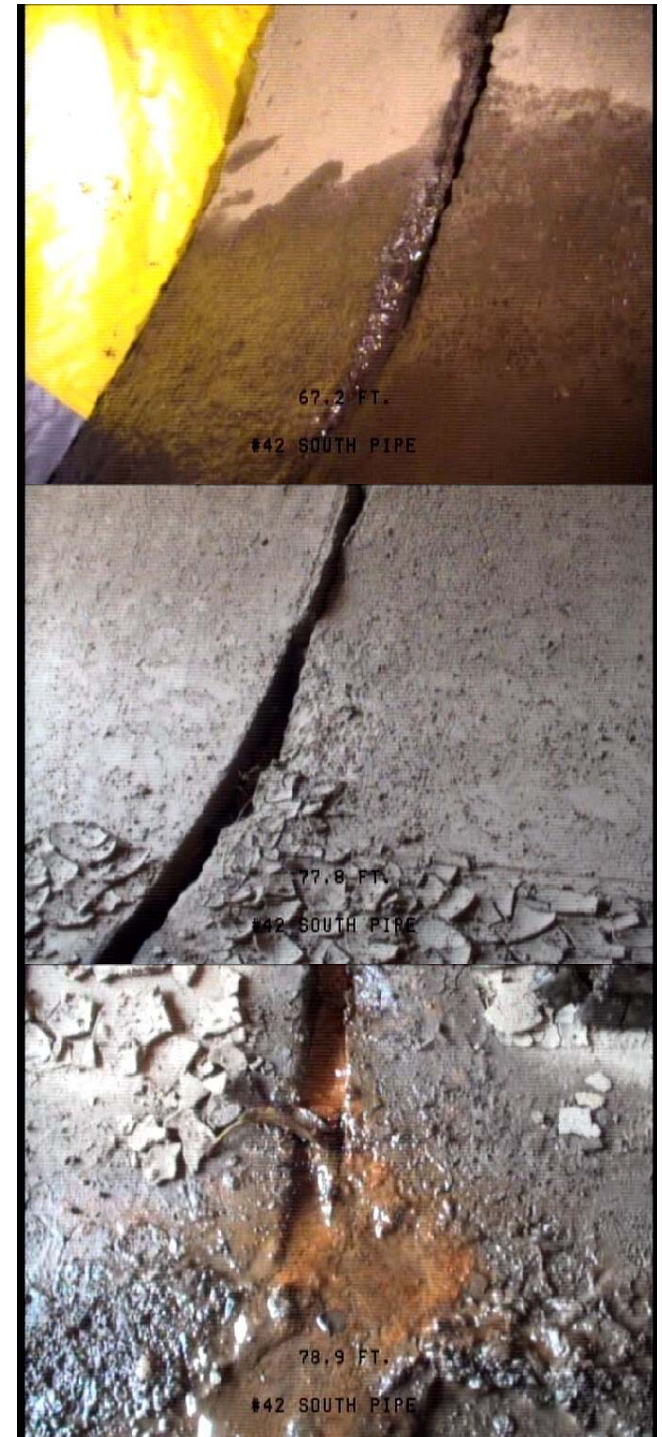
| Arch Avenue Box #42 | |
|---|---|
| 84ft | Radial cracking near joint/ cracking at joint and exposed rebar at 11 o'clock |

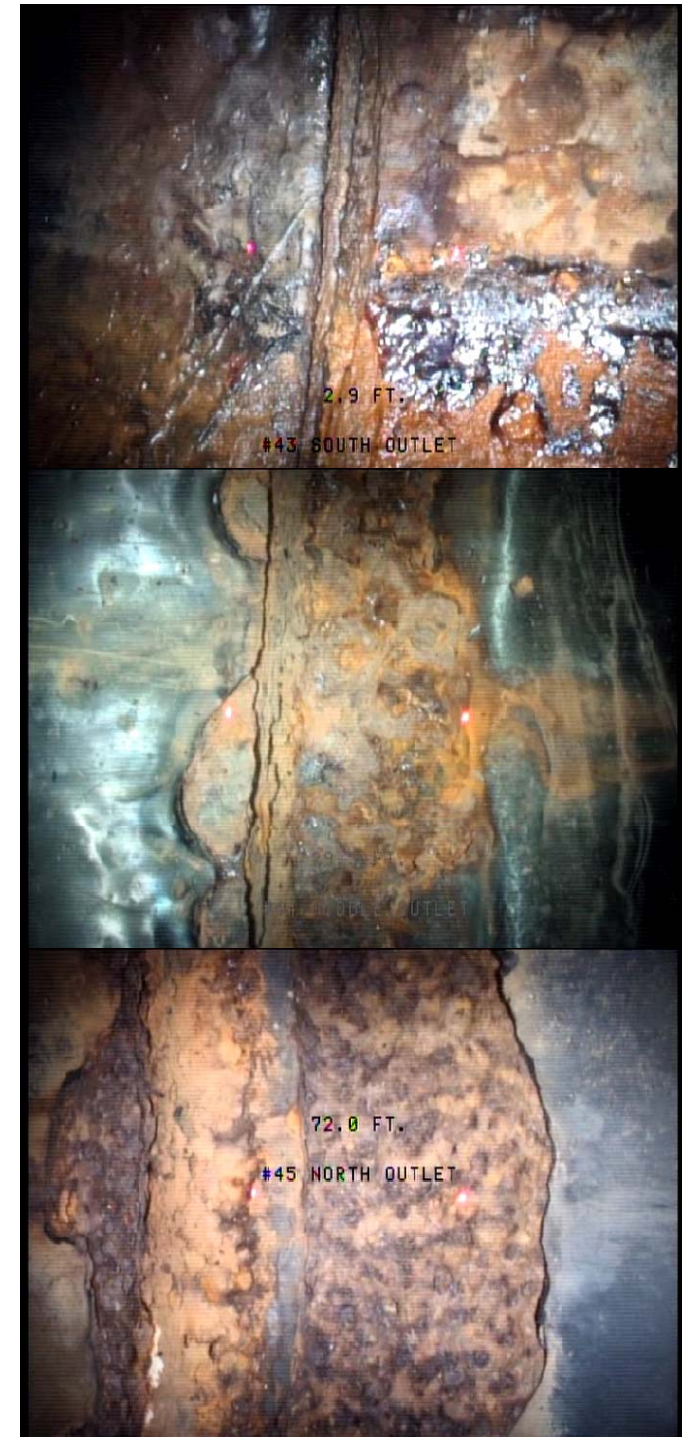
| Feet | Defect |
|---|---|
| 0-85 ft | All three pipes have moderate to severe corrosion at the joints. Missing protective coating and corrosion was also noted in flat areas and sharp bends. It appears in some sections that point repairs have been made on the protective coating. Recommend air pressure testing to verify integrity of the joints. |

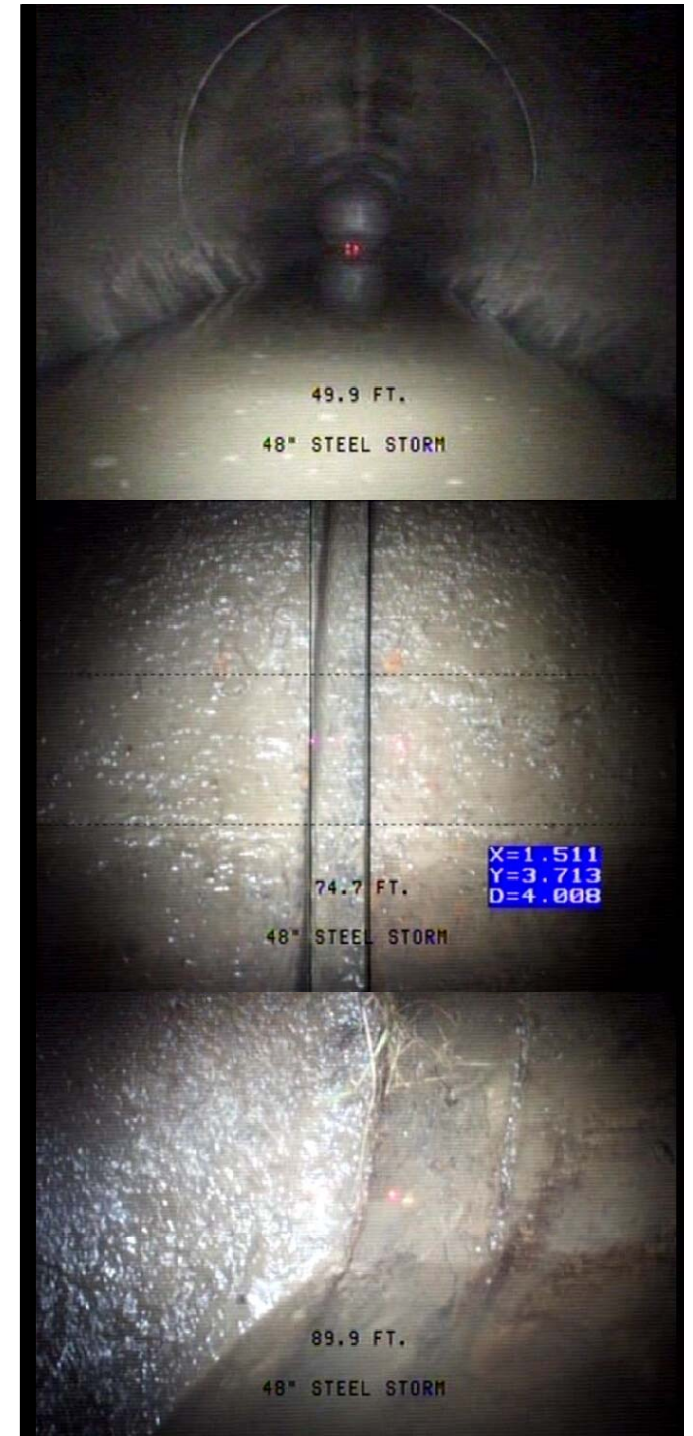
| Arch Avenue Pipe #46 (MH to Gatewell/Outlet) | |
|---|---|
| 0ft-90ft | Several joints appear to be wider at the bottom, indicating that the line has some slight settlement. |

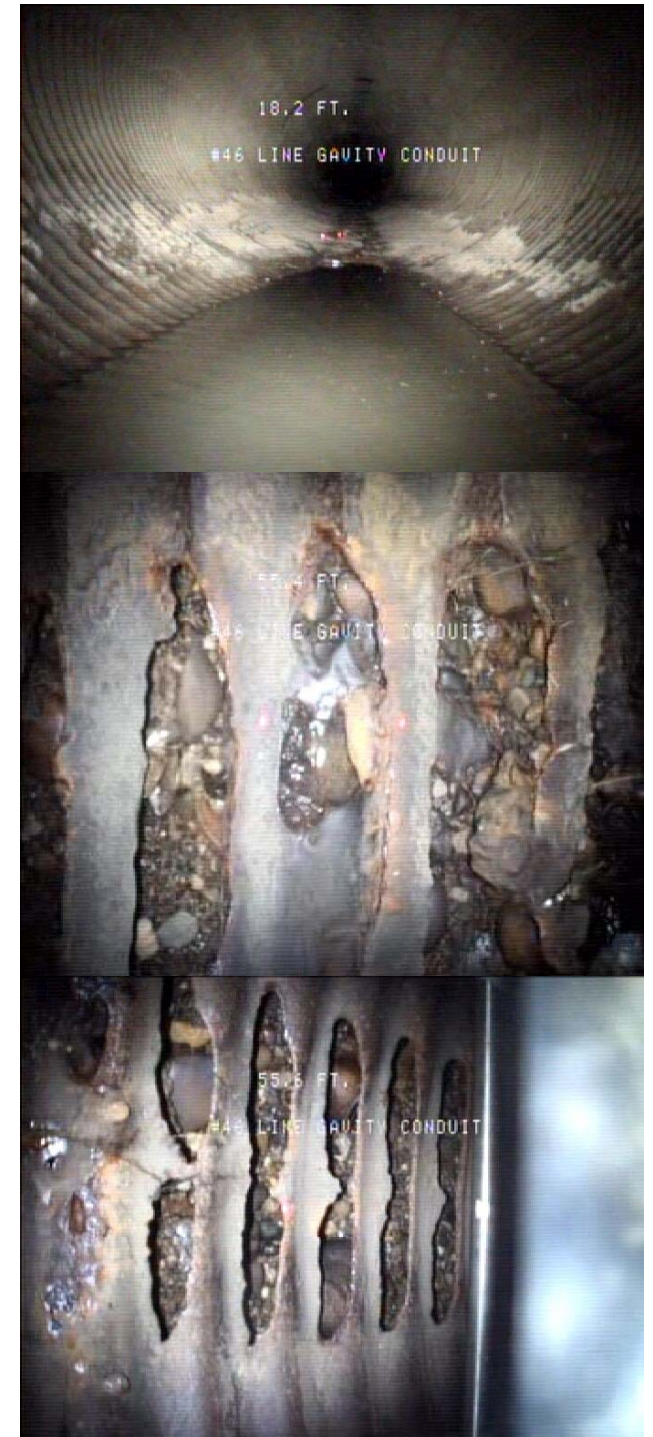
| Arch Avenue Pipe #46B (MH Upgrade) | |
|---|---|
| 0ft-317ft | Invert is rusted completely through in several areas throughout the pipe, starting to deflect and buckle in areas. |

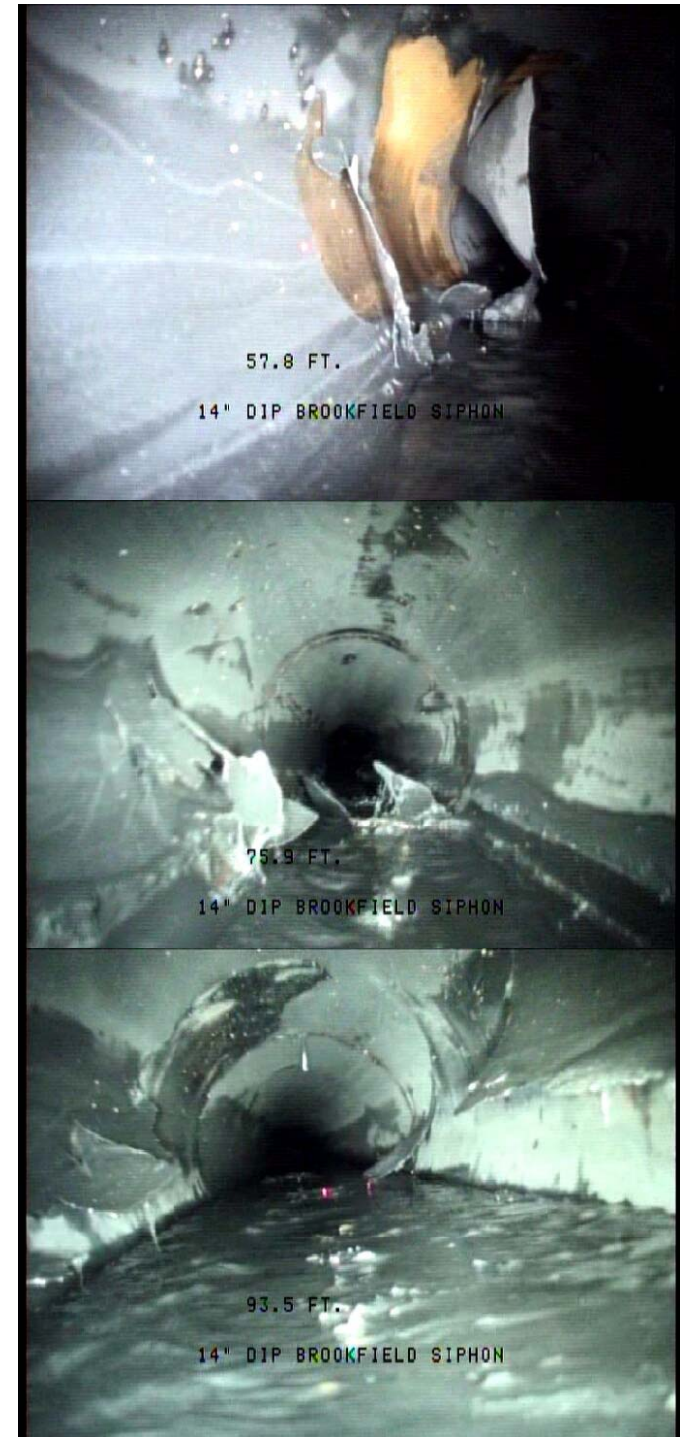
| Brookfield Siphon 14" – Outlet | |
|---|---|
| 93ft | Debris level to high to continue, inspection discontinued. |

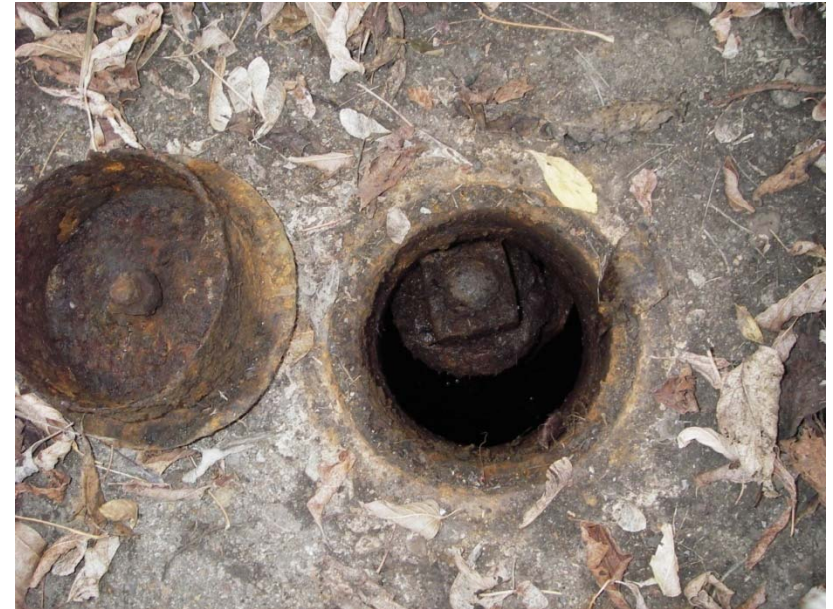
| Wooster Siphon Pipe No. 51 and 52 | |
|---|---|
| 0.0 | Gate valves frozen, could not be moved |

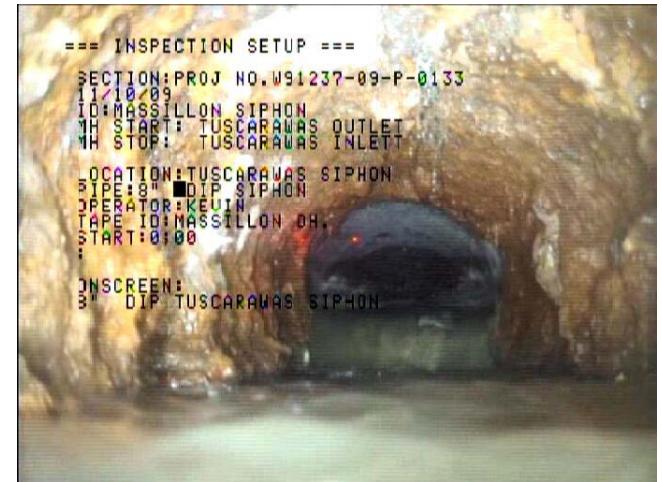
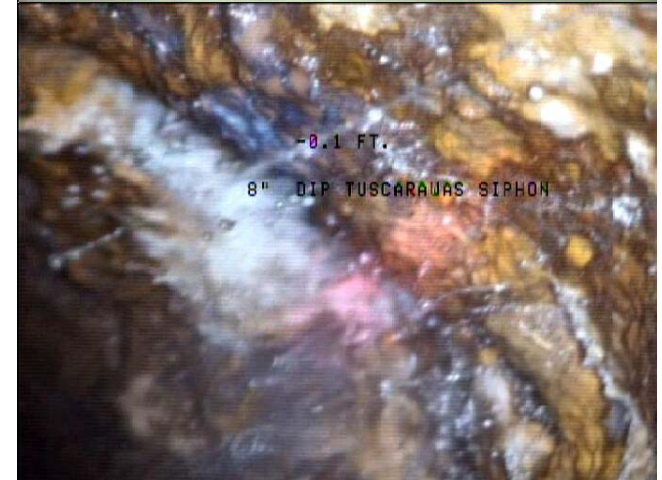
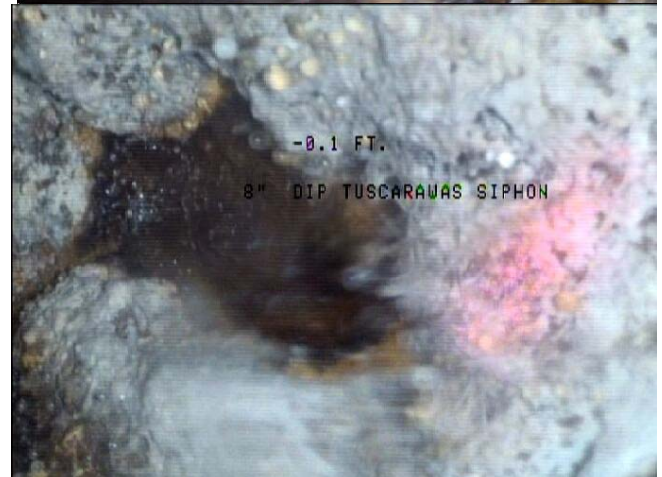
| Siphon Pipe No. 54 | |
|---|---|
| 2.0 | Severe corrosion at outlet |
