Pipes Inspected, Massillon Levee					
Size (Inches)	Material	Length (Feet)	Location					
18	RCP	103	West of RR with Flap Gate					
12	RCP?	175	Could not locate/unknown/does not exist					
42	RCP	95	Culvert through West Bank Levee opposite of Croose Avenue, 1000 ft					
			upstream of Cherry Rd.					
66	RCP	93	Culvert through East Bank Levee near control weir					
42	RCP	360	At inlet to siphon control weir					
			James Avenue Pump Station Gravity Outlet					
			Discharge from James Avenue Pump Station					
		100	Discharge from James Avenue Pump Station					
30	CIP	100	Discharge from James Avenue Pump Station					
			Federal Avenue Pump Station Outlet					
			Federal Avenue Pump Station Outlet					
			Discharge from Federal Avenue Pump Station					
		141	Discharge from Federal Avenue Pump Station					
30	CIP	141	Discharge from Federal Avenue Pump Station					
		120	Sippo Creek Pump Station					
			Discharge from Sippo Creek Pump Station

Army Corp of Engineers Rating Guidelines for Levee Inspection

HUNTINGTON DISTRICT

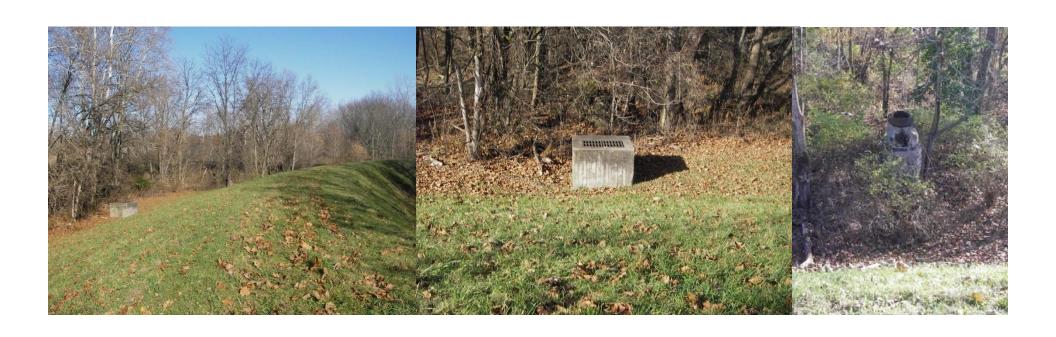
Pipe No. 23 18-Inch Storm Drain

Size				Corp	PACP		Т		
Pipes	(Inches)	Material	Length (Feet)	Location	Rating	Rating	Summary	Discussion/Recommedations		
23	18	RCP	103	West of RR with Flap Gate	U	5	Outlet manhole severely deteriorated, partially collapsed during testing, significant amount of root intrusion, several joints offset throughout the structure.	Manhole severely deteriorated and needs to be replaced. Roots need to be removed and pipe needs to be sealed/grouted or lined.		
24	12	RCP?	175	Could not locate/unknown/does not exist						
25	42	RCP	95	Culvert through West Bank Levee opposite of Croose Avenue, 1000 ft upstream of Cherry Rd.		5	Inlet was completely buried and plugged. Significant joint leakage was occurring at the third joint from the inlet. Water continued to discharge from the joint for several weeks after cleaning.	Consideration should be given to adding a box and drop grate near at the inlet, or grated inlet. Joint should be sealed. Water source infiltrating into the structure should be located.

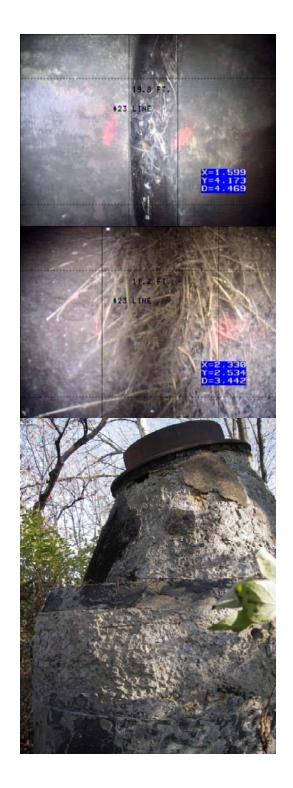
OVERALL CONDITION: NASSCO Grade 5: Manhole is currently failing/failed

GENERAL INSPECTION FINDING: Manhole severely deteriorated. Manhole partially collapsed during testing. Significant amount of root intrusion towards the inlet end of the structure. Several joint throughout the structure offset.

Pipe #23 West of Rail Road						
Feet	Defect					
2.2ft	Offset joint at invert					
3.8ft	Roots coming through joints at invert					
4.7ft	Roots coming through joint at approx. 9 o'clock					
11.2ft	Roots completely covering joint at right haunch, approx. 2" joint separation at invert					
19.8ft	1.5" joint separation at left haunch					
76.5ft	2" joint separation at approx. 3 o'clock					
80.8ft	Sediment covering invert					
88.3ft	1.5" joint separation at approx. 3 o'clock					
94.3ft	Approx. 2" joint separation right haunch					
103 ft	Manhole, significant deterioration					
<u> </u>

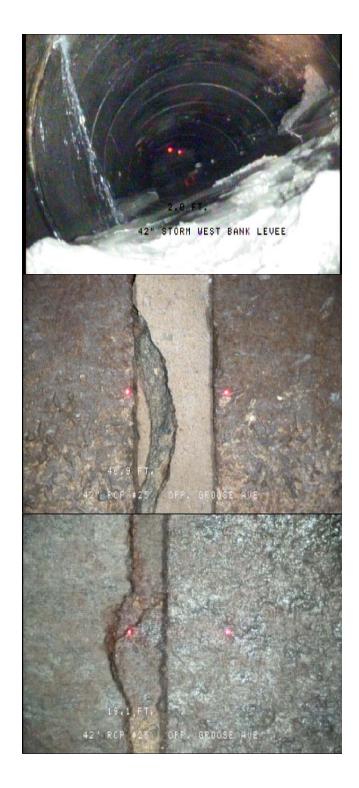
OVERALL CONDITION: NASSCO Grade 5 - Defect requires immediate attention

GENERAL INSPECTION FINDING: Inlet was completely buried and plugged. Significant joint leakage was occurring at the third joint from the inlet. Water continued to discharge from the joint for several weeks, Unsure of the water source. Joint material rolled from joint in several areas. Invert to springline appears to be grouted. Outlet end from gatewell to headwall could not be inspected.

Pipe #25				
Feet	Defect			
3.7ft	Offset joint, gasket rolled			
10.8ft	Significant leakage at joint, running for several			
	weeks			
15.1ft	Staining at joint			
19 1ft	Diagonal crack in hell			
22.4ft	Staining at joint			
31ft	Staining at joint			
46.9 ft	Gasket rolled			
78.9ft	Crack through bell

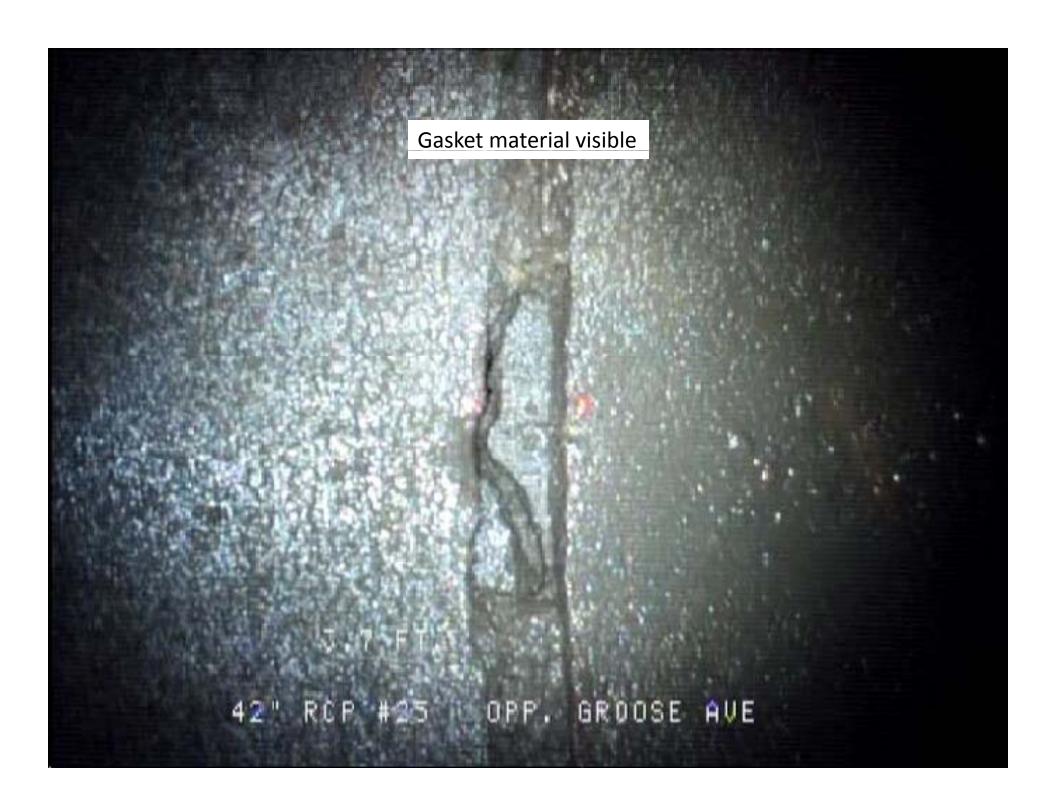
Joint leaking 3.7 FT. 42" RCP #25 OPP. GROOSE AVE " RCP #25 OPP. GROOSE AVE

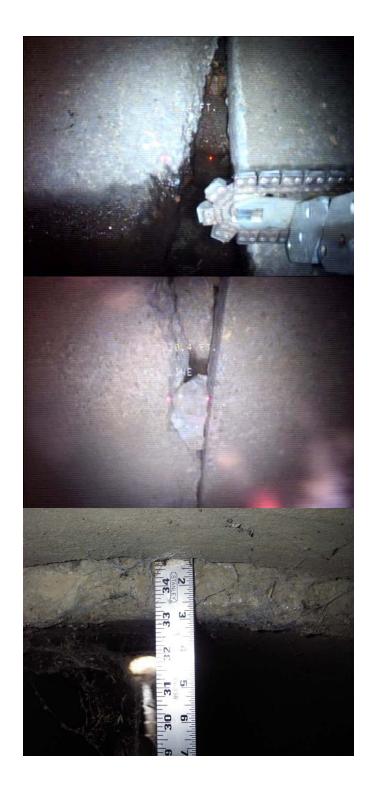
93ft	Large piece of headwall missing at invert of inlet approx. 36"				
	across

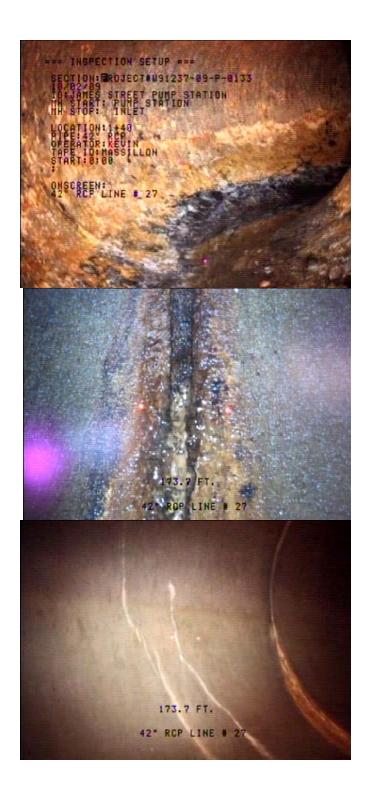
Pipe # 27					
Feet	Defect				
Start	DIP Pipe, moderately corroded				
2ft-123ft	DIP				
123ft	DIP to RCP				
127ft	Weeping joint				
141ft	Diagonal/Radial Cracking				
155ft	Radial Cracking				
169ft	Offset Joint				
173ft	Leaking Joint/Gushing/flowing				
175ft	Radial Cracking				
177ft	Staining at joint				
193ft	Diagonal/Radial Cracking				
200ft	Staining/moisture at joint				
251ft	Staining/moisture at joint				
262ft	Diagonal cracking at joint				
266ft	RCP to DIP				
376ft	Gatewell

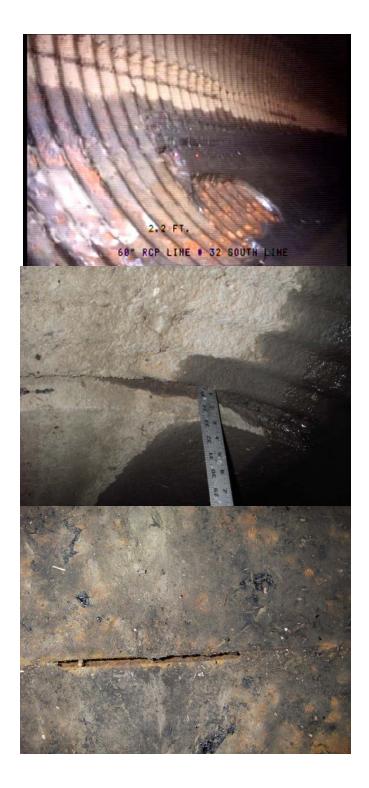
Pipe # 32	2, Federal Avenue South Gravity
Feet	Defect
2.0	Bituminous coating missing in haunch, moderately corroded
16.5	Bituminous coating missing in haunch, moderately corroded
19.7	Moisture at joint, 4 O'clock
22.0	Moisture at joint, 1.75" joint separation
42ft	Offset joint where CMP meets concrete, approx. 3" right side.
	Severely separated joint at crown.
53ft	Wet joint at approx. 3 o'clock
67ft	Staining at joint in crown
68ft	Rock in invert, could not move
79ft	Wet joint at approx. 3 o'clock
92ft	Staining at joint in crown
111ft	Wet joint at 9 o'clock
127ft	Approx. 1" joint separation, staining at 1:00
135ft	Gatewell

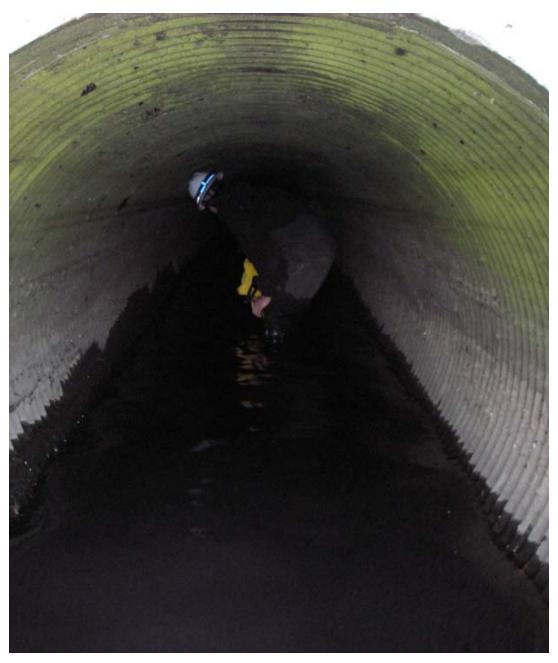
View of entrance at Federal Avenue south pipe

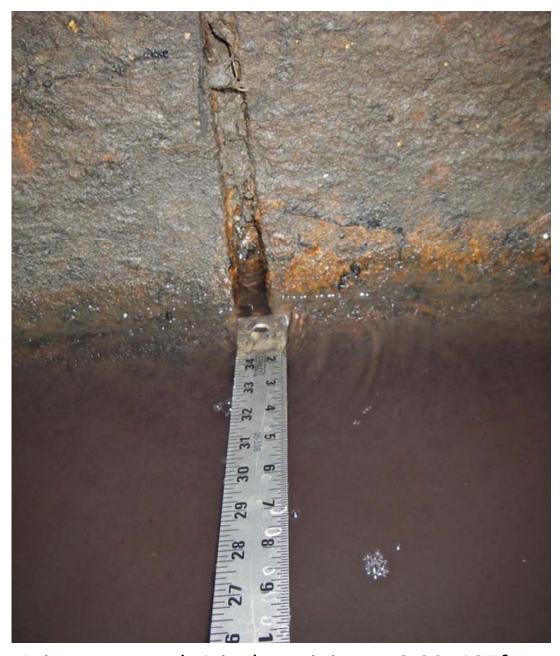
Joint separated, 1-inch, staining at 8:00- 127ft

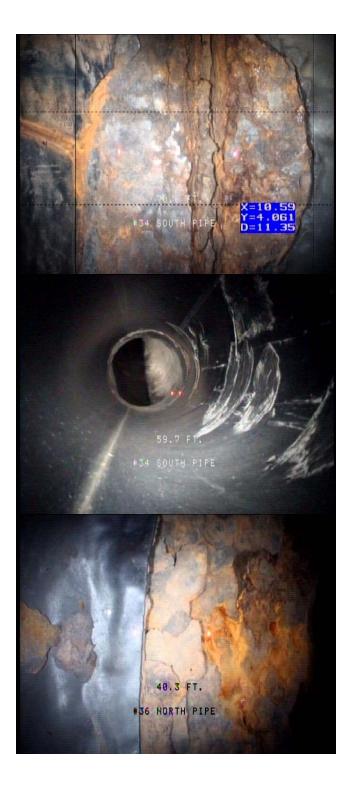
0-141 ft All three pipes have moderate to severe corrosion at the joints. Missing protective coating and corrosion was also noted in flat areas and sharp bends. It appears in some sections that point repairs have been made on the protective coating. Recommend air pressure testing to verify integrity of the	Feet	Defect
joints. *Note: Pipe #35 has severe loss of lining from air-release valve to pump station on the downward grade section of pipe.	0-141 ft	corrosion at the joints. Missing protective coating and corrosion was also noted in flat areas and sharp bends. It appears in some sections that point repairs have been made on the protective coating. Recommend air pressure testing to verify integrity of the joints. *Note: Pipe #35 has severe loss of lining from air-release valve to pump station on the

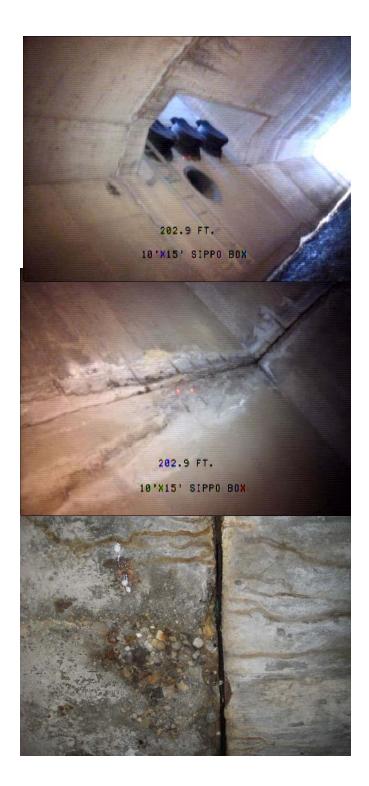
Sippo Avenue 15' X 10' Box #37					
Feet	Defect				
28ft	Spalling at joint				
30ft	Reinforcing steel exposed in crown				
39ft	Reinforcing steel exposed in crown				
56ft	Weeping and stained joint. Rebar exposed from				
	deteriorating joint.				
76ft	Rebar exposed from deteriorating joint .				
83ft	Weeping and stained joint. Rebar exposed from				
	deteriorating joint.				
98ft	Significant weeping and stained joint				
110ft	Weeping and stained joint. Rebar exposed from				
	deteriorating joint.				
118ft	4" scour hole left haunch				
Outlet-Pump Pipes	Invert under water, rough in areas, indicating				
	moderate scour in the invert.

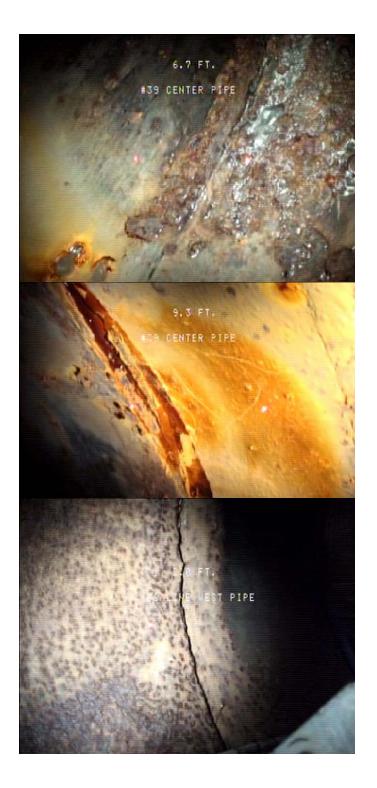
Feet	Defect
5, 10, 20 ft	All three pipes have moderate to severe corrosion and rust at the joints and pipe walls. Missing protective coating was predominately around the haunches and inverts of the pipe.
	Recommend air pressure testing to verify integrity of the joints.
	*Note: Pipe #39 (center) at 9.3ft has a severe offset/separated joint with potential leakage.

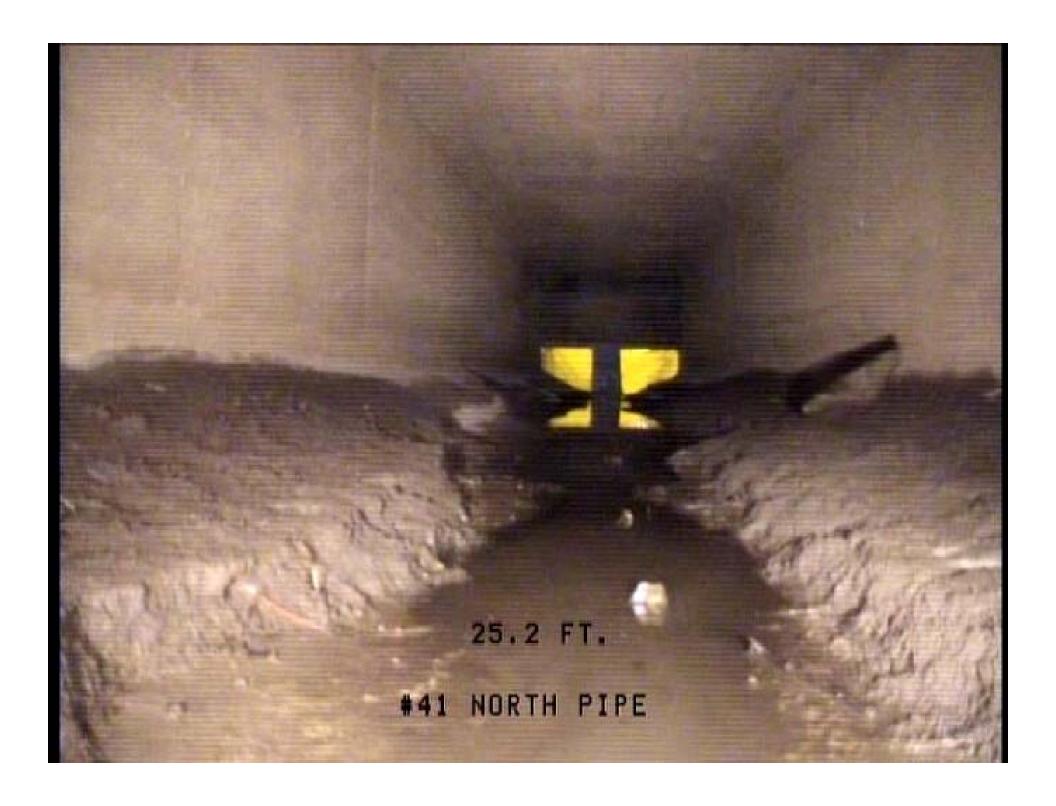
31.9 FT.

Possible hairline crack at 31.9 feet

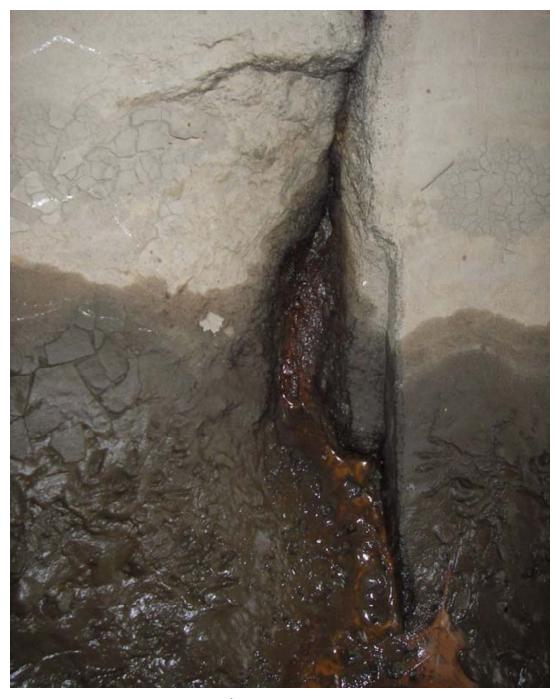
Scouring at joint in left haunch/soil or rust seeping in through joint- 79ft

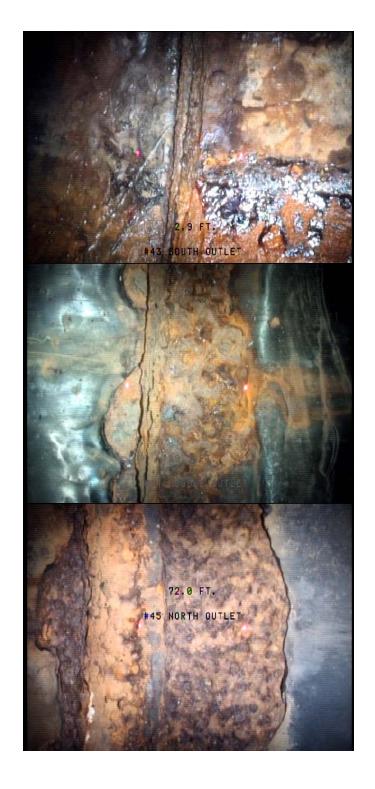
Feet	Defect
0-85 ft	All three pipes have moderate to severe corrosion at the joints. Missing protective coating and corrosion was also noted in flat areas and sharp bends. It appears in some sections that point repairs have been made on the protective coating. Recommend air pressure testing to verify integrity of the joints.

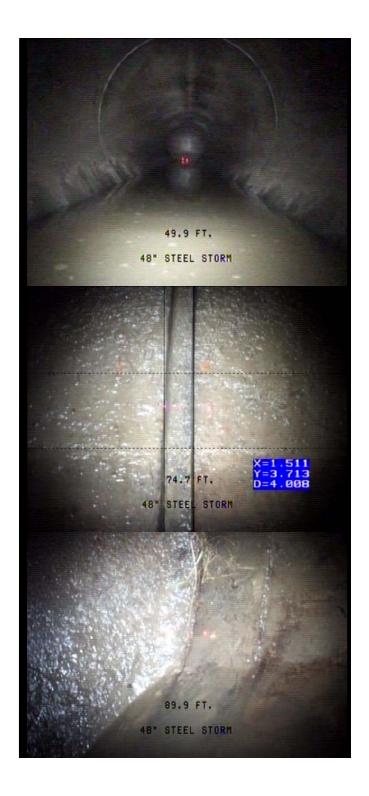
Arch Avenue Pipe #46 (MH to Gatewell/Outlet)				
Feet	Defect			
Oft-90ft	Several joints appear to be wider at the bottom, indicating that the line has some slight settlement.

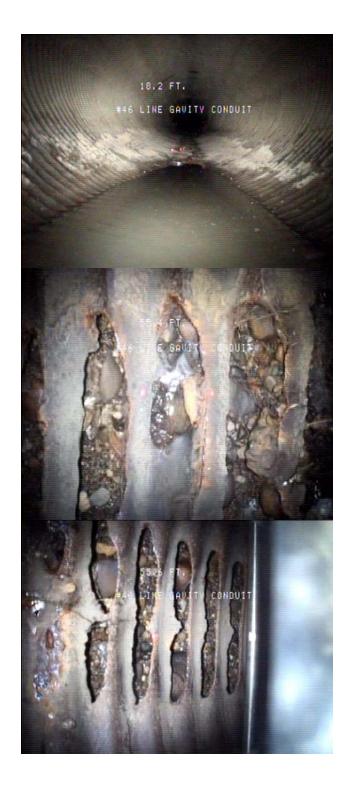
Arch Avenue Pipe #46B (MH Upgrade)				
Feet	Defect			
0ft-317ft	Invert is rusted completely through in several areas throughout the pipe, starting to deflect and buckle in areas.

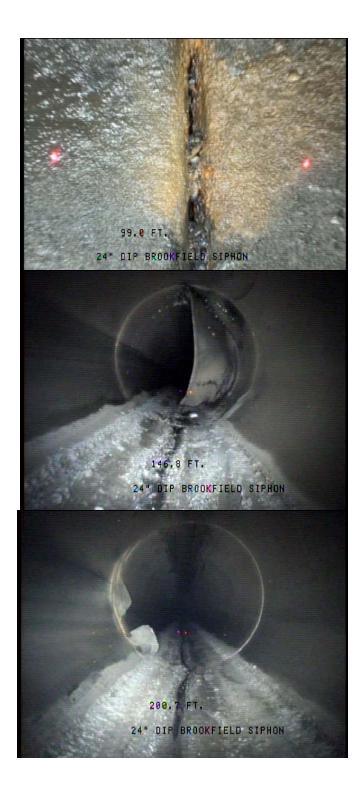
Brookfield Siphon 24"- Outlet			
Feet Observation/Defect			
10ft	Corroded joint at crown		
28ft	Approx. 1" joint separation at 7 o'clock, Corroded joint in crown		
45.6ft	Tear in lining at approx. 4o'clock		
78.7ft	Lining peeling away from pipe walls at haunches		
99ft	Rust coming from joint at crown		
134.7ft	Rusting of joint at crown		
146.8ft	Large piece of lining detached from pipe wall		
170.5ft	Minor joint corrosion at crown		
200.7ft	Lining peeling away from pipe wall along joint		
241.7ft	Minor joint separation at approx. 4 o'clock		
273.6ft	Lining peeling away from pipe walls at invert		
277.1ft	Corrosion of joint/ small tear in lining		
330.5ft	Minor joint separation >1/2"

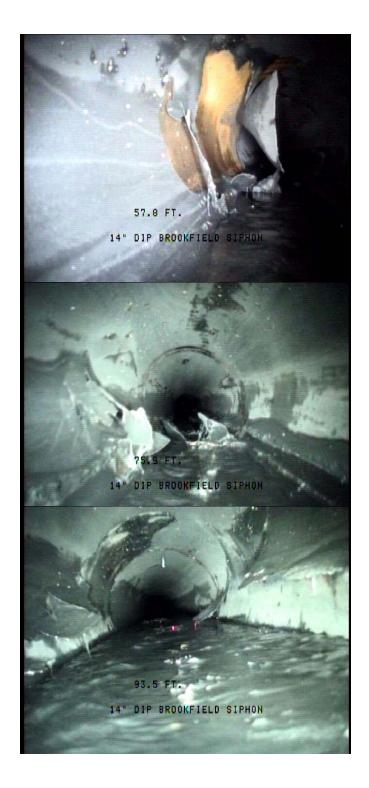
Brookfield Siphon 14" – Outlet		
Feet	Remarks/Defects	
58ft	Large sections of protective coating coming off	
75ft	Protective coating coming off	
78ft	Protective coating coming off	
93ft	Protective coating coming off	
93ft	Debris level to high to continue, inspection	
	discontinued.

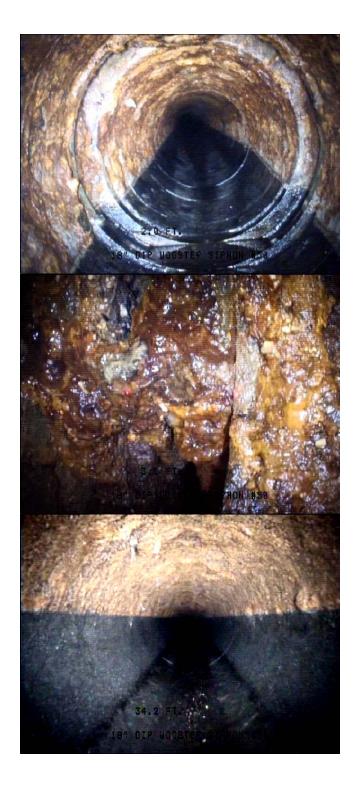
Wooster Siphon 18"- Outlet			
Feet	Observation/Defect		
2.0ft	Broken bell at crown		
3.5ft Severely corroded out gate valve			
3.5ft-108ft	Pipe above water line is severely corroded		
7.5ft Joint separation 1.75-inches			
20.0ft Joint separation approximately 1.75-inches			
108ft	Vertical offset at joint in crown viewable from 108		
	ft.		
108ft	Inspection discontinued

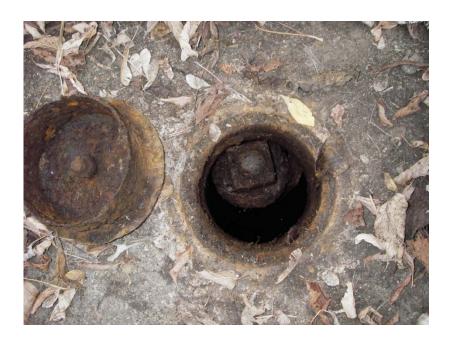
Wooster Siphon Pipe No. 51 and 52				
Feet	Observation/Defect			
0.0	Gate valves frozen, could not be moved

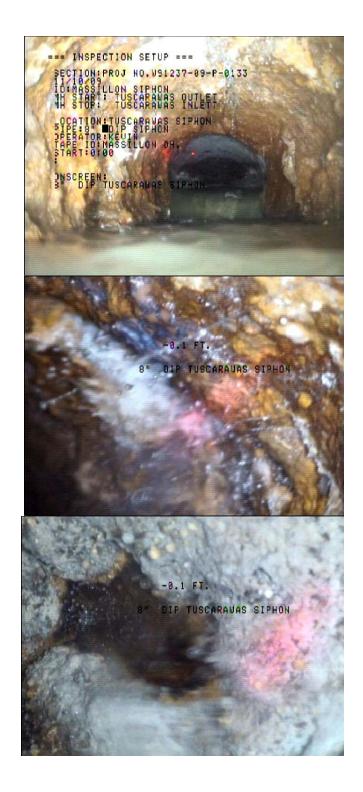
Siphon Pipe No. 54						
Feet Observation/Defect						
2.0 Severe corrosion at outlet

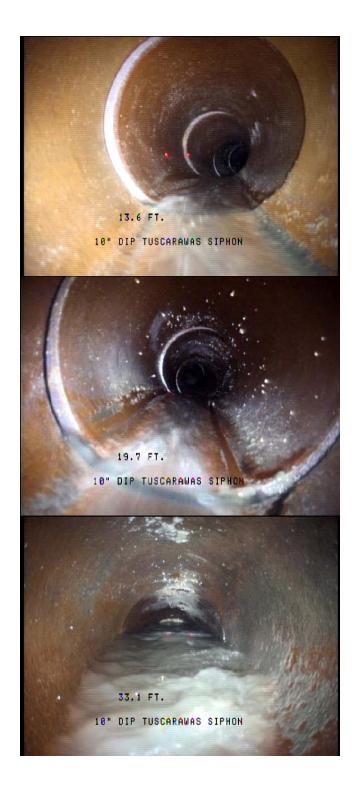
Siphon Pipe No. 54					
Feet	Observation/Defect				
2.0	Joint offset, possible crack in bell				
13.6	Several offset joints visible down grade				
15.0	Joint separation 0.91-inches				
18.3	Joint separation 1.26-inches				
18.3	Several offset joints visible down grade				
19.7	Offset joint in invert				
24.0	Pipe bends to the left/down river				
32.0	Grade begins to flatten out				
33.1	End inspection due to high water
