**DEPARTMENT OF THE ARMY**  
HUNTINGTON DISTRICT, CORPS OF ENGINEERS  
502 EIGHTH STREET  
HUNTINGTON, WV 25701

A routine continuing eligibility inspection of the Massillon Local Flood Protection Project was conducted on November 2-3, 2016, by Mr. Jon Samsa of your organization and Mr. Charles Barry and Mr. David Humphreys of the Huntington District.

## Flood Damage Reduction Segment / System Inspection Report

**Flood Damage Reduction Segment / System  
Inspection Report  
Massillon, OH, LPP, (East) (MALE)**

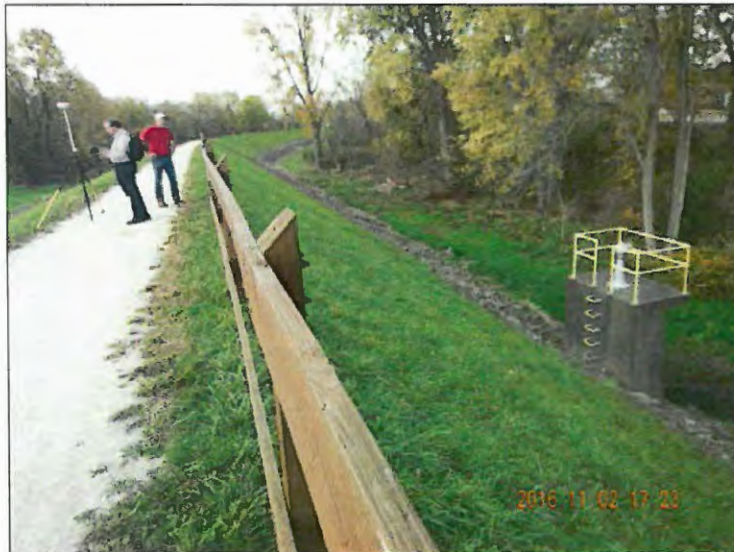
**Inspect ID:** MALE\_2016\_a\_0003 **Title:** USACE\_CELRH\_MALE\_2016\_a\_0003\_1.jpg  
**Rated Item:** 1. Unwanted Vegetation Growth **Caption:** Rating: Acceptable; Remarks: Typical landside toe. Note the improvement to the disposition of vegetation from previous inspections. Operations staff have done a good job of directing mowing contractor.; Vegetation across the project showed signs of attention by the USACE Operations staff. Much improved and certainly a continuous maintenance activity.

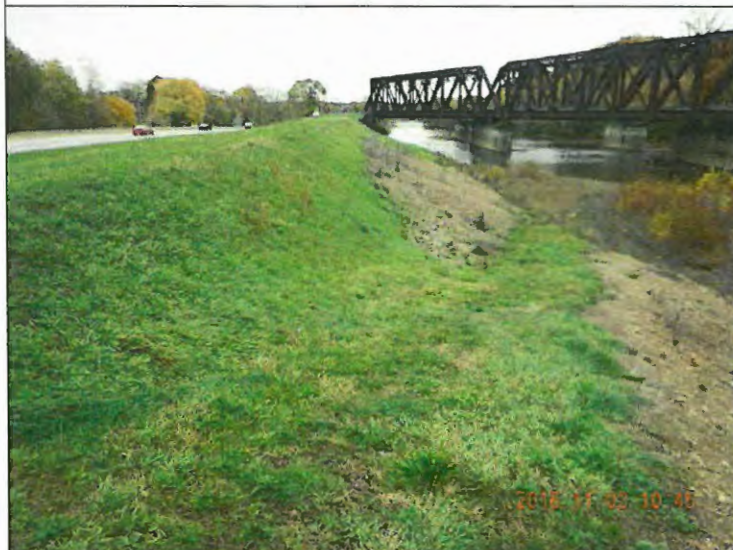
**Inspect ID:** MALE\_2016\_a\_0006 **Title:** USACE\_CELRH\_MALE\_2016\_a\_0006\_1.jpg  
**Rated Item:** 2. Sod Cover **Caption:** Rating: Minimally Acceptable; Remarks: Sod cover challenged at this location.; This is an overbuilt section for channel access so erosion concern is low, but poor sod cover exhibited.

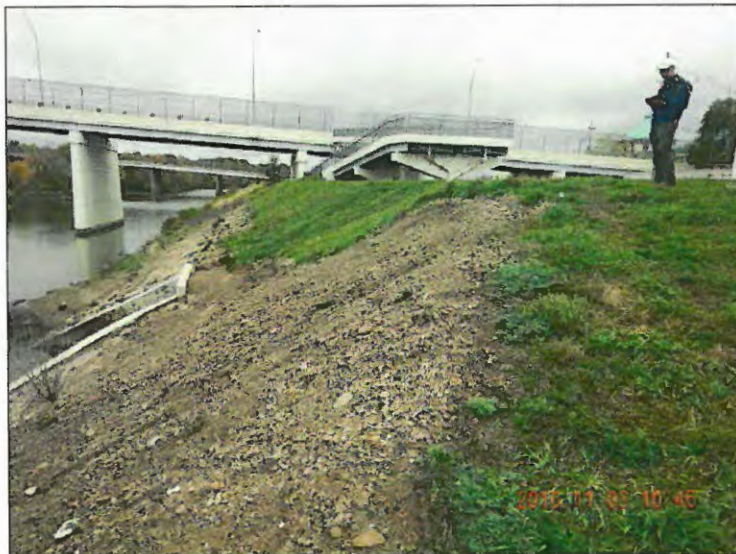
**Inspect ID:** MALE\_2016\_a\_0006 **Title:** USACE\_CELRH\_MALE\_2016\_a\_0006\_2.jpg  
**Rated Item:** 2. Sod Cover **Caption:** Rating: Minimally Acceptable; Remarks: Sod cover challenged at this location.; Poor sod cover in the area of the Sippo Creek outlet.

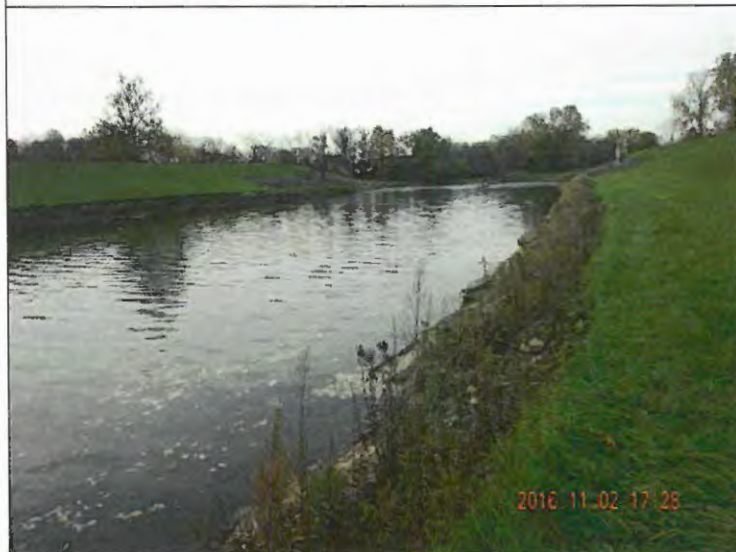
**Inspect ID:** MALE\_2016\_a\_0004 **Title:** USACE\_CELRH\_MALE\_2016\_a\_0004\_1.jpg  
**Rated Item:** 6. Erosion/ Bank Caving **Caption:** Rating: Acceptable; Remarks: No erosion present in this particular reach.; Erosion has been an issue at Massillon and USACE has performed bank stabilization with stone protection schemes. Given this history, erosion should be something inspectors monitor at every visit to the project area.

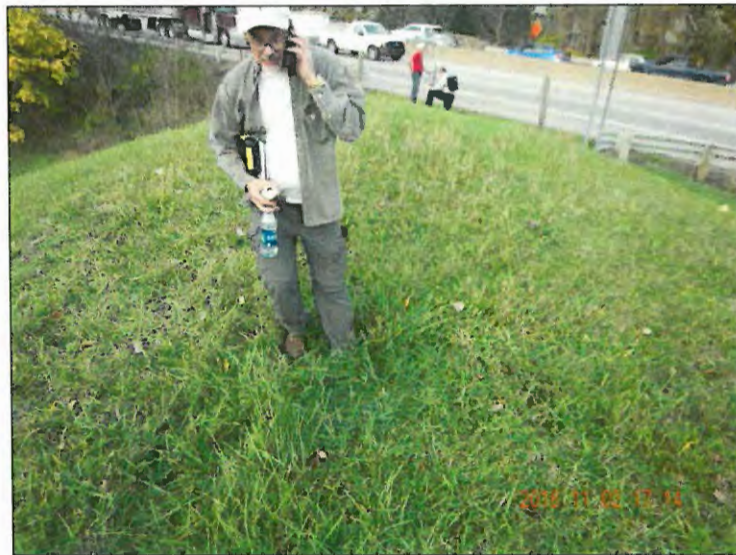
**Inspect ID:** MALE\_2016\_a\_0001 **Title:** USACE\_CELRH\_MALE\_2016\_a\_0001\_1.jpg  
**Rated Item:** 8. Depressions/ Rutting **Caption:** Rating: Unacceptable; Remarks: There's a 10-inch diameter hole in the crest of the levee near the tie-in to Route 21. It is roughly ten-inches deep. It is well-defined, circular and more of a safety hazard than a performance hazard. Perhaps it is a valve for a pipeline crossing.; Thigh-deep hole (safety concern) in top of levee.

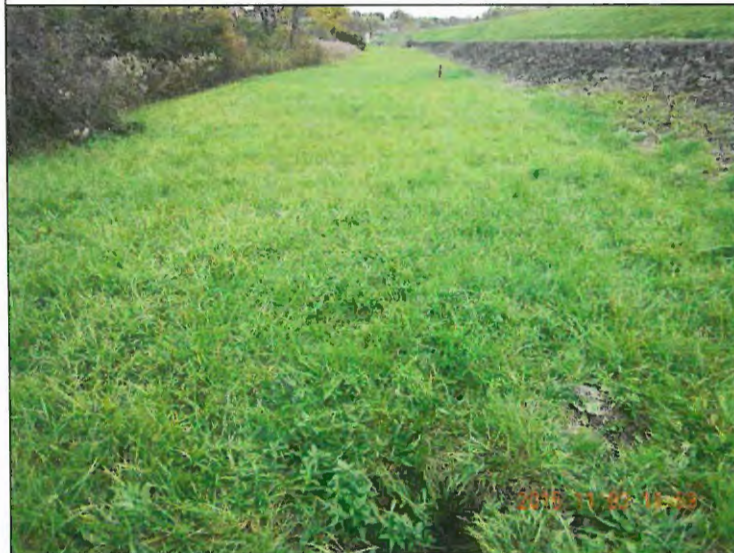
**Inspect ID:** MALE\_2016\_a\_0002 **Title:** USACE\_CELRH\_MALE\_2016\_a\_0002\_1.jpg  
**Rated Item:** 8. Depressions/ Rutting **Caption:** Rating: Unacceptable; Remarks: A sinkhole about 15-20' east of the levee/toe drain north of piezometer B6 09.; Depression landward of levee toe.

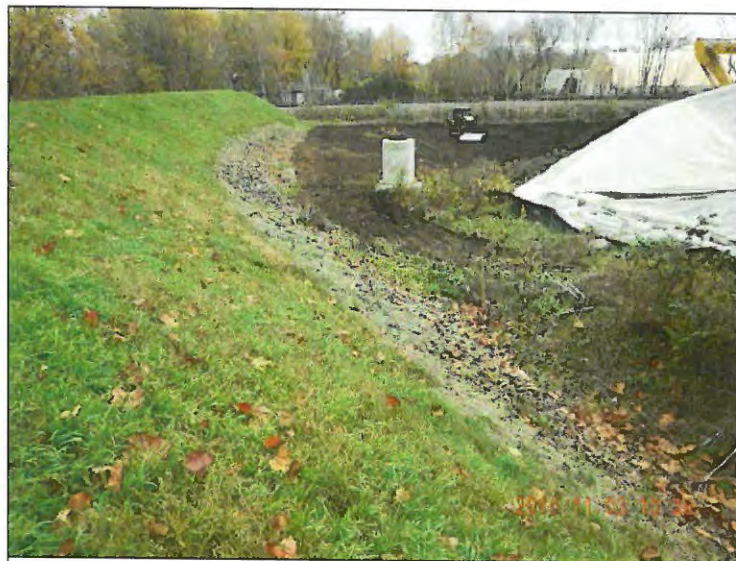
**Inspect ID:** MALW\_2016\_a\_0009 **Title:** USACE\_CELRH\_MALW\_2016\_a\_0009\_1.jpg **Rated Item:** 2. Sod Cover **Caption:** Rating: Acceptable; Remarks: Levee begins; good sod cover present.; Potential encroachment activity addressed in the Encroachments rated item. Good sod cover on levee shown.

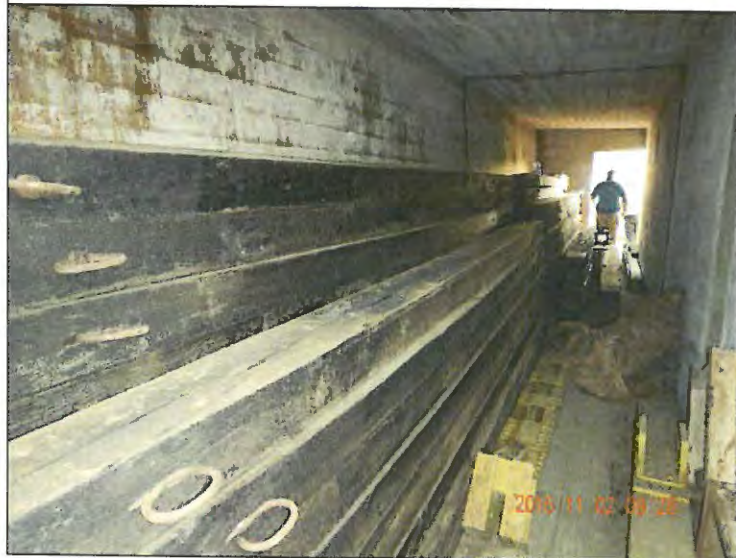
**Inspect ID:** MALW\_2016\_a\_0019 **Title:** USACE\_CELRH\_MALW\_2016\_a\_0019\_1.jpg **Rated Item:** 4. Closure Structures (Stop Log, Earthen Closures, Gates, or Sandbag Closures) (A or U only) **Caption:** Rating: Acceptable; Remarks: Stoplog Storage Building in good condition. Logs and components present. Erection instructions present.

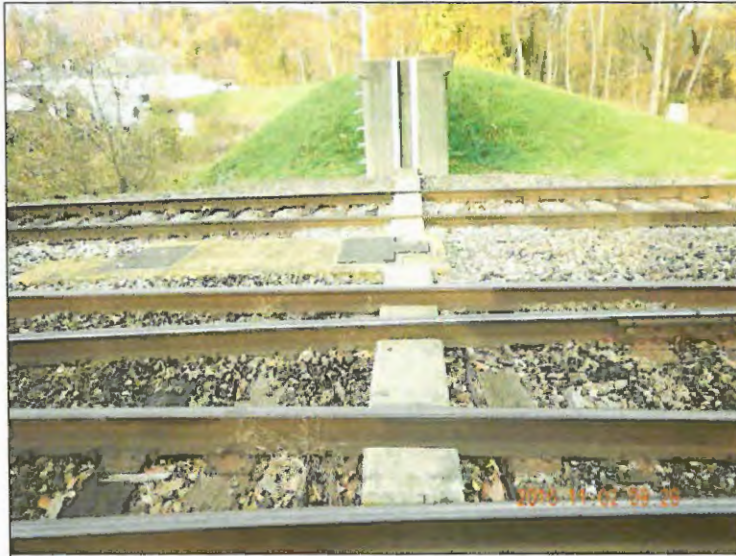
**Inspect ID:** MALW\_2016\_a\_0003 **Title:**  
USACE\_CELRH\_MALW\_2016\_a\_0003\_1.jpg **Rated Item:** 4. Concrete Surfaces  
**Caption:** Rating: Acceptable; Remarks: B&O Railroad Stop Log Closure - good  
condition and recently trial erected.

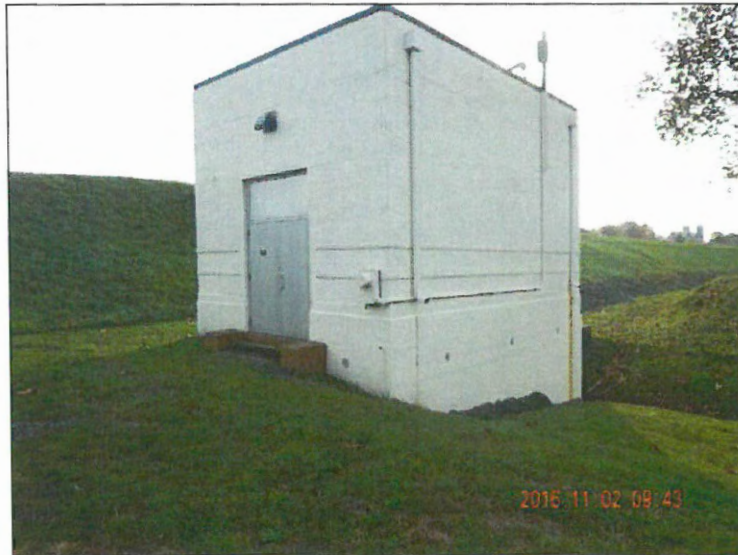
**Inspect ID:** MALW\_2016\_a\_0001 **Title:**  
USACE\_CELRH\_MALW\_2016\_a\_0001\_1.jpg **Rated Item:** 1. Pump Stations  
Operating, Maintenance, Training, & Inspection Records **Caption:** Rating: Acceptable;  
**Remarks:** James Ave Pump Station in good condition.
