## MASSILLON DAILY INSPECTION REPORT

Project: Nova Dr Force Main Repair Road: Nova Dr SE Date: 12/19/11

Project: \_\_\_\_\_ Road: \_\_\_\_\_ Nova Rd SE Date: 12/13/11  
 Weather: AM: \_\_\_\_\_ Temperature: AM: \_\_\_\_\_ Precipitation: \_\_\_\_\_  
 NOON: \_\_\_\_\_ NOON: \_\_\_\_\_  
 PM: OVERCAST PM: 42  
 Lost Day: Yes ☐ No ☐ Reason: \_\_\_\_\_

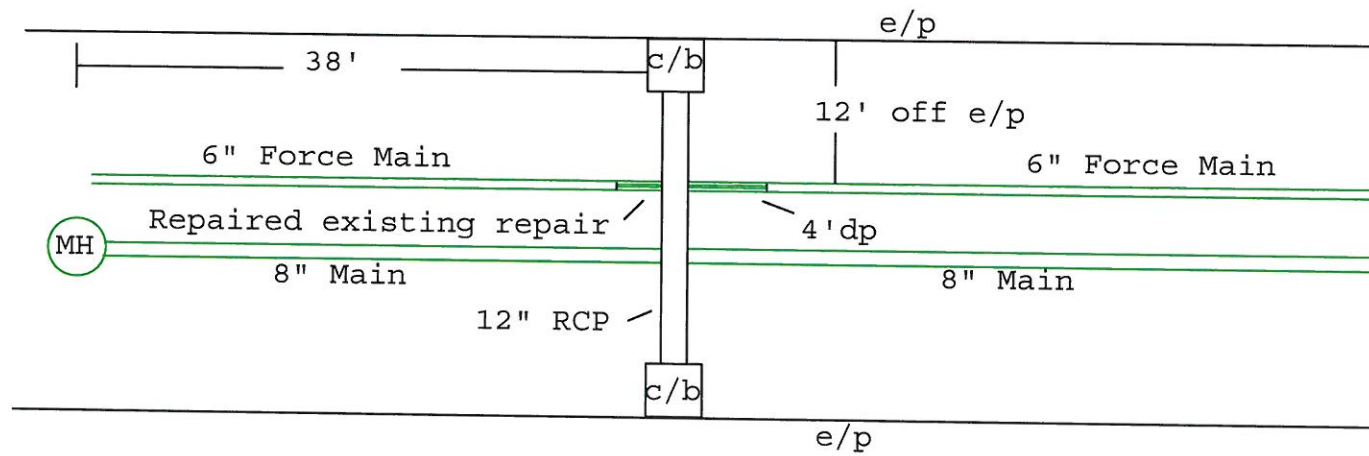
600 Nova Dr SE

| Paid Item<br>or Ref No. | Plan<br>Page | Location or Description | Quantity |
|---|---|---|---|
| | | Force main leaking in front of US Chemical & Plastic | |

Temporarily fixed 6" force main with 2 hard back ferncos. Sewer was repaired before with SDR 35 and 2 ferncos.
