**JOHN PATRICK  
PICARD  
ARCHITECT INC.**

January 27, 2023

Re: Unsafe Structure Inspection for 14 and 20 Lincoln Way East in Massillon, Ohio

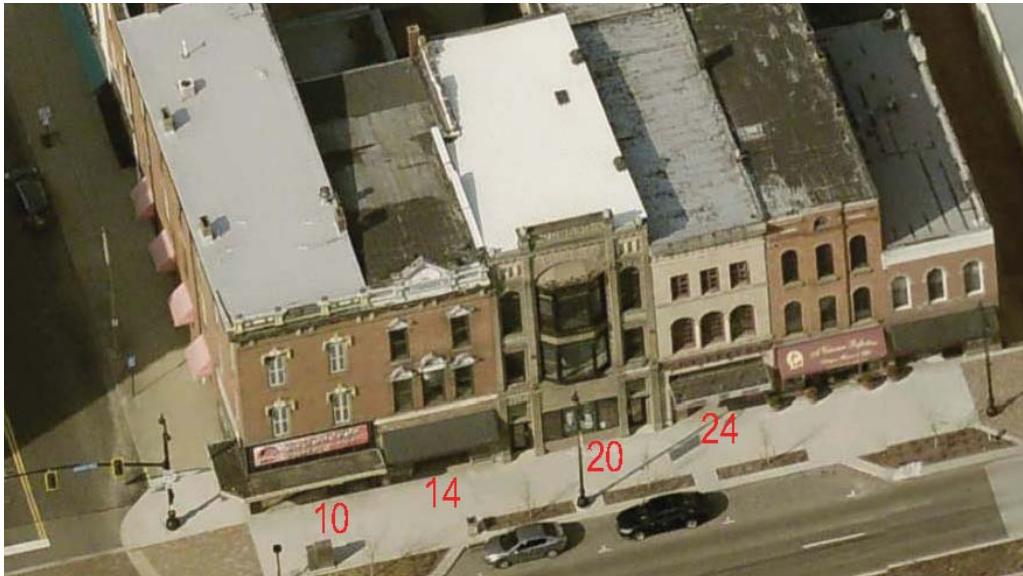
Image 1

On January 18, 2023 at approximately 11:30 a.m., I conducted the first of several inspections of the existing structures located at 14 and 20 Lincoln Way East in Massillon, Ohio. Both buildings are vacant and owned by Towne Plaza LTD (***See Image 1***).

Unfortunately, the condition of these two buildings is grave and the potential of collapse is evident as seen in the two previous collapses. These two buildings pose a direct threat to the buildings at 24 Lincoln Way East and 10 Lincoln Way East, in that an uncontrolled collapse would structurally harm the adjoining structures. This block was constructed originally, as one building with floor system bearing walls between addresses. This results in a situation of each contiguous building being only as strong as its weakest component. Catastrophic failure of 14 or 20 Lincoln Way East could result in a failure of 10 and 24 Lincoln Way East. I strongly recommend shoring and reinforcing the exterior walls and floor systems immediately in both 24

and 10 Lincoln Way East. Adjoining public sidewalks and streets must be protected from collapsing or falling buildings to an extent of a minimum of one and one half the height of the collapsing structure

I suggest that the ornamental architectural features and stone on the south face of the building be carefully removed and stored for a future use opportunity (*See Images 1, 16, 26, 27 & 35*).

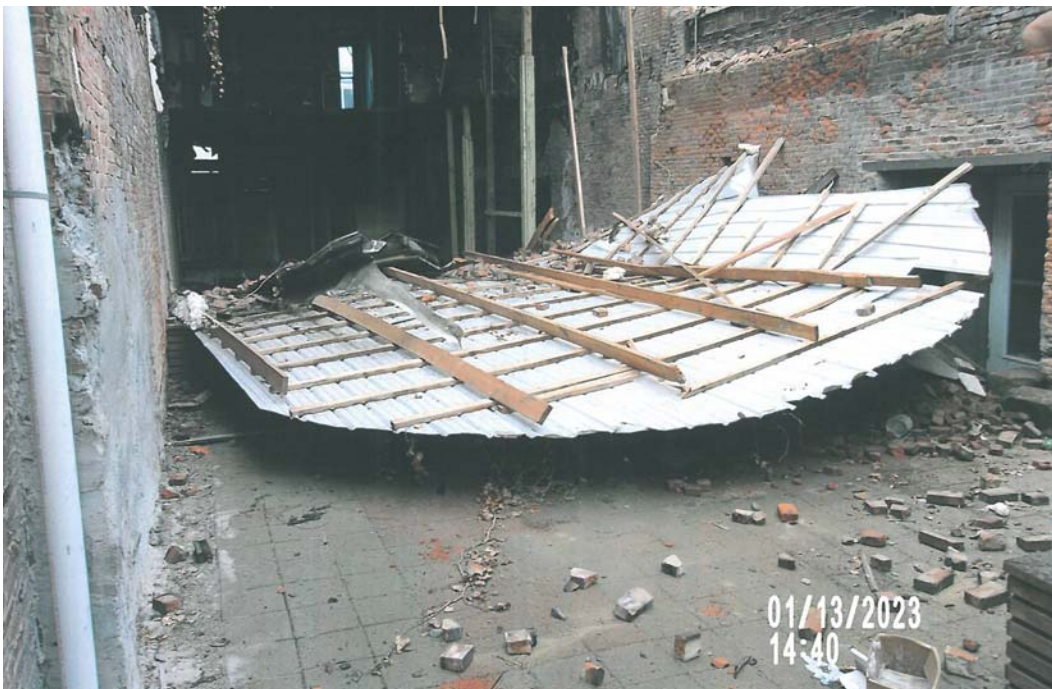
Image 2

Apparently, in the previous week, the masonry/metal sided rear facade on 20 Lincoln Way East collapsed and it is my understanding that the rear of 14 Lincoln Way East collapsed approximately ten months ago. This more recent collapse pulled the remaining masonry facade off of the rear surface of 14 Lincoln Way East (***See Images 2, 3 & 4***).

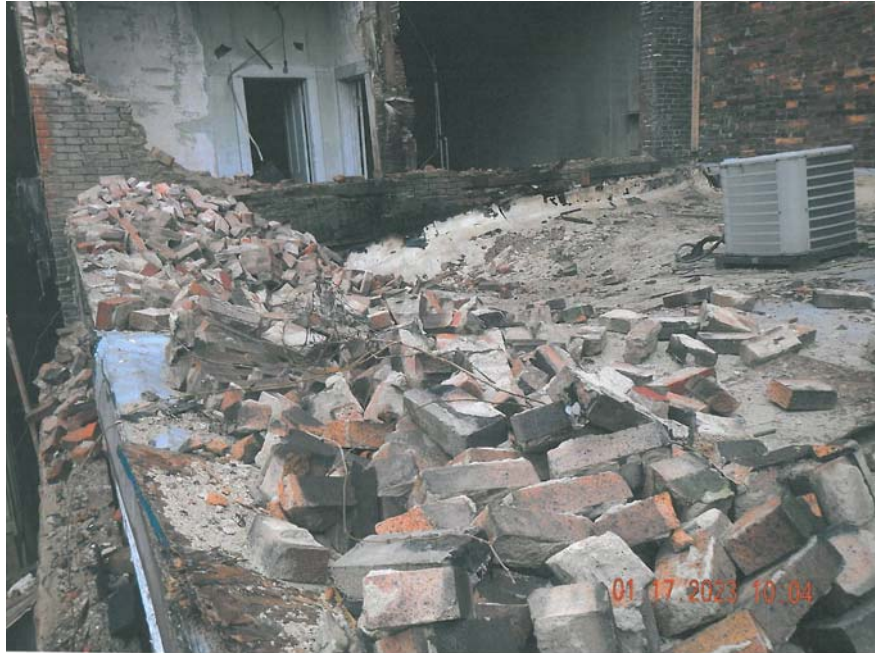
Image 3

It should also be noted that the brick debris from this recent collapse penetrated the roof of the lower adjacent building causing the structural failure of the lower roof (***See Images 3 & 34***).

Due to years of water infiltration and many years of neglect, the mortar between many of the masonry bricks is completely gone, leaving only gravity as the structural system for the buildings. This fact is evident by the lack of mortar present on the fallen brick on the ground and the open joints in the still standing walls **(See Images 3, 12, 13, 14, 15, 26 & 27).**

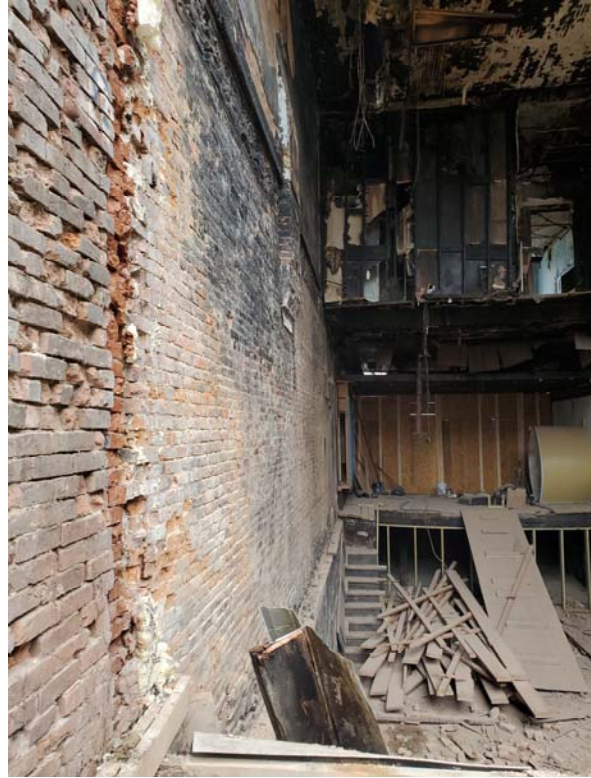
Image 6

20 Lincoln Way East was ravaged by a substantial fire approximately 14 years ago leaving the building with laterally unsupported walls in heights exceeding 27'. In addition, timber structures that experience heat and water exposures are severely weakened, which in this case, greatly increases the potential for additional collapse **(See Images 6, 9, 10, 11 & 13).**

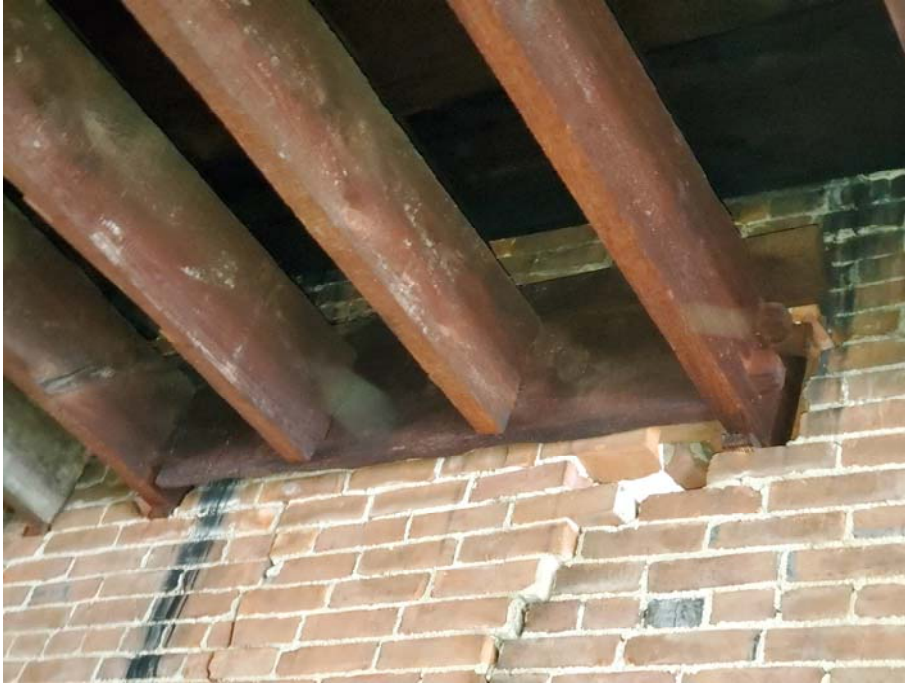
Image 7

The separation wall between 24 Lincoln Way East is now leaning into the void that was 20 Lincoln Way East as evidenced by the wall cracks and wall displacement on the third floor of 24 Lincoln Way East **(See Images 7, 8, 28, 29 & 30).**

The two adjacent properties must have their adjoining walls tied into their existing floor/roof framing systems and the floors shored at 24 Lincoln Way East. These floors need to be shored due to the likelihood that the masonry wall between 24 and 20 Lincoln Way East will peel off as 20 Lincoln Way East is demolished.

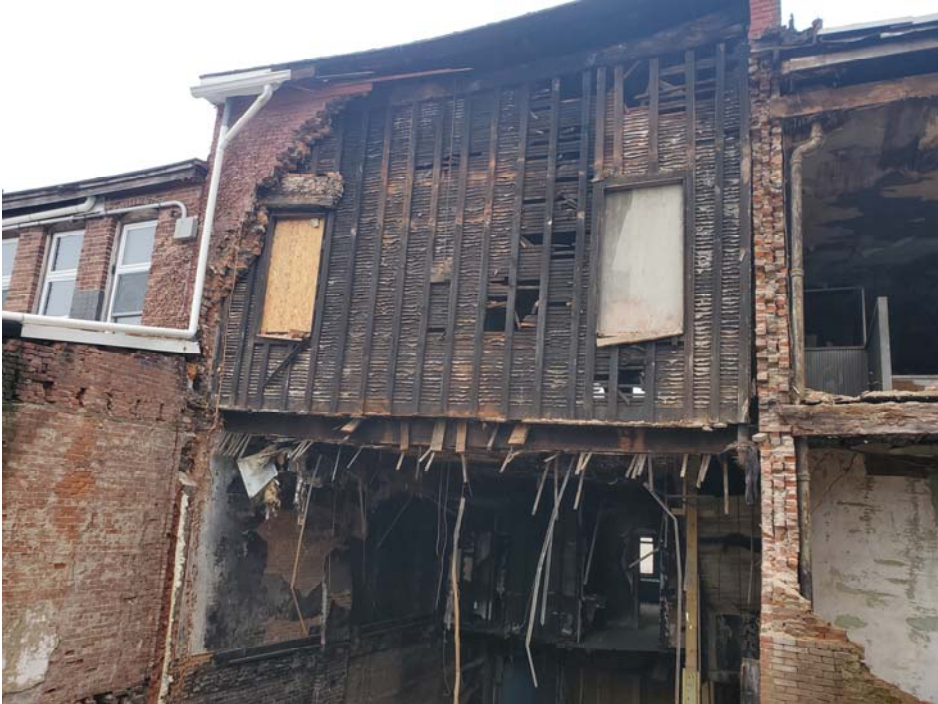
Image 11

In building 20, as is apparent in **Images 11 and 13**, the remaining floor joists are sagging in the middle under the still present unstable roof and floor loads. An additional concern is the presence of an upside-down fire cut of the floor joist **(See Image 12).**

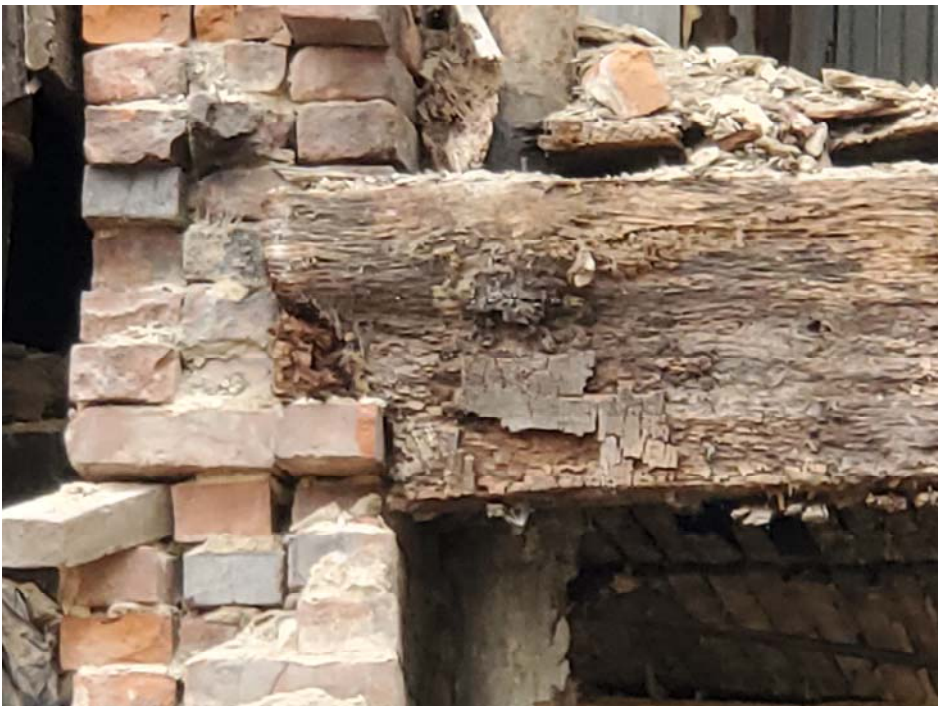
Image 12

This improper cut further weakened the remaining masonry walls above the joist (due to prying from the joists) as the building continued to sag under improperly supported loads and decaying framing members.

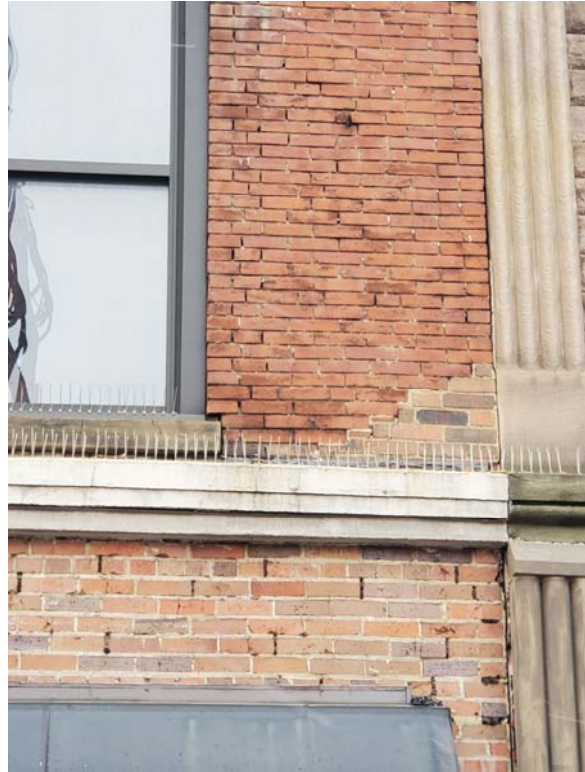
Image 16

The facade walls on these buildings, as well as the additional facade walls on this block of buildings, are not properly tied into the backup floor/roof framing. In some cases, the facade is not connected at all. The facade wall on 14 Lincoln Way East is clearly tilting out from the top in excess of 2" as is evident from the wall cracks in **Images 16, 17 & 18.**

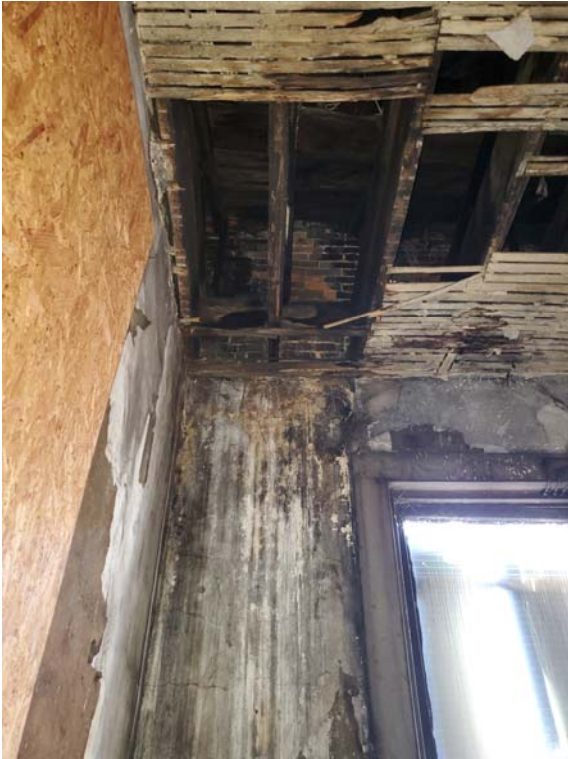
Image 19

It was also noted that the front, southwest corner of 10 Lincoln Way East is failing and is pulling away from its roof framing backup **(See Images 19, 20, 21 & 22).**

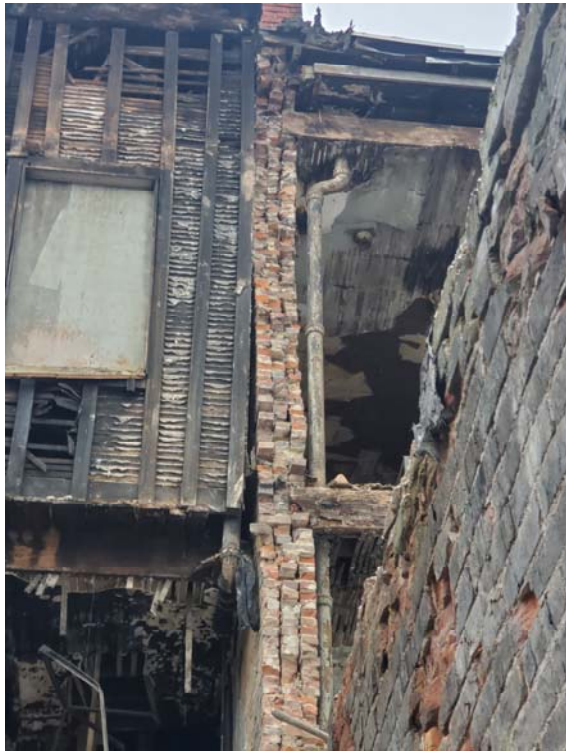
Image 23

The parapet wall running north-south between 24 and 20 Lincoln Way East is curling over in response to decay, failing mortar and wall movement below. This is also true at the parapet wall between 20 and 14 Lincoln Way East **(See Images 23, 24, 25, 32 & 33).**
