DAM SAFETY INSPECTION REPORT

Sippo Creek Reservoir Dam
Class I

File Number: 0614-012

Inspection Date: April 26, 2001

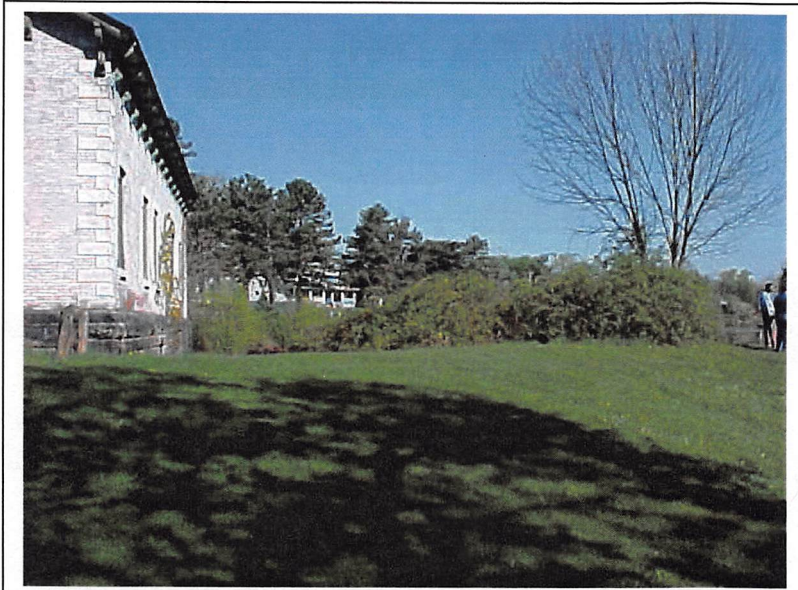
Photograph 1:
Defunct pump house and
trees & brush on right end of
dam.

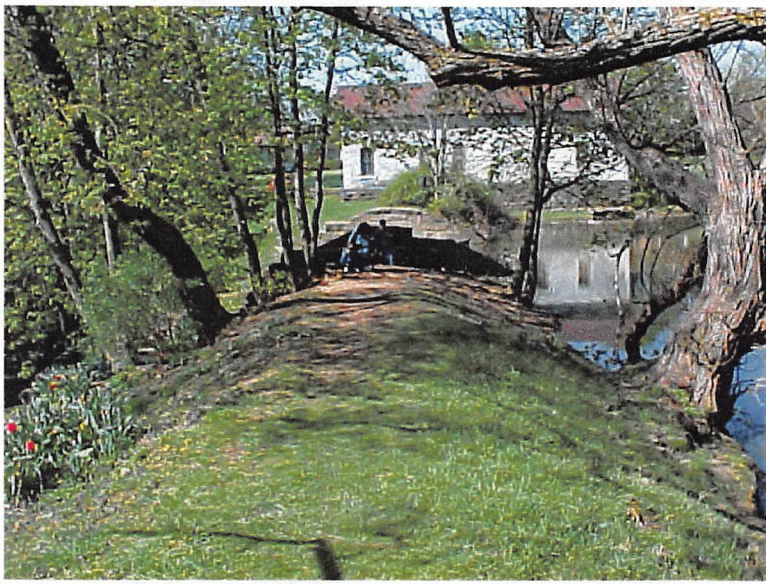
Photograph 2:
Trees & brush noted on
upstream and downstream
slopes.

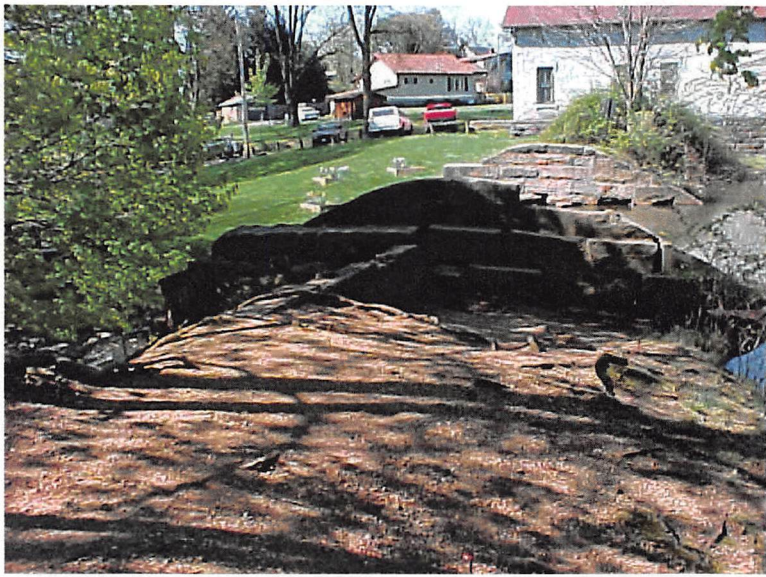
Photograph 3:
Severe erosion noted on left
upstream and downstream
slope adjacent to spillway.

Runoff Erosion (Gullies): Quantity: 2 Depth: 3' Width: 6' Length: 10' Location: (adj. to structure, entire slope, lt end, rt end, middle, see dwg) ADJACENT TO SPILLWAY SIDES Notes/Causes:

Runoff Erosion (Gullies): Quantity: 2 Depth: 2' Width: 6' Length: 6'
Location: (adj. to structure, entire crest, lt end, rt end, middle, see dwg) _____
Notes/Causes: ADJACENT TO SPILLWAY SIDES

Runoff Erosion (Gullies): Quantity: 2 Depth: 2' Width: 4' Length: 25'
Location: (adj. to structure, entire slope, lt end, rt end, middle, see dwg) _____
Notes/Causes: ADJACENT TO SIDES OF SPILLWAY

2. The erosion on the upstream slope and crest of the embankment must be repaired and the upstream slope and crest must be protected from pedestrian foot traffic. Prepare plans and specifications for repairing the erosion and installing erosion protection. See the "Ground Cover" fact sheet included in this section for additional information.

3. Repair the erosion gullies along the sides of the spillway on the downstream slope. See the “Ground Cover” fact sheet included in this section for additional information.

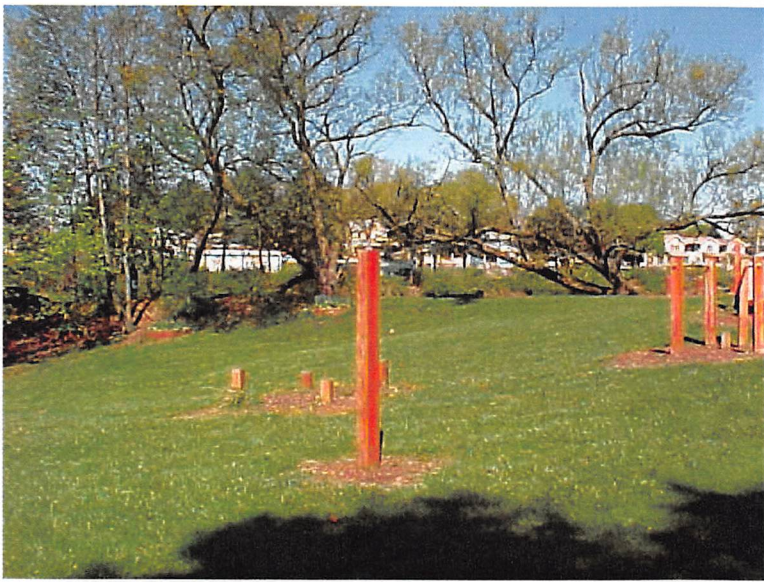
2. Earthen embankments are not designed to be overtopped and are particularly susceptible to erosion. Should the dam overtop, the exercise equipment on the crest and the flower boxes on the downstream slope will cause turbulence in the flow of water. Any turbulence in the flow will increase the water's ability to erode the embankment. Turbulence and erosion build off of each other in a destructive cycle, each increasing the other, and erosion of the embankment during overtopping can quickly lead to failure of the dam.

Photograph 4:
Trees & brush on left side of dam. Exercise equipment in foreground appears to be downstream of groin, however, some equipment was noted on crest of dam..

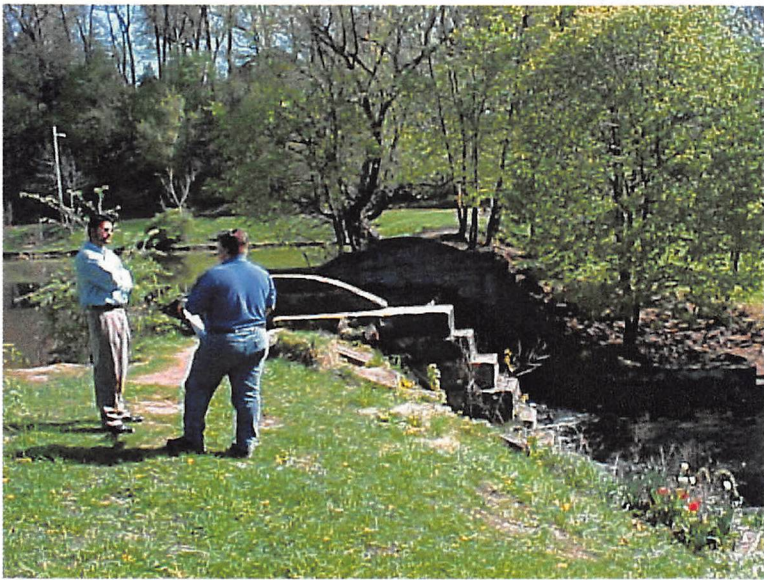
1. Low areas on the crest create a reduction of freeboard and a greater likelihood that the dam will be overtopped during severe floods. Earthen embankments are not designed to be overtopped and are particularly susceptible to erosion. Should the dam overtop, floodwaters will concentrate in the low area, increasing the likelihood of erosion on the crest and downstream face. Overtopping can lead to failure of the embankment. Low areas may be repaired by leveling the crest to a uniform elevation using suitable, properly compacted fill material. Any unsuitable material (sand, gravel, topsoil, etc.) should be removed from the embankment surface before placing fill. The repaired areas should also be properly re-seeded, using at least 6 inches of topsoil, and a healthy grass cover should be reestablished.

Photograph 5:
Uneven crest and erosion adjacent to the right side of the spillway.

Notes/Causes: VERTICAL ALIGNMENT OF THE CREST IS VARIABLE OVER THE ENTIRE LENGTH OF THE DAM. WORST AREAS ARE NEAR THE SPILLWAY.

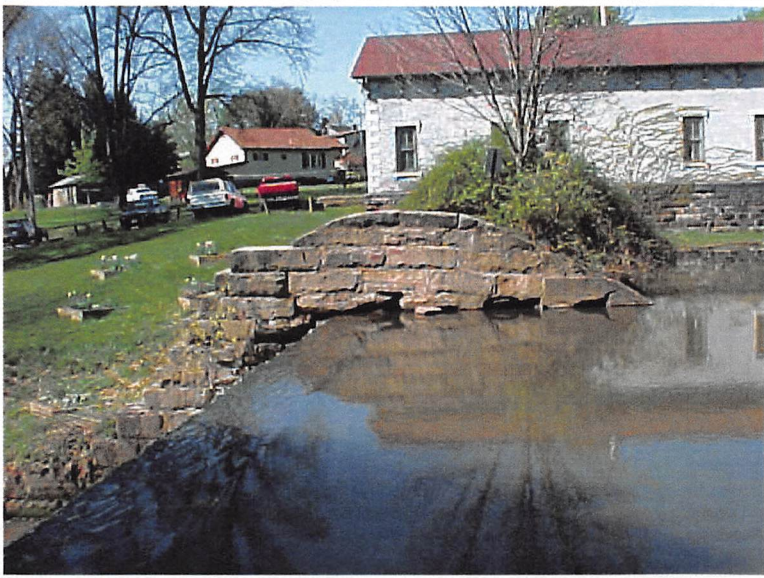
Photograph 6:
Missing blocks and mortar in the spillway sidewalls.

2. Replace the missing stones and the deteriorated mortar between many of the stones of the entire principal spillway. See the “Open Channel Spillways (Earth and Rock)” fact sheet included in this section for additional information.

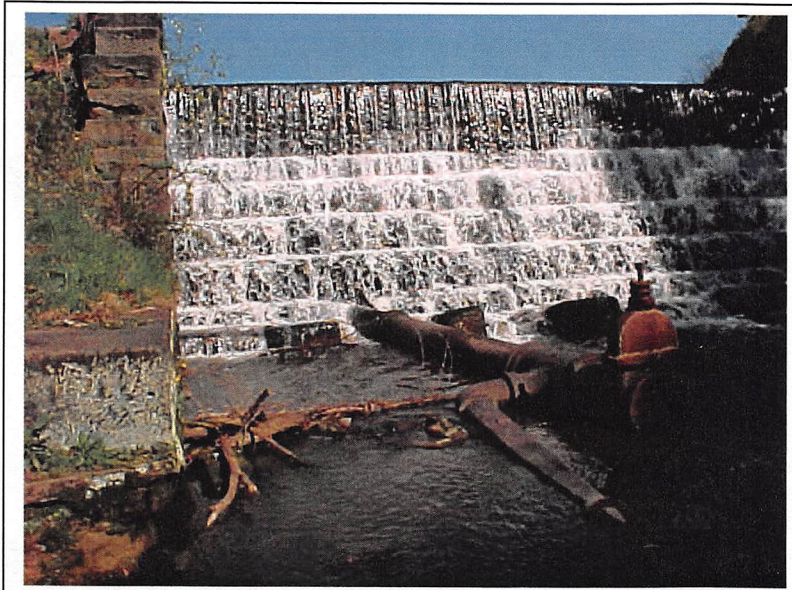
Photograph 7:
Lake drain is located in
spillway.

4. Replace the lake drain valve operator. See the “Lake Drains” fact sheet included in this section for additional information.
5. After its operability has been inspected by a registered professional engineer, perform routine maintenance of the lake drain. The maintenance should be performed annually and should include operation and lubrication of the valve in accordance with the manufacturer’s specifications. See the “Lake Drains” fact sheet included in this section for additional information.

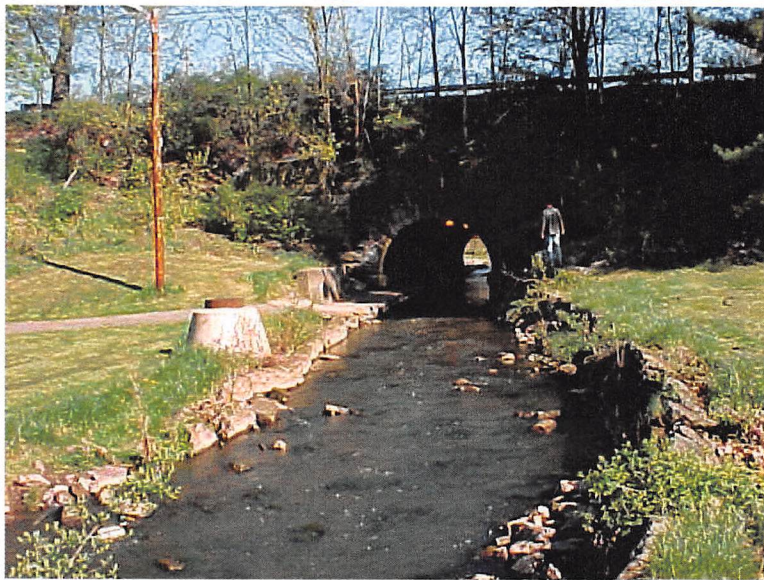
Photograph 8:
Downstream end of culvert
for State Route 241, is
located approximately 1500
feet from dam.

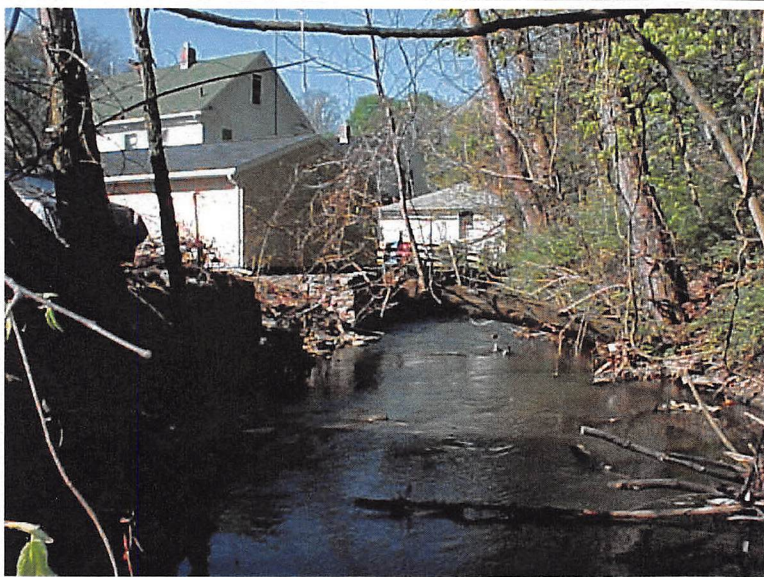
Photograph 9:
Residential area approximately
1 mile downstream of dam.
This home is located at 1114
Tremont Ave. SE.
