# DAM SAFETY INSPECTION REPORT

Sippo Creek Reservoir Dam  
Class I  
Stark County, Perry Township  
File Number: 0614-012  
February 21, 2006

**SIPPO CREEK RESERVOIR DAM  
FEBRUARY 21, 2006  
FILE NUMBER: 0614-012**

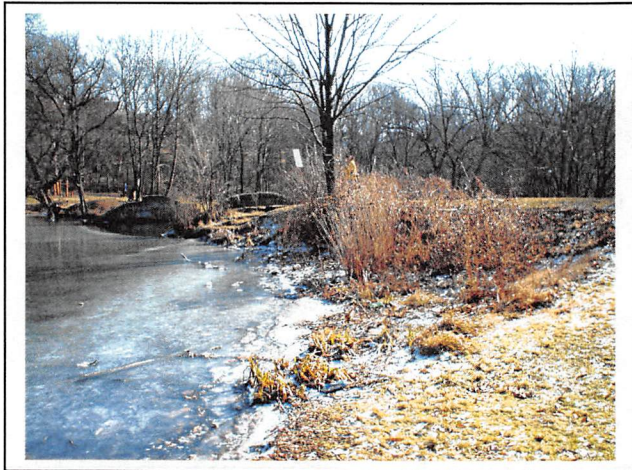
Overview of the upstream slope.  
Note the trees and brush.

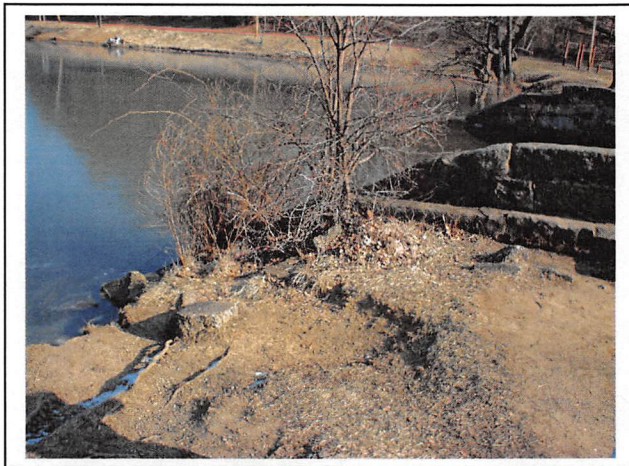
View of the right upstream slope  
and crest near the principal  
spillway inlet. Note the erosion  
and lack of vegetal ground  
cover.

2. The erosion on the upstream slope and crest of the embankment must be repaired and the upstream slope and crest must be protected from erosion. Prepare plans and specifications for repairing the erosion and installing erosion protection. See the "Upstream Slope Protection" and "Ground Cover" fact sheet included in this section for additional information.

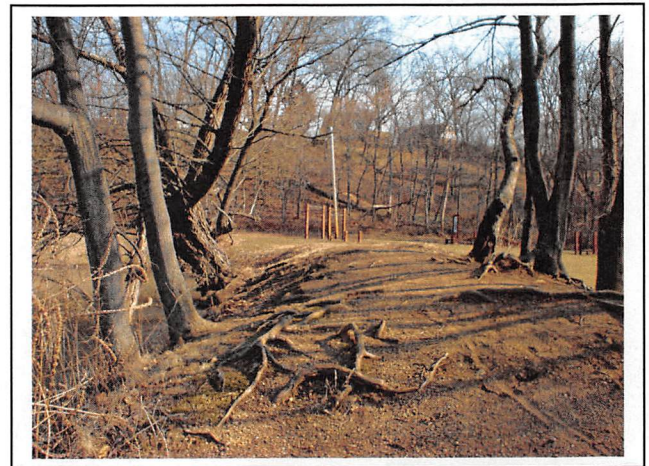
View of the left crest. Note the  
lack of vegetal cover and the  
exposed tree roots from erosion.

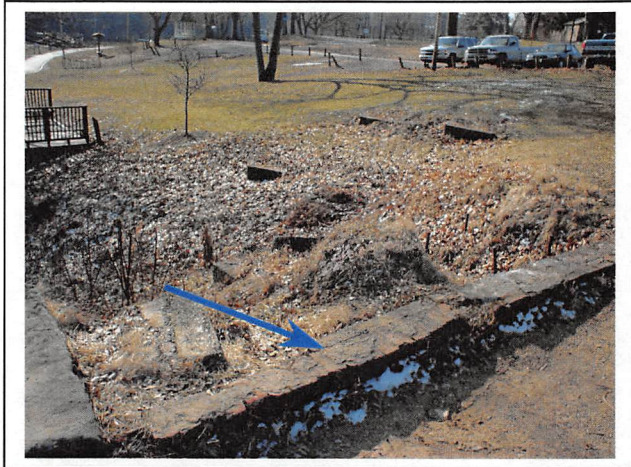
View of the brick cut-off wall across the right half of crest and the downstream slope.

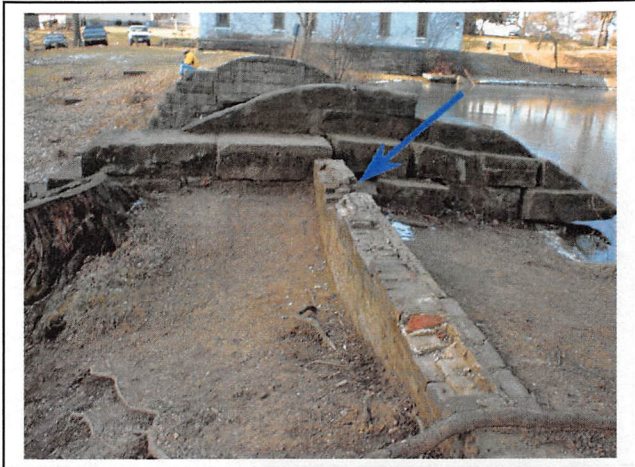
View of the brick cut-off wall across the left half of crest. The blue arrow indicates where bricks have become displaced from the wall.

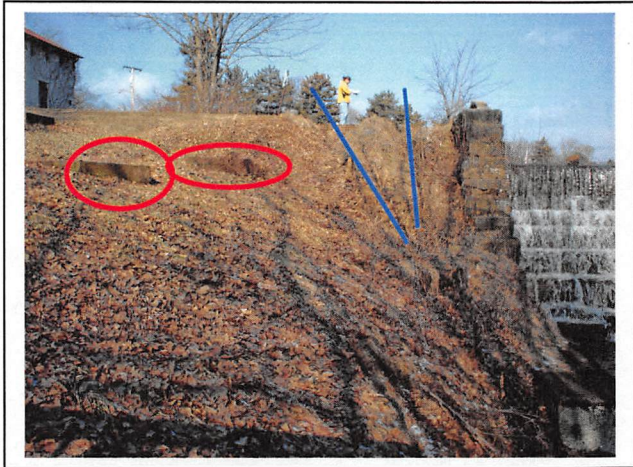
View of the right downstream slope. The red circles indicate the locations of planter boxes on the slope, and the blue lines indicate the location of erosion gullies on the slope.

2. Repair the erosion gullies on the right side of the downstream slope near the principal spillway sidewall. See the "Ground Cover" fact sheet included in this section for additional information.
3. Remove the flower planters from left and right half of the downstream slopes. See the "Earth Dam Failures" fact sheet

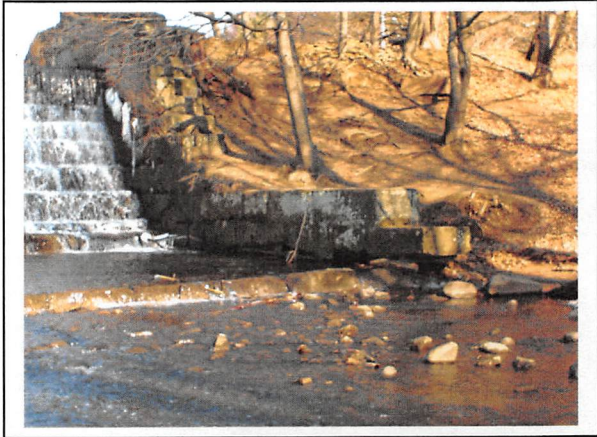
View of the left downstream slope. Note the lack of vegetal ground cover and the trees on the dam.

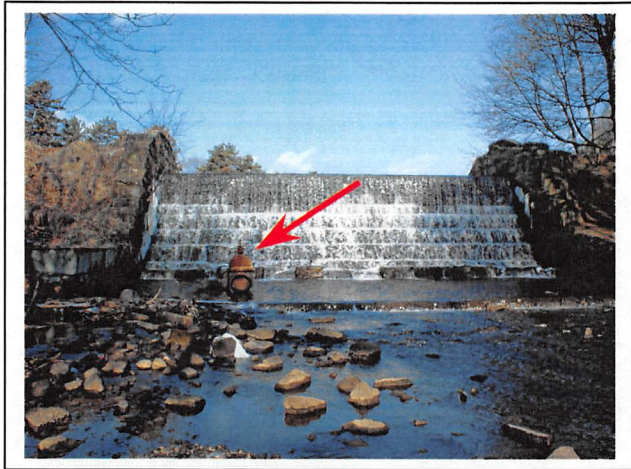
View of the hand placed masonry block principal spillway. The red arrow points to the lake drain pipe and valve.

4. The lake drain must operate properly. Investigate the integrity of the drain, and as necessary, prepare plans and specifications for the repair or replacement of the lake drain. See the "Lake Drains" fact sheet included in this section for additional information.

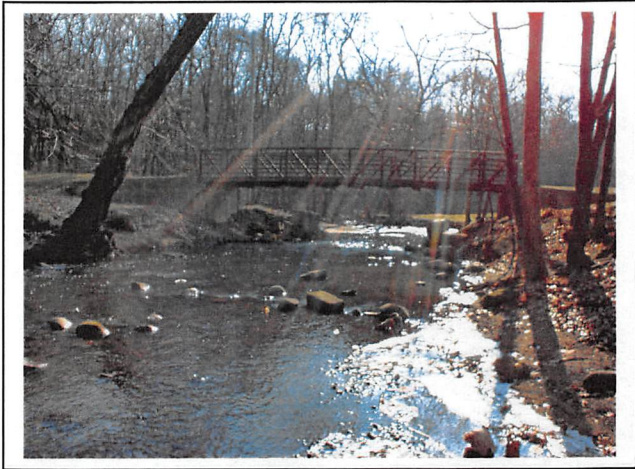
View of the principal spillway outlet channel.

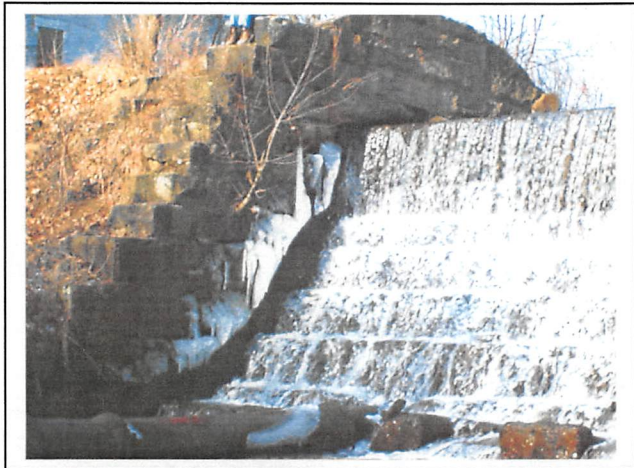
View of the interior right principal spillway side wall. Note the ice from seepage through the joints in the wall. Also note the sapling growing from out of the wall.

3. The entire spillway system must be repaired. Prepare plans and specifications for repair of the seepage through the sidewalls, the undermining of the upstream and downstream end of each sidewall, the loose and missing stones that comprise the spillway, the erosion around the sides of the apron of the spillway, and proper outlet erosion protection. The condition of the spillway system must be monitored for further deterioration. See the "Open Channel Spillways (Concrete Chutes and Weirs)", the "Outlet Erosion Control Structures (Stilling Basins)", and the "Seepage Through Earthen Dams" fact sheets included in this section for additional information.

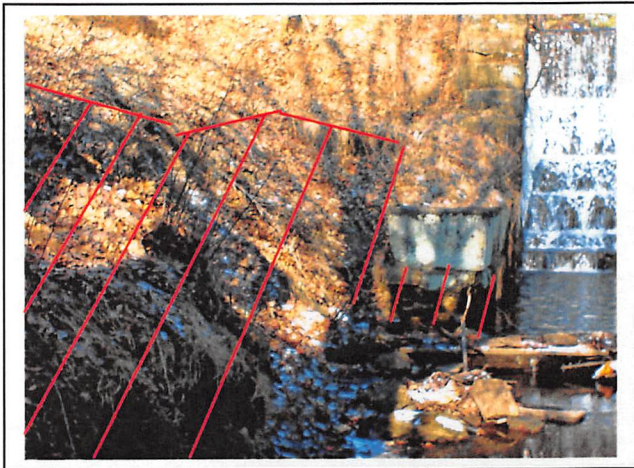
View of the downstream end of the right side wall. The red hatched area indicates erosion. Note that it is eroded behind and under the end of the wall.

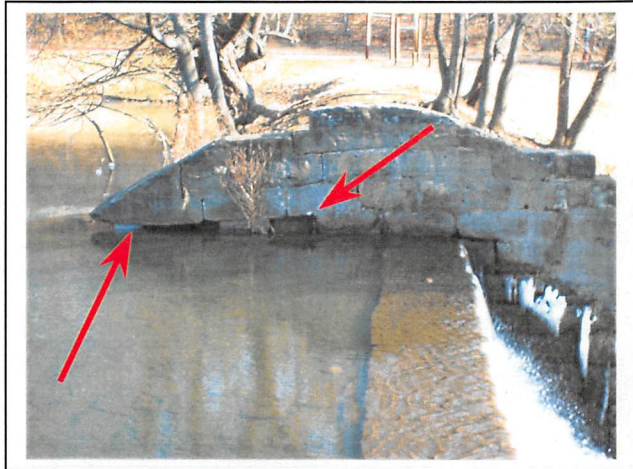
Interior view of the left upstream end of the principal spillway sidewall. The arrows indicate undermining of the wall and missing stones. Also note the seepage emerging from the side wall through unsealed joints.

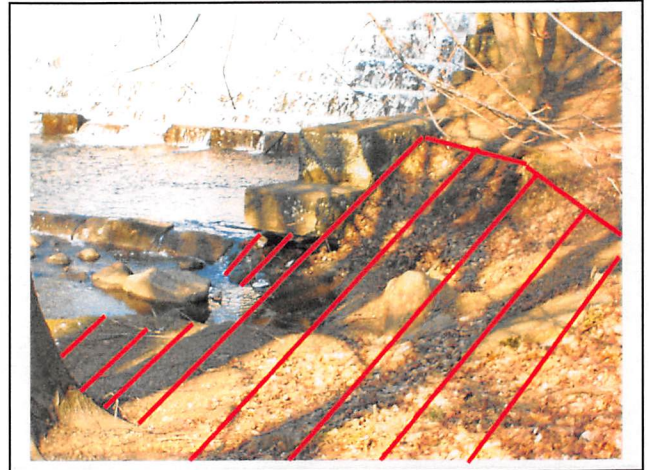
View of the downstream side of the left side wall. The hatched lines indicate erosion under and behind the side wall.

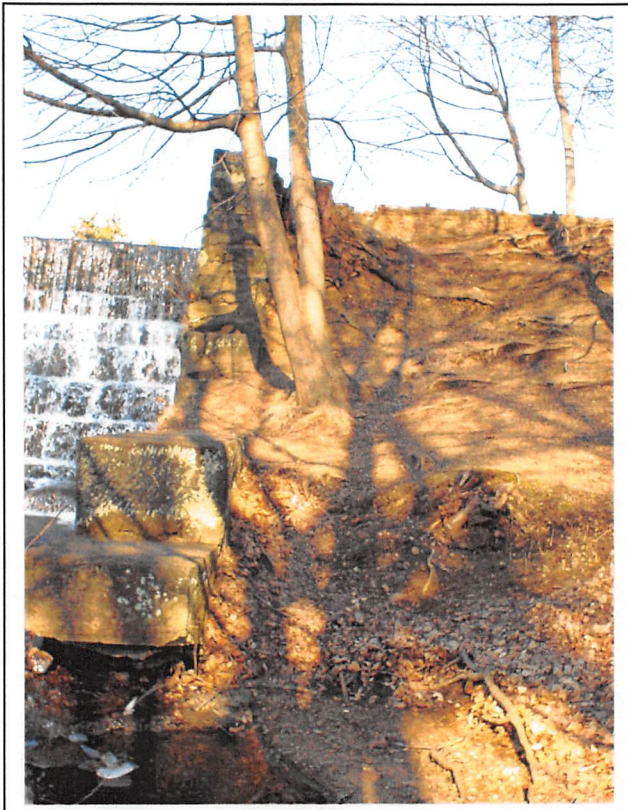
Other views of the undermining and erosion at the downstream end of the left side wall.
