DAM SAFETY INSPECTION REPORT

Sippo Creek Reservoir Dam

File Number: 0614-012

Inspection Date: May 25, 2010

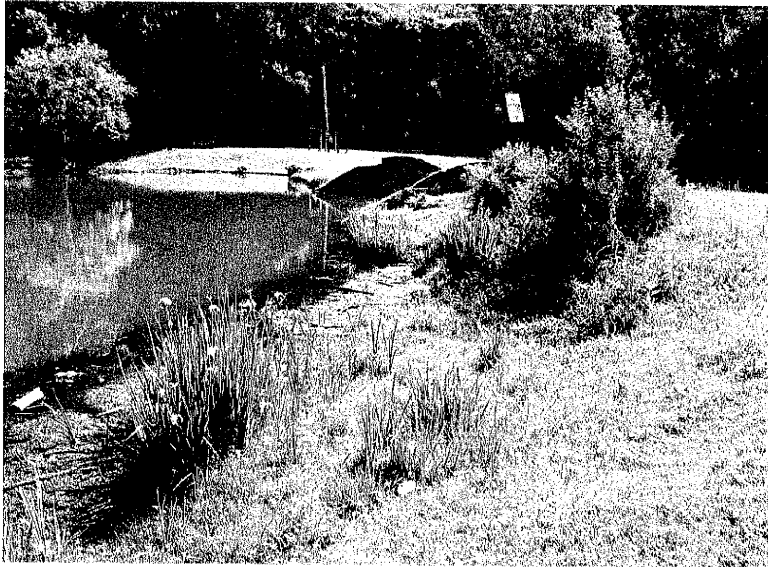
Photograph No. 1:

View of the upstream slope on the right half of dam. Note the trees and brush at the shore line.

2. Remove the brush from the upstream slope shoreline and around the principal spillway sidewalls. Seed all disturbed areas to establish a proper grass cover. See the "Trees and Brush" fact sheet included in this section for additional information.

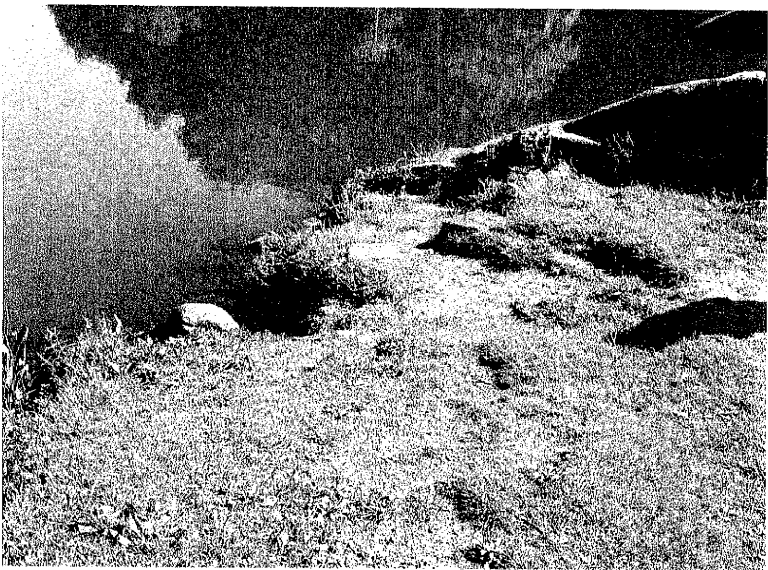
Photograph No. 2:

View of the erosion on the upstream slope next to the principal spillway inlet.

3. The erosion on the upstream slope of the embankment must be repaired and the upstream slope must be protected from erosion. Prepare plans and specifications for repairing the erosion and installing erosion protection.

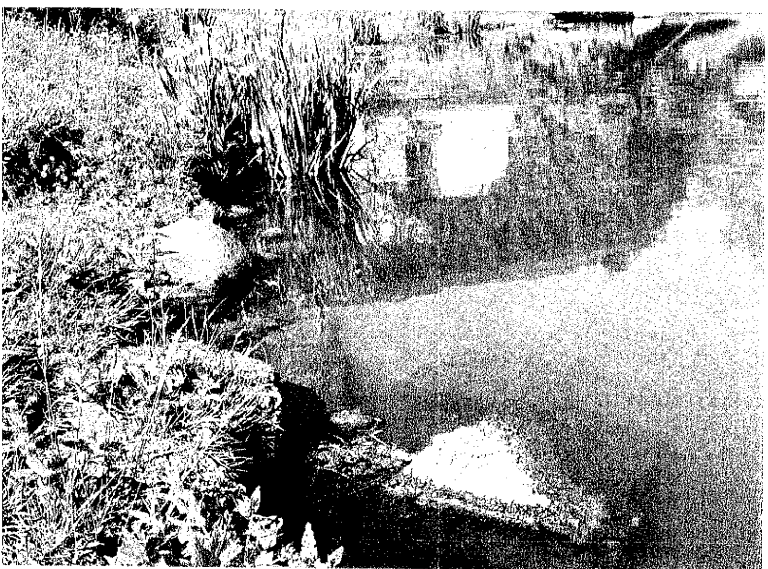
Photograph No. 3:

View of displaced slope protection on the right half.

None
 Riprap: Average Diameter: BROKEN CONCRETE SLABS
(adequate, sparse, displaced, weathered, vegetation) (bedding/fabric noted - yes/no)
Notes: SLOPE PROTECTION WAS NOT PROPERLY INSTALLED AND HAS BEEN DISPLACED IN THE LAKE

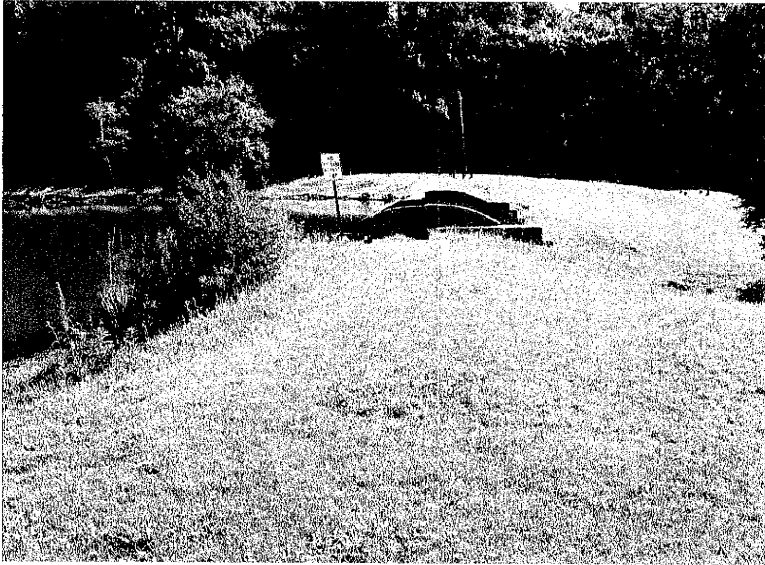
Photograph No. 4:

View of the crest of the dam. Note that it is much lower near the spillway.

4. The embankment crest alignment must be uniform. Investigate the vertical alignment of the crest near the principal spillway sidewalls and prepare plans and specifications for the correction of any problems. Regardless of the results of the investigation, the alignment of the crest must be monitored weekly. This item should be completed in coordination with Item 1 above.

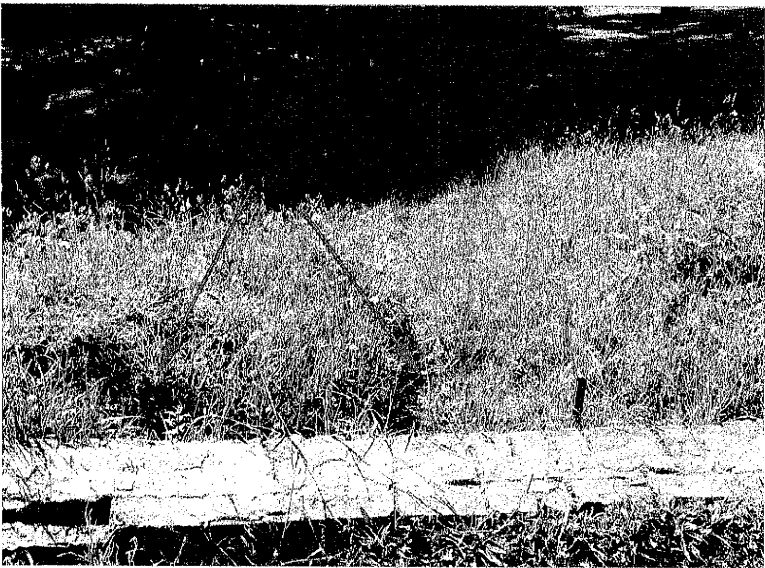
Photograph No. 5:

Exposed cut-off wall on the right crest. The arrow also point to two large erosion gullies on the downstream slope.

5. The cut-off wall along the crest must be repaired. Prepare plans and specifications for the repair or replacement of the wall. This item should be completed in coordination with Item 3 above.

3. Repair the erosion gullies on the downstream slope, adjacent to the spillway. See the "Earth Dam Failures" fact sheet included in this section for additional information.

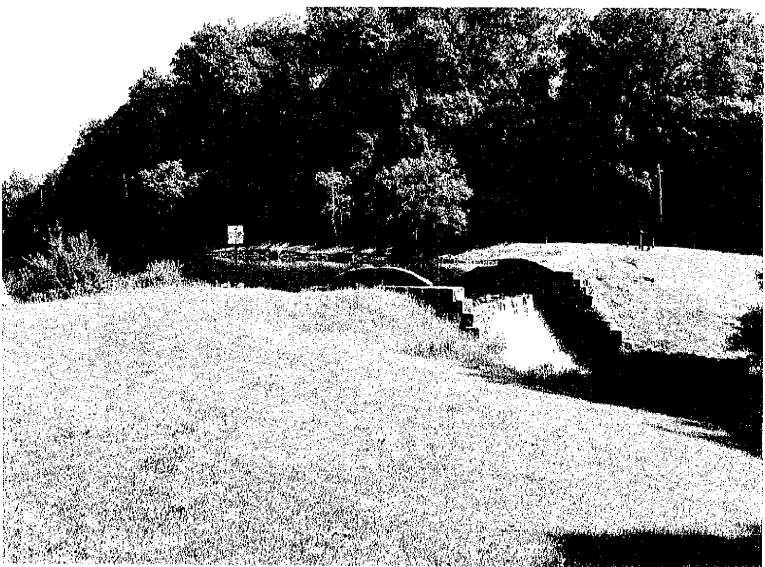
Photograph No. 6:

View of the right downstream slope. Again notice how much lower the crest of the dam is near the spillway.

6. The extremely steep downstream slope to the right of the principal spillway must be regraded. Prepare plans and specifications to flatten the slope. The steepness and overall stability of the embankment must be monitored weekly until repairs can be made.

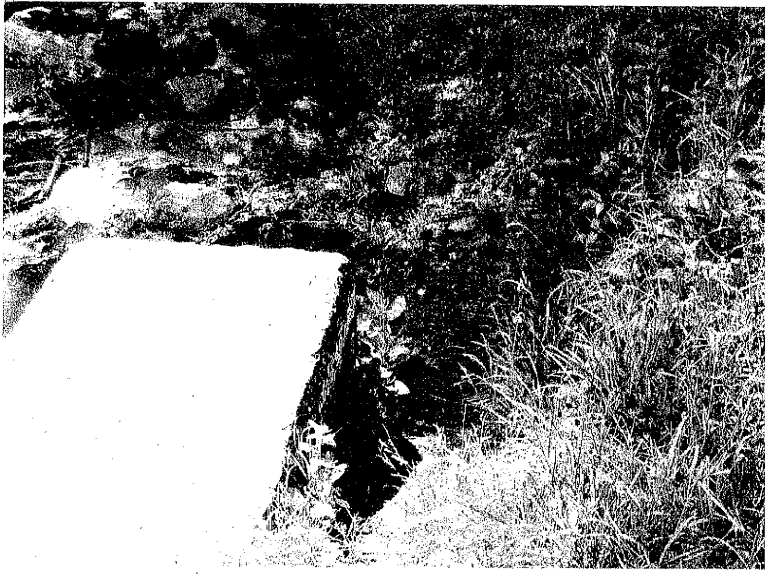
Photograph No. 7:

Erosion at end of slope next to spillway.

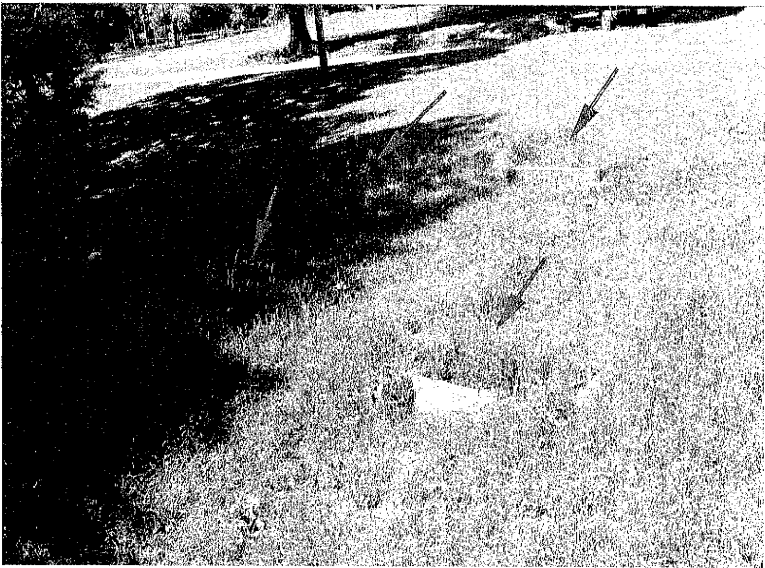
Photograph No. 8:

View of four flower planters on the downstream slope. They were so overgrown that they were barely visible.

6. Remove the planters on the downstream slope.

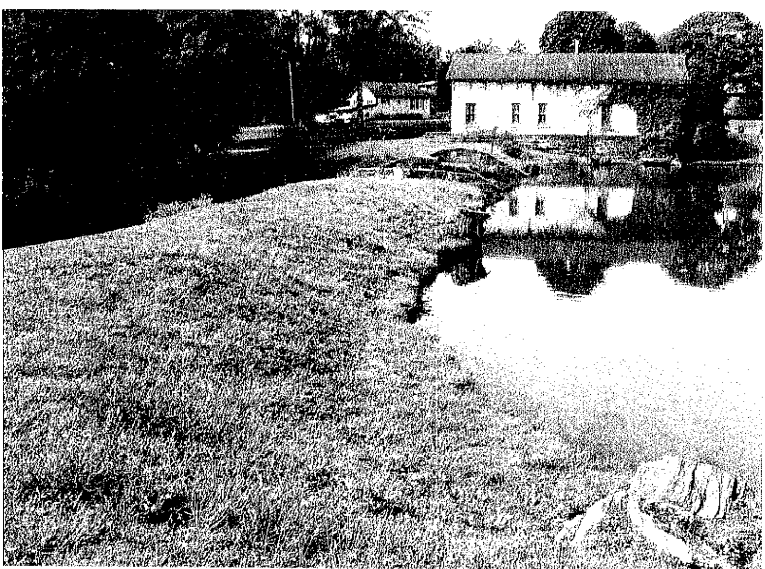
Photograph No. 9:

View of the upstream slope and crest on the left side of the dam.

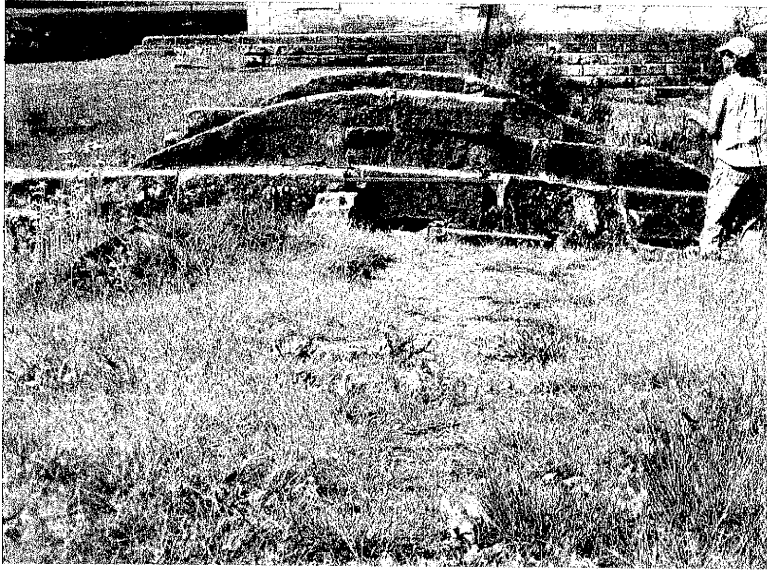
Photograph No. 10:

View of the crest on the left half of dam near the spillway. Again note how low the crest is. The crest should be where the red line on the photograph is.

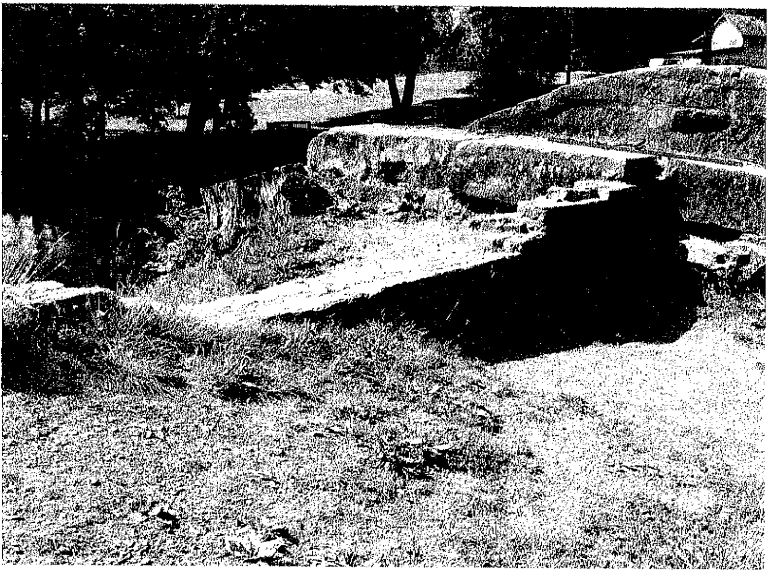
Photograph No. 11:

View of the cut-off wall in the crest on the left half of the dam. Again, note the loss of fill in the area. Red line indicates where the crest height should be.

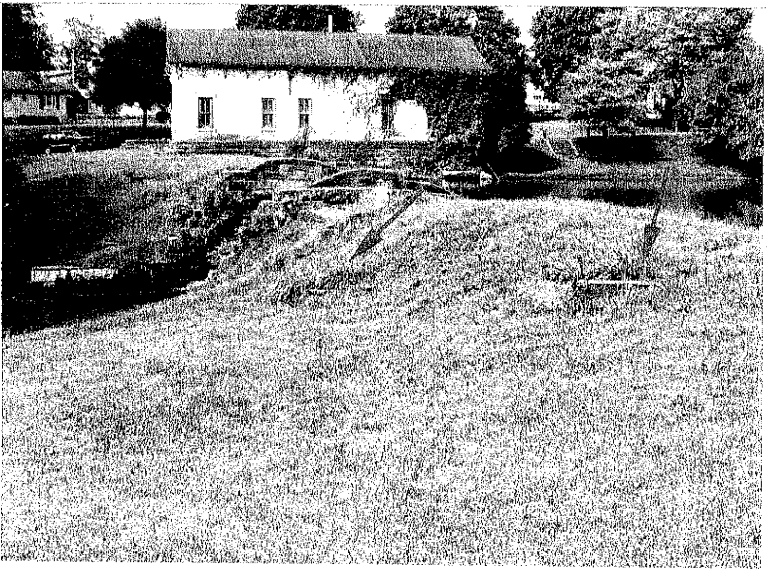
Photograph No. 12:

Downstream slope of left half of dam. Again note the flower planters buried in the slope.

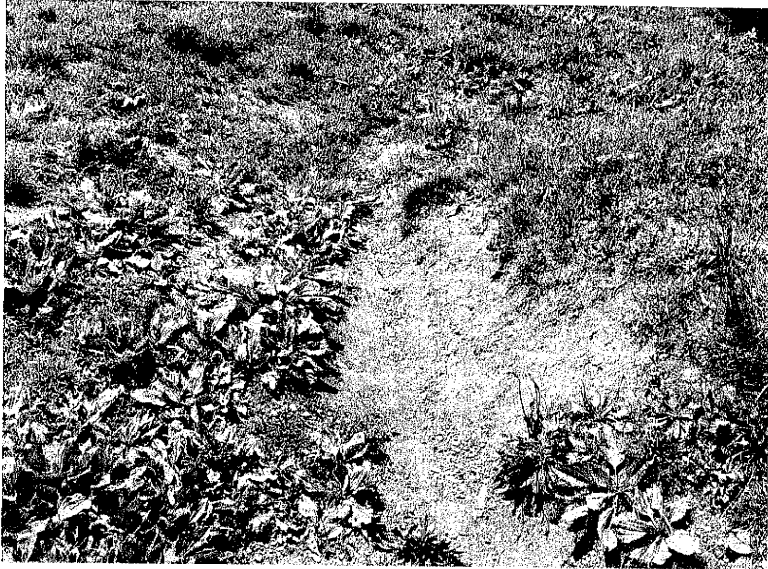
Photograph No. 13:

Erosion on the downstream slope near the spillway.

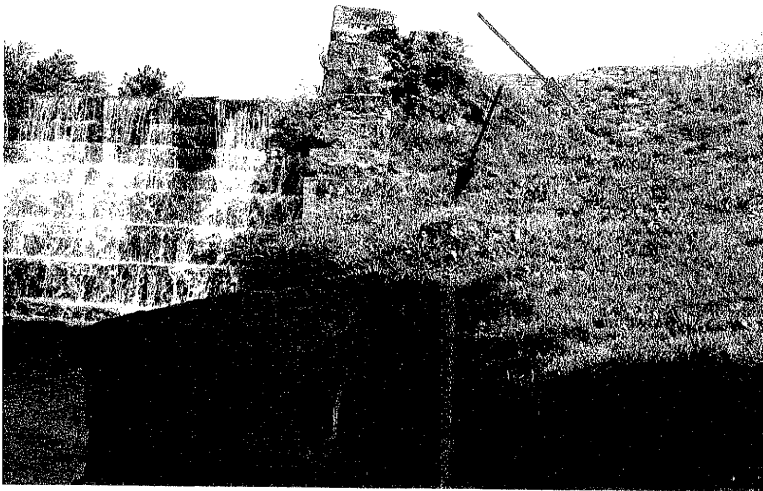
Photograph No. 14:

View of the left downstream slope. The red arrow points to erosion and the blue arrow points to a tree stump.

4. Repair the rodent burrows on the upstream slope. See the "Rodent Control" fact sheet included in this section for additional information.
5. Remove or grind down all the tree stumps on the embankment. Seed the all bare and sparse areas on the embankment to establish a proper grass cover. See the "Trees and Brush" and "Ground Cover" fact sheets included in this section for additional information.

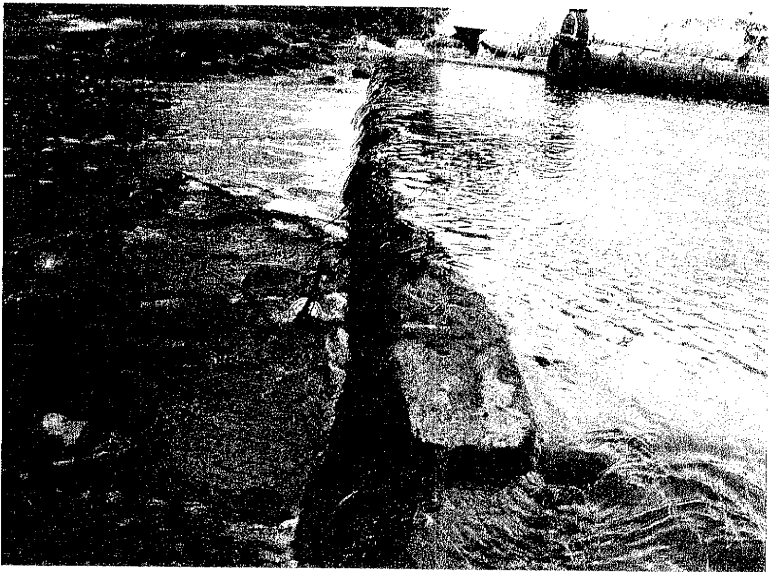
Photograph No. 17:

End sill of the principal spillway stilling basin. Note how weathered and worn the stone appears.

2. The spillway system must perform properly without endangering the safety of the dam. Investigate the deterioration, deformation, structural integrity, and undermining of the entire spillway system, and prepare plans and specifications for the repair or replacement of the entire spillway system. Regardless of the results of the investigation, the condition of the entire spillway system must be monitored weekly. This item should be completed in coordination with Item 1 above.

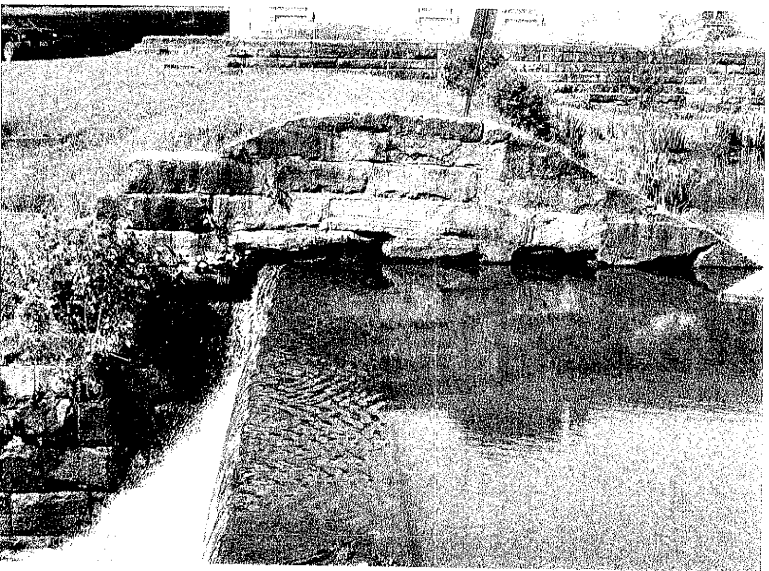
Photograph No. 18:

Right side wall of principal spillway. Note the undermining of the wall and the vegetation growing the cracks of the masonry.

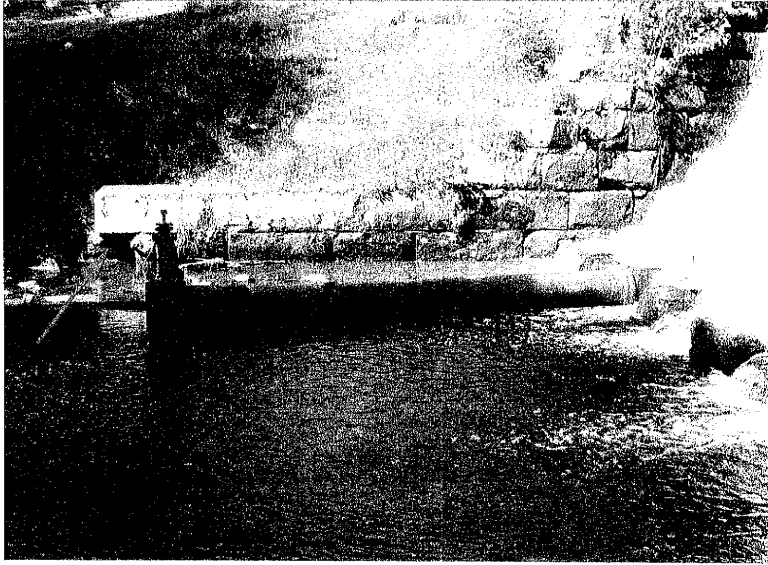
Photograph No. 19:

View of the lower portion of the right spillway sidewall. The arrow indicates where the water has eroded around the wall.

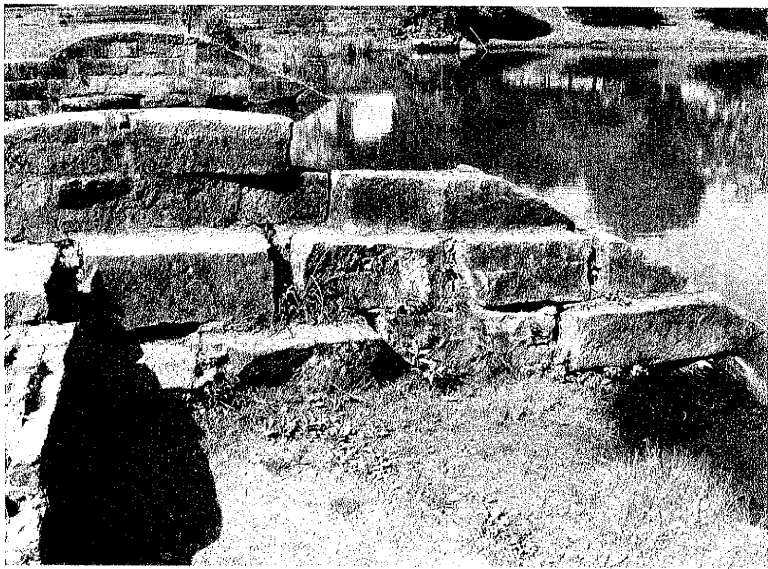
Photograph No. 20:

View of the left spillway sidewall. Note the missing and displaced stones. Also note the undermining of the inlet wall.

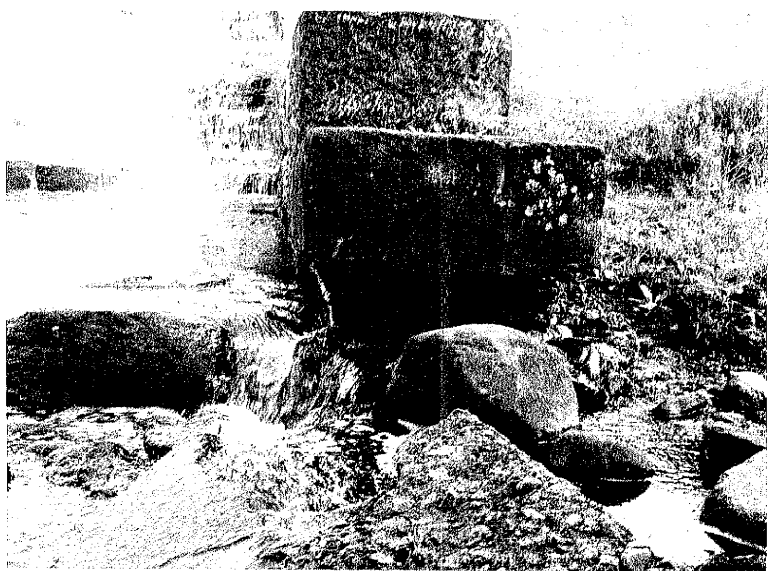
Photograph No. 21:

Water had also undermined the end of the left spillway side wall.

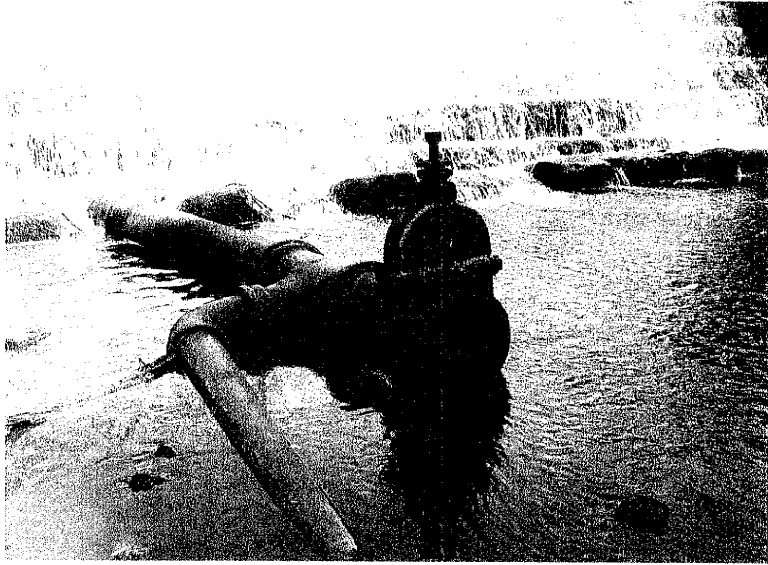
Photograph No. 22:

Lake drain valve. Unsure if it is operable.

1. The lake drain valve must operate properly. Investigate the integrity of the valve/sluice gate. If the valve does not work, you must hire an engineer to prepare plans and specifications for repair or replacement of the drain. See the "Lake Drains" fact sheet included in this section for additional information.
