DAM SAFETY INSPECTION REPORT

Sippo Creek Reservoir Dam

File Number: 0614-012

Inspection Date: June 16, 2015

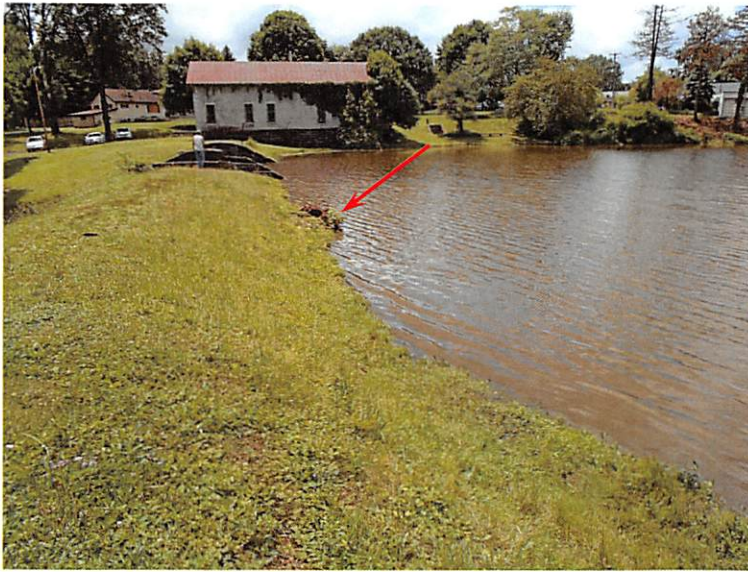
Photograph No. 1:

View of the upstream slope and crest. Note that trees and brush have been cleared; however, not all stumps have been removed. Arrow points to stump on slope.

1. Remove the tree stumps and brush from the upstream slope and downstream slope. Seed all disturbed areas to establish a proper grass cover. See the "Trees and Brush" fact sheet included in this section for additional information.
2. Seed the bare and sparse areas on the upstream slope and crest to establish a proper grass cover. See the "Ground Cover" fact sheet included in this section for additional information.
3. Repair the erosion gullies on the downstream slope. See the "Ground Cover" fact sheet included in this section for additional information.
4. Repair the rodent burrow on the upstream slope adjacent to the left principal spillway side wall. See the "Rodent Control" fact sheet included in this section for additional information.

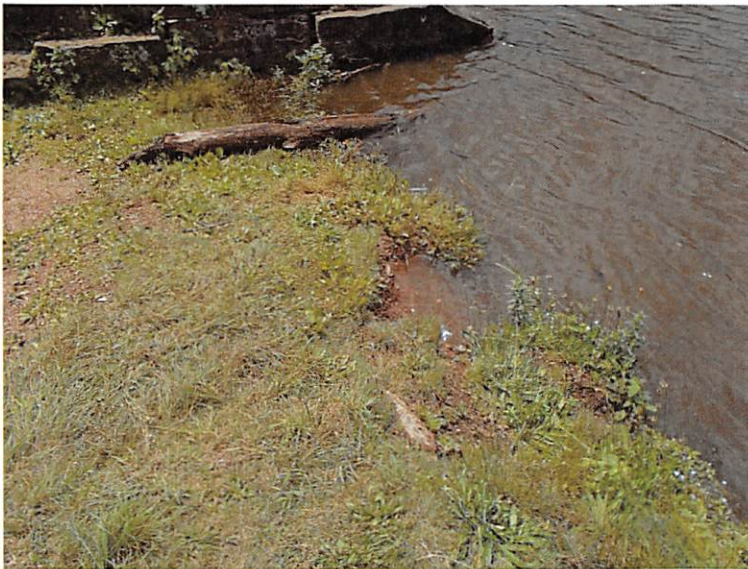
Photograph No. 2:

View of active erosion immediately to the left of the principal spillway.

7. The erosion on the upstream slope of the embankment must be repaired and the upstream slope must be protected from erosion. Prepare plans and specifications for repairing the erosion and installing erosion protection.

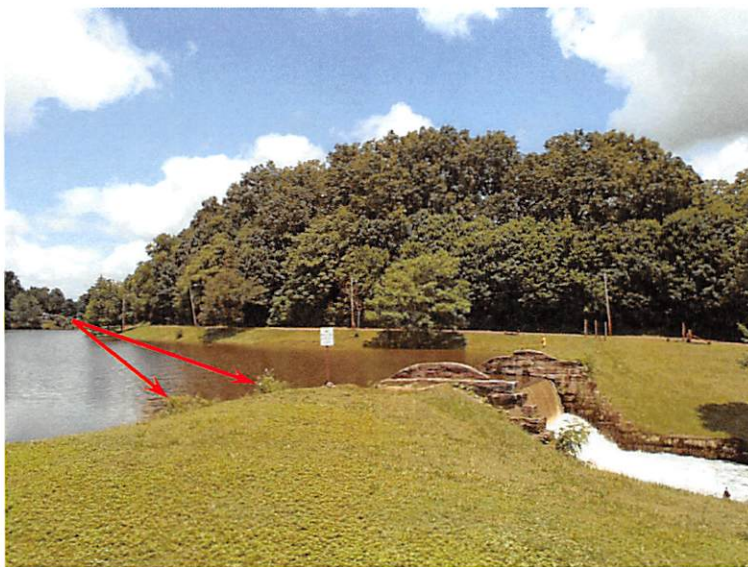
Photograph No. 3:

View of the crest and downstream slope on the right half of dam. Arrows point to a small amount of brush that remains on the right upstream slope.

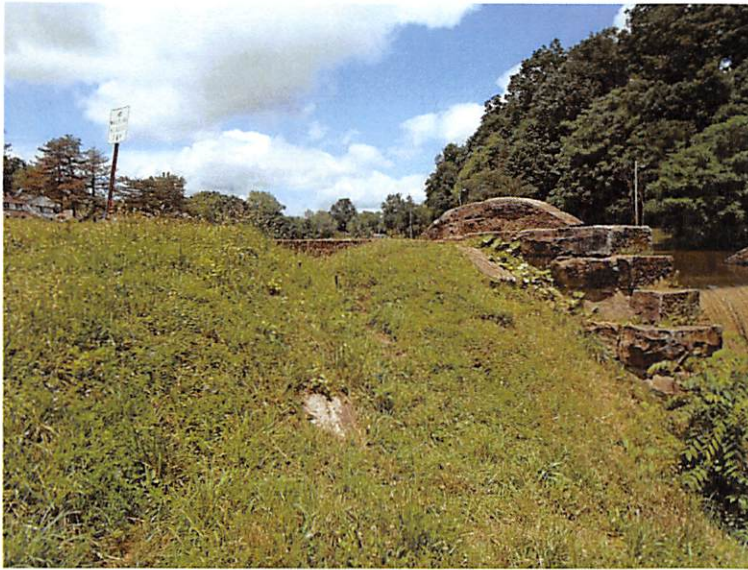
Photograph No. 4:

Past overtopping has caused low areas on the crest and erosion gullies on the downstream slope.

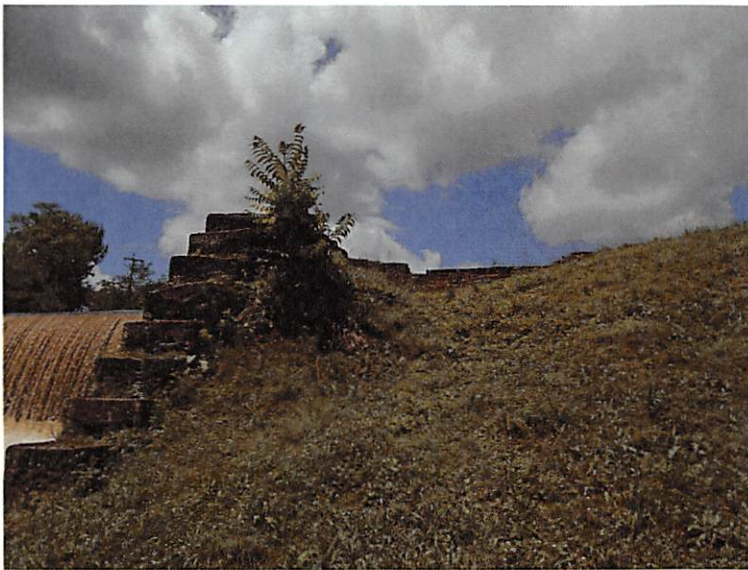
Photograph No. 5:

Past overtopping has caused low areas on the crest and erosion gullies on the downstream slope.

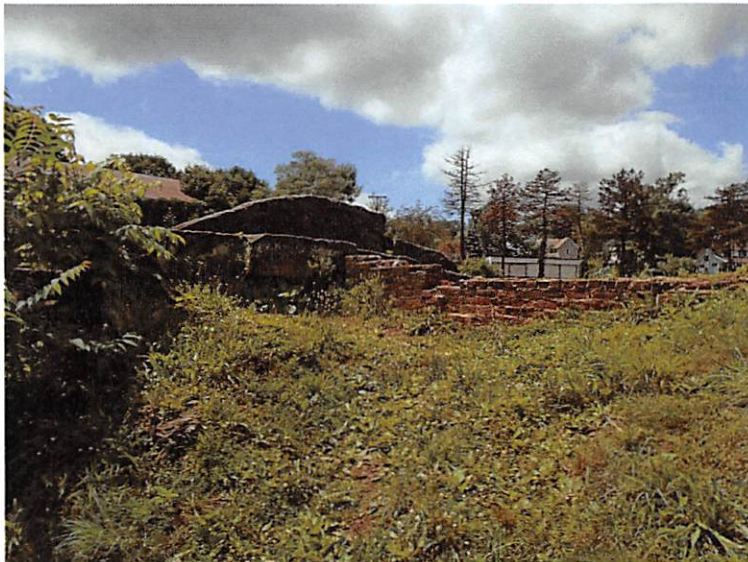
Photograph No. 6:

A close up view of the picture above.

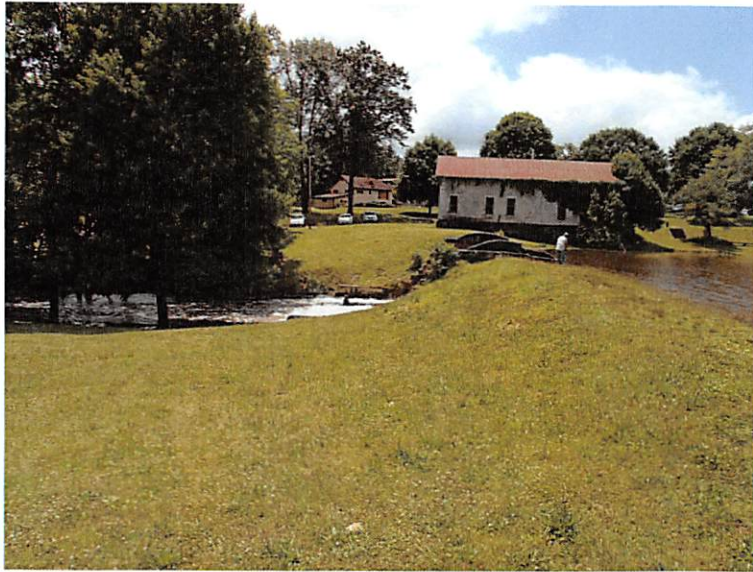
Photograph No. 7:

Overview of the downstream slope.

8. The extremely steep downstream slope to the right of the principal spillway must be regraded. Prepare plans and specifications to flatten the slope. The steepness and overall stability of the embankment must be monitored weekly until repairs can be made.

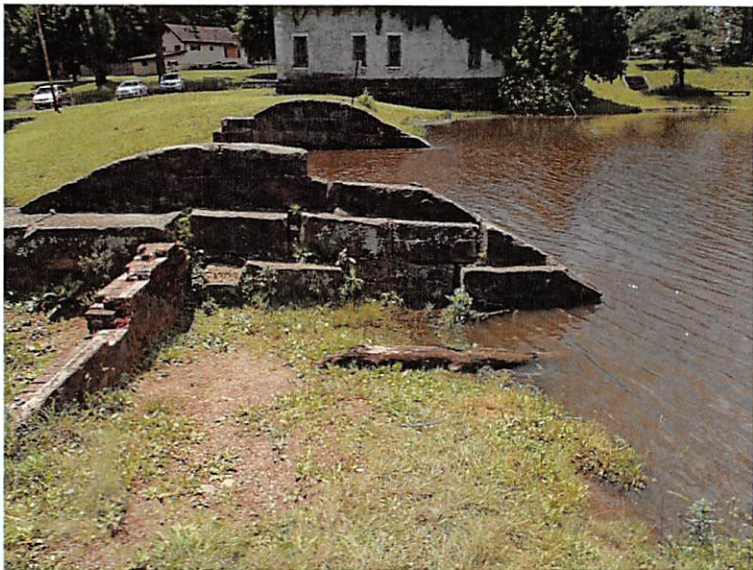
Photograph No. 8:

A view of the principal spillway inlet and the brick cutoff wall. These structures are in the process of failing.

3. The principal spillway system must perform properly without endangering the safety of the dam. Investigate the structural integrity and undermining of the principal spillway system and, as necessary, prepare plans and specifications for the correction of any problems. The condition of the principal spillway system must be monitored weekly for further deterioration until repairs can be made. This item should be completed in coordination with Item 2 above.

6. The cut-off wall along the crest must be repaired or replaced. Prepare plans and specification for the repair or replacement of the wall. This item should be completed in coordination with Item 4 above.

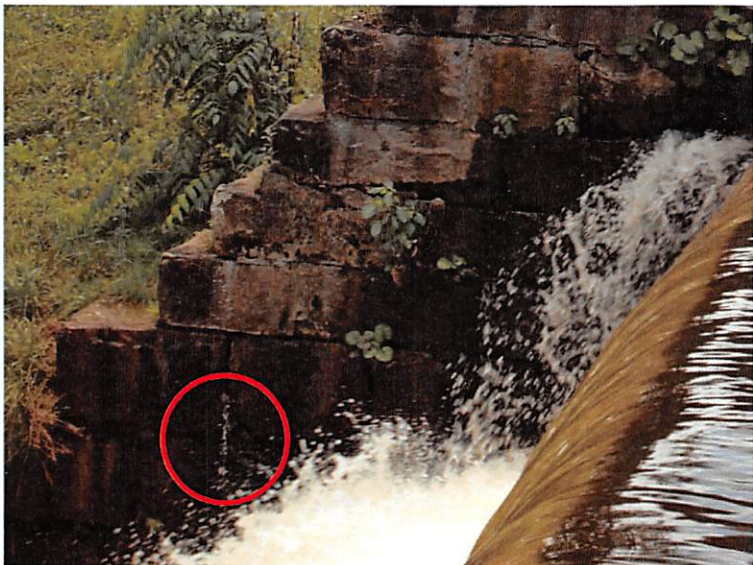
Photograph No. 9:

View of the interior side of the right principal spillway sidewall. Note the crumbling stones, the loss of joint material, and the vegetation growing in the open joints. The red circle indicates where water is coming out between the stones.

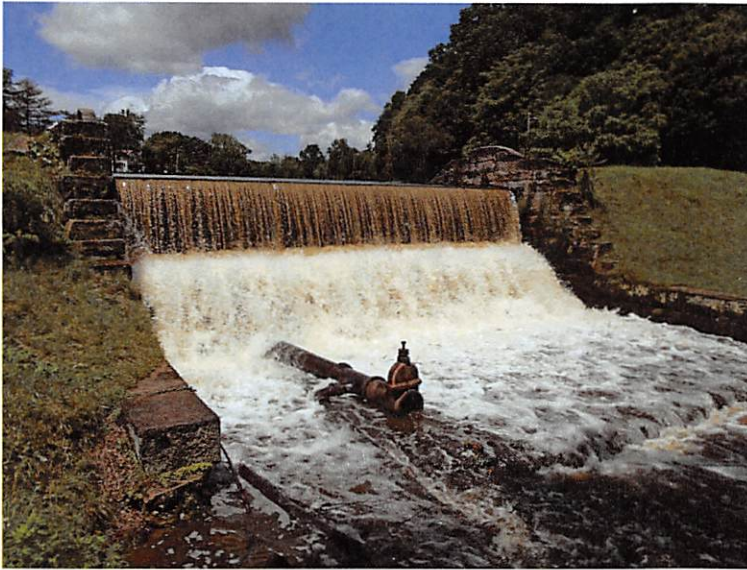
Photograph No. 10:

View of the principal spillway outlet. The lake drain can be seen at the bottom.

4. The lake drain valve must operate properly. Investigate the integrity of the valve. If the valve does not work, you must hire an engineer to prepare plans and specifications for repair or replacement of the drain.

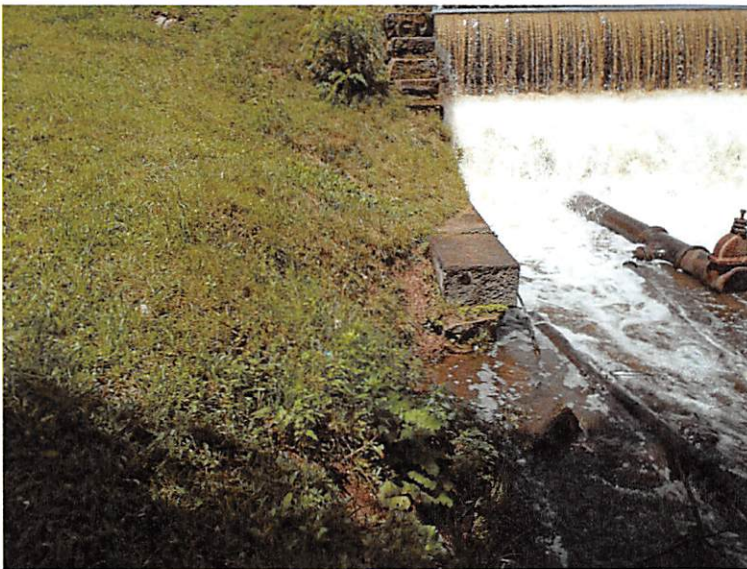
Photograph No. 11:

Both the right and left ends of the spillway sidewalls were severely undermined.

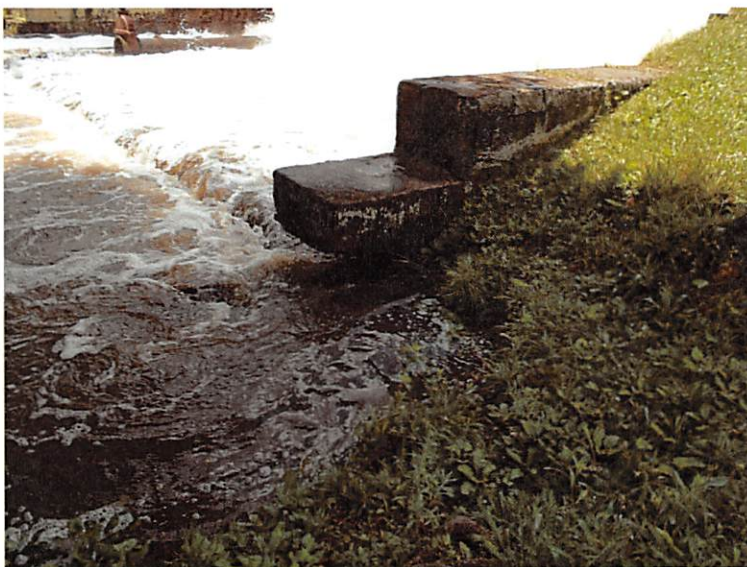
Photograph No. 12:

Both the right and left ends of the spillway sidewalls were severely undermined.
