DAM SAFETY INSPECTION REPORT

Sippo Creek Reservoir Dam

Stark County, Perry Township

Inspection Date: June 16, 2015

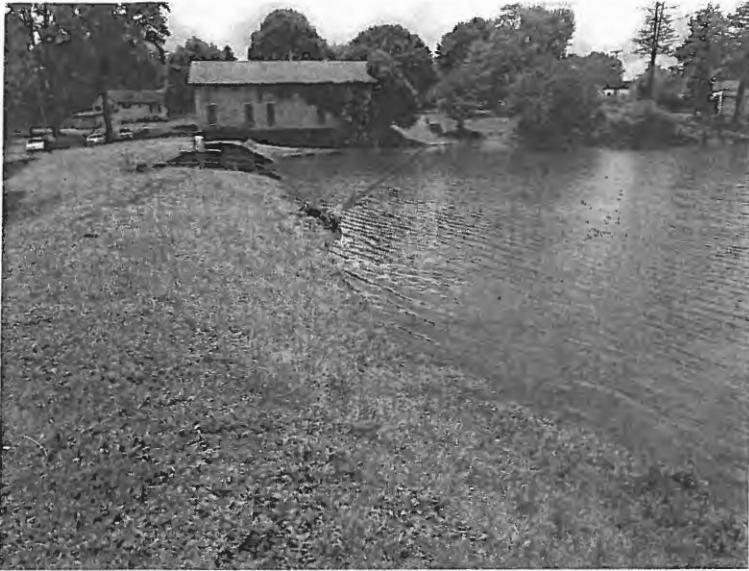
Photograph No. 1:

View of the upstream slope and crest. Note that trees and brush have been cleared; however, not all stumps have been removed. Arrow points to stump on slope.

1. Remove the tree stumps and brush from the upstream slope and downstream slope. Seed all disturbed areas to establish a proper grass cover. See the "Trees and Brush" fact sheet included in this section for additional information.
2. Seed the bare and sparse areas on the upstream slope and crest to establish a proper grass cover. See the "Ground Cover" fact sheet included in this section for additional information.
3. Repair the erosion gullies on the downstream slope. See the "Ground Cover" fact sheet included in this section for additional information.
4. Repair the rodent burrow on the upstream slope adjacent to the left principal spillway side wall. See the "Rodent Control" fact sheet included in this section for additional information.

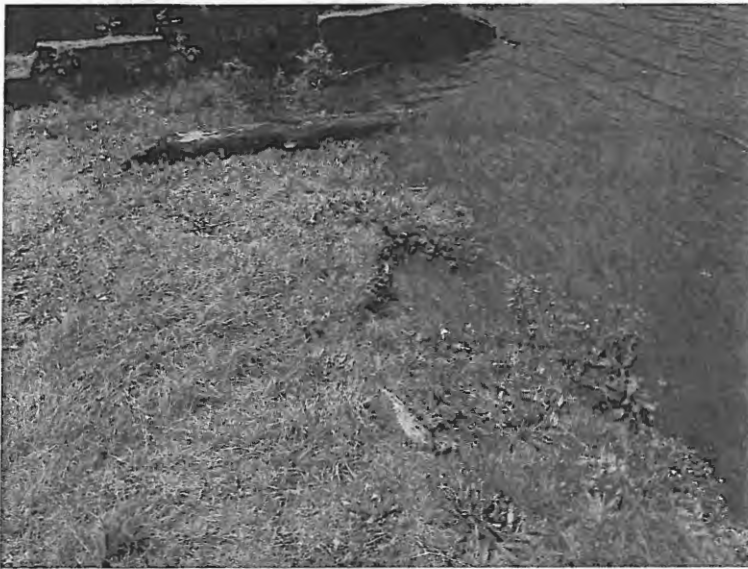
Photograph No. 2:

View of active erosion immediately to the left of the principal spillway.

7. The erosion on the upstream slope of the embankment must be repaired and the upstream slope must be protected from erosion. Prepare plans and specifications for repairing the erosion and installing erosion protection.

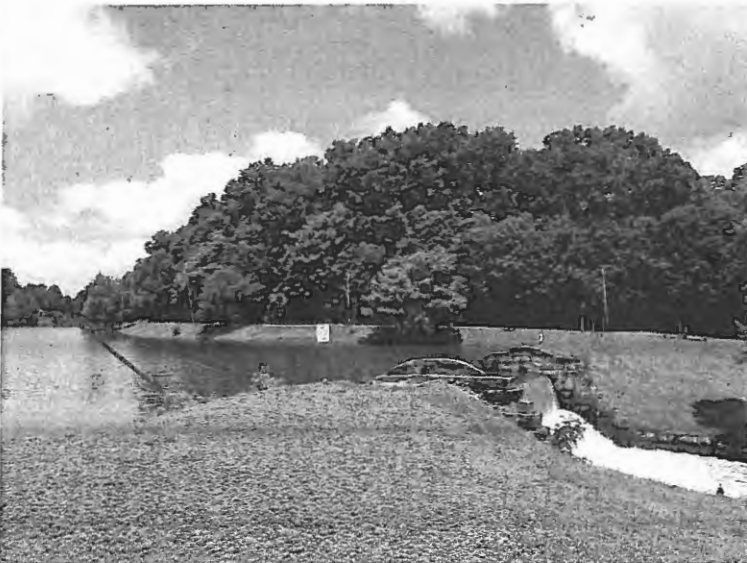
Photograph No. 3:

View of the crest and downstream slope on the right half of dam. Arrows point to a small amount of brush that remains on the right upstream slope.

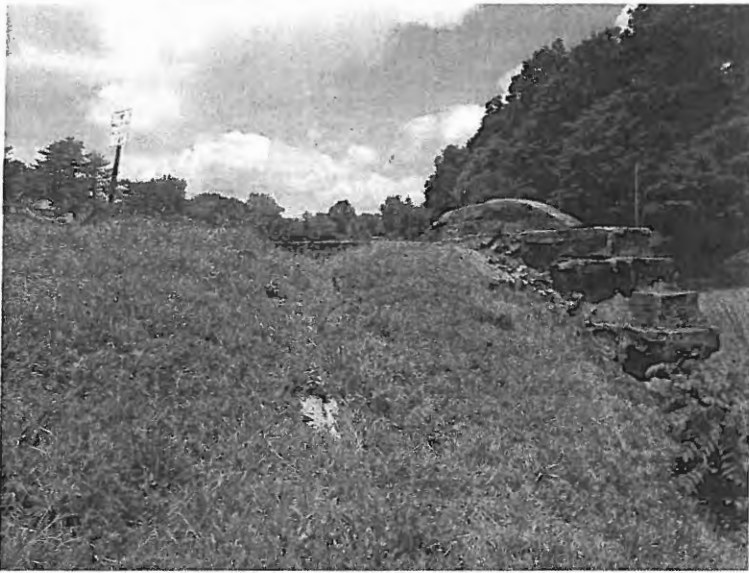
Photograph No. 4:

Past overtopping has caused low areas on the crest and erosion gullies on the downstream slope.

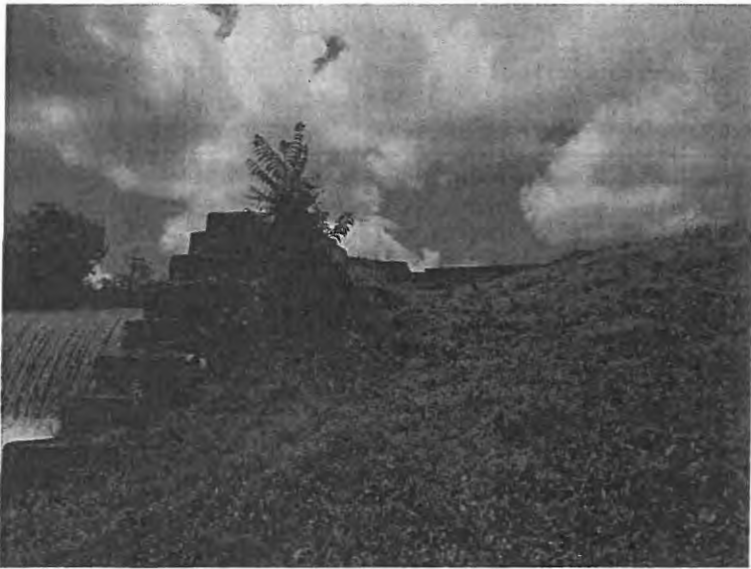
Photograph No. 5:

Past overtopping has caused low areas on the crest and erosion gullies on the downstream slope.

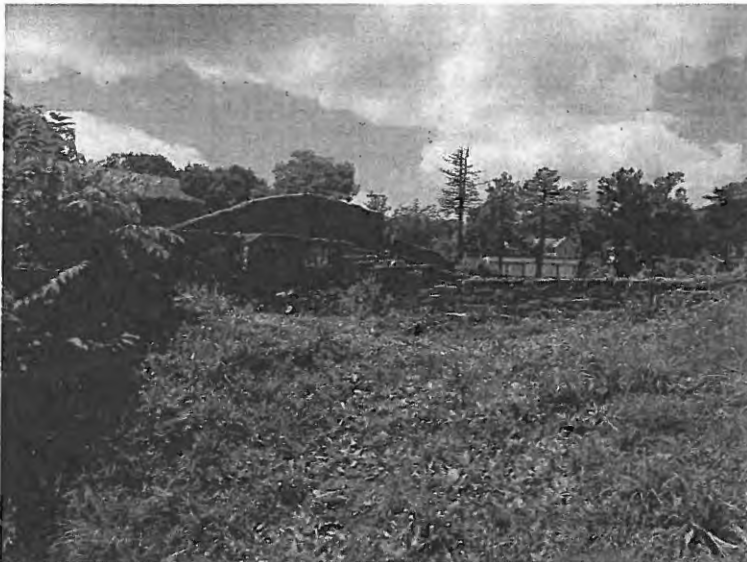
Photograph No. 6:

A close up view of the picture above.

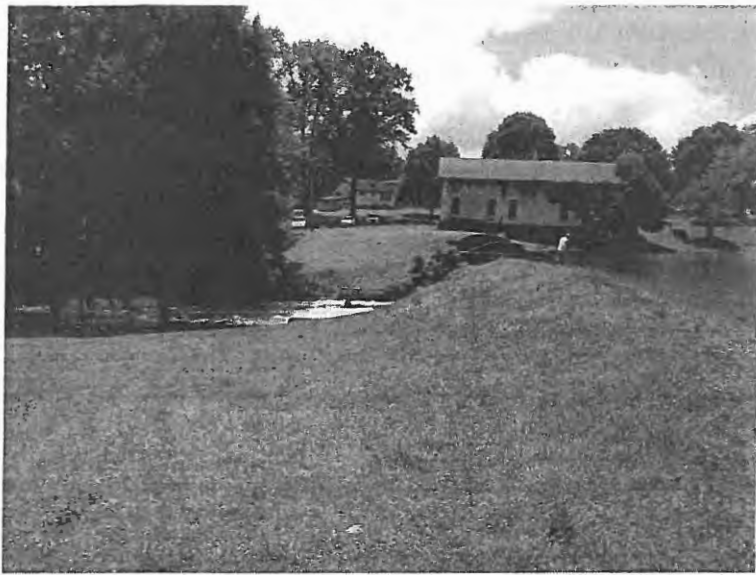
Photograph No. 7:

Overview of the downstream slope.

8. The extremely steep downstream slope to the right of the principal spillway must be regraded. Prepare plans and specifications to flatten the slope. The steepness and overall stability of the embankment must be monitored weekly until repairs can be made.

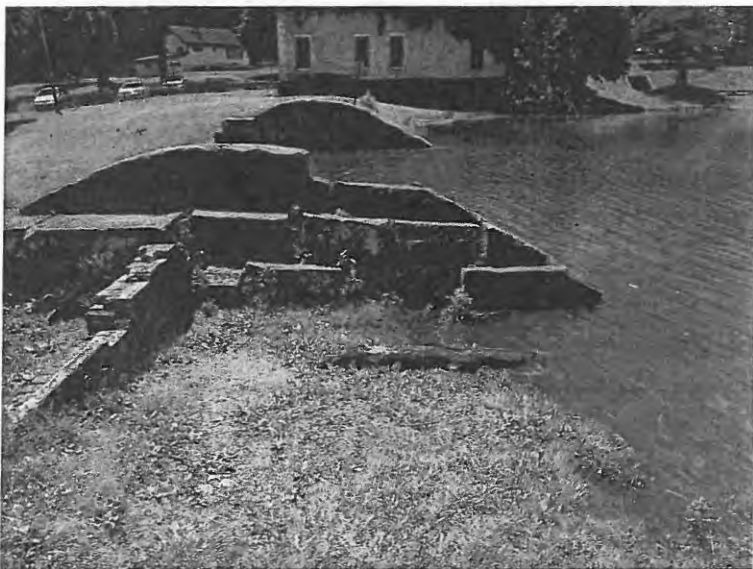
Photograph No. 8:

A view of the principal spillway inlet and the brick cutoff wall. These structures are in the process of failing.

3. The principal spillway system must perform properly without endangering the safety of the dam. Investigate the structural integrity and undermining of the principal spillway system and, as necessary, prepare plans and specifications for the correction of any problems. The condition of the principal spillway system must be monitored weekly for further deterioration until repairs can be made. This item should be completed in coordination with Item 2 above.

6. The cut-off wall along the crest must be repaired or replaced. Prepare plans and specification for the repair or replacement of the wall. This item should be completed in coordination with Item 4 above.

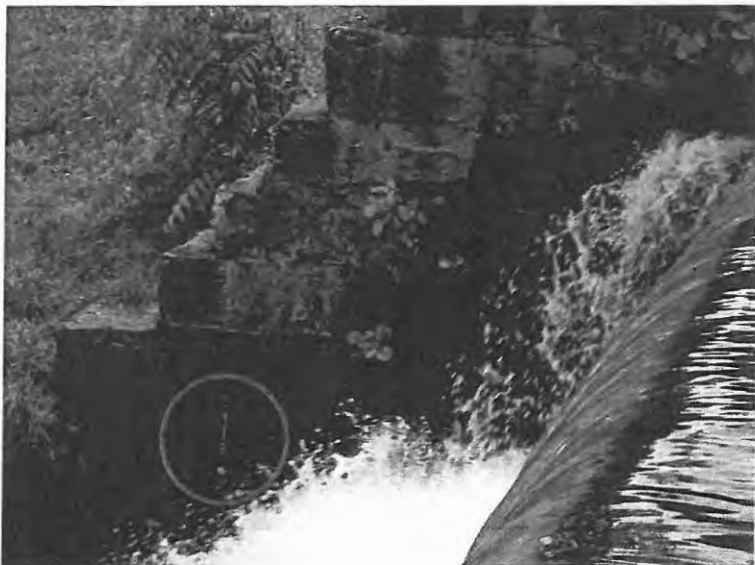
Photograph No. 9:

View of the interior side of the right principal spillway sidewall. Note the crumbling stones, the loss of joint material, and the vegetation growing in the open joints. The red circle indicates where water is coming out between the stones.

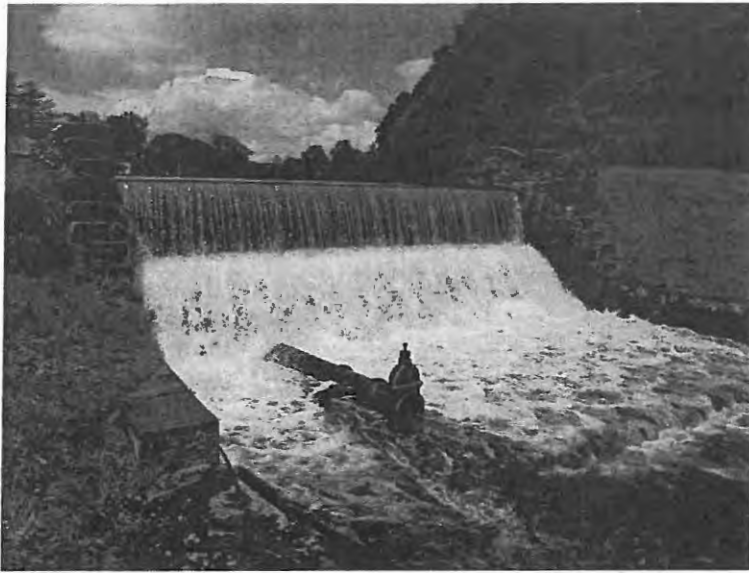
Photograph No. 10:

View of the principal spillway outlet. The lake drain can be seen at the bottom.

4. The lake drain valve must operate properly. Investigate the integrity of the valve. If the valve does not work, you must hire an engineer to prepare plans and specifications for repair or replacement of the drain.

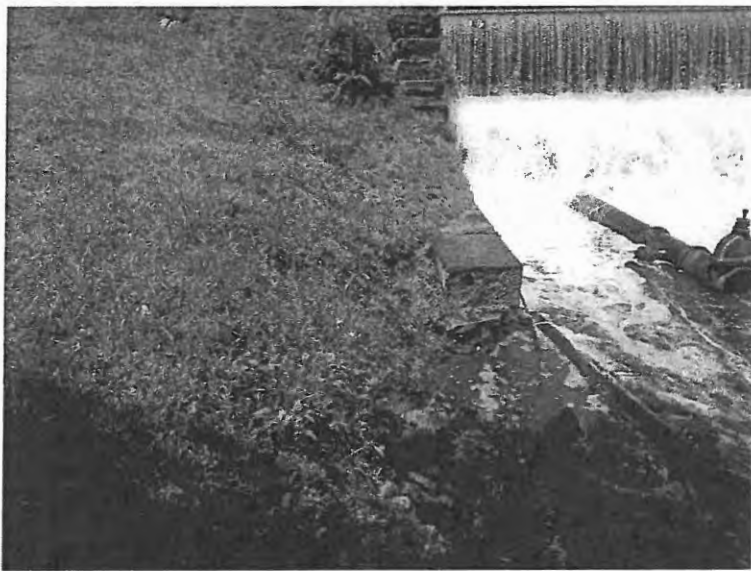
Photograph No. 11:

Both the right and left ends of the spillway sidewalls were severely undermined.

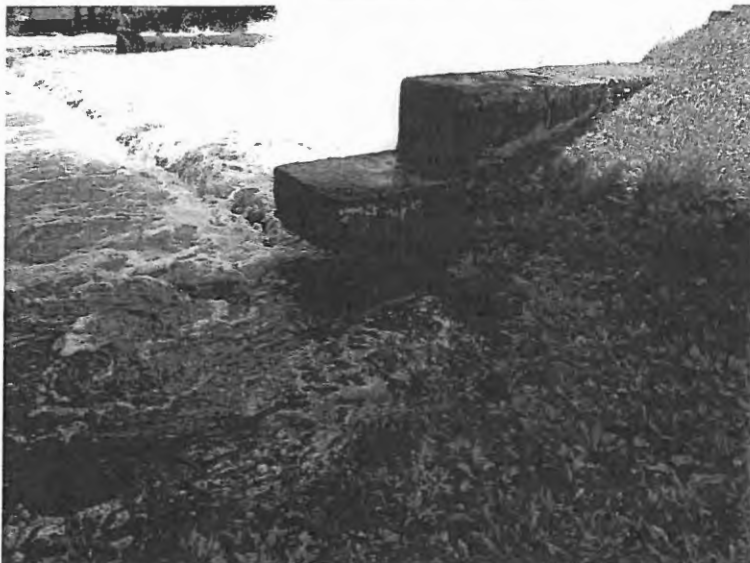
Photograph No. 12:

Both the right and left ends of the spillway sidewalls were severely undermined.
