RE: Sippo Creek Reservoir Dam
File Number: 0614-012
Stark County

DAM SAFETY INSPECTION REPORT

Sippo Creek Reservoir Dam

Inspection Date: May 25, 2010

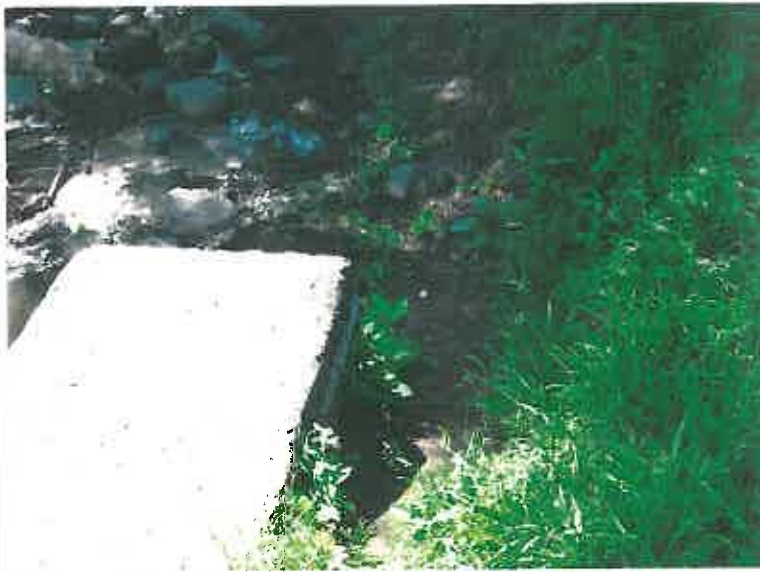
Photograph No. 7:

Erosion at end of slope next to spillway.

3. Repair the erosion gullies on the downstream slope, adjacent to the spillway. See the "Earth Dam Failures" fact sheet included in this section for additional information.

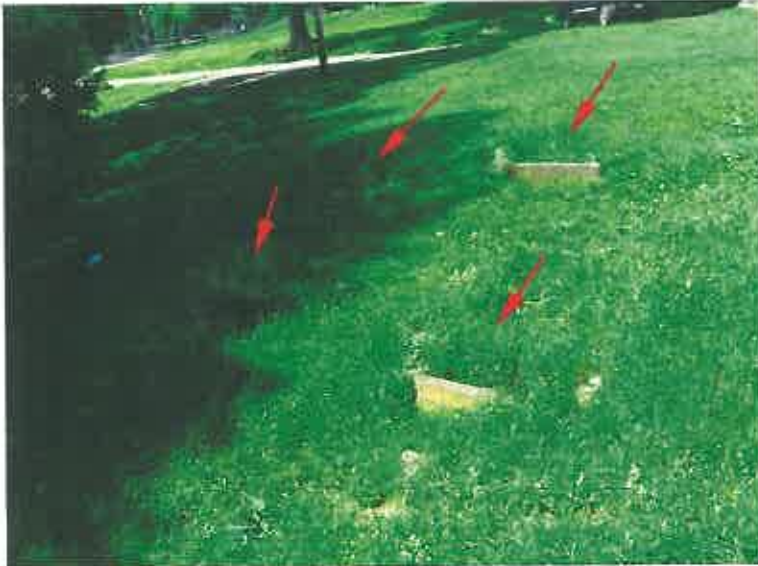
Photograph No. 8:

View of four flower planters on the downstream slope. They were so overgrown that they were barely visible.

6. Remove the planters on the downstream slope.

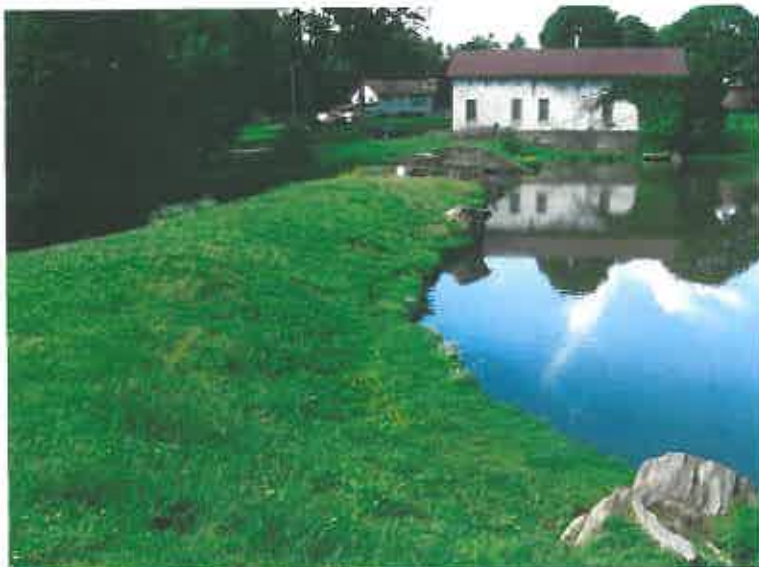
Photograph No. 9:

View of the upstream slope and crest on the left side of the dam.

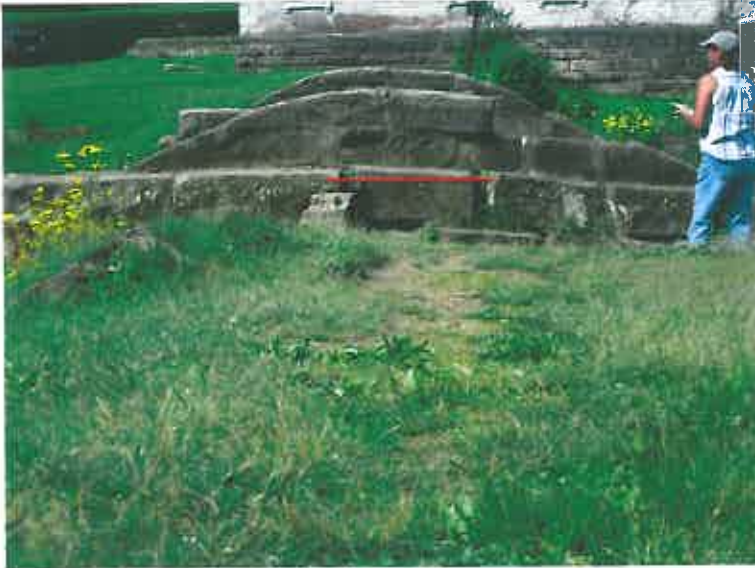
Photograph No. 10:

View of the crest on the left half of dam near the spillway. Again note how low the crest is. The crest should be where the red line on the photograph is.

4. The embankment crest alignment must be uniform. Investigate the vertical alignment of the crest near the principal spillway sidewalls and prepare plans and specifications for the correction of any problems. Regardless of the results of the investigation, the alignment of the crest must be monitored weekly. This item should be completed in coordination with Item 1 above.

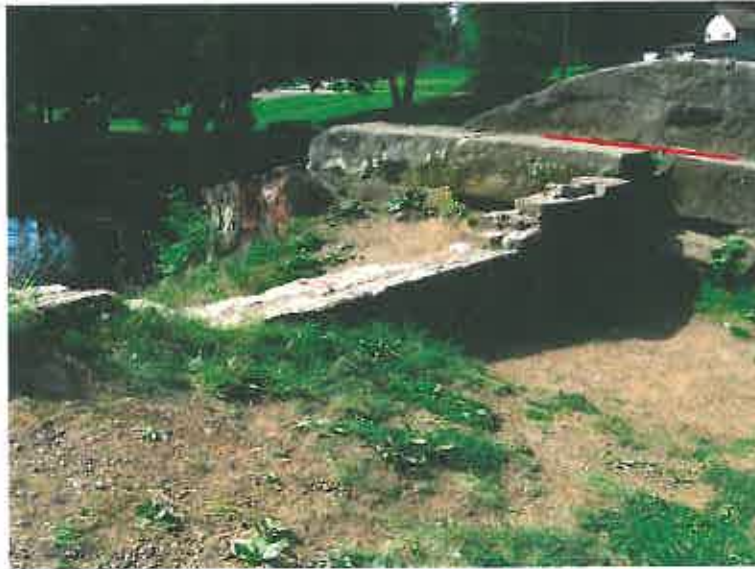
Photograph No. 11:

View of the cut-off wall in the crest on the left half of the dam. Again, note the loss of fill in the area. Red line indicates where the crest height should be.

5. The cut-off wall along the crest must be repaired. Prepare plans and specifications for the repair or replacement of the wall. This item should be completed in coordination with Item 3 above.

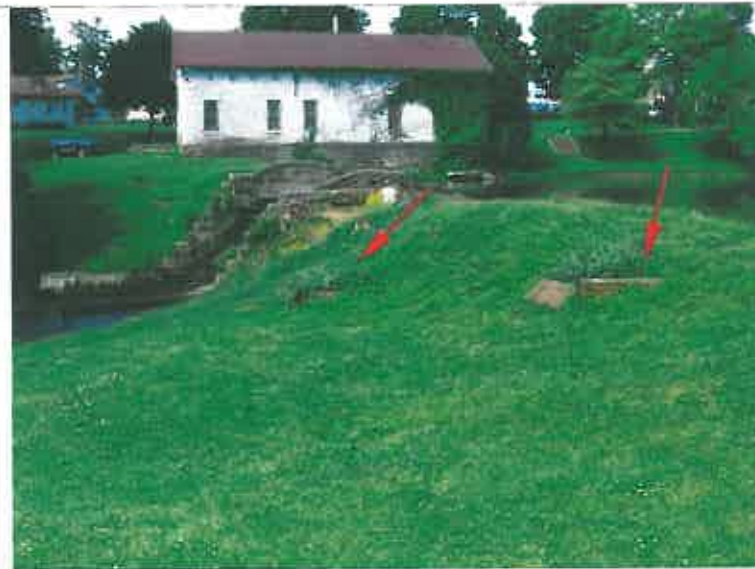
Photograph No. 12:

Downstream slope of left half of dam. Again note the flower planters buried in the slope.

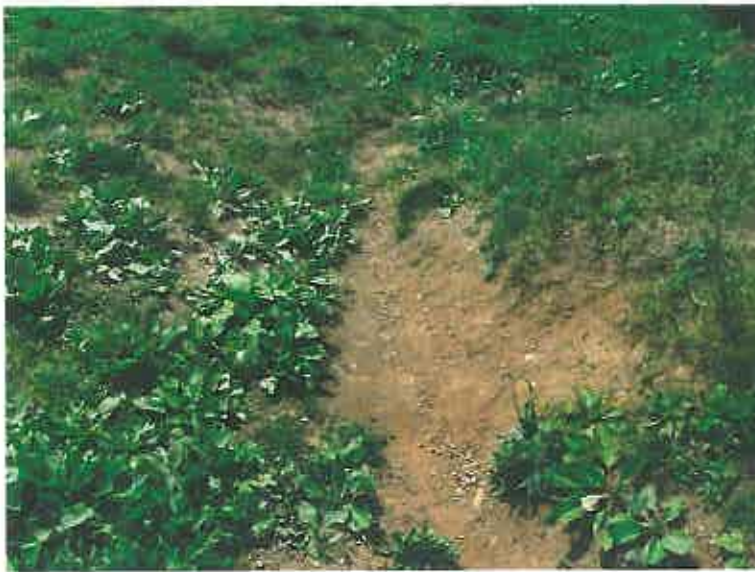
Photograph No. 13:

Erosion on the downstream slope near the spillway.

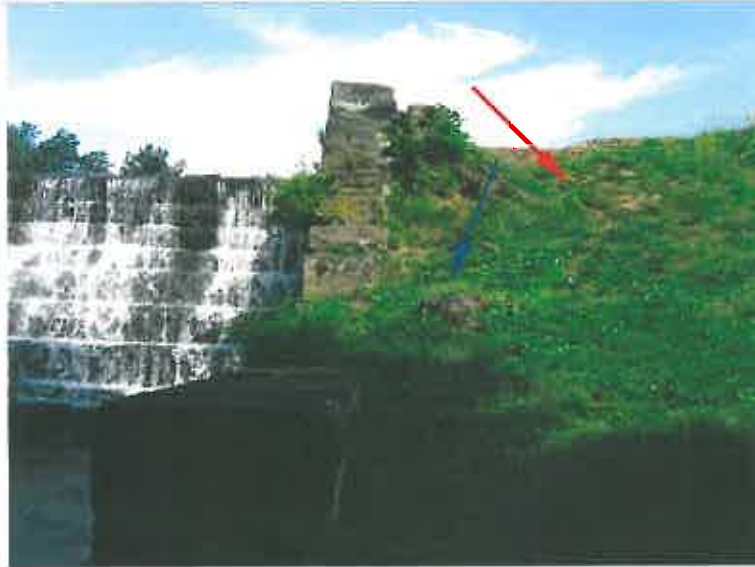
Photograph No. 14:

View of the left downstream slope. The red arrow points to erosion and the blue arrow points to a tree stump.

4. Repair the rodent burrows on the upstream slope. See the "Rodent Control" fact sheet included in this section for additional information.
5. Remove or grind down all the tree stumps on the embankment. Seed the all bare and sparse areas on the embankment to establish a proper grass cover. See the "Trees and Brush" and "Ground Cover" fact sheets included in this section for additional information.

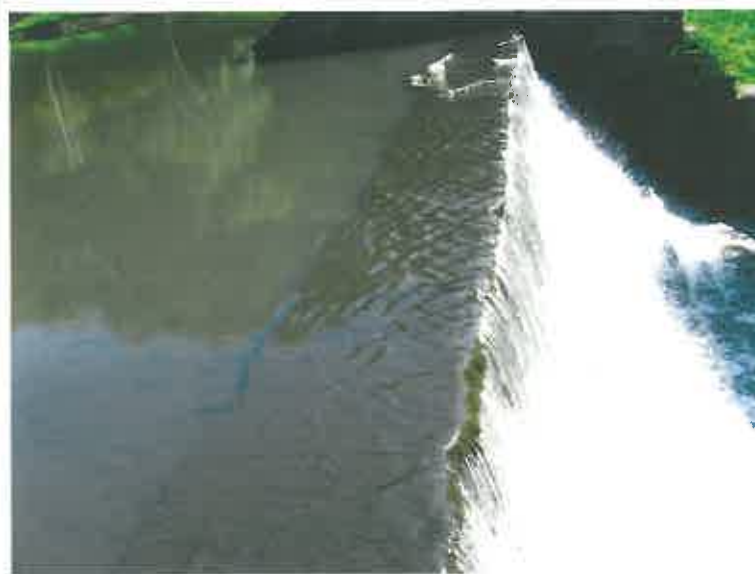
Photograph No. 15:

Principal spillway inlet.

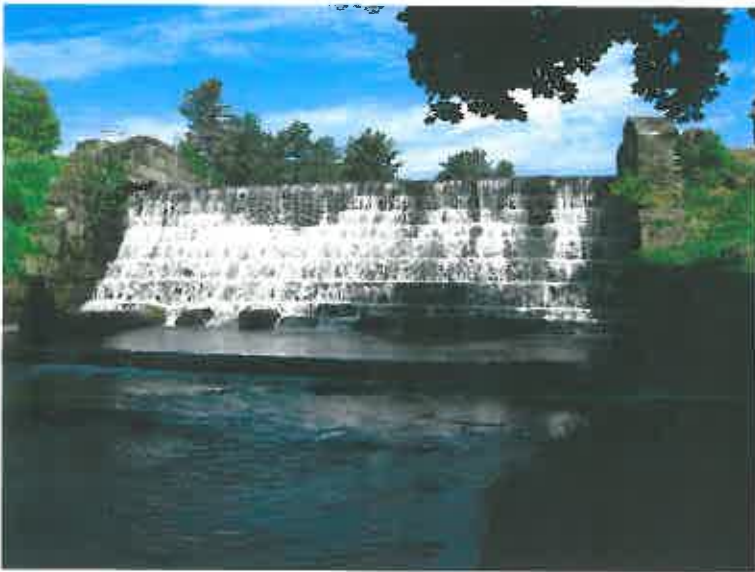
Photograph No. 16:

Principal spillway outlet.

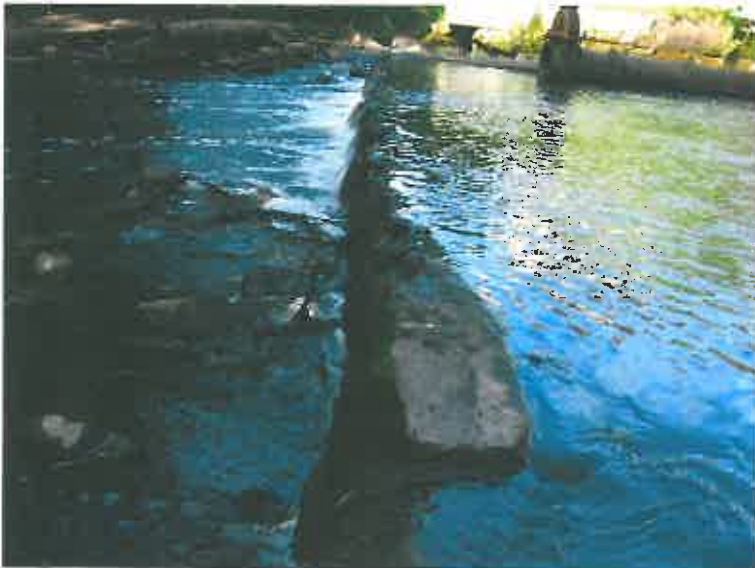
Photograph No. 17:

End sill of the principal spillway stilling basin. Not how weathered and worn the stone appears.

2. The spillway system must perform properly without endangering the safety of the dam. Investigate the deterioration, deformation, structural integrity, and undermining of the entire spillway system, and prepare plans and specifications for the repair or replacement of the entire spillway system. Regardless of the results of the investigation, the condition of the entire spillway system must be monitored weekly. This item should be completed in coordination with Item 1 above.

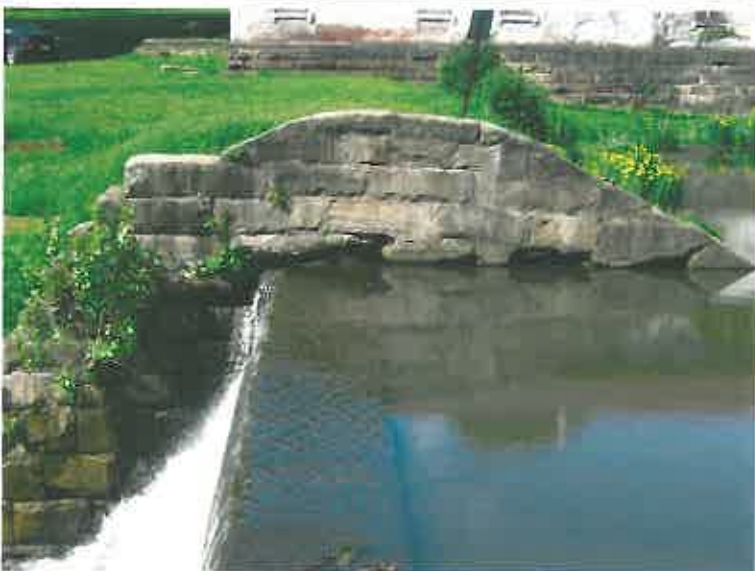
Photograph No. 18:

Right side wall of principal spillway. Note the undermining of the wall and the vegetation growing the cracks of the masonry.
