# Dam Classification Checklist

Name of Dam: Sippo Creek Reservoir Dam File Number: 0614-012  
 County: Stark Date: May 25, 2010 Engineer: TMG

Name of Dam: Sippo Creek Reservoir Dam

Date of Inspection: MAY 25, 2010

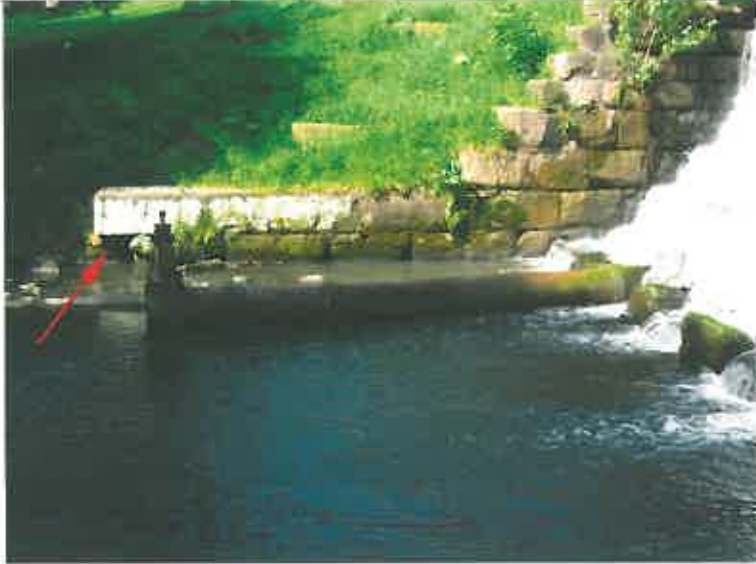
**Photograph No. 19:**

**View of the lower portion of the right spillway sidewall. The arrow indicates where the water has eroded around the wall.**

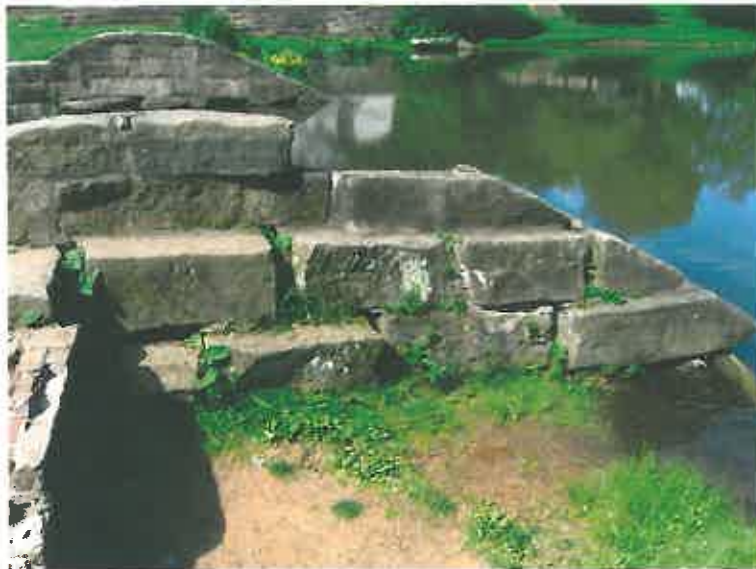
**Photograph No. 20:**

**View of the left spillway sidewall. Note the missing and displaced stones. Also note the undermining of the inlet wall.**

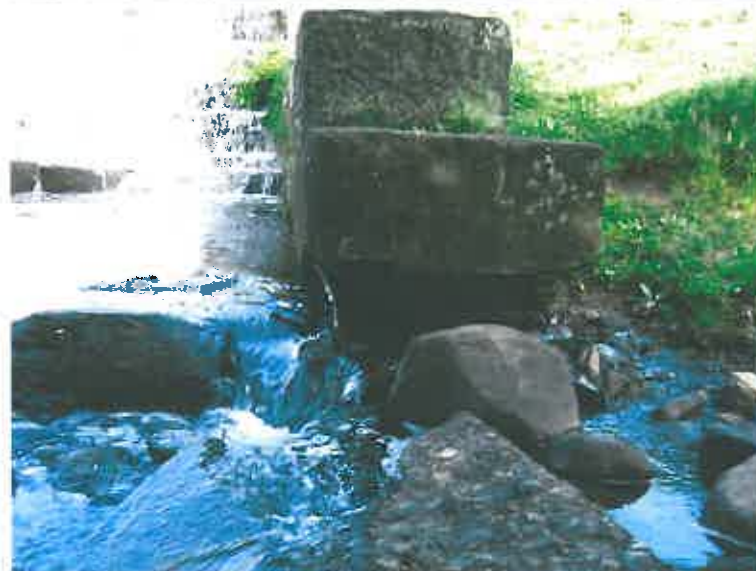
**Photograph No. 21:**

**Water had also undermined the end of the left spillway side wall.**

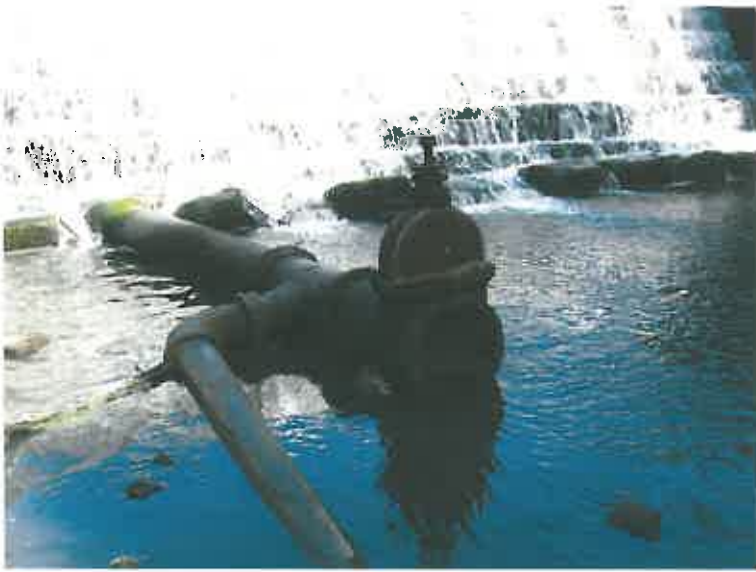
**Photograph No. 22:**

**Lake drain valve. Unsure if it is operable.**

All operable? (yes, no) UNKNOWN IF LAKE DRAIN IS OPERABLE.

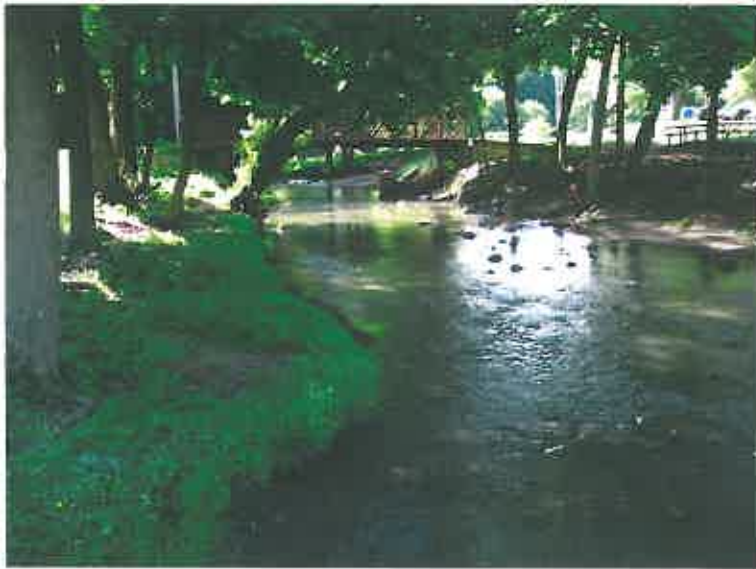
**Photograph No. 23:**

**Outlet channel.**
