Name: SIPPO CREEK RESERVOIR DAM

File No: 0614-012

SIPPO CREEK RESERVOIR DAM
June 2010 versus December 2016
FILE NUMBER: 0614-012

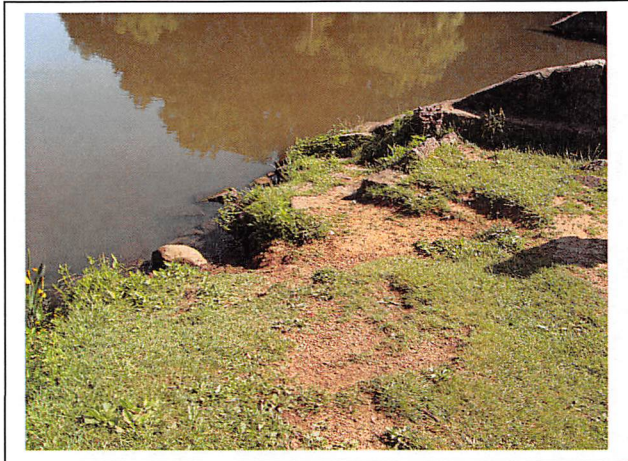
View of the upstream slope that abuts the right principal spillway sidewall in 2010.

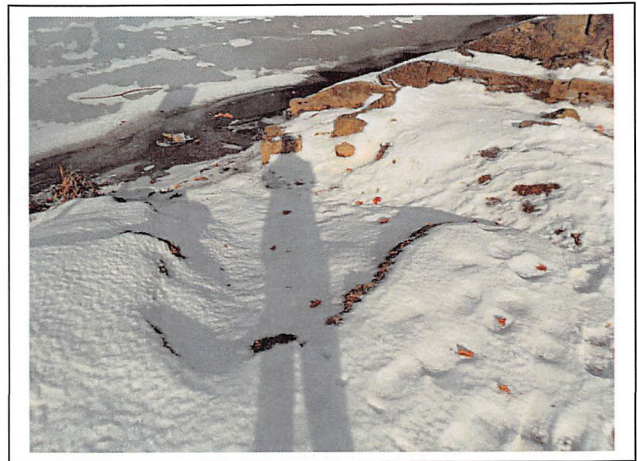
View of the upstream slope that abuts the right principal spillway sidewall in 2016. Though difficult to see because of the snow cover, erosion of the slope has increased.

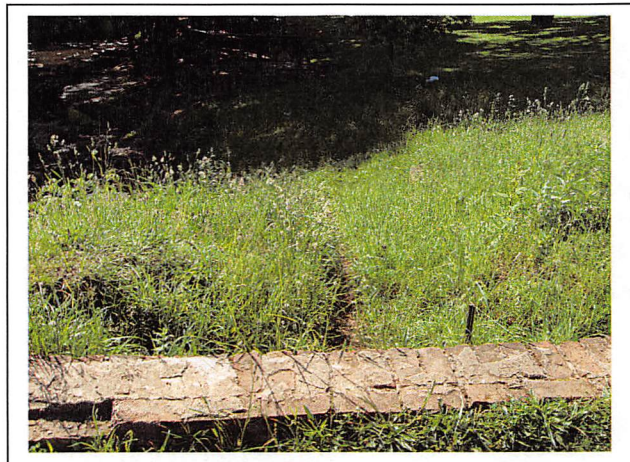
View of the brick cutoff wall on the right side of the spillway in 2010. Note that the wall is intact.
(View from upstream to downstream)

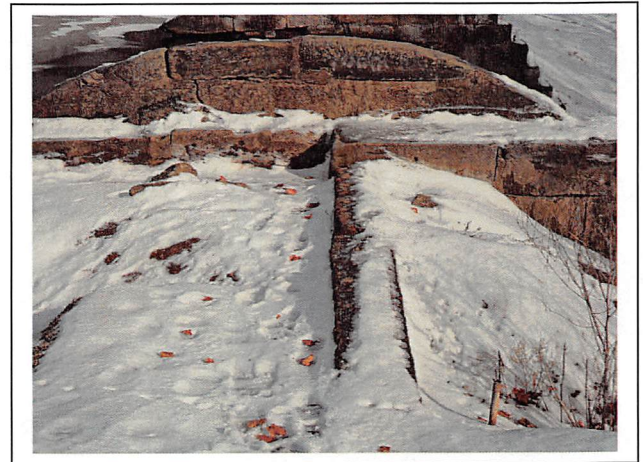
View of the brick cutoff wall on the right side of the spillway in 2016. Note that the wall has remained intact.
(View from right to left)

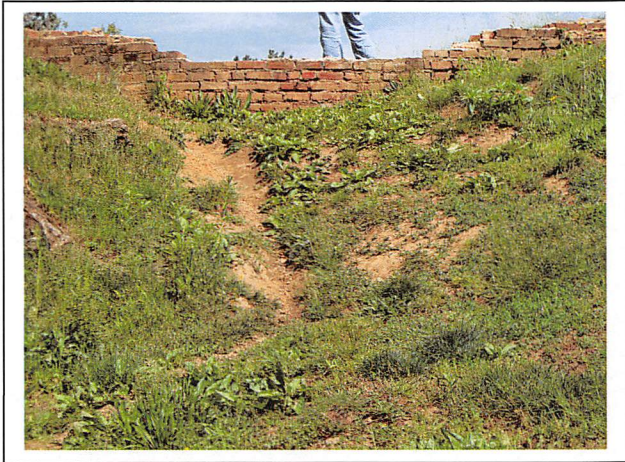
View of the brick cutoff wall on the left side of the spillway in 2010. Note that the bricks are becoming displaced.

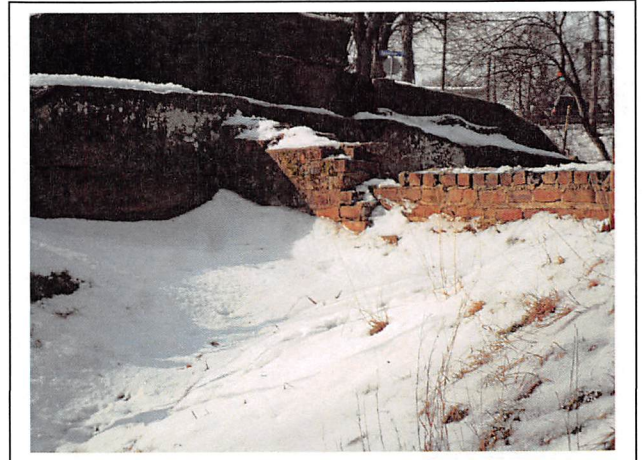
View of the brick cutoff wall on the left side of the spillway in 2016. Note that another layer of bricks has been displaced.

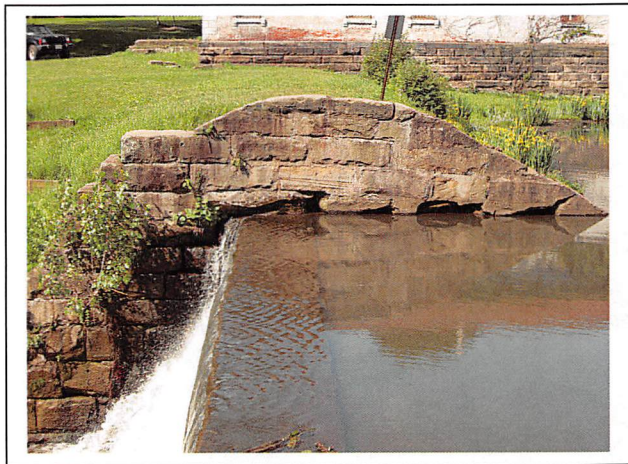
View of the right principal spillway side wall in June 2010. This wall has remained for the most part unchanged.

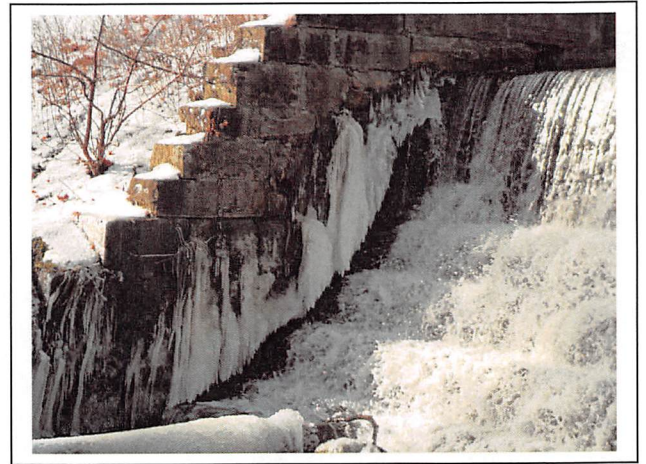
View of the right principal spillway side wall in 2016. The icicles indicate that water is flowing between the stones.

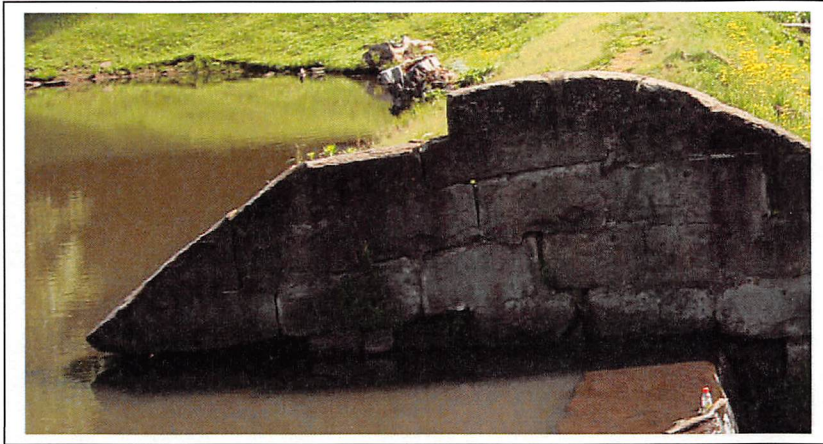
View of left principal spillway side wall in June 2010.

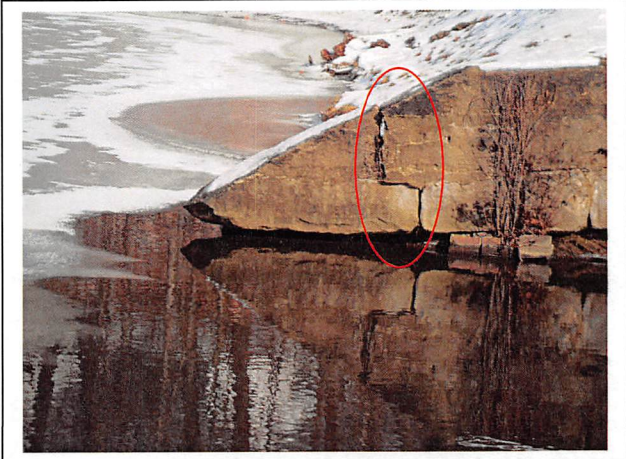
View of the upstream end of the left principal spillway wall in 2016. Note that the stones have shifted and now daylight can be seen between the stones.

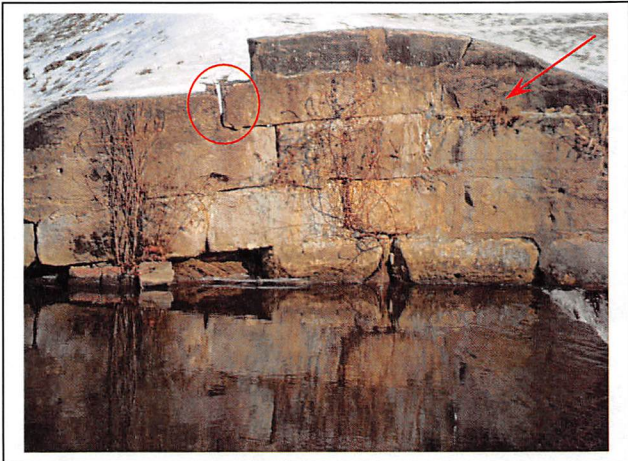
View of the left principal spillway wall in 2016. Note again that the stones have shifted and now daylight can be seen between the stones. Also note that vegetation is growing between more of the joints, indicating the joints have separated.

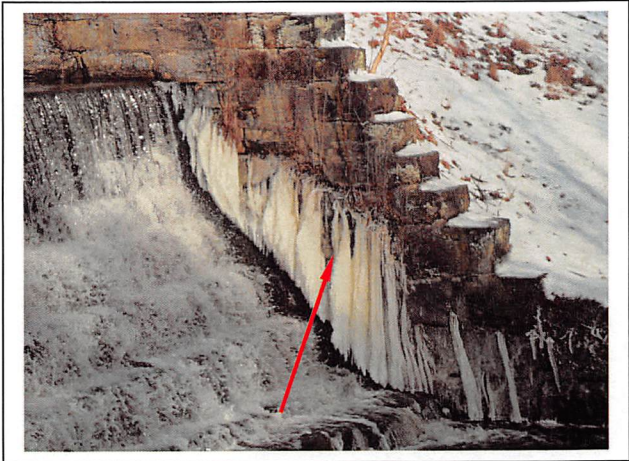
View of the left principal spillway wall in 2016. The icicles indicate water is flowing through the joints of the wall.
