| <b>Street</b> | East Bank Levee/Near control Weir | <b>City</b> | Massillon |

| <b>Sewer Use</b> | Stormwater Pipe | <b>Direction of Survey</b> | Downstream |

**Pacp Quick Overall Rating:** 2200

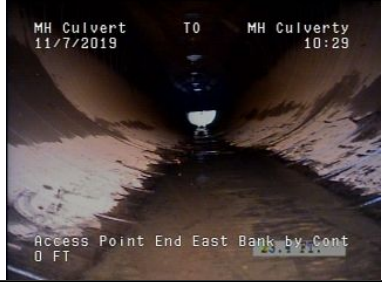
| Distance | Fault Observation | Picture |
|---|---|---|
| 0.0 | Access Point End of Pipe<br>Remarks: East Bank by Control Weir Inlet | |

(0.0) AEP - Access Point End of Pipe Remark:  
East Bank by Control Weir Inlet

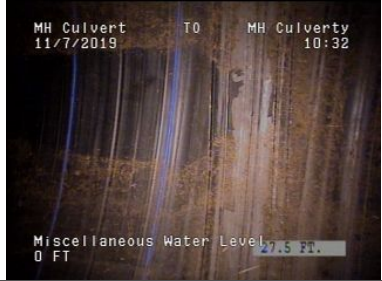
| Distance | Fault Observation | Picture |
|---|---|---|
| 0.0 | Miscellaneous Water Level | |

(0.0) MWL - Miscellaneous Water Level

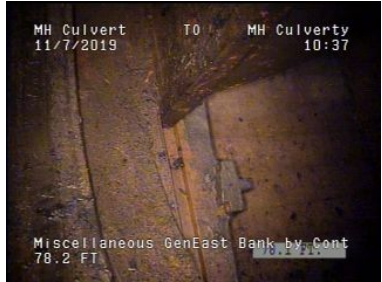
| Distance | Fault Observation | Picture |
|---|---|---|
| 78.2 | Miscellaneous General Observation<br>Remarks: East Bank by Control Weir Gate House | |

(78.2) MGO - Miscellaneous General Observation  
Remark: East Bank by Control Weir Gate House

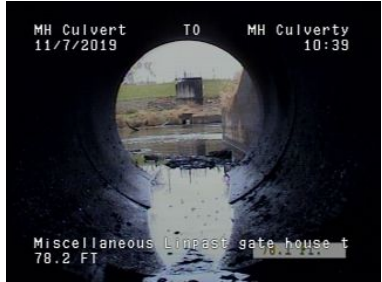
| Distance | Fault Observation | Picture |
|---|---|---|
| 78.2 | Miscellaneous Lining Change<br>Remarks: past gate house there is no liner its just RCP | |

(78.2) MLC - Miscellaneous Lining Change  
Remark: past gate house there is no liner its just  
RCP

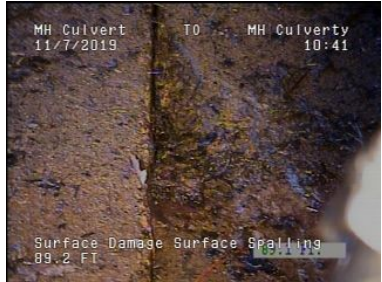
| Distance | Fault Observation | Picture |
|---|---|---|
| 89.2 | Surface Damage Surface Spalling<br>Position: 5 Joint | |

(89.2) SSS - Surface Damage Surface Spalling -  
Position: 5

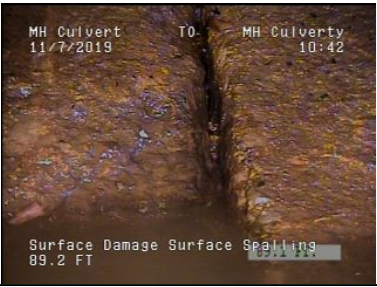
| Distance | Fault Observation | Picture |
|---|---|---|
| 89.2 | Surface Damage Surface Spalling<br>Position: 7<br>Joint | <p>MH Culvert 11/7/2019 TO MH Culvert 10:42</p> <p>Surface Damage Surface Spalling 89.2 FT</p> |

(89.2) SSS - Surface Damage Surface Spalling -  
Position: 7

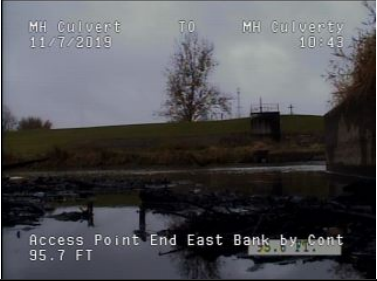
| Distance | Fault Observation | Picture |
|---|---|---|
| 95.7 | Access Point End of Pipe<br>Remarks: East Bank by Control Weir<br>Outlet | <p>MH Culvert 11/7/2019 TO MH Culvert 10:43</p> <p>Access Point End East Bank by Cont 95.7 FT</p> |

(95.7) AEP - Access Point End of Pipe Remark:  
East Bank by Control Weir Outlet
