| Pipe Segment Reference | Jamestown Pump Station | Date | 11/5/2019 10:47 |

| Sewer Use | Stormwater Pipe | Direction of Survey | Upstream |

| Shape | Circular | Material | Reinforced Concrete Pipe |
| Lining Method | Cured-In-Place Pipe | Pipe Joint Length | |

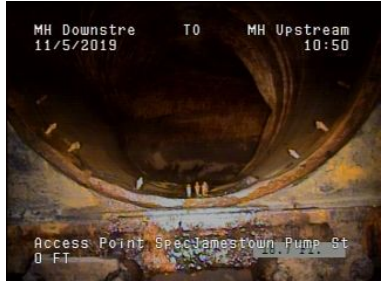
| Distance | Fault Observation | Picture |
|---|---|---|
| 0.0 | Access Point Special Chamber<br>Remarks: Jamestown Pump Station | MH Downstre 11/5/2019 TO MH Upstream 10:50<br>Access Point SpecJamestown Pump St 0 FT |

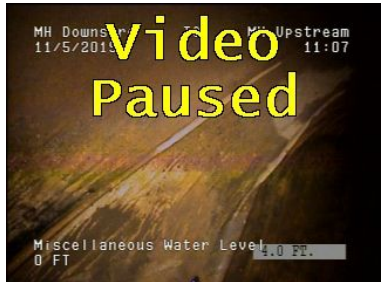
| Distance | Fault Observation | Picture |
|---|---|---|
| 0.0 | Miscellaneous Water Level | MH Downstre 11/5/2019 TO MH Upstream 11:07<br>Video Paused<br>Miscellaneous Water Level 4.0 FT. 0 FT |

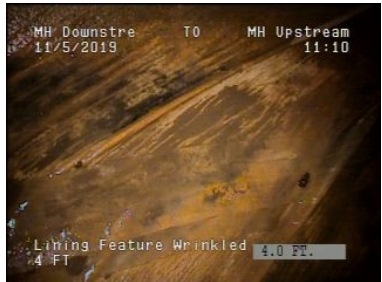
| Distance | Fault Observation | Picture |
|---|---|---|
| 4.0 | Lining Feature Wrinkled<br>Position: 12 To 12 | MH Downstre 11/5/2019 TO MH Upstream 11:10<br>Lining Feature Wrinkled 4.0 FT. 4 FT |

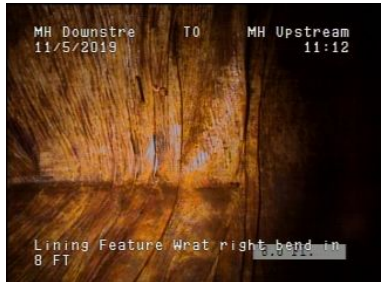
| Distance | Fault Observation | Picture |
|---|---|---|
| 8.0 | Lining Feature Wrinkled<br>Position: 12 To 7<br>Remarks: at right bend in pipe | MH Downstre 11/5/2019 TO MH Upstream 11:12<br>Lining Feature Wrat right bend in 8 FT |

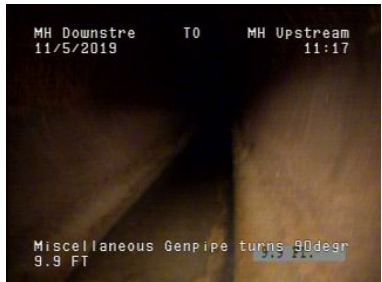
| Distance | Fault Observation | Picture |
|---|---|---|
| 9.9 | Miscellaneous General Observation<br>Remarks: pipe turns 90degrees to the right | MH Downstre 11/5/2019 TO MH Upstream 11:17<br>Miscellaneous Genpipe turns 90degr 9.9 FT |

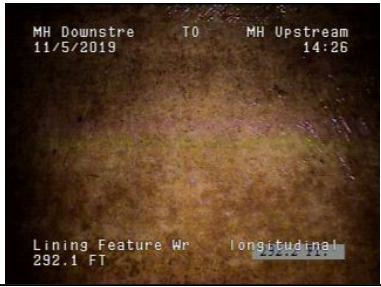
| Distance | Fault Observation | Picture |
|---|---|---|
| 292.1 | Lining Feature Wrinkled<br>Position: 7<br>Cont Defect: F02<br>Remarks: longitudinal | |

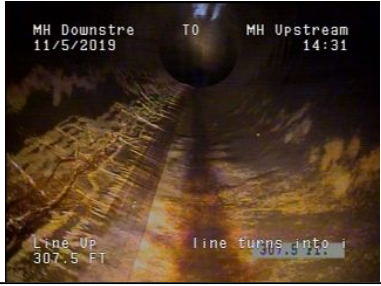
| Distance | Fault Observation | Picture |
|---|---|---|
| 307.5 | Line Up<br>Remarks: line turns into incline<br>Maint Weight: 4 | |

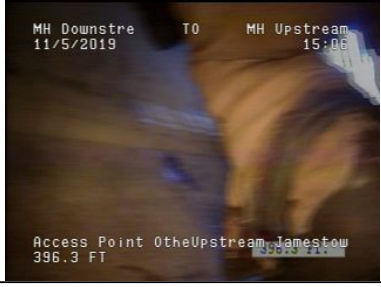
| Distance | Fault Observation | Picture |
|---|---|---|
| 396.3 | Access Point Other<br>Remarks: Upstream Jamestown End<br>Inspection | |

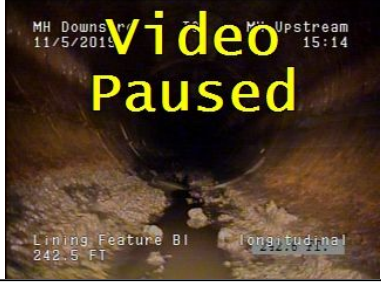
| Distance | Fault Observation | Picture |
|---|---|---|
| 396.3 | Lining Feature Blistered<br>Position: 6 To 7<br>Cont Defect: F04<br>Remarks: longitudinal | |
