## Project Information

| Owner | | Customer | City of Massillon |
| Street | Jamestown | | |

**Upstream MH:** Pump Ciphon #30

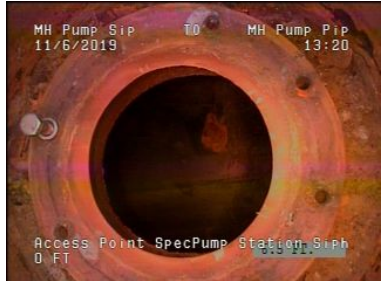
| Distance | Fault Observation | Picture |
|---|---|---|
| 0.0 | Access Point Special Chamber<br>Remarks: Pump Station Siphon #2 | A photograph showing the interior of a circular access point. The walls are made of reddish-brown material, possibly brick or concrete. A large, dark, circular opening is visible in the center. Text overlay: MH Pump Sip 11/6/2019 TO MH Pump Pip 13:20 Access Point Spec Pump Station Siph 0 FT |

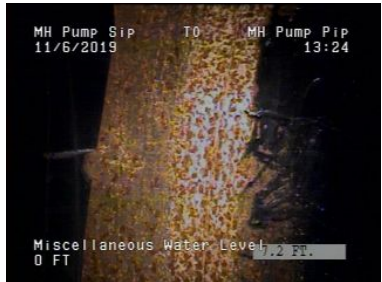
| Distance | Fault Observation | Picture |
|---|---|---|
| 0.0 | Miscellaneous Water Level | A photograph showing a close-up of a pipe joint. The pipe is dark and appears to be made of metal. A small, dark, rectangular object is visible near the joint. Text overlay: MH Pump Sip 11/6/2019 TO MH Pump Pip 13:24 Miscellaneous Water Level 0 FT |

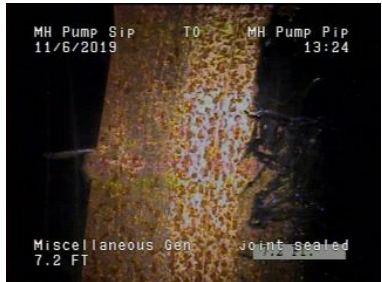
| Distance | Fault Observation | Picture |
|---|---|---|
| 7.2 | Miscellaneous General Observation<br>Remarks: joint sealed | A photograph showing a close-up of a pipe joint. The pipe is dark and appears to be made of metal. A small, dark, rectangular object is visible near the joint. Text overlay: MH Pump Sip 11/6/2019 TO MH Pump Pip 13:24 Miscellaneous Gen joint sealed 7.2 FT |

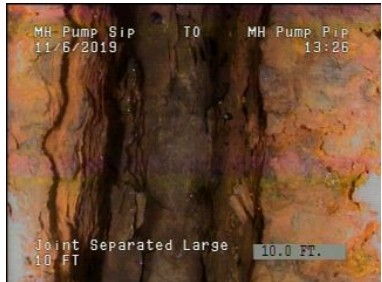
| Distance | Fault Observation | Picture |
|---|---|---|
| 10.0 | Joint Separated Large | A photograph showing a close-up of a pipe joint. The pipe is dark and appears to be made of metal. A large, dark, rectangular object is visible near the joint. Text overlay: MH Pump Sip 11/6/2019 TO MH Pump Pip 13:26 Joint Separated Large 10.0 FT |

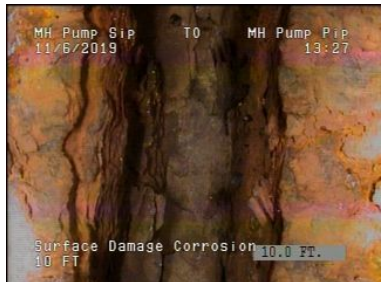
| Distance | Fault Observation | Picture |
|---|---|---|
| 10.0 | Surface Damage Corrosion<br>Position: 5 To 7<br>Joint | A photograph showing a close-up of a pipe joint. The pipe is dark and appears to be made of metal. A large, dark, rectangular object is visible near the joint. Text overlay: MH Pump Sip 11/6/2019 TO MH Pump Pip 13:27 Surface Damage Corrosion 10.0 FT |
