| <b>Owner</b> | | <b>Customer</b> | City of Massillon |
| <b>Street</b> | Jamestown | <b>City</b> | Massillon |

| <b>Sewer Use</b> | Stormwater Pipe | <b>Direction of Survey</b> | Downstream |

| <b>Shape</b> | Circular | <b>Material</b> | Reinforced Concrete Pipe |

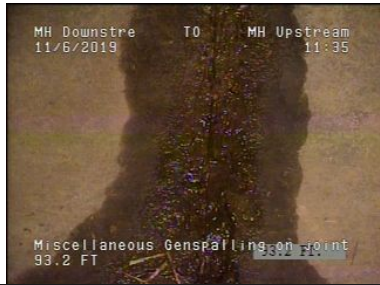
| Distance | Fault Observation | Picture |
|---|---|---|
| 93.2 | Miscellaneous General Photo<br>Position: 5 To 8<br>Remarks: spalling on joint | A photograph showing a vertical joint in a concrete structure. The joint surface is rough and shows signs of spalling. Text overlay: MH Downstre 11/6/2019 TO MH Upstream 11:35. Bottom text: Miscellaneous General Photo 93.2 FT. |

(93.2) MGP - Miscellaneous General Photo -  
Position: 5 To 8 Remark: spalling on joint

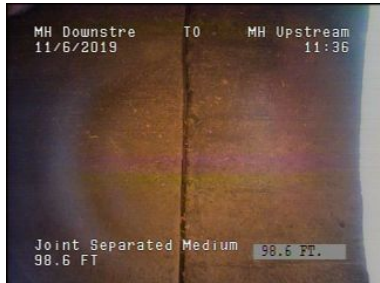
| Distance | Fault Observation | Picture |
|---|---|---|
| 98.6 | Joint Separated Medium | A photograph showing a vertical joint in a concrete structure. The joint is separated, and the surface is medium-colored. Text overlay: MH Downstre 11/6/2019 TO MH Upstream 11:36. Bottom text: Joint Separated Medium 98.6 FT. |

(98.6) JSM - Joint Separated Medium

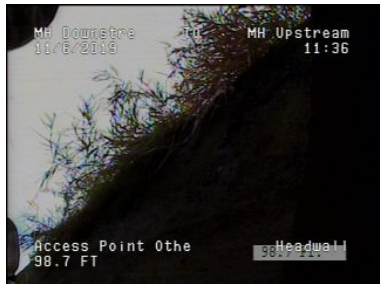
| Distance | Fault Observation | Picture |
|---|---|---|
| 98.7 | Access Point Other<br>Remarks: Headwall Downstream | A photograph showing an access point in a concrete structure. The headwall is visible, and the surface is dark. Text overlay: MH Downstre 11/6/2019 TO MH Upstream 11:36. Bottom text: Access Point Other 98.7 FT. |

(98.7) AZ - Access Point Other Remark: Headwall  
Downstream
