# Project:

**Street:** Jamestown

**Upstream MH:** Pump Siphon #29

**Downstream MH:** Pump Pipe Inlet #29

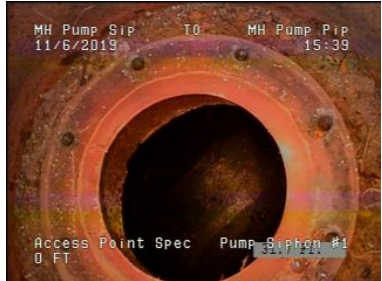
| Distance | Fault Observation | Picture |
|---|---|---|
| 0.0 | Special Chamber<br>Remarks: Pump Siphon #1 | |

(0.0) AOC - Special Chamber Remark: Pump  
Siphon #1

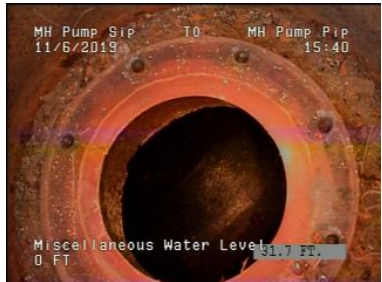
| Distance | Fault Observation | Picture |
|---|---|---|
| 0.0 | Water Level | |

(0.0) MWL - Water Level

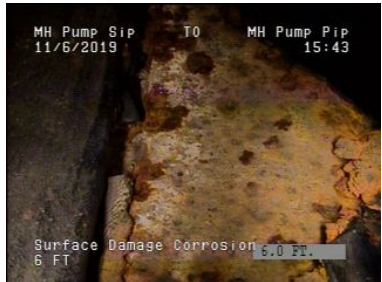
| Distance | Fault Observation | Picture |
|---|---|---|
| 6.0 | Surface Corrosion Metal Pipe<br>Position: 5 To 7<br>Joint | |

(6.0) SCP - Surface Corrosion Metal Pipe -  
Position: 5 To 7

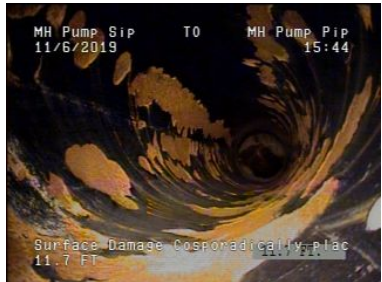
| Distance | Fault Observation | Picture |
|---|---|---|
| 11.7 | Surface Corrosion Metal Pipe<br>Position: 1 To 12<br>Cont Defect: S01<br>Remarks: sporadically placed | |

(11.7) SCP - Surface Corrosion Metal Pipe -  
Position: 1 To 12 - Cont Def: S01 Remark:  
sporadically placed

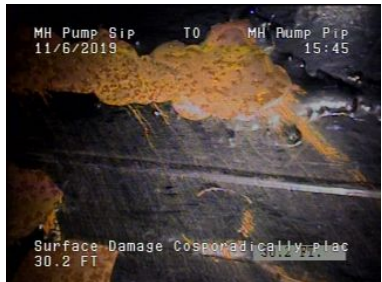
| Distance | Fault Observation | Picture |
|---|---|---|
| 30.2 | Surface Corrosion Metal Pipe<br>Position: 1 To 12<br>Cont Defect: F01<br>Remarks: sporadically placed | |

(30.2) SCP - Surface Corrosion Metal Pipe -  
Position: 1 To 12 - Cont Def: F01 Remark:  
sporadically placed

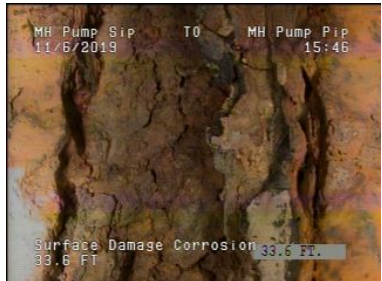
| Distance | Fault Observation | Picture |
|---|---|---|
| 33.5 | Surface Corrosion Metal Pipe<br>Position: 4 To 8<br>Joint | |

(33.5) SCP - Surface Corrosion Metal Pipe -  
Position: 4 To 8

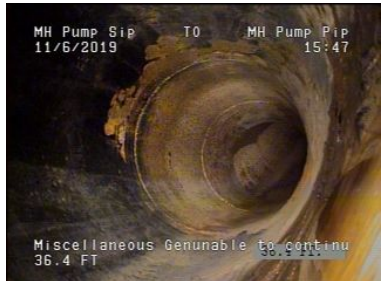
| Distance | Fault Observation | Picture |
|---|---|---|
| 36.4 | General Observation<br>Remarks: unable to continue due to tractor getting stuck at grade change, city of massillon is aware of the lack of access at inlet end of pipe to assist tractor | |

(36.4) MGO - General Observation Remark: unable to continue due to tractor getting stuck at grade change, city of massillon is aware of the lack of access at inlet end of pipe to assist tractor

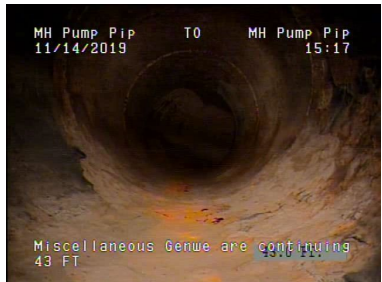
| Distance | Fault Observation | Picture |
|---|---|---|
| 43.0 | Miscellaneous General Observation<br>Remarks: we are continuing video inspection from previous end location after switching to larger tires | |

(43.0) MGO - Miscellaneous General Observation  
Remark: we are continuing video inpection from previous end location after switching to larger tires

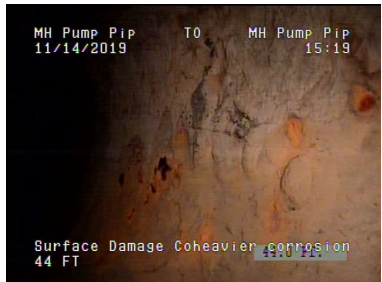
| Distance | Fault Observation | Picture |
|---|---|---|
| 44.0 | Surface Damage Corrosion<br>Position: 4 To 8<br>Cont Defect: S02<br>Remarks: heavy corrosion damage | |

(44.0) SCP - Surface Damage Corrosion -  
Position: 4 To 8 - Cont Def: S02 Remark: heavy  
corrosion damage

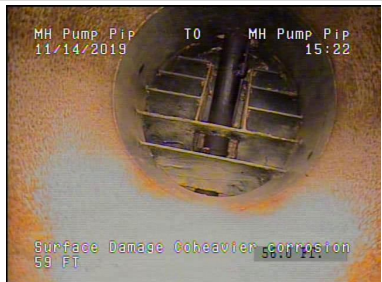
| Distance | Fault Observation | Picture |
|---|---|---|
| 59.0 | Surface Damage Corrosion<br>Position: 4 To 8<br>Cont Defect: F02<br>Remarks: heavy corrosion damage | |

(59.0) SCP - Surface Damage Corrosion -  
Position: 4 To 8 - Cont Def: F02 Remark: heavy  
corrosion damage

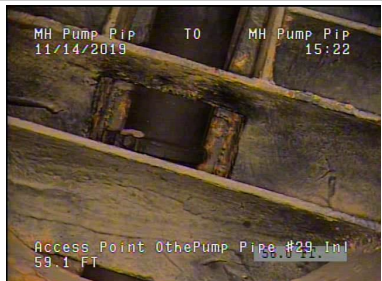
| Distance | Fault Observation | Picture |
|---|---|---|
| 59.1 | Access Point Other<br>Remarks: pump inlet gate | |

(59.1) AZ - Access Point Other Remark: pump inlet gate
