# Project:

**Date:** 11/6/2019 12:21:00 PM

**Street:** Jamestown

**Upstream MH:** Pump Ciphon #29

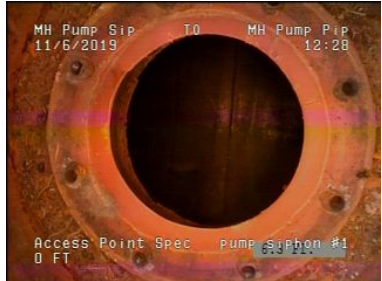
| Distance | Fault Observation | Picture |
|---|---|---|
| 0.0 | Access Point Special Chamber<br>Remarks: pump siphon #1 | A photograph of a circular access point with a red frame. The text overlay includes 'MH Pump Sip 11/6/2019', 'TO MH Pump Pip 12:28', and 'Access Point Spec Pump Siphon #1 0 FT'. |

(0.0) AOC - Access Point Special Chamber  
Remark: pump siphon #1

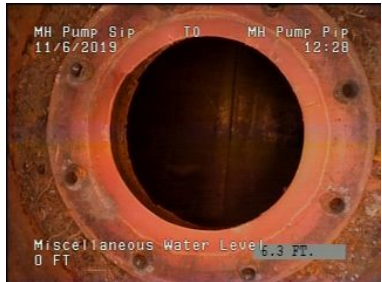
| Distance | Fault Observation | Picture |
|---|---|---|
| 0.0 | Miscellaneous Water Level | A photograph of a circular access point with a red frame. The text overlay includes 'MH Pump Sip 11/6/2019', 'TO MH Pump Pip 12:28', and 'Miscellaneous Water Level 6.3 FT. 0 FT'. |

(0.0) MWL - Miscellaneous Water Level

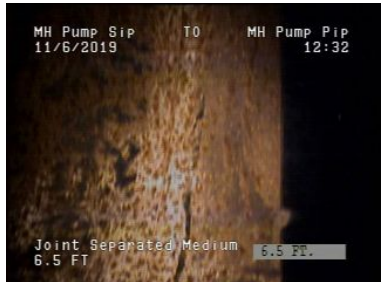
| Distance | Fault Observation | Picture |
|---|---|---|
| 6.5 | Joint Separated Medium | A photograph of a pipe joint with a visible separation. The text overlay includes 'MH Pump Sip 11/6/2019', 'TO MH Pump Pip 12:32', and 'Joint Separated Medium 6.5 FT. 6.5 FT'. |

(6.5) JSM - Joint Separated Medium

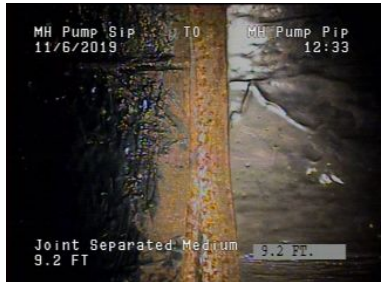
| Distance | Fault Observation | Picture |
|---|---|---|
| 9.2 | Joint Separated Medium | A photograph of a pipe joint with a visible separation. The text overlay includes 'MH Pump Sip 11/6/2019', 'TO MH Pump Pip 12:33', and 'Joint Separated Medium 9.2 FT. 9.2 FT'. |

(9.2) JSM - Joint Separated Medium

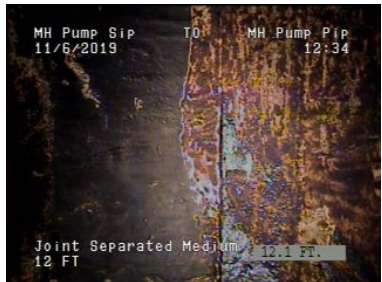
| Distance | Fault Observation | Picture |
|---|---|---|
| 12.0 | Joint Separated Medium | A photograph of a pipe joint with a visible separation. The text overlay includes 'MH Pump Sip 11/6/2019', 'TO MH Pump Pip 12:34', and 'Joint Separated Medium 12.1 FT. 12 FT'. |

(12.0) JSM - Joint Separated Medium

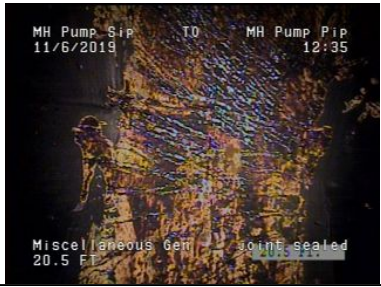
| Distance | Fault Observation | Picture |
|---|---|---|
| 20.5 | Miscellaneous General Observation<br>Remarks: joint sealed | |

(20.5) MGO - Miscellaneous General Observation  
Remark: joint sealed

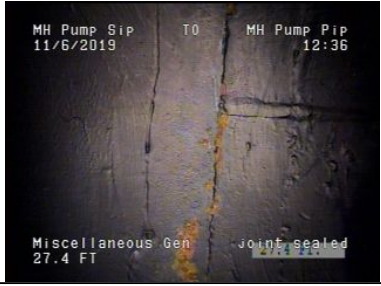
| Distance | Fault Observation | Picture |
|---|---|---|
| 27.4 | Miscellaneous General Observation<br>Remarks: joint sealed | |

(27.4) MGO - Miscellaneous General Observation  
Remark: joint sealed

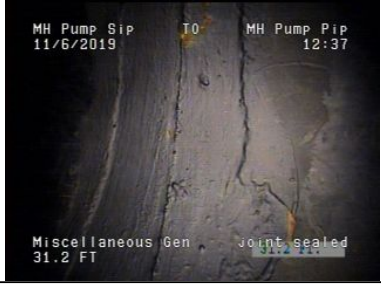
| Distance | Fault Observation | Picture |
|---|---|---|
| 31.2 | Miscellaneous General Observation<br>Remarks: joint sealed | |

(31.2) MGO - Miscellaneous General Observation  
Remark: joint sealed

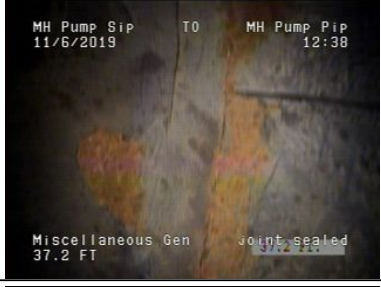
| Distance | Fault Observation | Picture |
|---|---|---|
| 37.2 | Miscellaneous General Observation<br>Remarks: joint sealed | |

(37.2) MGO - Miscellaneous General Observation  
Remark: joint sealed

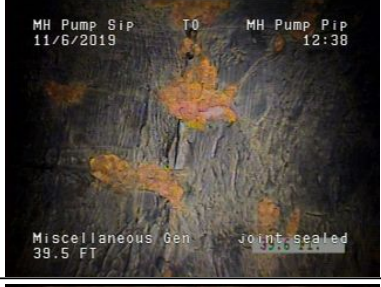
| Distance | Fault Observation | Picture |
|---|---|---|
| 39.5 | Miscellaneous General Observation<br>Remarks: joint sealed | |

(39.5) MGO - Miscellaneous General Observation  
Remark: joint sealed

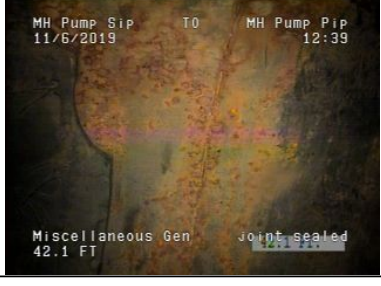
| Distance | Fault Observation | Picture |
|---|---|---|
| 42.1 | Miscellaneous General Observation<br>Remarks: joint sealed | |

(42.1) MGO - Miscellaneous General Observation  
Remark: joint sealed

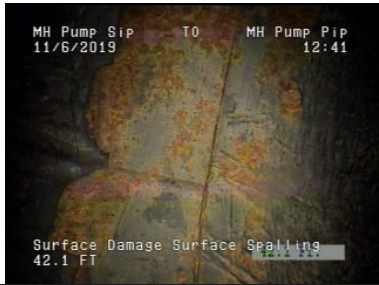
| Distance | Fault Observation | Picture |
|---|---|---|
| 42.1 | Surface Damage Surface Spalling<br>Position: 12 To 12 | |

(42.1) SSS - Surface Damage Surface Spalling -  
Position: 12 To 12

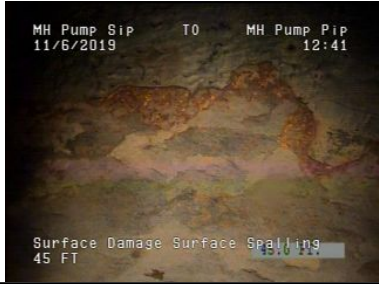
| Distance | Fault Observation | Picture |
|---|---|---|
| 45.0 | Surface Damage Surface Spalling<br>Position: 12 To 12 | |

(45.0) SSS - Surface Damage Surface Spalling -  
Position: 12 To 12

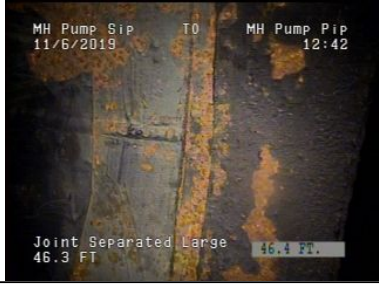
| Distance | Fault Observation | Picture |
|---|---|---|
| 46.3 | Joint Separated Large | |

(46.3) JSL - Joint Separated Large

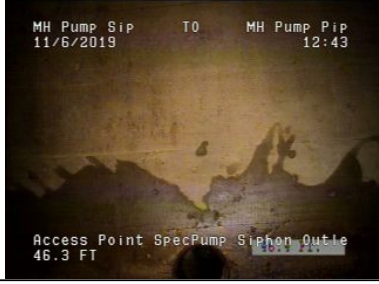
| Distance | Fault Observation | Picture |
|---|---|---|
| 46.3 | Access Point Special Chamber<br>Remarks: Pump Siphon Outlet #1 | |

(46.3) AOC - Access Point Special Chamber  
Remark: Pump Siphon Outlet #1
