| Surveyor Name | Matthew W. Adams | Certificate Number | 00000000 |
| Street | Jamestown | City | Massillon |

| Sewer Use | Stormwater Pipe | Direction of Survey | Upstream |

**Pacp Quick Overall Rating:** 3A00

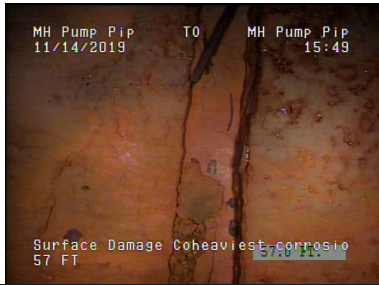
| Distance | Fault Observation | Picture |
|---|---|---|
| 57.0 | <b>Surface Damage Corrosion</b><br><b>Position: 12 To 12</b><br><b>Cont Defect: F02</b><br><b>Joint</b><br><b>Remarks: heaviest is at 5-8 O'clock positions</b> | |

(57.0) SCP - Surface Damage Corrosion -  
Position: 12 To 12 - Cont Def: F02 Remark:  
heaviest is at 5-8 O'clock positions

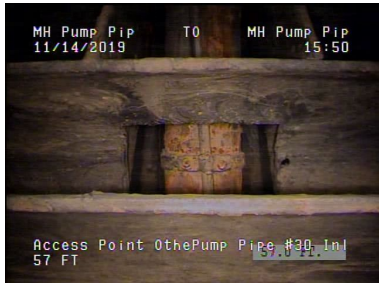
| Distance | Fault Observation | Picture |
|---|---|---|
| 57.0 | <b>Access Point Other</b><br><b>Remarks: Pump Pipe #30 Inlet Gate</b> | |
