# Project:

**Date:** 11/6/2019 2:30:00 PM

**Upstream MH:** Pump Siphon #31

**Downstream MH:** Pump Pipe Inlet #31

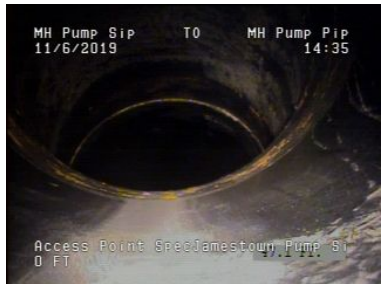
| Distance | Fault Observation | Picture |
|---|---|---|
| 0.0 | <b>Special Chamber</b><br><b>Remarks: Jamestown Pump Siphon #3</b> | |

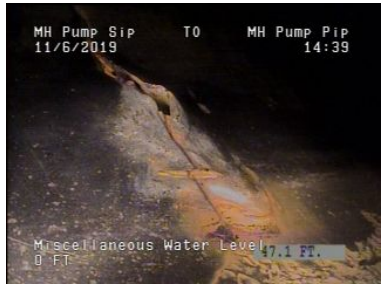
| Distance | Fault Observation | Picture |
|---|---|---|
| 0.0 | <b>Water Level</b> | |

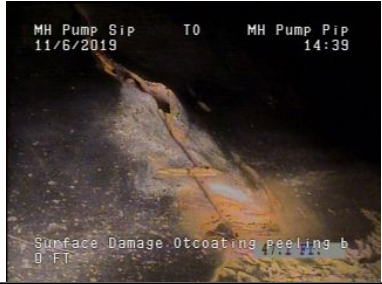
| Distance | Fault Observation | Picture |
|---|---|---|
| 0.0 | <b>Surface Other</b><br><b>Position: 12 To 12 Joint</b><br><b>Remarks: coating peeling back</b> | |

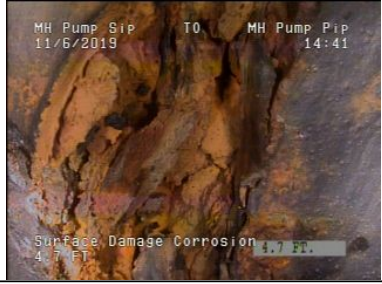
| Distance | Fault Observation | Picture |
|---|---|---|
| 4.7 | <b>Surface Corrosion Metal Pipe</b><br><b>Position: 5 To 7 Joint</b> | |

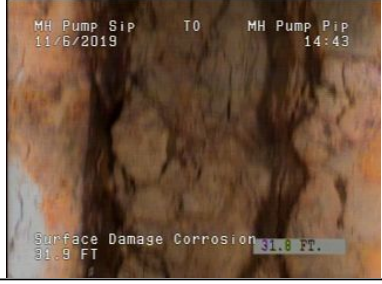
| Distance | Fault Observation | Picture |
|---|---|---|
| 31.9 | <b>Surface Corrosion Metal Pipe</b><br><b>Position: 4 To 8 Joint</b> | |

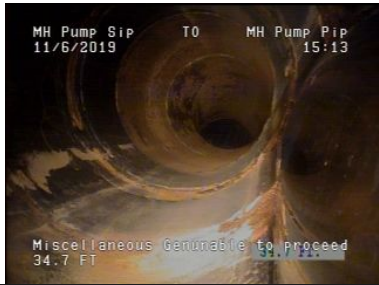
| Distance | Fault Observation | Picture |
|---|---|---|
| 34.7 | <b>General Observation</b><br><b>Remarks: unable to proceed past this point due to lack of access on inlet end of pipe, camera stuck at change of grade</b> | |

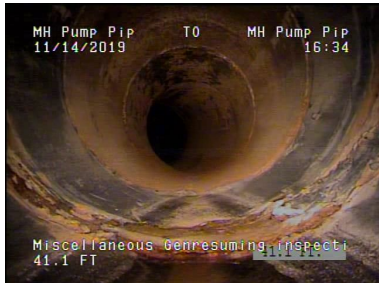
| Distance | Fault Observation | Picture |
|---|---|---|
| 41.1 | <b>Miscellaneous General Observation</b><br><b>Remarks: resuming inspection at previous stopping point</b> | |

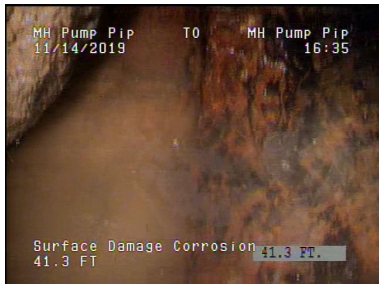
| Distance | Fault Observation | Picture |
|---|---|---|
| 41.3 | <b>Surface Damage Corrosion</b><br><b>Position: 12 To 12 Joint</b><br><b>Remarks: heaviest corrosion is from 4-8 O'clock</b> | |

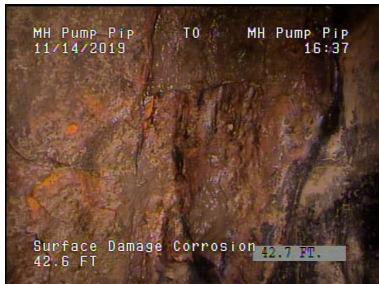
| Distance | Fault Observation | Picture |
|---|---|---|
| 42.6 | <b>Surface Damage Corrosion</b><br><b>Position: 5 To 7</b><br><b>Remarks: heavy corrosion</b> | |

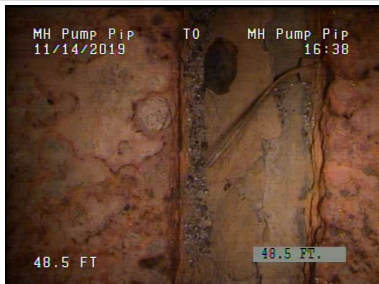
| Distance | Fault Observation | Picture |
|---|---|---|
| 48.5 | <b>Joint Separated Large</b> | |

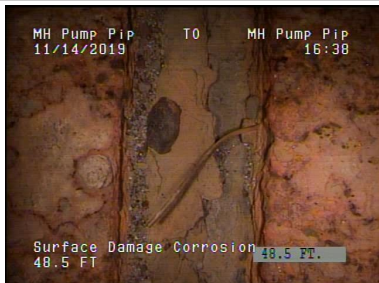
| Distance | Fault Observation | Picture |
|---|---|---|
| 48.5 | <b>Surface Damage Corrosion</b><br><b>Position: 12 To 12 Joint</b> | |

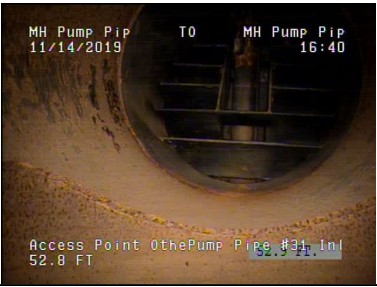
| Distance | Fault Observation | Picture |
|---|---|---|
| 52.9 | Access Point Other<br>Remarks: Pump Pipe #31 Inlet | <p>MH Pump Pip 11/14/2019 TO MH Pump Pip 16:40</p> <p>Access Point Other Pump Pipe #31 Inlet 52.8 FT</p> |
