# Project:

**Pacp Quick Overall Rating:** 4134

**Upstream MH:** Pump Ciphon #31

**Downstream MH:** Pump Pipe Outlet #31

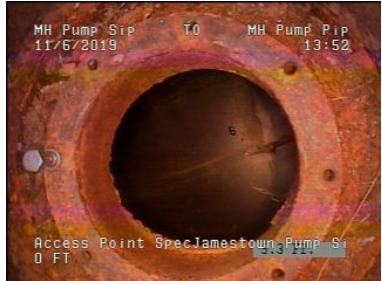
| Distance | Fault Observation | Picture |
|---|---|---|
| 0.0 | Access Point Special Chamber<br>Remarks: Jamestown Pump Siphon #3 | A photograph showing the interior of a circular access point. The walls are made of reddish-brown material, possibly brick or concrete, and show signs of wear and discoloration. The center is dark, suggesting a deep opening. Text overlays include 'MH Pump Sip 11/6/2019', 'TO MH Pump Pip 13:52', and 'Access Point SpecJamestown Pump Si 0 FT'. |

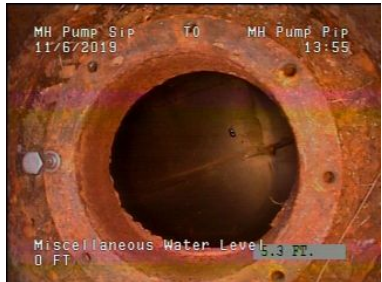
| Distance | Fault Observation | Picture |
|---|---|---|
| 0.0 | Miscellaneous Water Level | A photograph showing the interior of a circular access point, similar to the first one. The walls are reddish-brown. Text overlays include 'MH Pump Sip 11/6/2019', 'TO MH Pump Pip 13:55', and 'Miscellaneous Water Level 5.3 FT. 0 FT'. |

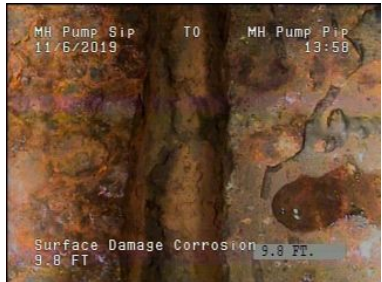
| Distance | Fault Observation | Picture |
|---|---|---|
| 9.8 | Surface Damage Corrosion<br>Position: 12 To 12 Joint | A close-up photograph of the pipe surface showing significant corrosion and surface damage. The metal is pitted and discolored. Text overlays include 'MH Pump Sip 11/6/2019', 'TO MH Pump Pip 13:58', and 'Surface Damage Corrosion 9.8 FT. 9.8 FT'. |

(9.8) SCP - Surface Damage Corrosion - Position:  
12 To 12

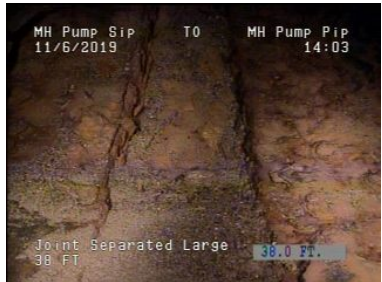
| Distance | Fault Observation | Picture |
|---|---|---|
| 38.0 | Joint Separated Large | A photograph showing a large separation at a pipe joint. The pipe is dark and the joint is clearly visible as a gap. Text overlays include 'MH Pump Sip 11/6/2019', 'TO MH Pump Pip 14:03', and 'Joint Separated Large 38.0 FT. 38 FT'. |

(38.0) JSL - Joint Separated Large

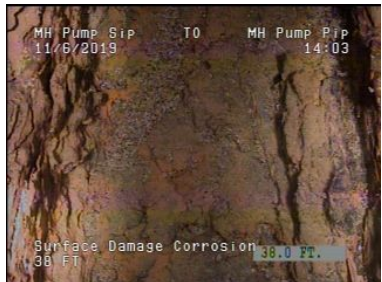
| Distance | Fault Observation | Picture |
|---|---|---|
| 38.0 | Surface Damage Corrosion<br>Position: 5 To 7 Joint | A close-up photograph of the pipe surface showing significant corrosion and surface damage, similar to the previous image. Text overlays include 'MH Pump Sip 11/6/2019', 'TO MH Pump Pip 14:03', and 'Surface Damage Corrosion 38.0 FT. 38 FT'. |

(38.0) SCP - Surface Damage Corrosion -  
Position: 5 To 7
