| <b>Owner</b> | | <b>Customer</b> | City of Massillon |
| <b>Street</b> | West of RR W/Flap Gate | <b>City</b> | Massillon |

| <b>Sewer Use</b> | Stormwater Pipe | <b>Direction of Survey</b> | Upstream |

| <b>Shape</b> | Circular | <b>Material</b> | Reinforced Concrete Pipe |

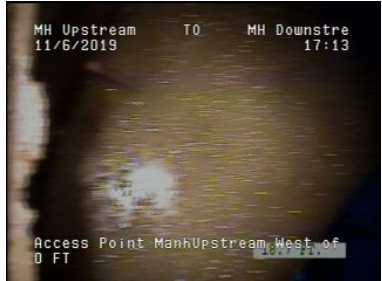
| Distance | Fault Observation | Picture |
|---|---|---|
| 0.0 | Access Point Manhole<br>Remarks: Upstream West of RR | A photograph looking down into a manhole. The walls are dark and the bottom is obscured by darkness. Text overlay: MH Upstream 11/6/2019 TO MH Downstre 17:13. Bottom text: Access Point ManUpstream West of 0 FT. |

(0.0) AMH - Access Point Manhole Remark:  
Upstream West of RR

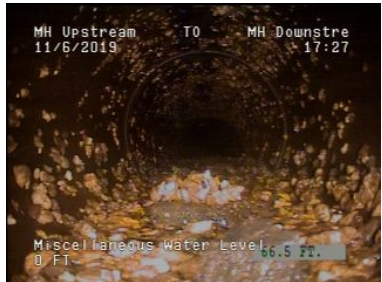
| Distance | Fault Observation | Picture |
|---|---|---|
| 0.0 | Miscellaneous Water Level | A photograph looking down into a manhole. The bottom is covered with a layer of water and some debris. Text overlay: MH Upstream 11/6/2019 TO MH Downstre 17:27. Bottom text: Miscellaneous Water Level 66.5 FT. |

(0.0) MWL - Miscellaneous Water Level

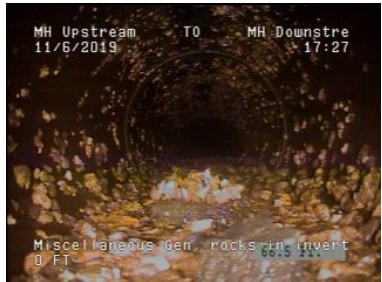
| Distance | Fault Observation | Picture |
|---|---|---|
| 0.0 | Miscellaneous General Observation<br>Remarks: rocks in invert | A photograph looking down into a manhole. The bottom is covered with a layer of water and many small rocks. Text overlay: MH Upstream 11/6/2019 TO MH Downstre 17:27. Bottom text: Miscellaneous Gen. rocks in invert 0 FT. |

(0.0) MGO - Miscellaneous General Observation  
Remark: rocks in invert

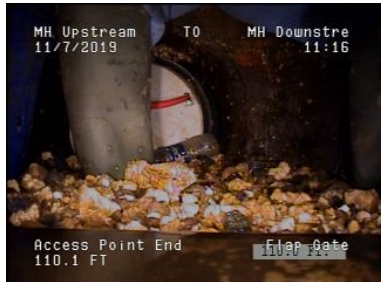
| Distance | Fault Observation | Picture |
|---|---|---|
| 110.1 | Access Point End of Pipe<br>Remarks: Flap Gate | A photograph looking down into a manhole. The bottom is covered with a layer of water and many small rocks. A flap gate is visible. Text overlay: MH Upstream 11/7/2019 TO MH Downstre 11:16. Bottom text: Access Point End 110.1 FT. Flap Gate. |

(110.1) AEP - Access Point End of Pipe Remark:  
Flap Gate
