MAP OF SURVEY

Being Lot Number 12575 in the City of Massillon, County of Stark, Ohio. And the Topography of said lot and the lands that are adjacent.

DATE: NOV. 28, 1981

FOR: ECKROATE

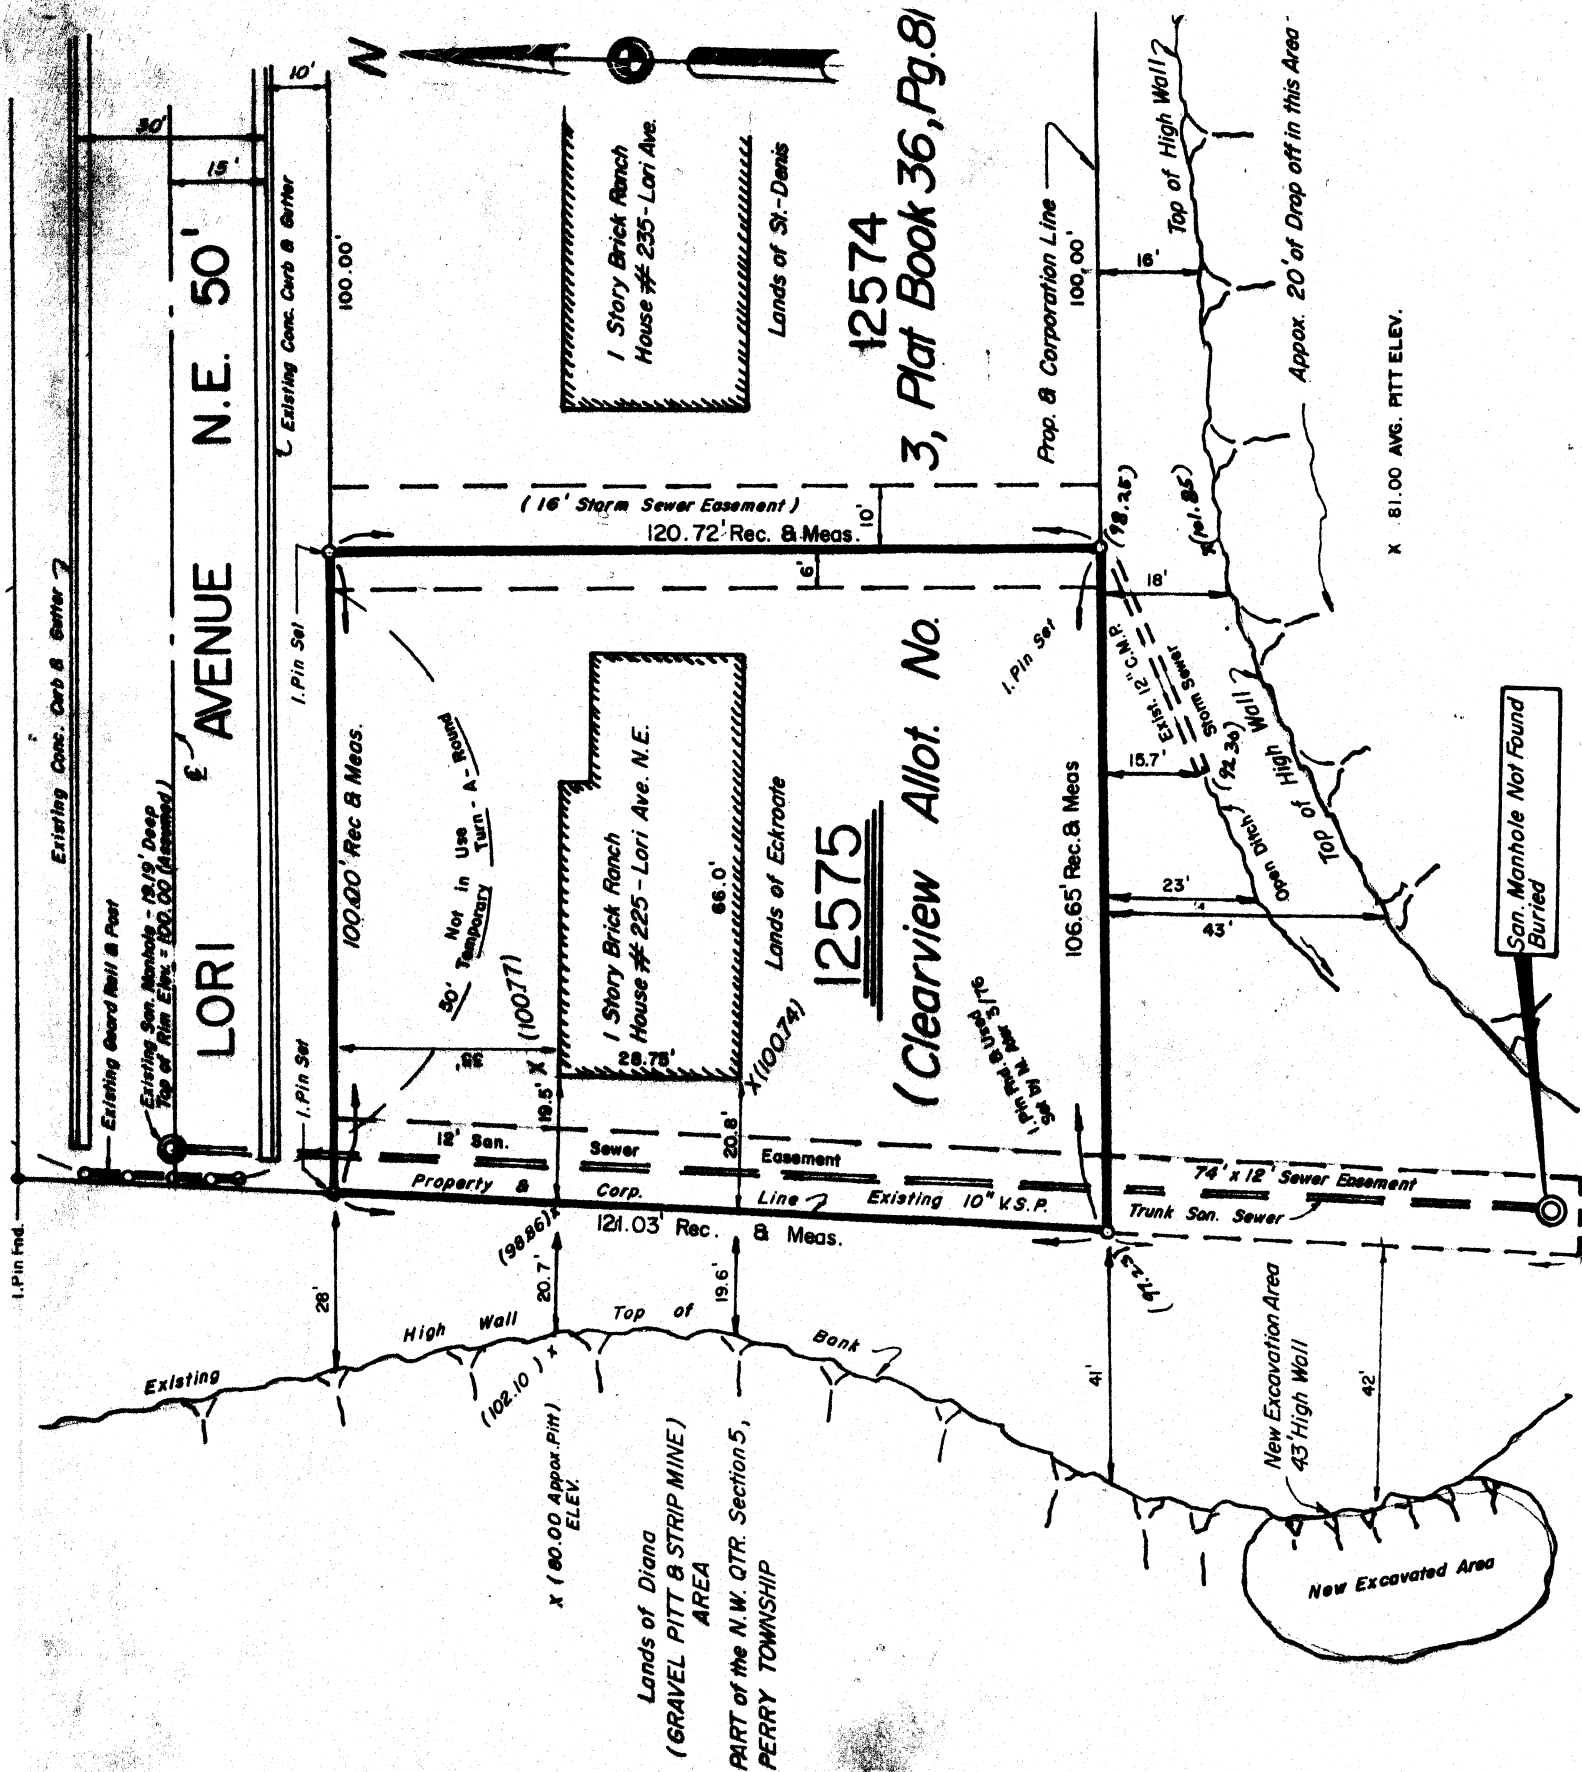
1. Mr. Diana is in violation of the Ohio Surface Mining Laws. Page 8, Paragraph 11, Assuring adequate lateral support and being closer then 50 foot from your property line. Also Section 4153.11, closer than 50 foot to a public road, (Lori Ave. N.E.); and also Item #2 being the same elevation at a point 50 foot from the said road and at an angle of 40 degrees from said road found on page 28 of the Ohio Surface Mine Law Book.

2. Final highwalls around your property are not 18 degrees or less and I don't know if the Ohio Department of Natural Resources, Division of Reclamation considers these highwalls as final or furture highwalls. I would think final but check with them. At present they are about a 70 to 85 degree slope.

3. Highwalls in general:
It is the intent of the Department of Reclamation to insure public safety at all times. Ref: NRim-111-07.
(D) Restrict assess to the highwall as approached from the top. This is in violation.
