May 6, 2003

Re: Color Television Inspection Services (for A. R. Lockhart Development Co.)  
Kenyon Creek Development - 8" and 12" Sanitary Sewers

for A. R. Lockhart Development Company  
Kenyon Creek Development  
Sanitary Sewers  
Tape No. 03012

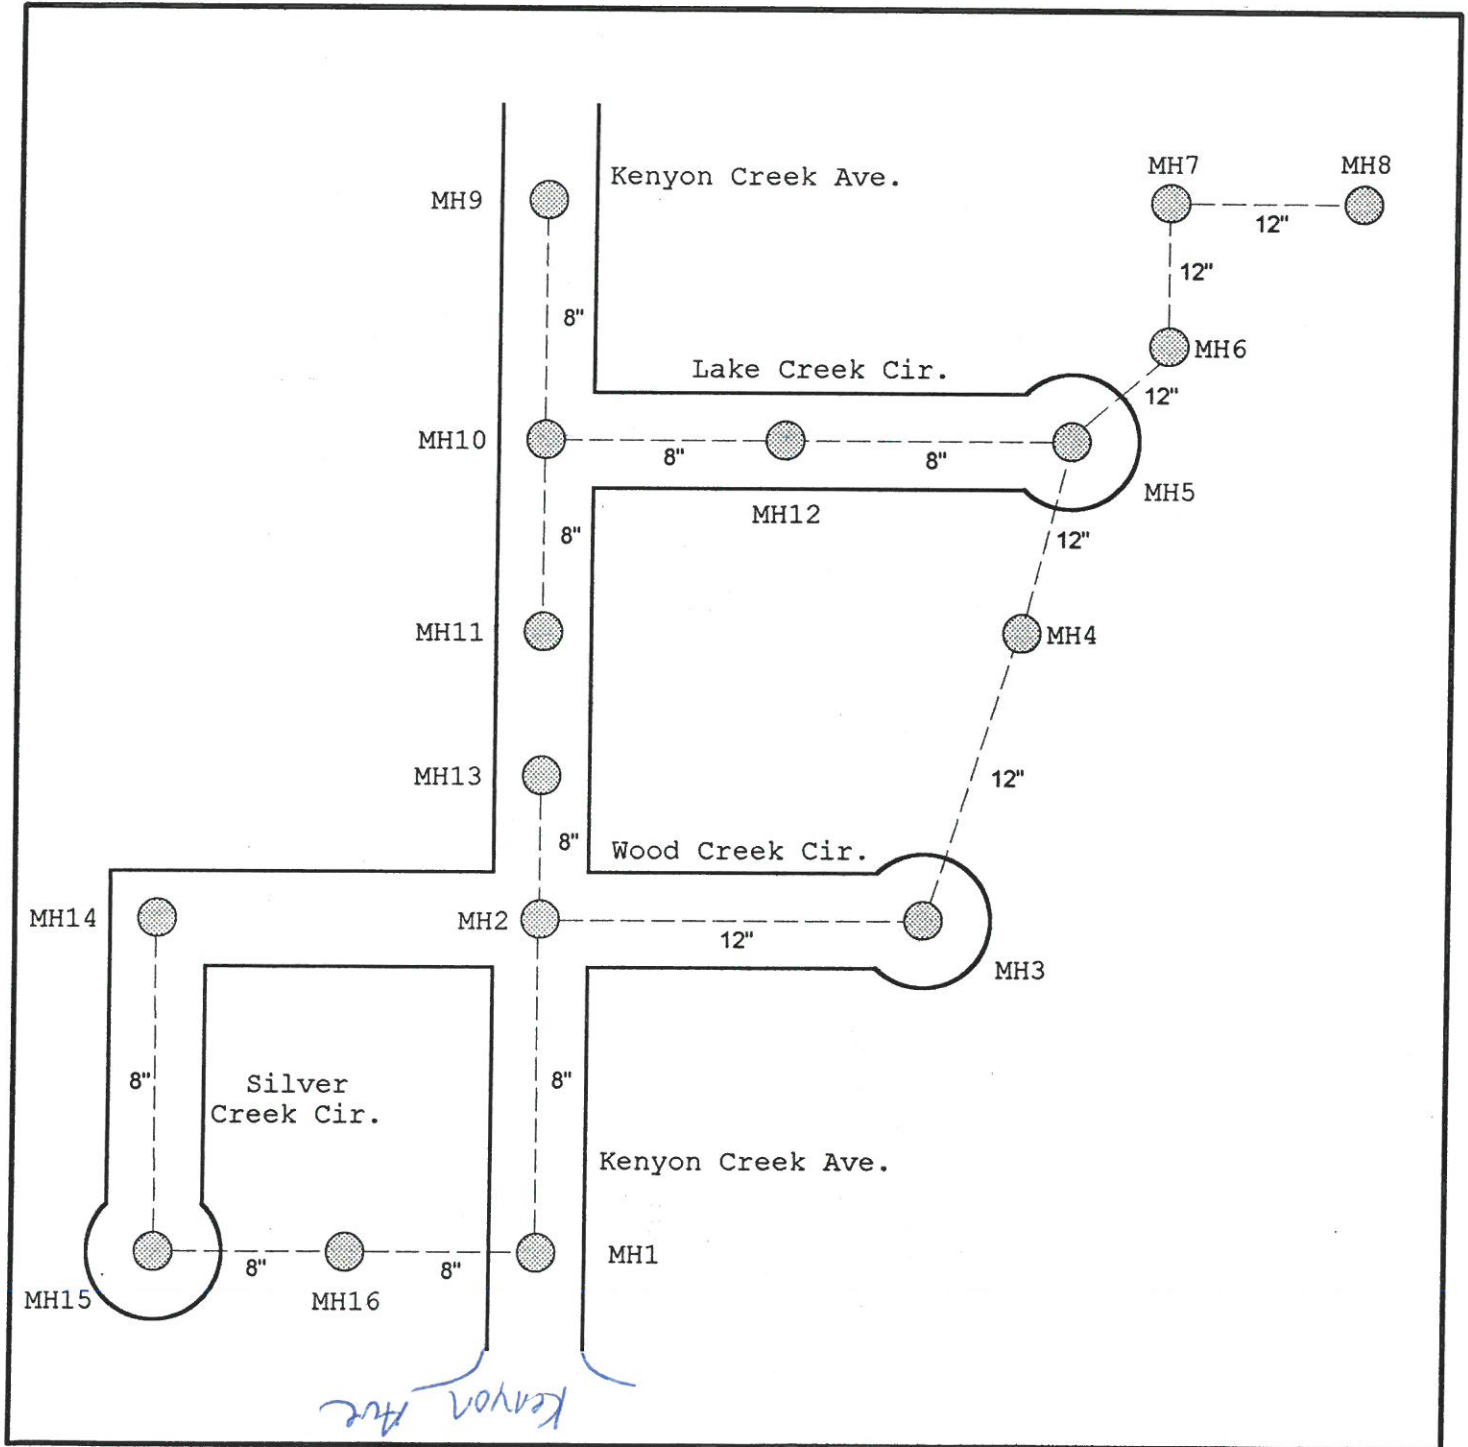
The pipe inspected consisted of 8" and 12" plastic sanitary sewer in 12.5' laying lengths. Manholes were precast and had vented covers. Alignment and grade were good, and all joints appeared tight and even.
