C&K Industrial Services, Inc.  
5617 E. Schaaf Rd.  
Independence, Ohio 44131  
216-642-0055

## PACP Report with Pipe Run and Incident Snapshots

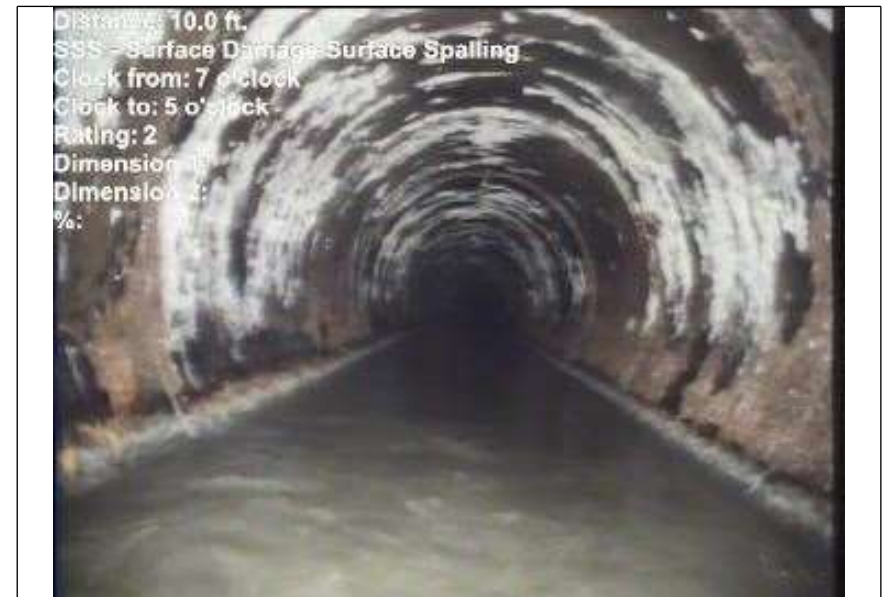
At: 10 ft. 7/5 SSS - Surface Damage Surface Spalling  
Joint: No

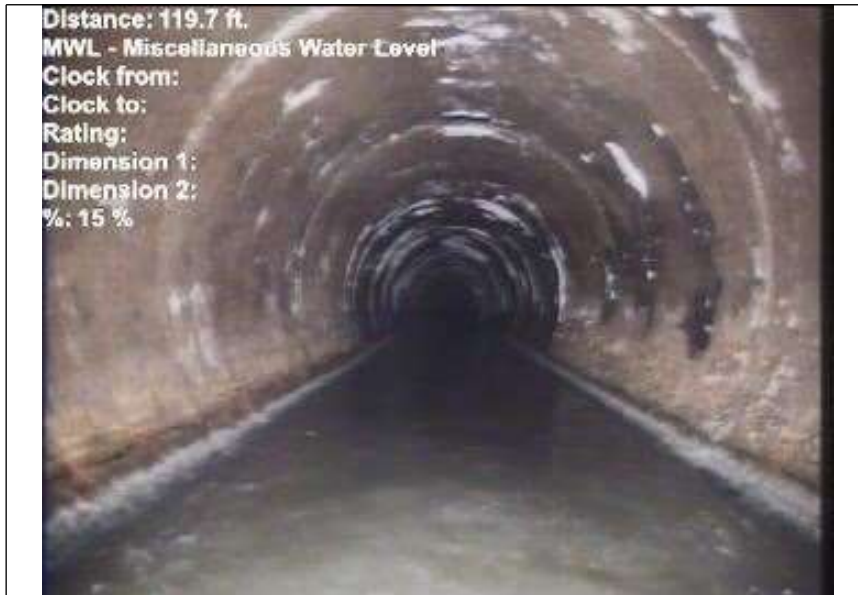
At: 119.7 ft. MWL - Miscellaneous Water Level  
Joint: No 15 %

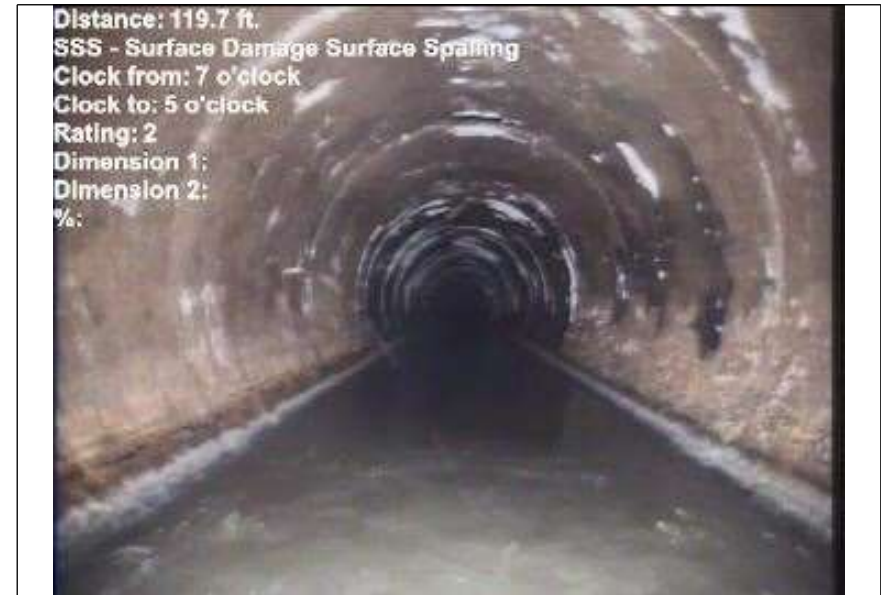
At: 119.7 ft. 7/5 SSS - Surface Damage Surface Spalling  
Joint: No

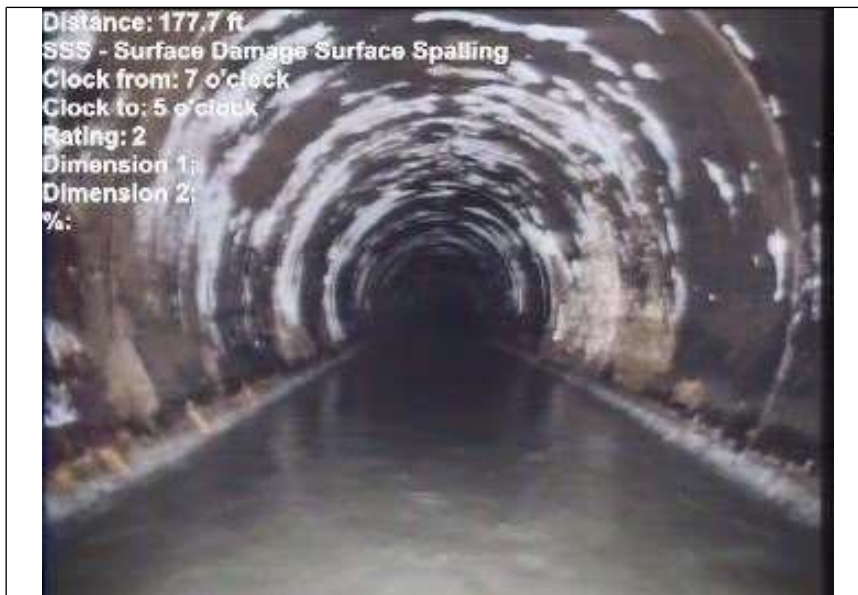
At: 177.7 ft. 7/5 SSS - Surface Damage Surface Spalling  
Joint: No

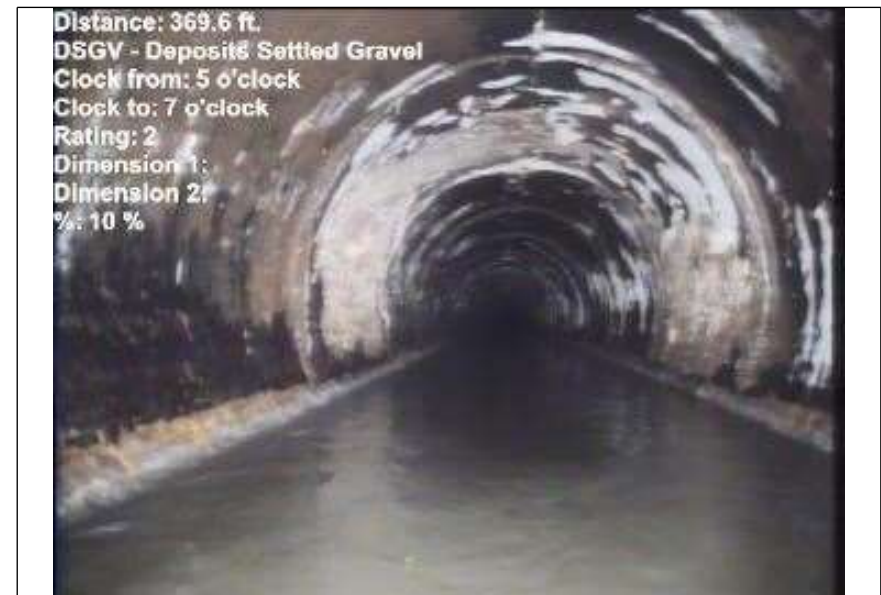
At: 369.6 ft. 5/7 DSGV - Deposits Settled Gravel  
Joint: No 10 %

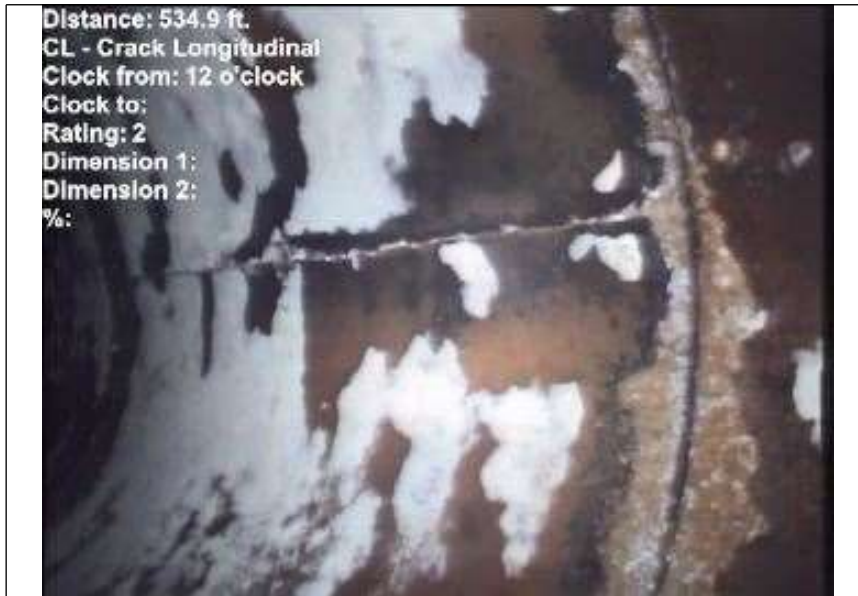
At: 534.9 ft. 12/ CL - Crack Longitudinal  
Joint: Yes

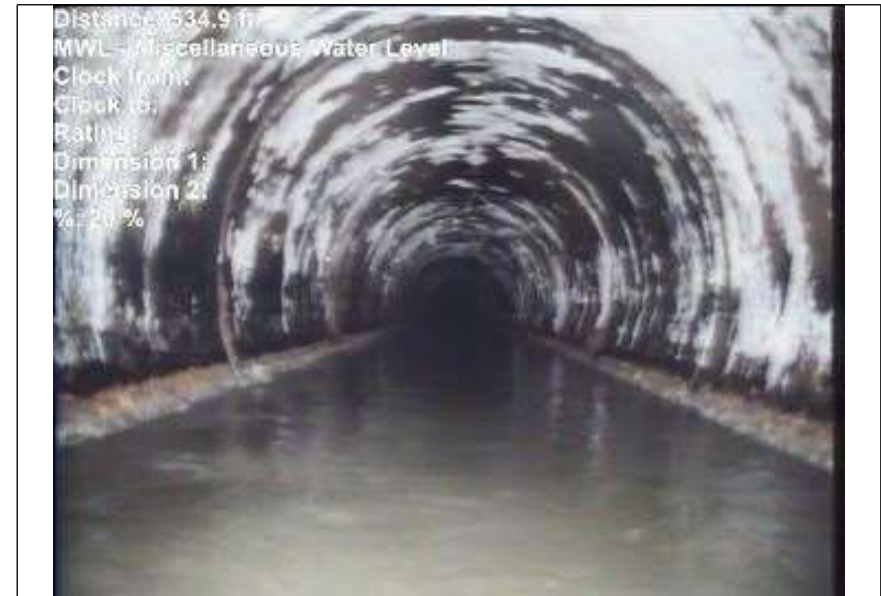
At: 534.9 ft. MWL - Miscellaneous Water Level  
Joint: No 20 %

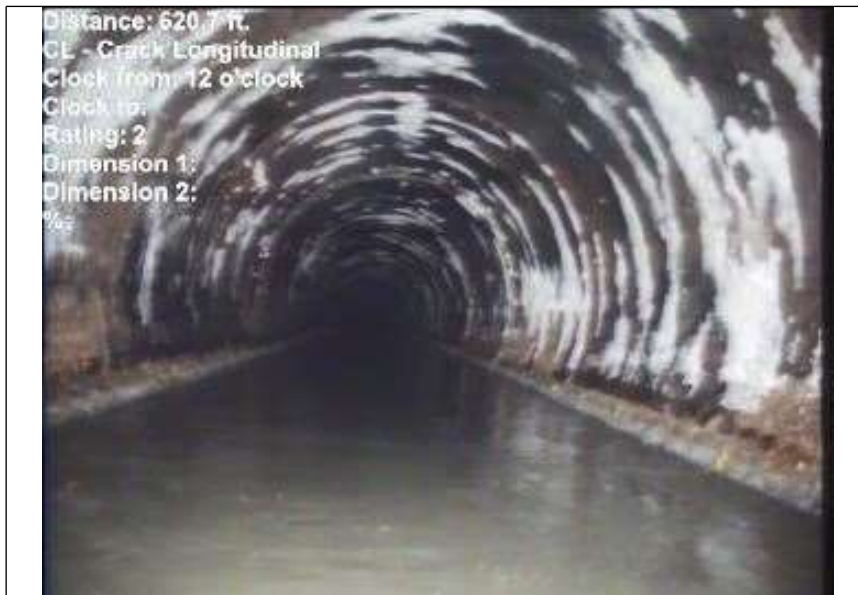
At: 620.7 ft. 12/ CL - Crack Longitudinal  
Joint: Yes

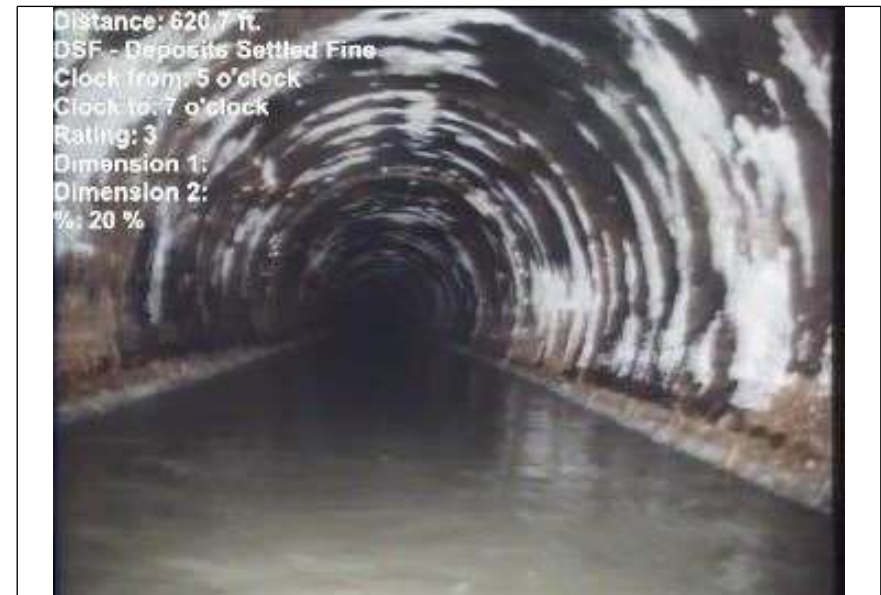
At: 620.7 ft. 5/7 DSF - Deposits Settled Fine  
Joint: No 20 %

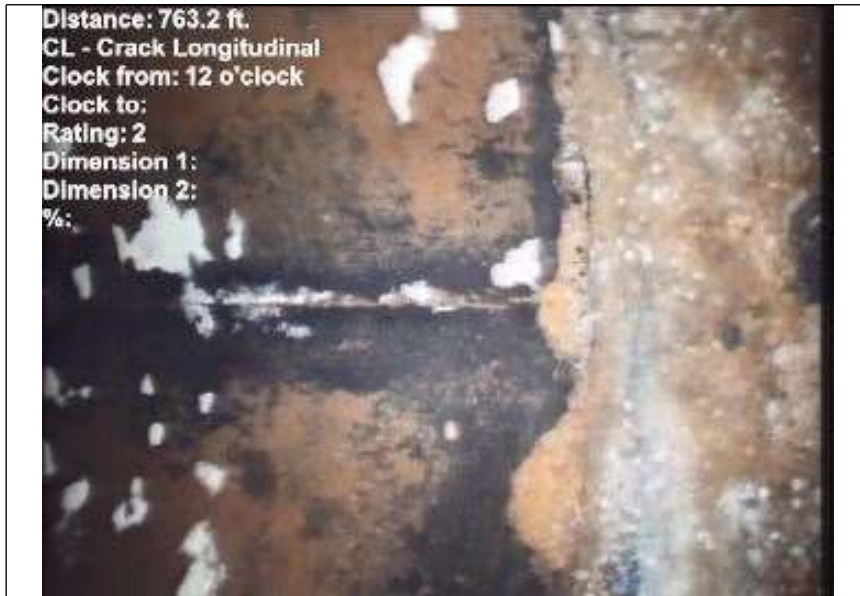
At: 763.2 ft. 12/. CL - Crack Longitudinal  
Joint: No

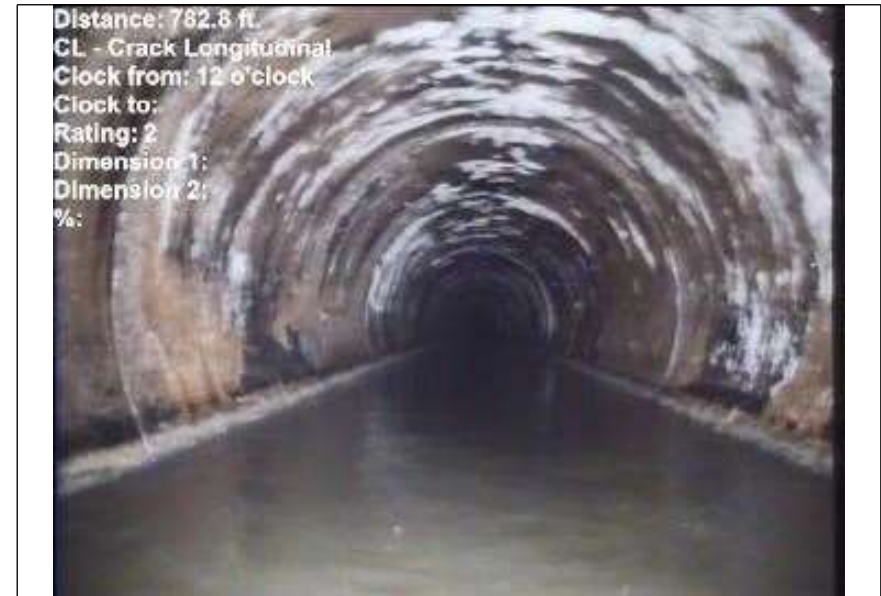
At: 782.8 ft. 12/. CL - Crack Longitudinal  
Joint: No

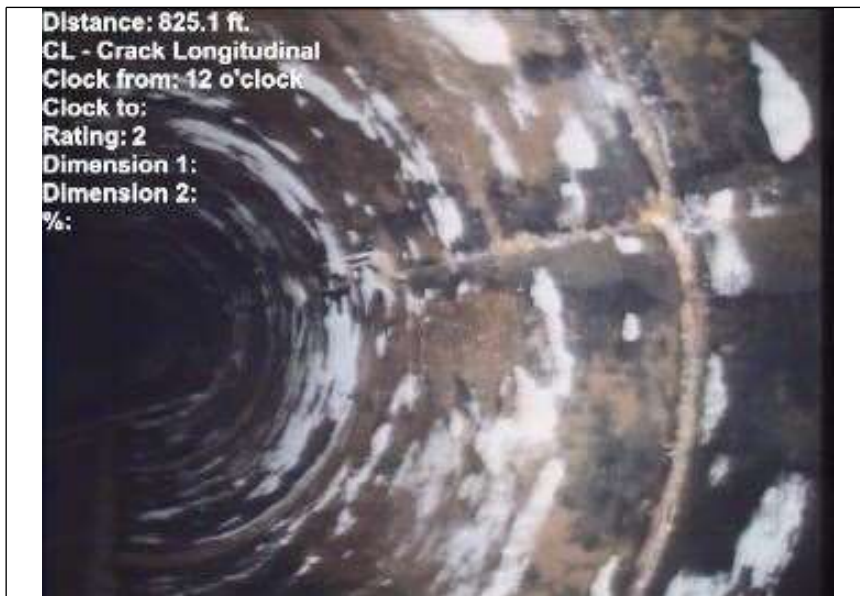
At: 825.1 ft. 12/. CL - Crack Longitudinal  
Joint: No

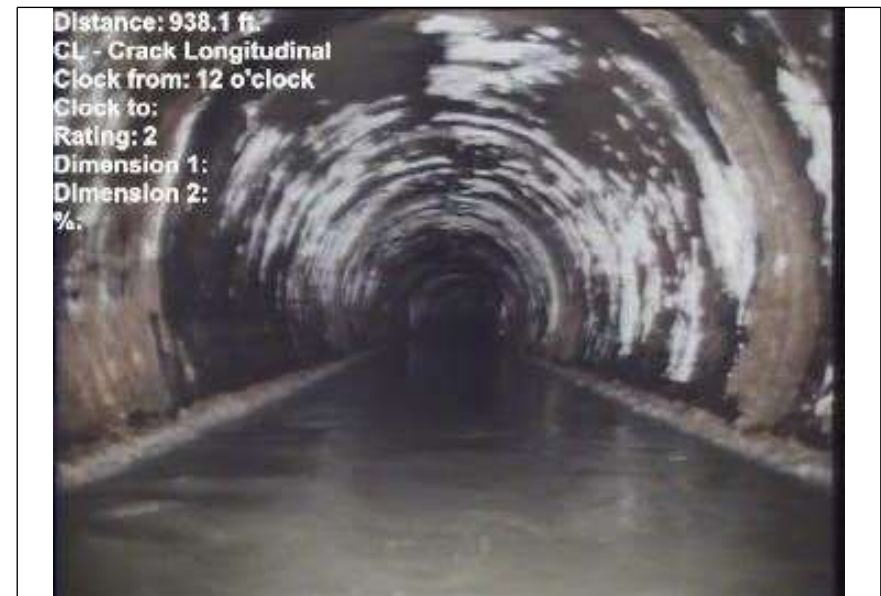
At: 938.1 ft. 12/. CL - Crack Longitudinal  
Joint: No

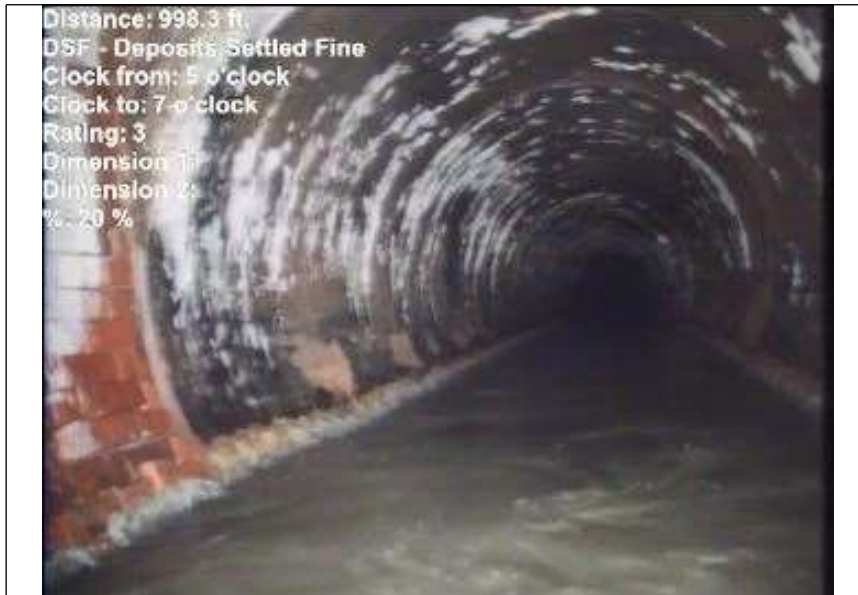
At: 998.3 ft. 5/7 DSF - Deposits Settled Fine  
Joint: No 20 %

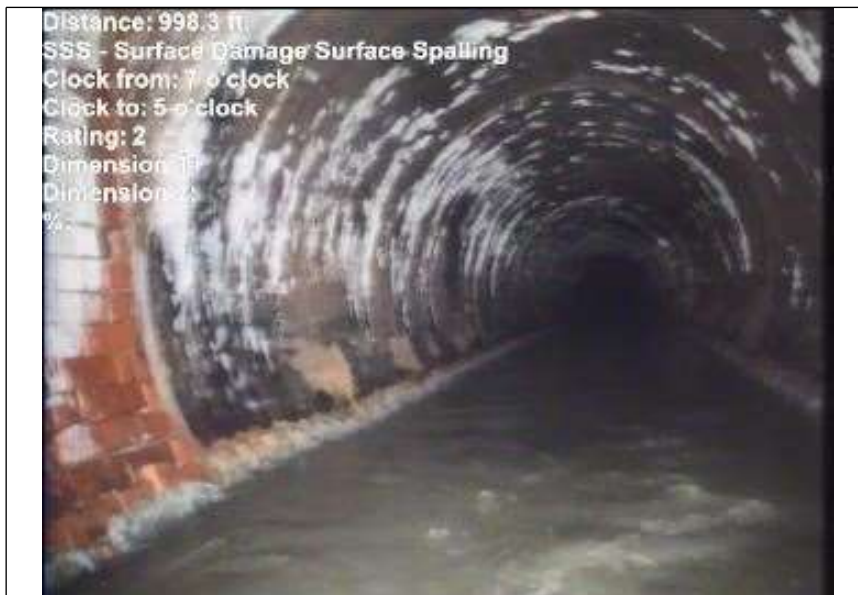
At: 998.3 ft. 7/5 SSS - Surface Damage Surface Spalling  
Joint: No

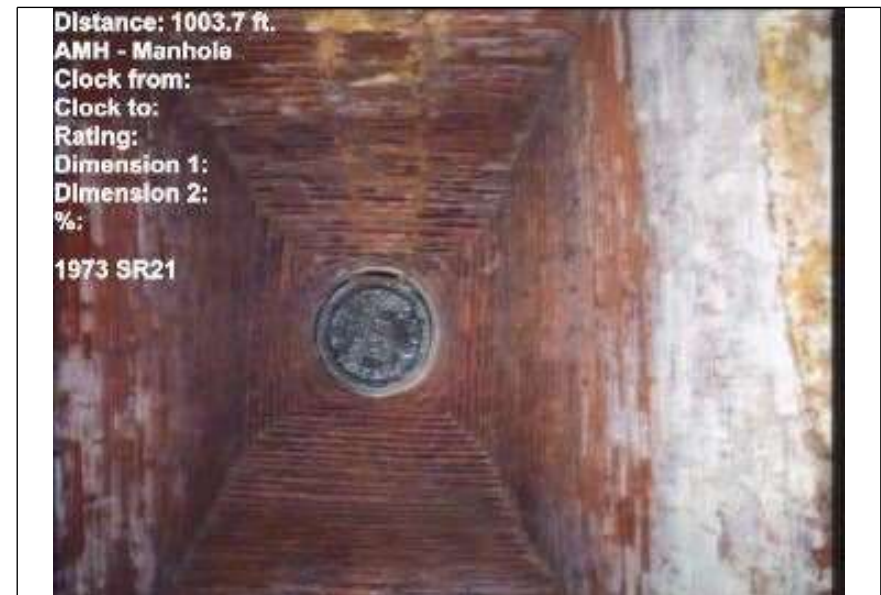
At: 1003.7 ft. AMH - Manhole  
Joint: No 1973 SR21
