**US Army Corps  
of Engineers®**

## Flood Damage Reduction Segment / System Inspection Report

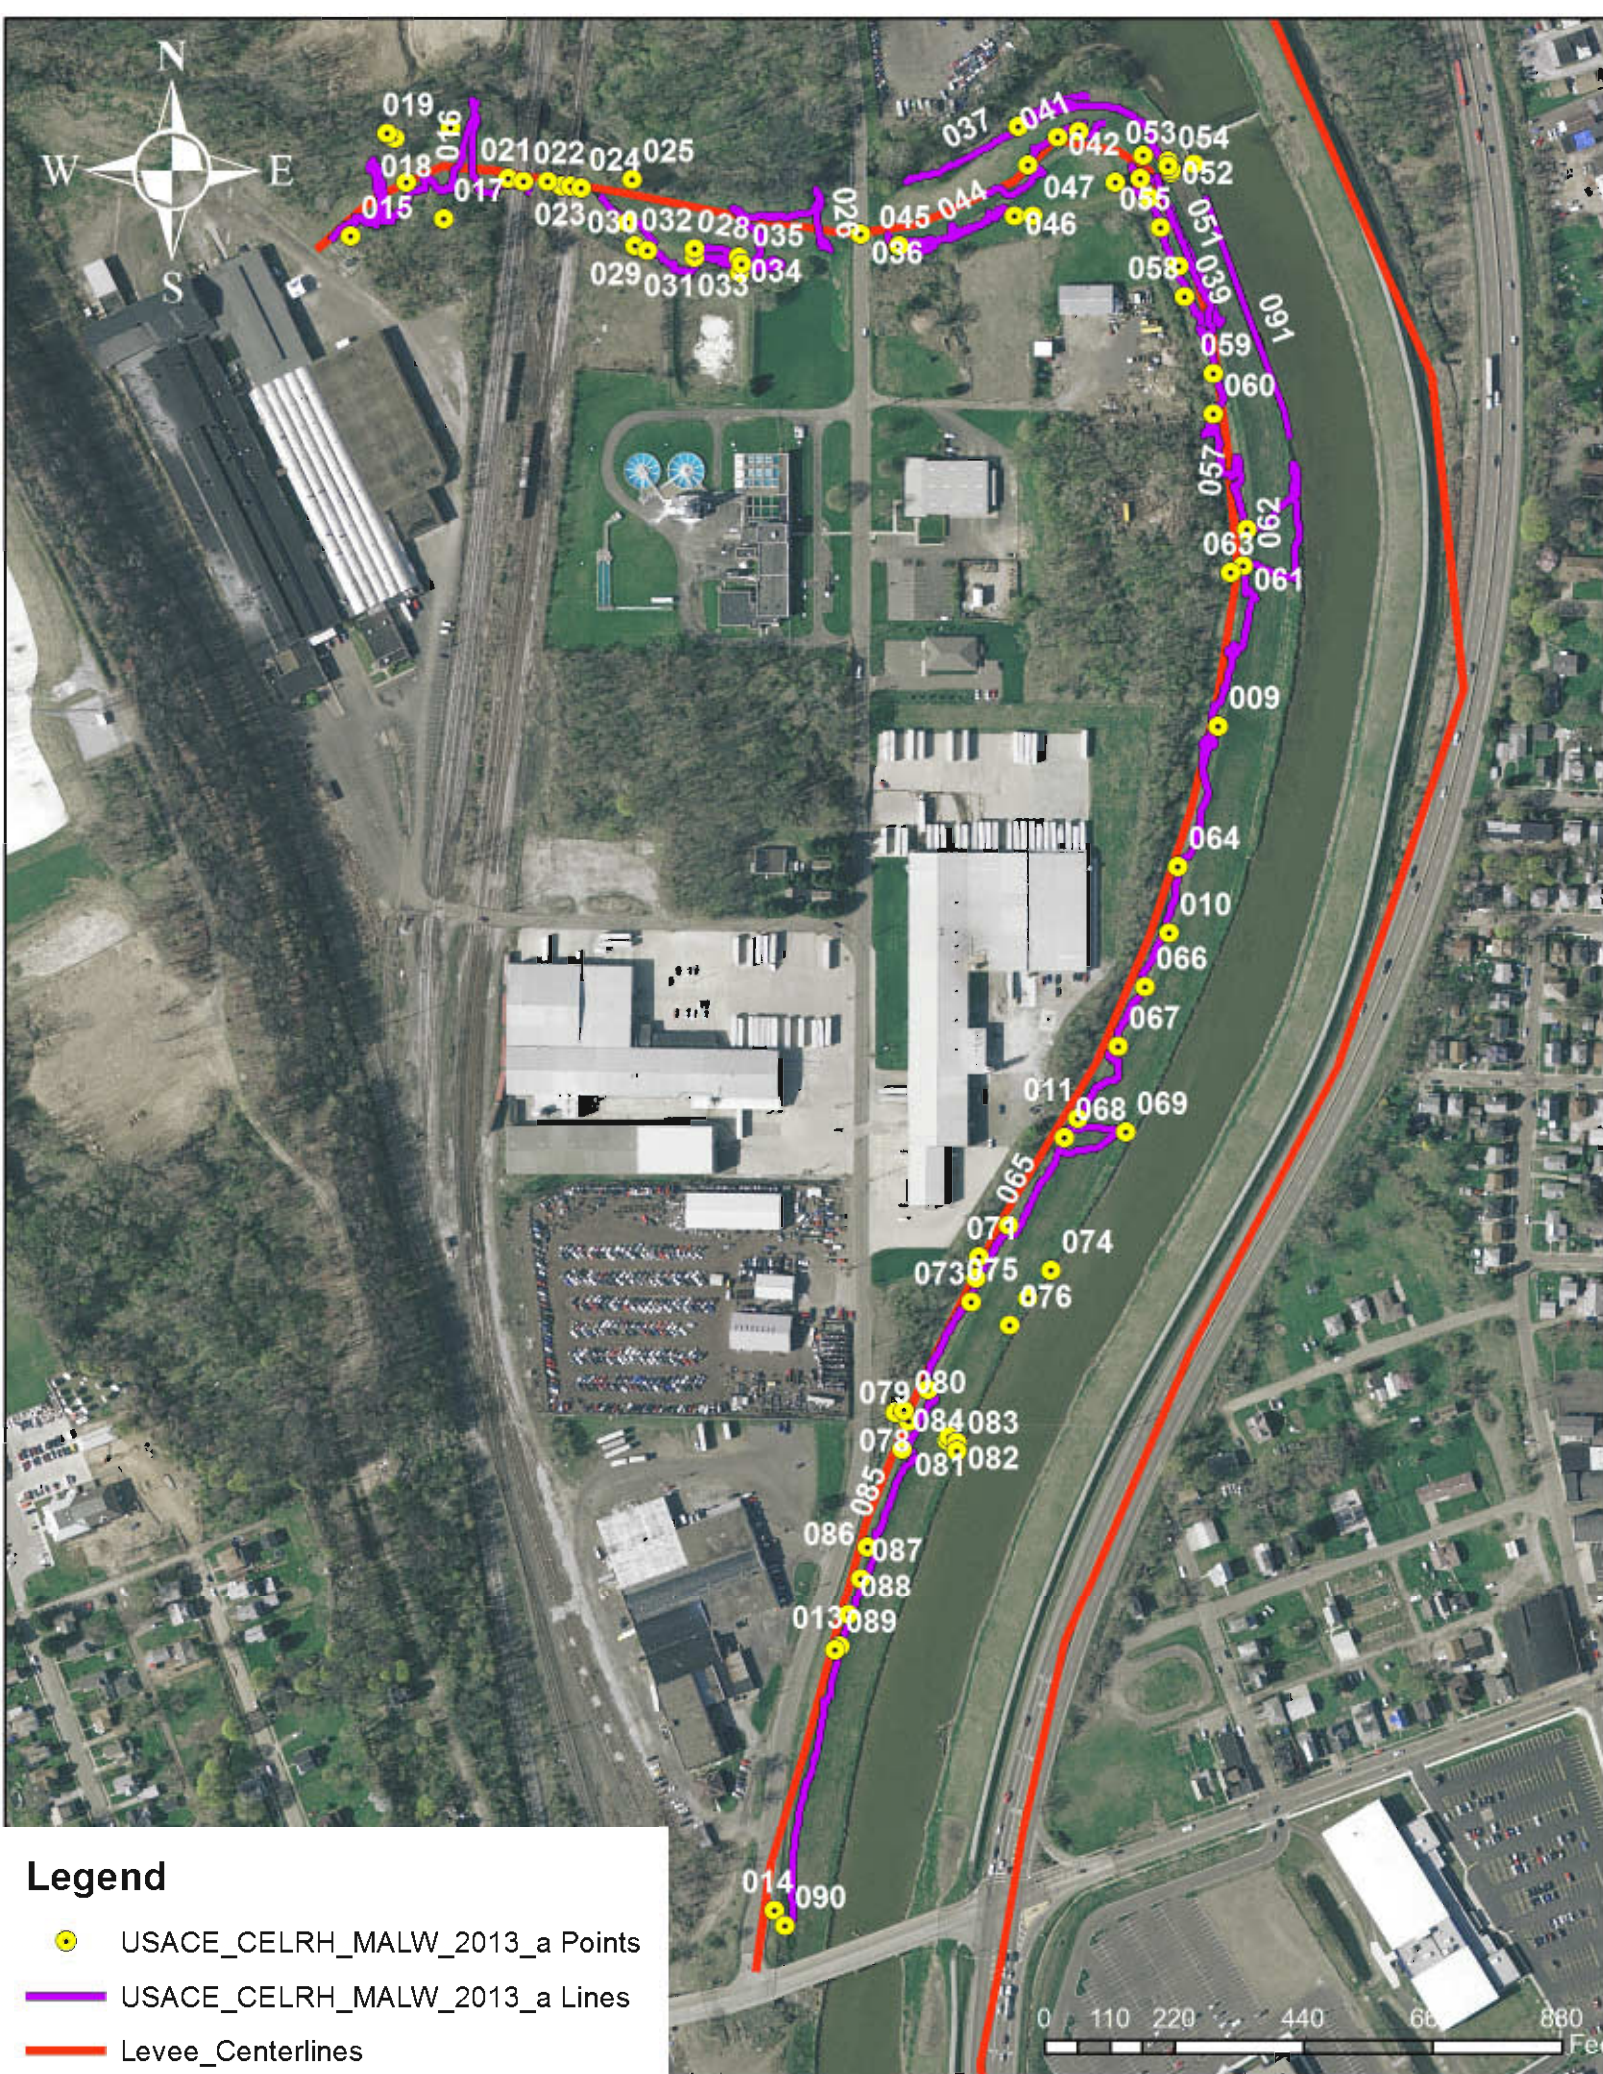
| Inspect_ID | Feature | Item | Rating | Remarks | Status |
