## GUIDANCE FOR CCTV AND SONAR INSPECTION PIPES PENETRATING LEVEES

11 November 2010

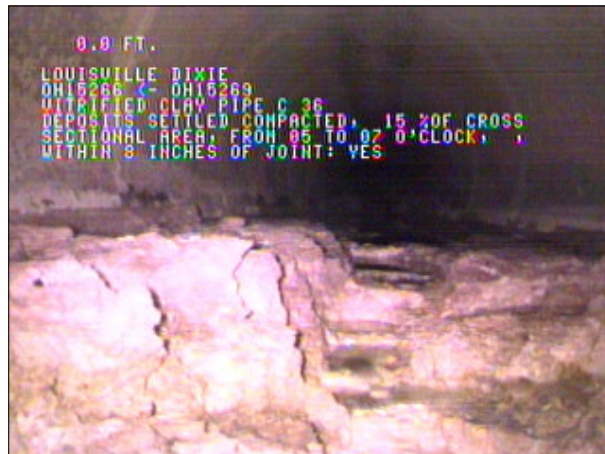
| 1:300 | Position | Code | Observation | MPEG | Photo | Grade |
|---|---|---|---|---|---|---|
| | 0.00 | DSC | Deposits Settled Compacted, 15 %of cross sectional area, from 05 to 07 o'clock, , within 8 inches of joint: YES | 00:01:06 | 65_3A | M 3 |

Photo: OH15269\_OH15266124326\_05112009\_A.JPG, VCR  
No.: FLOOD WALL#2, 01:42:36  
0FT, Deposits Settled Compacted, 15 %of cross sectional area, from 05 to 07 o'clock, , within 8 inches of joint: YES

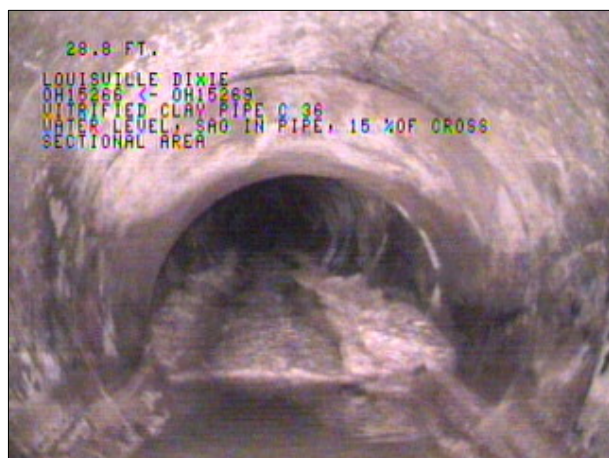
| 1:300 | Position | Code | Observation | MPEG | Photo | Grade |
|---|---|---|---|---|---|---|
| | 28.80 | MWLS | Water Level, Sag in pipe, 15 %of cross sectional area | 00:02:29 | 65_4A | M 2 |

Photo: OH15269\_OH15266124455\_05112009\_A.JPG, VCR  
No.: FLOOD WALL#2, 01:43:58  
28.8FT, Water Level, Sag in pipe, 15 %of cross sectional area

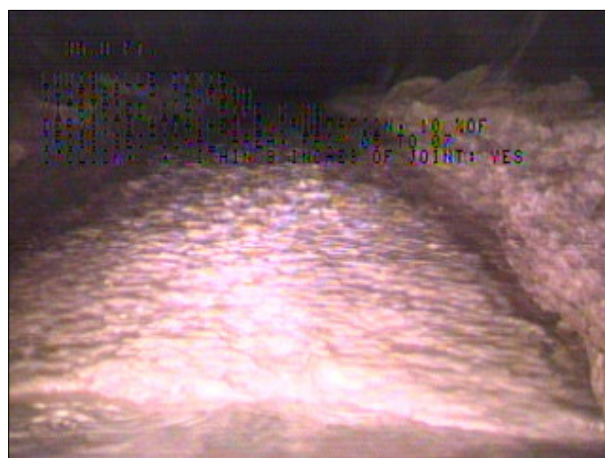
| 1:300 | Position | Code | Observation | MPEG | Photo | Grade |
|---|---|---|---|---|---|---|
| | 35.80 | DAE | Deposits Attached Encrustation, 10 %of cross sectional area, from 05 to 07 o'clock, , within 8 inches of joint: YES | 00:02:43 | 65_5A | M 2 |

Photo: OH15269\_OH15266124520\_05112009\_A.JPG, VCR  
No.: FLOOD WALL#2, 01:44:10  
35.8FT, Deposits Attached Encrustation, 10 %of cross sectional area, from 05 to 07 o'clock, , within 8 inches of joint: YES

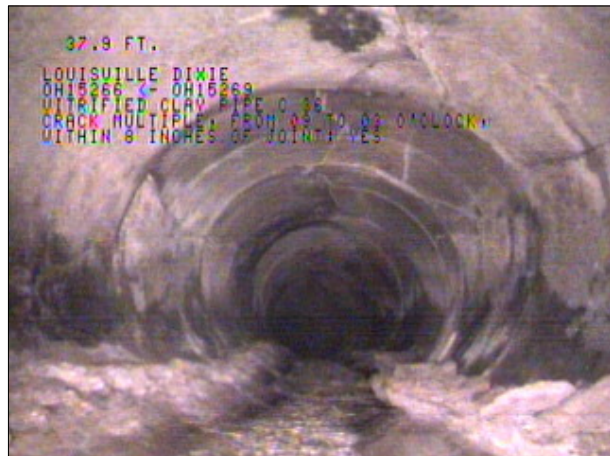
| 1:300 | Position | Code | Observation | MPEG | Photo | Grade |
|---|---|---|---|---|---|---|
| | 37.90 | CM | Crack Multiple, from 09 to 03 o'clock, within 8 inches of joint: YES | 00:02:55 | 65_6A | S 3 |

Photo: OH15269\_OH15266124541\_05112009\_A.JPG, VCR  
No.: FLOOD WALL#2, 01:44:21  
37.9FT, Crack Multiple, from 09 to 03 o'clock, within 8 inches of joint: YES

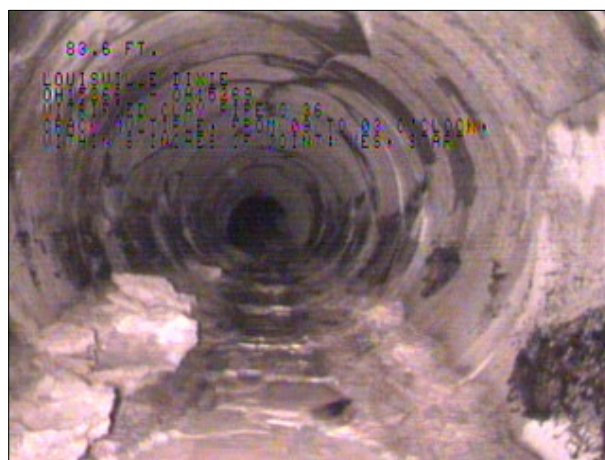
| 1:300 | Position | Code | Observation | MPEG | Photo | Grade |
|---|---|---|---|---|---|---|
| | 83.60 | S1 CM | Crack Multiple, from 09 to 03 o'clock, within 8 inches of joint: YES, Start | 00:04:50 | 65_9A | S 3 |

Photo: OH15269\_OH15266124807\_05112009\_A.JPG, VCR  
No.: FLOOD WALL#2, 01:46:12  
83.6FT, Crack Multiple, from 09 to 03 o'clock, within 8 inches of joint: YES, Start

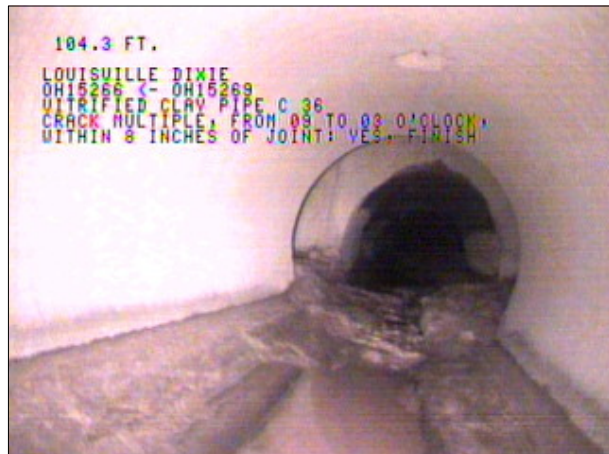
| 1:300 | Position | Code | Observation | MPEG | Photo | Grade |
|---|---|---|---|---|---|---|
| | 104.30 | F1 CM | Crack Multiple, from 09 to 03 o'clock, within 8 inches of joint: YES, Finish | 00:05:27 | 65_10A | S 3 |

Photo: OH15269\_OH15266124848\_05112009\_A.JPG, VCR  
No.: FLOOD WALL#2, 01:46:48  
104.3FT, Crack Multiple, from 09 to 03 o'clock, within 8 inches of joint: YES, Finish
