FLOOD PLAIN INFORMATION

TUSCARAWAS RIVER

STARK COUNTY

PREPARED FOR  
STATE OF OHIO  
DEPARTMENT OF NATURAL RESOURCES  
BY  
CORPS OF ENGINEERS U.S. ARMY  
HUNTINGTON DISTRICT  
HUNTINGTON, WEST VIRGINIA  
JANUARY 1970

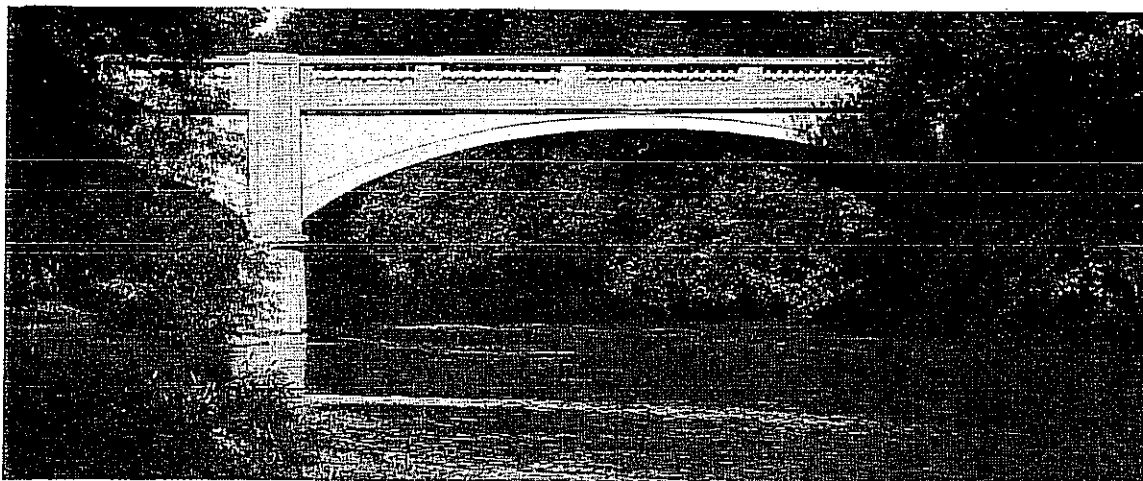
Figure 1---TUSCARAWAS RIVER BRIDGES

Downstream side of the Blough Avenue bridge in Navarre at Mile 81.00.

The Blough Avenue Bridge, built in 1924, at river mile 81.00 in Navarre, is a reinforced concrete arch. The 263-foot bridge has three spans with a total opening length of 178 feet. Both the 1913 and Intermediate Regional Flood levels are below the bridge floor but the south approach road would be completely flooded. Under Standard Project Flood conditions the bridge deck and approach would also be inundated.

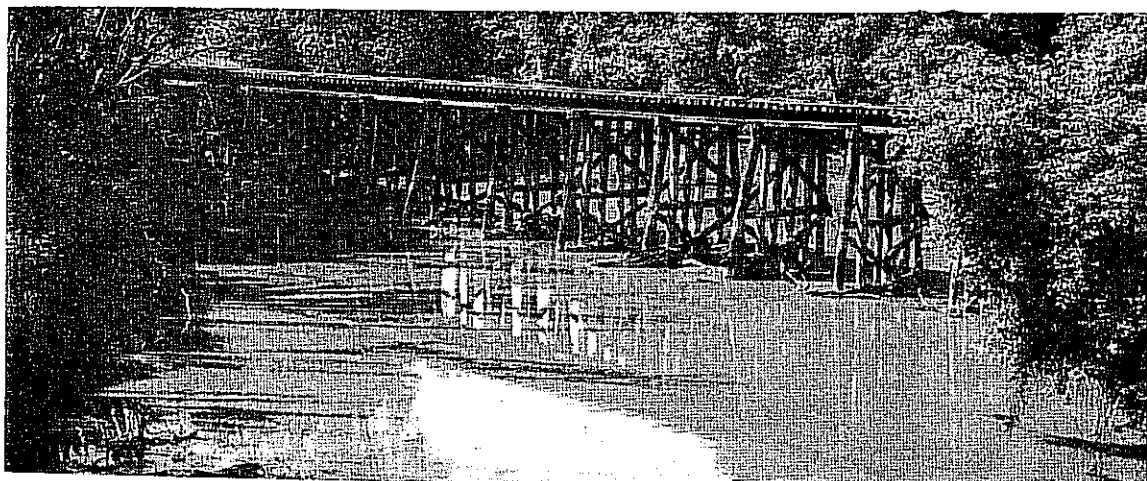
Upstream side of the N.Y.C. & St. L. railroad bridge at Mile 82.15 in Navarre.

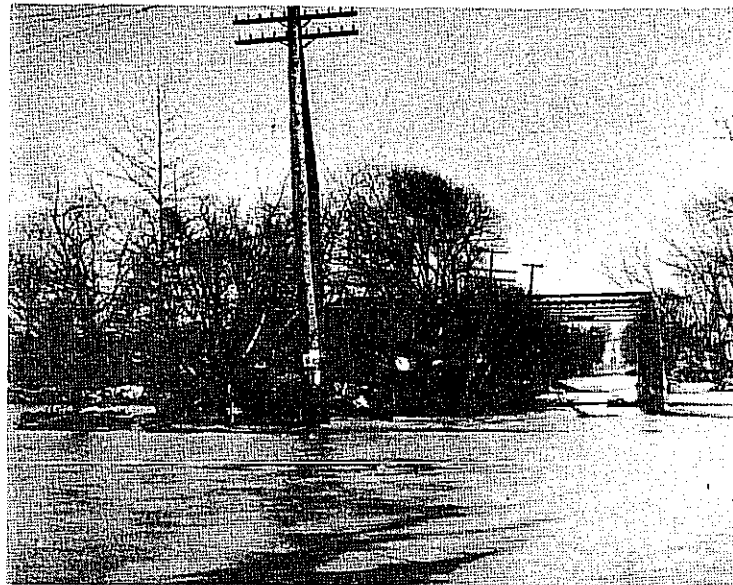
FIGURE 5 - FLOOD SCENES IN MASSILLON - MARCH 1913

Cherry Road bridge over the Tuscarawas River. This bridge was rebuilt, channel relocated and widened and levees built as a part of the local protection works. Note the buildup of debris on the upstream side of the bridge.

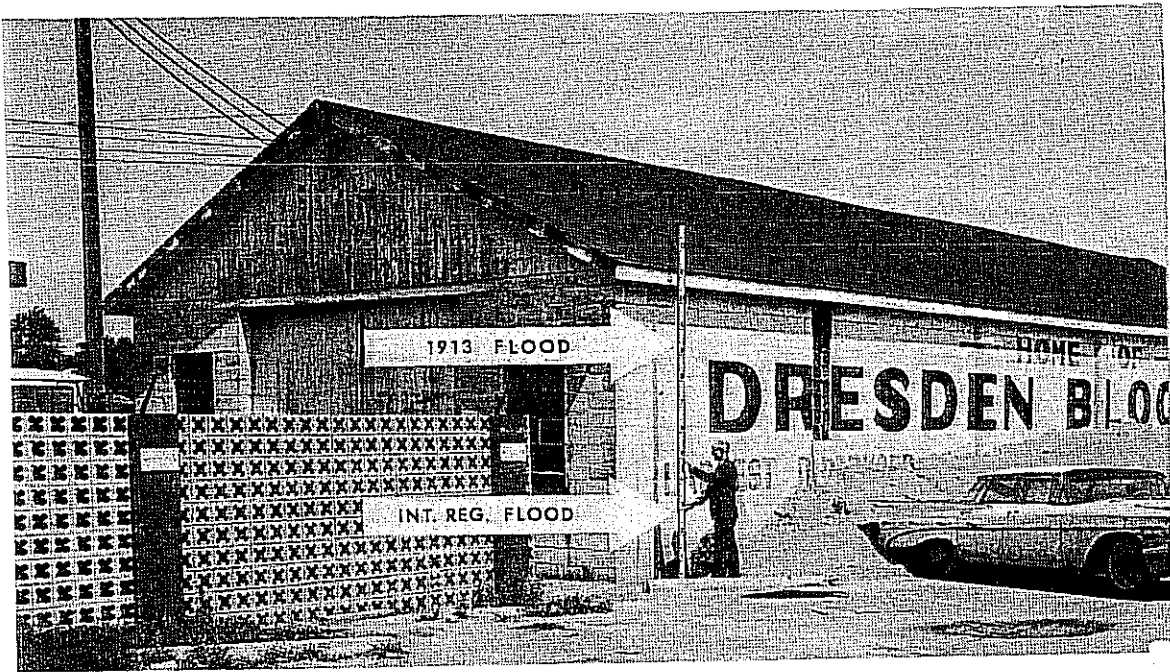
FIGURE 8 - FLOOD HEIGHTS AT MASSILLON

This structure is located outside the Massillon local protection works and shows the levels of the Intermediate Regional Flood and the flood of March 1913.
