PHASE I  
ENVIRONMENTAL SITE  
ASSESSMENT  
SELECT PROPERTIES  
THIRD STREET NW  
MASSILLON, OHIO.

September 14, 1994

Berquist and Associates  
Massillon, Ohio

URS CONSULTANTS  
23355 Mercantile Road Cleveland, Ohio 44122  
j:\adm\berquist\5050600\reports\massprc.rpt

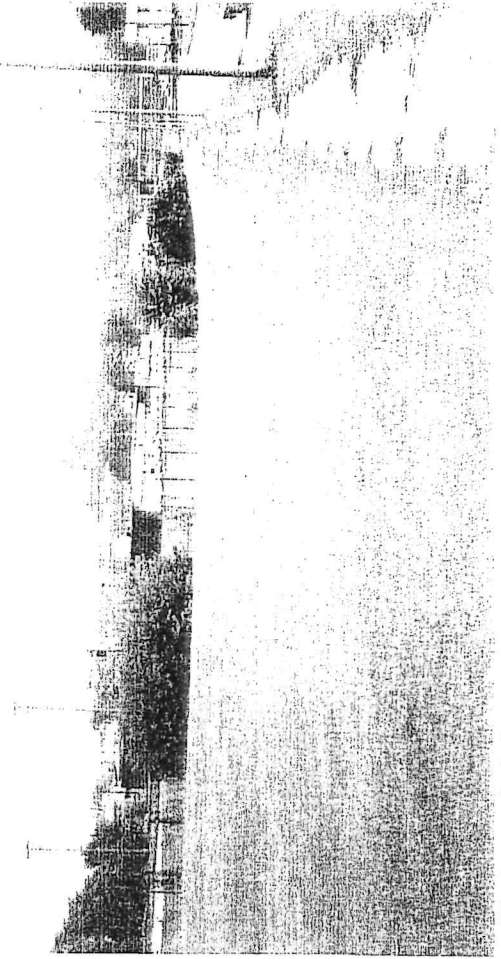
Photograph 8 8/25/94  
Agathon Ball Field

Agathon field is a >4.5 acre parcel of property located on the northern most section of the project area. The site consists of baseball fields and one combination storage shed/concession stand. The entire ball field is ringed by a fence (see Photograph 8, Appendix B).

Based on these conclusions, a Phase II Site Investigation is warranted and recommended for both the Ohio Drilling company main plant site and the Agathon ballfield. The Phase II study would include subsurface sampling at the UST and some areas of surface spillage at the Ohio Drilling site and select subsurface sampling at the Agathon ball field.
