Massillon Levee Pipe Inspection  
Final Report  
February 4, 2010

Pipeline and Drainage Consultants  
Subsidiary of Spartan Construction

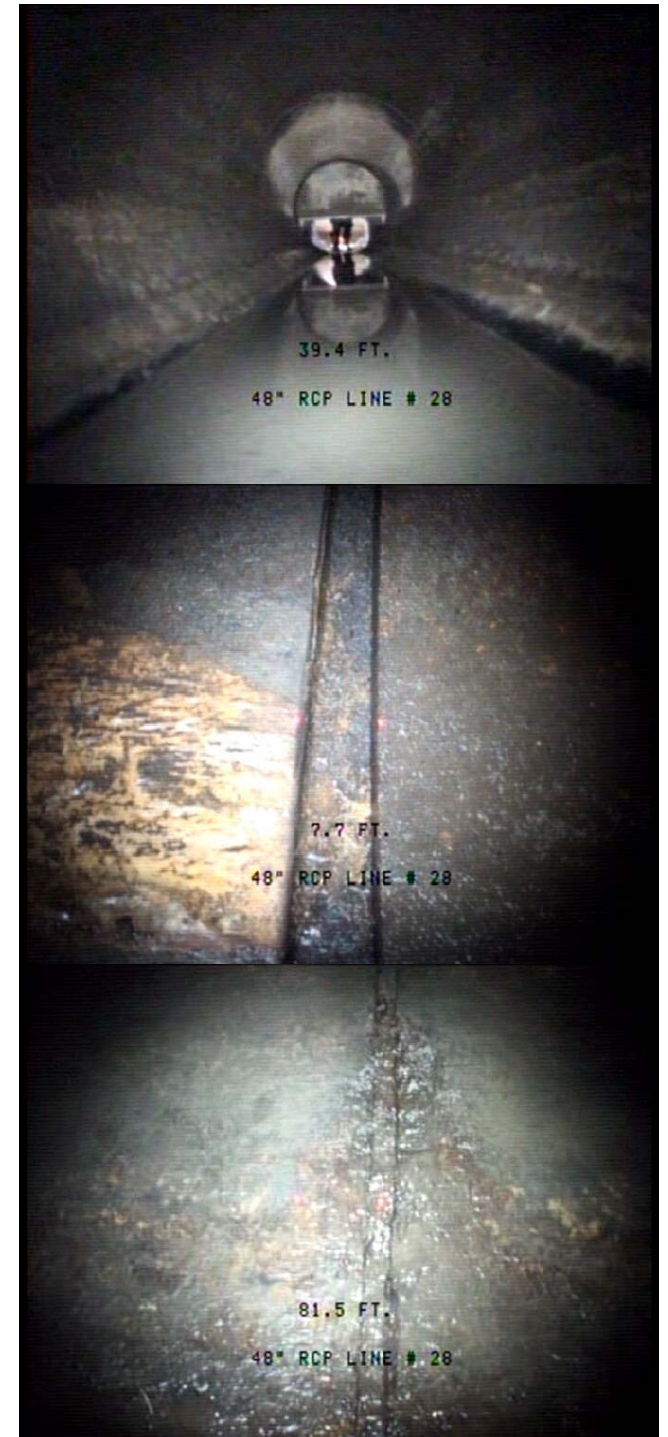
| Pipe # 28 | |
|---|---|
| 96.1ft | Inlet tight |

\*Inspected inlet to out

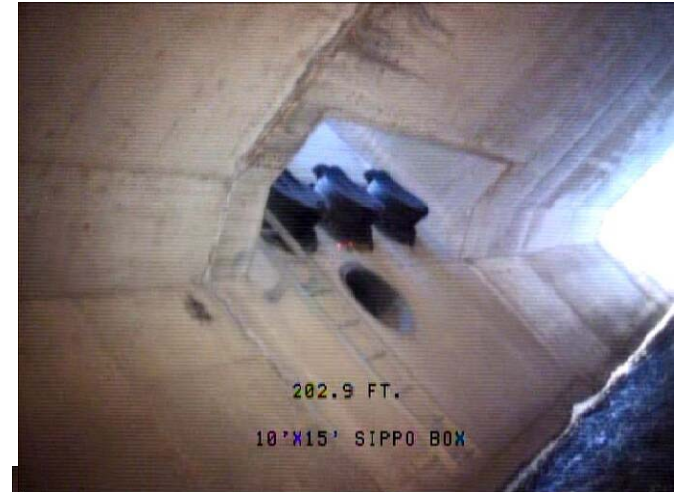
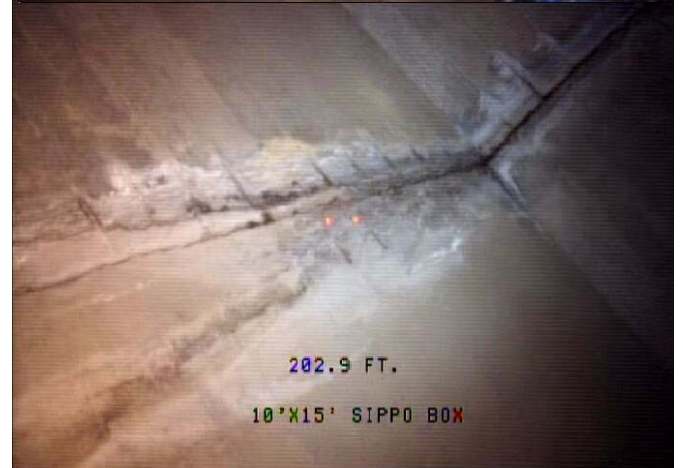
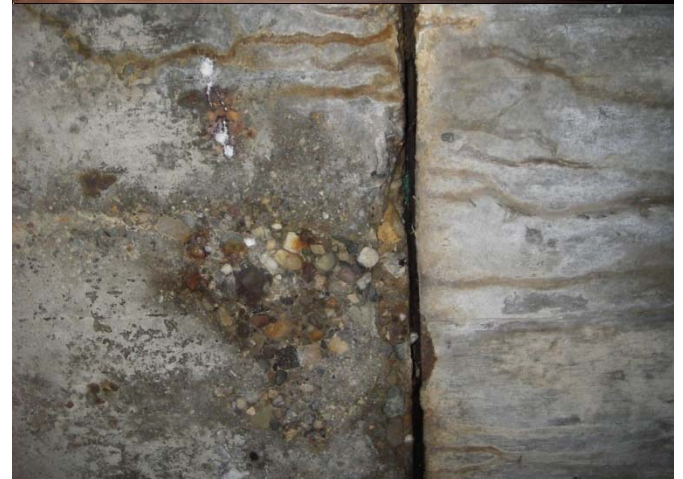
OVERALL CONDITION: NASSCO Rating 3: Moderate defects that will continue to deteriorate.

GENERAL INSPECTION FINDINGS: Most of the joints appear to have some weeping and/or signs of staining at the joints. Invert is rough in areas indicating moderate scouring. Rebar exposed and some spalling noticed in areas.

| Sippo Avenue 15' X 10' Box #37 | |
|---|---|
| 28ft | Spalling at joint |
| 56ft | Weeping and stained joint. Rebar exposed from deteriorating joint. |
| 76ft | Rebar exposed from deteriorating joint. |
| 83ft | Weeping and stained joint. Rebar exposed from deteriorating joint. |
| 98ft | Significant weeping and stained joint |
| 110ft | Weeping and stained joint. Rebar exposed from deteriorating joint. |
| 118ft | 4" scour hole left haunch |
| Outlet-Pump Pipes | Invert under water, rough in areas, indicating moderate scour in the invert. |

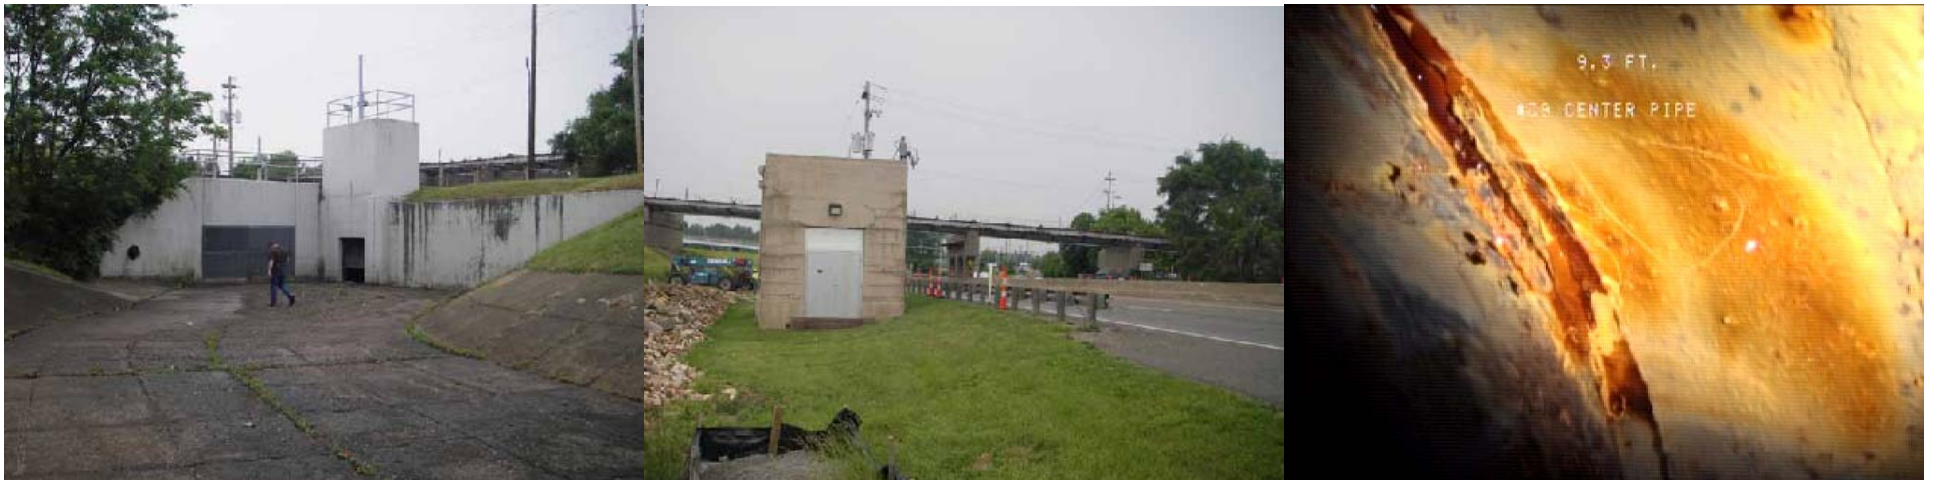
### Pipe #38, 39, 40

OVERALL CONDITION: NASSCO Grade 4: Pipe will properly fail in 5 to 10 years. Pipe rated at a more serious condition due to that it is a pump line going through a levee.

GENERAL INSPECTION FINDINGS: All three pipes have moderate to severe corrosion and rust at the joints and pipe walls. Missing protective coating was predominately around the haunches and inverts of the pipe. Recommend air pressure testing to verify integrity of the joints.

\*Note: Pipe #39 (center) at 9.3ft has a severe offset/separated joint with potential leakage.

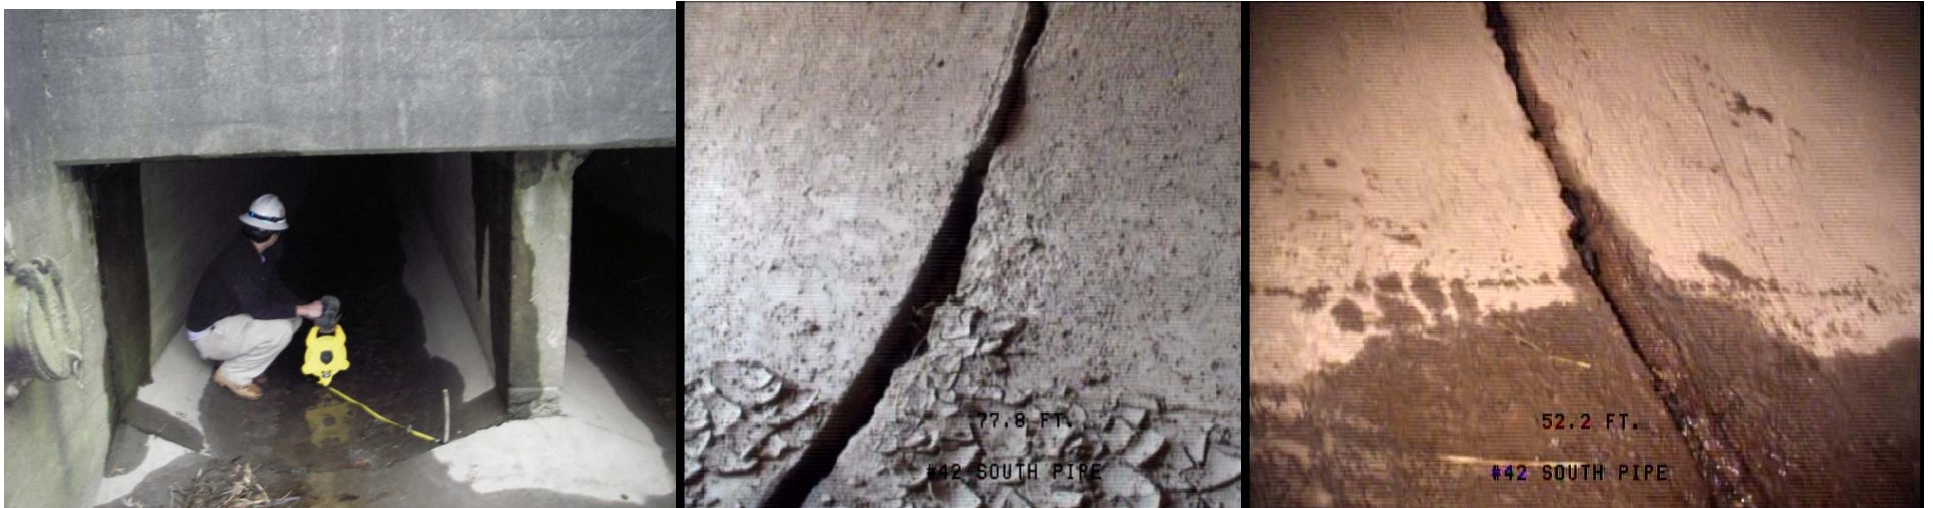
# Massillon, Ohio Arch Avenue 6'x6'RCB Pipe #42 (South Box)

OVERALL CONDITION: NASSCO Rating 3: Moderate defects that will continue to deteriorate.

| Arch Avenue Box #42 | |
|---|---|
| 0ft-2ft | Spalling, staining, and moisture at joint |
| 18ft | Spalling at joint right side |
| 52ft | Moisture in joint |
| 68ft-70ft | Spalling/staining of joint, deterioration and scouring at haunch |
| 84ft | Radial cracking near joint/ cracking at joint and exposed rebar at 11 o'clock |

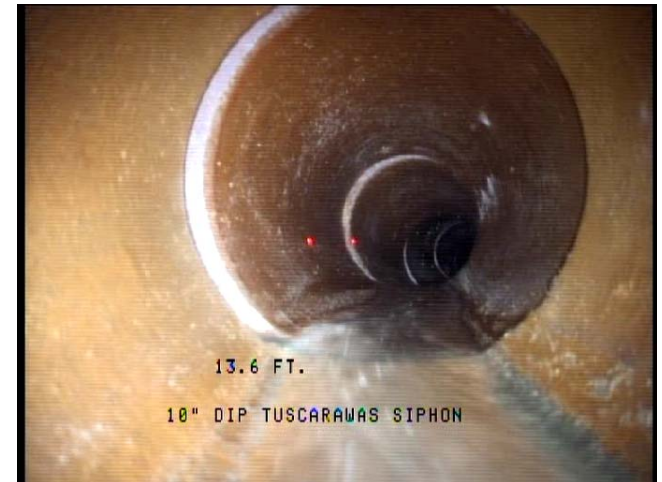
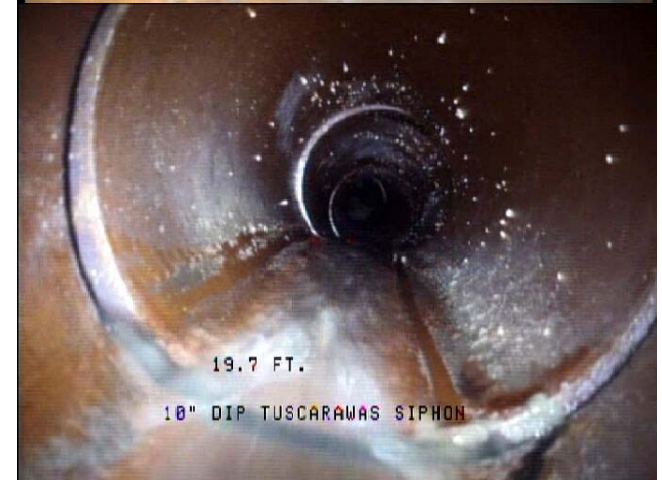
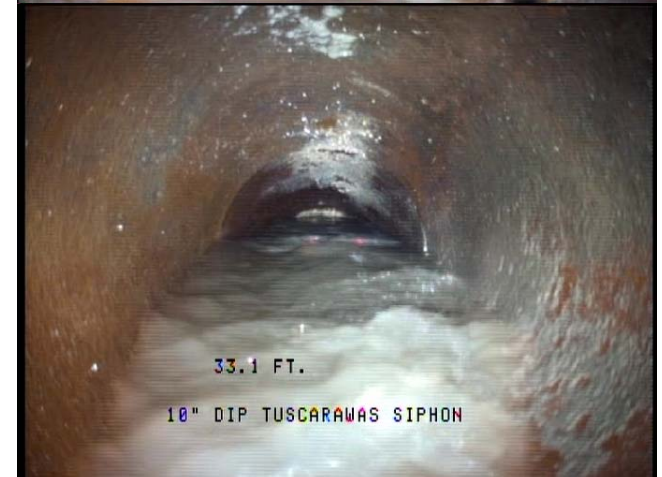
| Siphon Pipe No. 54 | |
|---|---|
| 32.0 | Grade begins to flatten out |
| 33.1 | End inspection due to high water |
