Pipes Inspected, Massillon Levee					
Size (Inches)	Material	Length (Feet)	Location					
18	RCP	103	West of RR with Flap Gate					
12	RCP?	175	Could not locate/unknown/does not exist					
42	RCP	95	Culvert through West Bank Levee opposite of Croose Avenue, 1000 ft					
			upstream of Cherry Rd.					
66	RCP	93	Culvert through East Bank Levee near control weir					
42	RCP	360	At inlet to siphon control weir					
			James Avenue Pump Station Gravity Outlet					
			Discharge from James Avenue Pump Station					
		100	Discharge from James Avenue Pump Station					
30	CIP	100	Discharge from James Avenue Pump Station					
			Federal Avenue Pump Station Outlet					
			Federal Avenue Pump Station Outlet					
			Discharge from Federal Avenue Pump Station					
		141	Discharge from Federal Avenue Pump Station					
30	CIP	141	Discharge from Federal Avenue Pump Station					
		120	Sippo Creek Pump Station					
			Discharge from Sippo Creek Pump Station

Army Corp of Engineers Rating Guidelines for Levee Inspection

HUNTINGTON DISTRICT

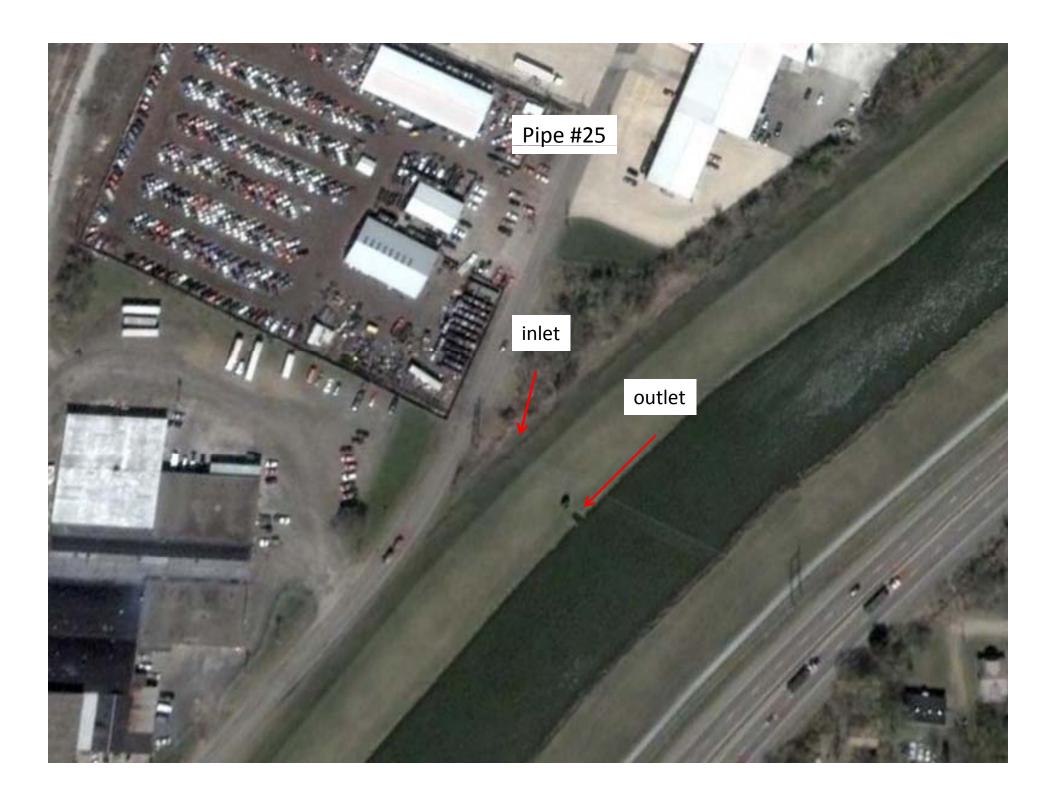
OVERALL CONDITION: NASSCO Grade 5 - Defect requires immediate attention

GENERAL INSPECTION FINDING: Inlet was completely buried and plugged. Significant joint leakage was occurring at the third joint from the inlet. Water continued to discharge from the joint for several weeks, Unsure of the water source. Joint material rolled from joint in several areas. Invert to springline appears to be grouted. Outlet end from gatewell to headwall could not be inspected.

Pipe #25				
Feet	Defect			
3.7ft	Offset joint, gasket rolled			
10.8ft	Significant leakage at joint, running for several			
	weeks			
15.1ft	Staining at joint			
19 1ft	Diagonal crack in hell			
22.4ft	Staining at joint			
31ft	Staining at joint			
46.9 ft	Gasket rolled			
78.9ft	Crack through bell

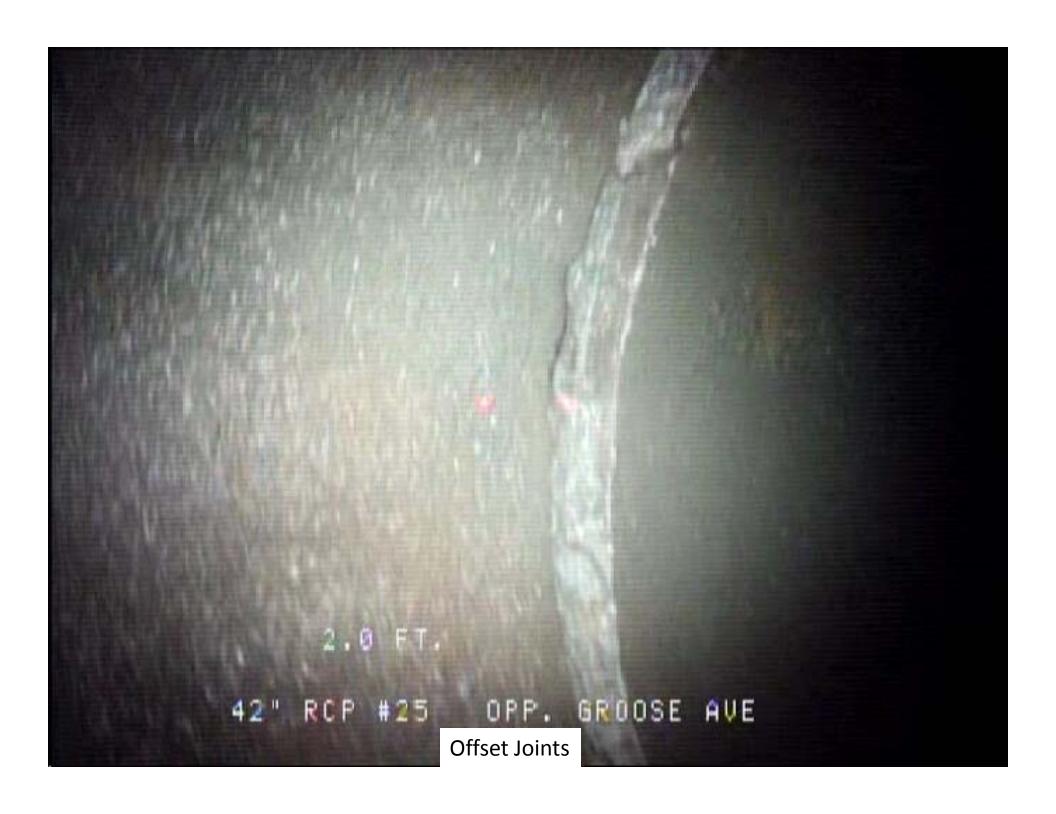
Joint leaking 3.7 FT. 42" RCP #25 OPP. GROOSE AVE " RCP #25 OPP. GROOSE AVE

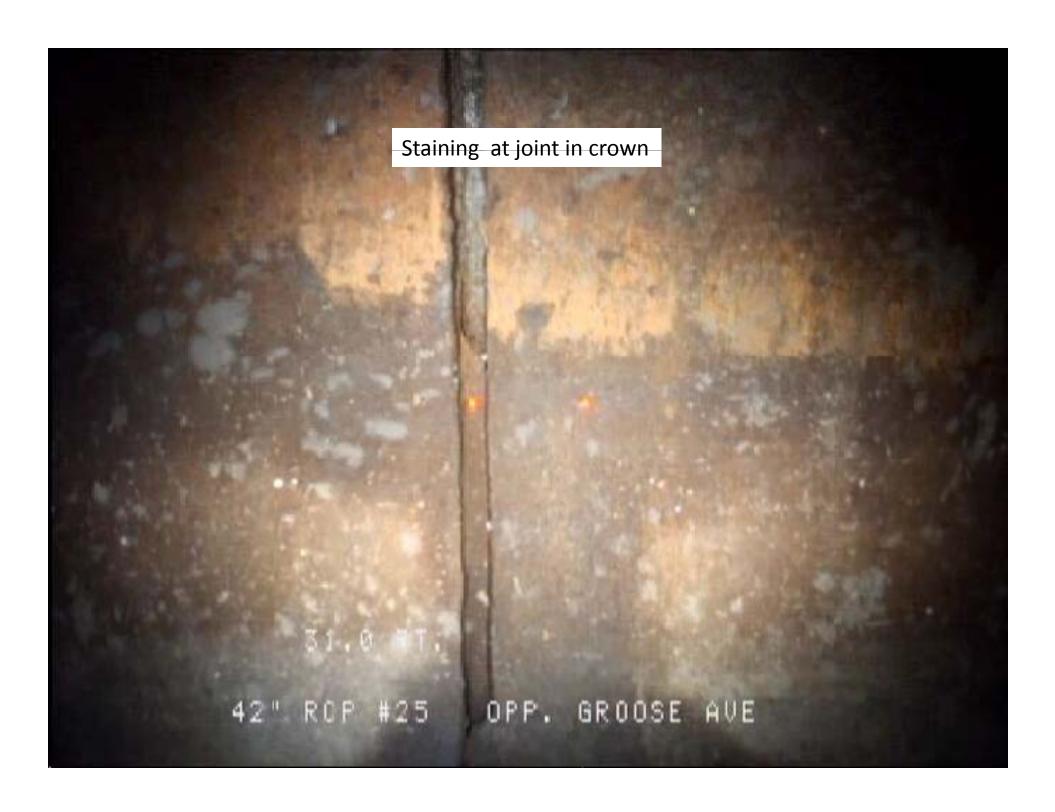
22.4 FT.

Staining at joint in crown

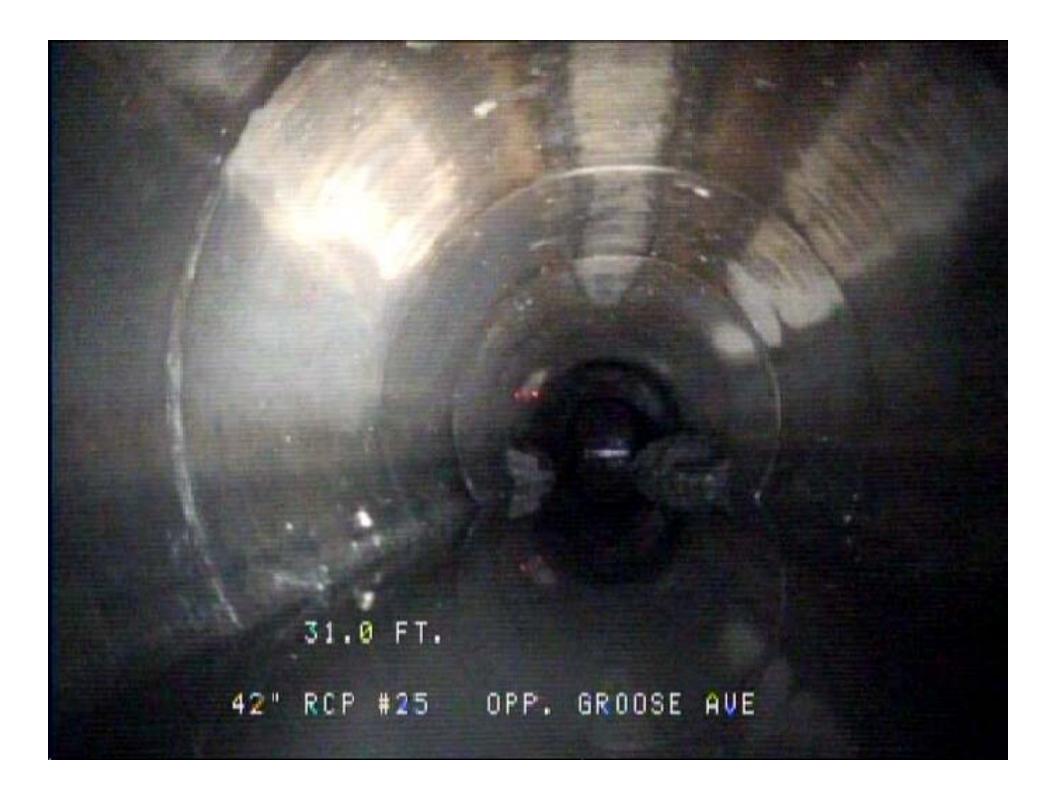
Pipe grouted to springline, photo inverted 38.8 FT. OPP. GROOSE AVE 42" RCP #25

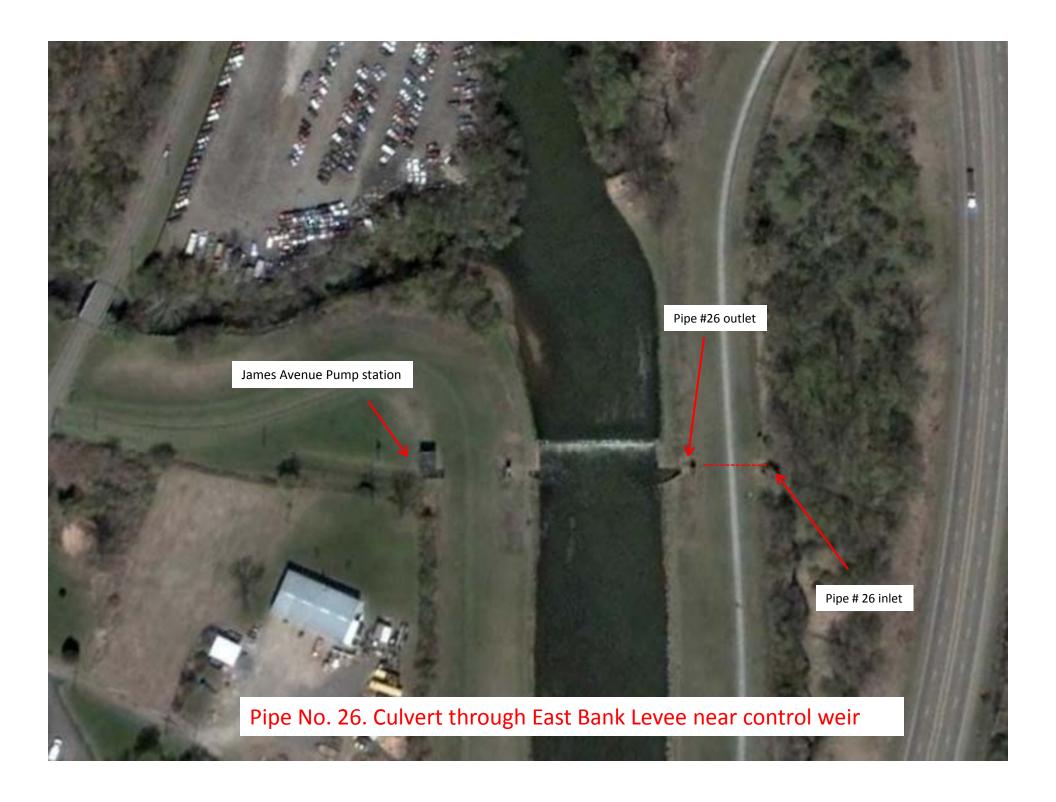
Pipe No. 26 66-Inch RCP Storm Drain

OVERALL CONDITION: NASSCO Grade 5 - Defects required immediate attention

GENERAL INSPECTION FINDING: Several joints offset throughout the structure, several joints broken, moisture present at several joints, pipes starting to show possible distress from water moving outside the structure.

Pipe # 26					
Feet	Defect				
Start-Outlet	Invert of headwall scoured/eroded and missing, 17" across. 4"				
	depth of invert missing				
ft Offset joint, cracked, spalled, scoured					
12ft	Concrete missing from invert of pipe, entrance into gatewell				
21ft	Busted, broken joint. Piece missing from joint/scouring/ 4"				
	joint separation, offset joint , backfill visible				
22ft	Spalling/joint				
35ft	Moisture/water flowing @haunch				
42ft	Deterioration of joint at invert				
46ft	Offset Joint				
52ft	1" offset joint				
57ft	Spalling at joint				
62ft	Seal exposed and being pushed from joint				
67ft	Joint seal deteriorating, moisture present at joint				
67ft	Wet joint left haunch				
73ft	1 1/2" joint separation left haunch, moisture present				
73ft	4" penetration left haunch				
78ft	Scouring of joint at approx. 11 o'clock				
83ft	Spalled/broken invert/moisture present				
88ft	Spalled/broken invert/moisture present

93ft	Large piece of headwall missing at invert of inlet approx. 36"				
	across
