Pipes Inspected, Massillon Levee					
Size (Inches)	Material	Length (Feet)	Location					
18	RCP	103	West of RR with Flap Gate					
12	RCP?	175	Could not locate/unknown/does not exist					
42	RCP	95	Culvert through West Bank Levee opposite of Croose Avenue, 1000 ft					
			upstream of Cherry Rd.					
66	RCP	93	Culvert through East Bank Levee near control weir					
42	RCP	360	At inlet to siphon control weir					
			James Avenue Pump Station Gravity Outlet					
			Discharge from James Avenue Pump Station					
		100	Discharge from James Avenue Pump Station					
30	CIP	100	Discharge from James Avenue Pump Station					
			Federal Avenue Pump Station Outlet					
			Federal Avenue Pump Station Outlet					
			Discharge from Federal Avenue Pump Station					
		141	Discharge from Federal Avenue Pump Station					
30	CIP	141	Discharge from Federal Avenue Pump Station					
		120	Sippo Creek Pump Station					
			Discharge from Sippo Creek Pump Station

Army Corp of Engineers Rating Guidelines for Levee Inspection

HUNTINGTON DISTRICT

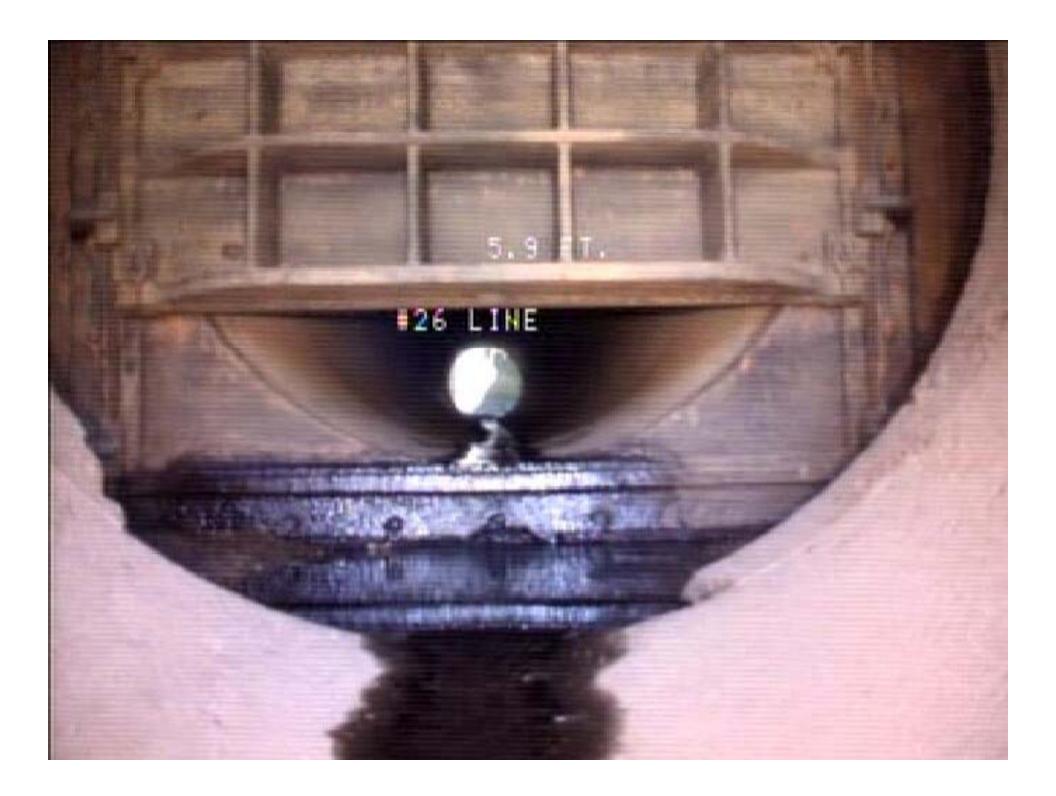
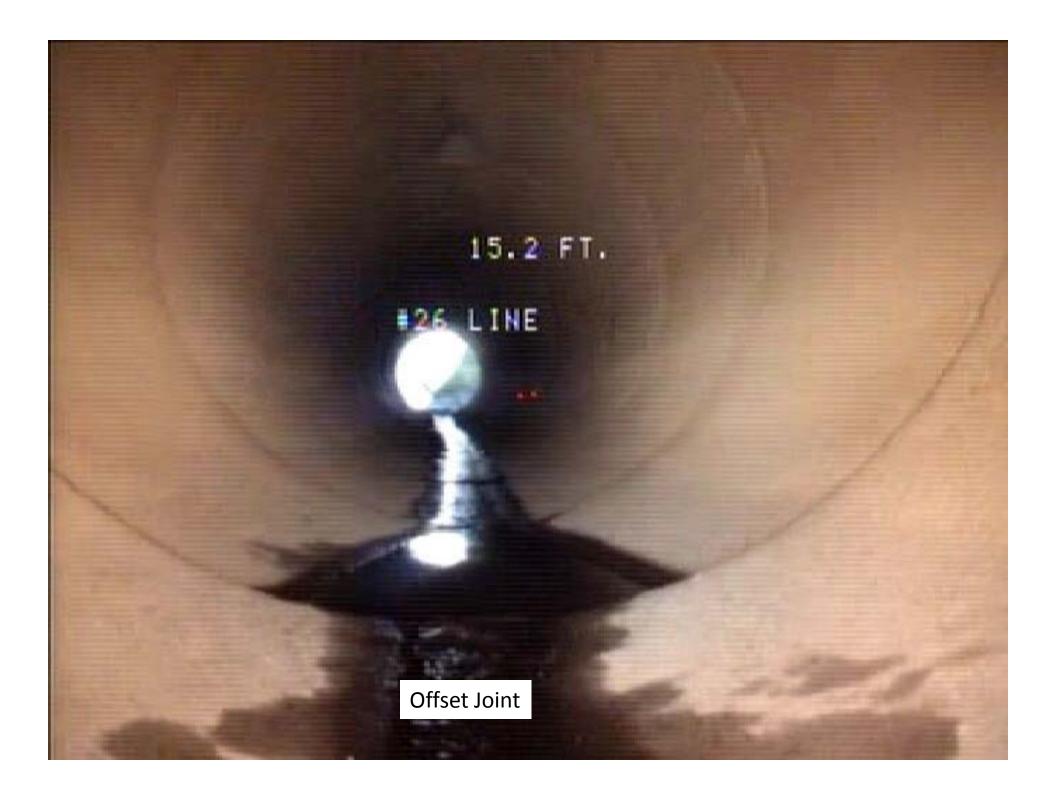
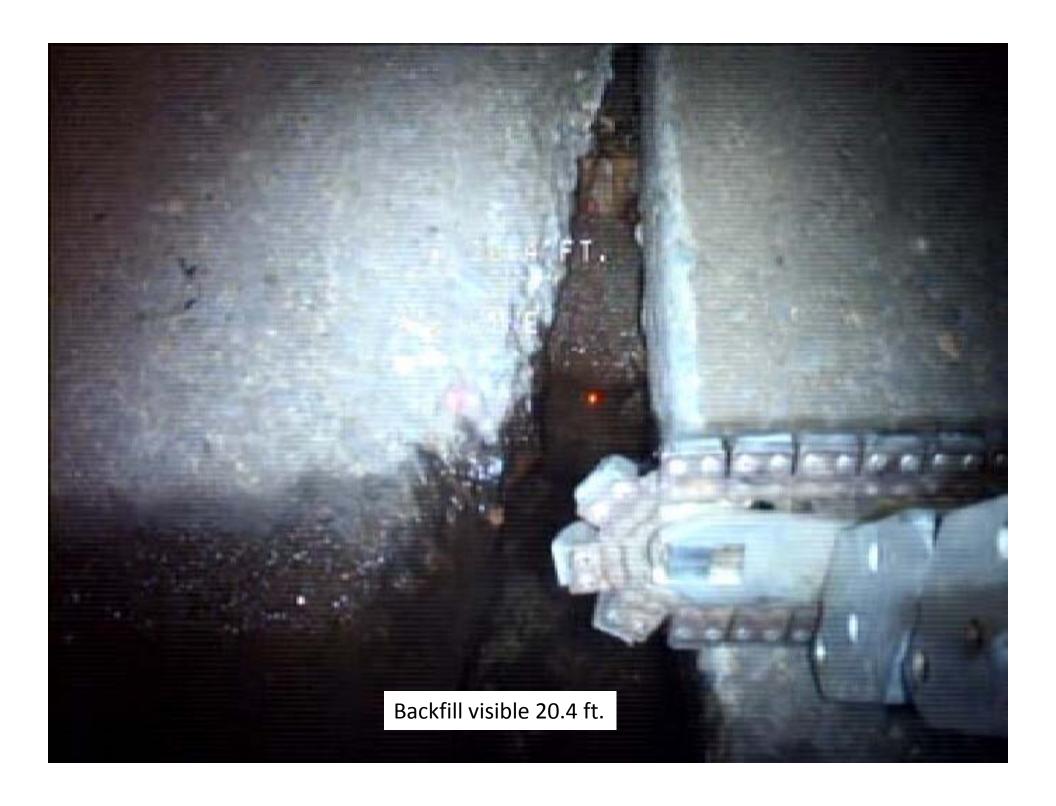
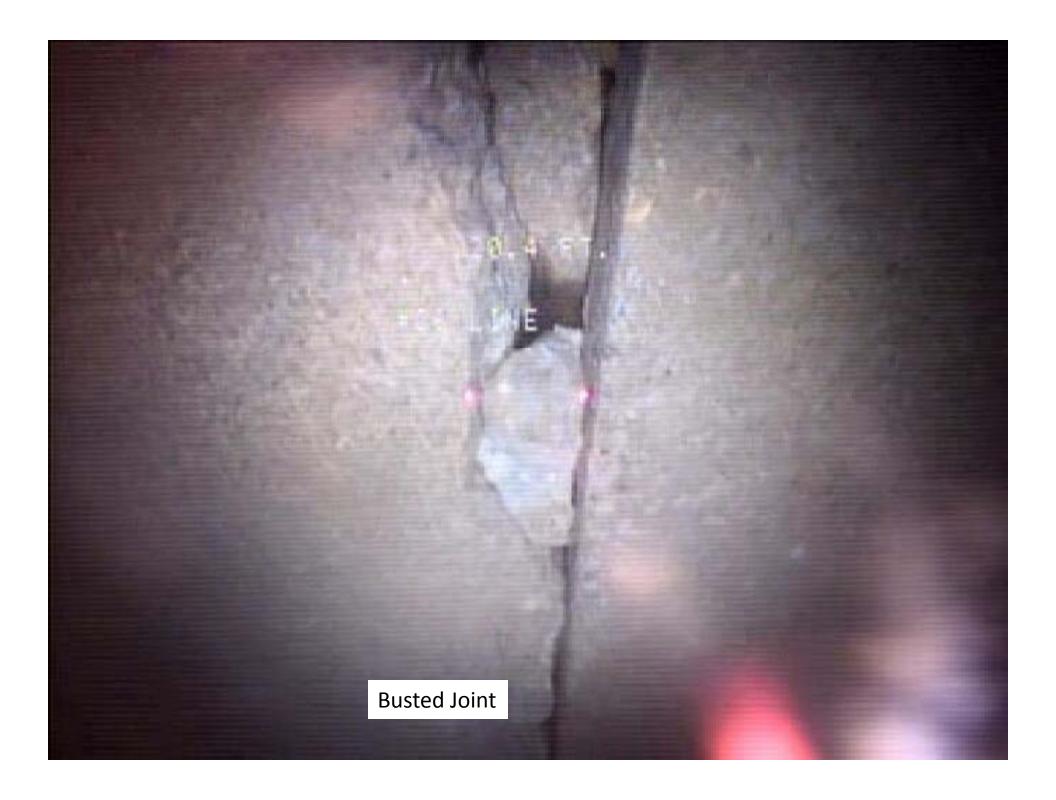
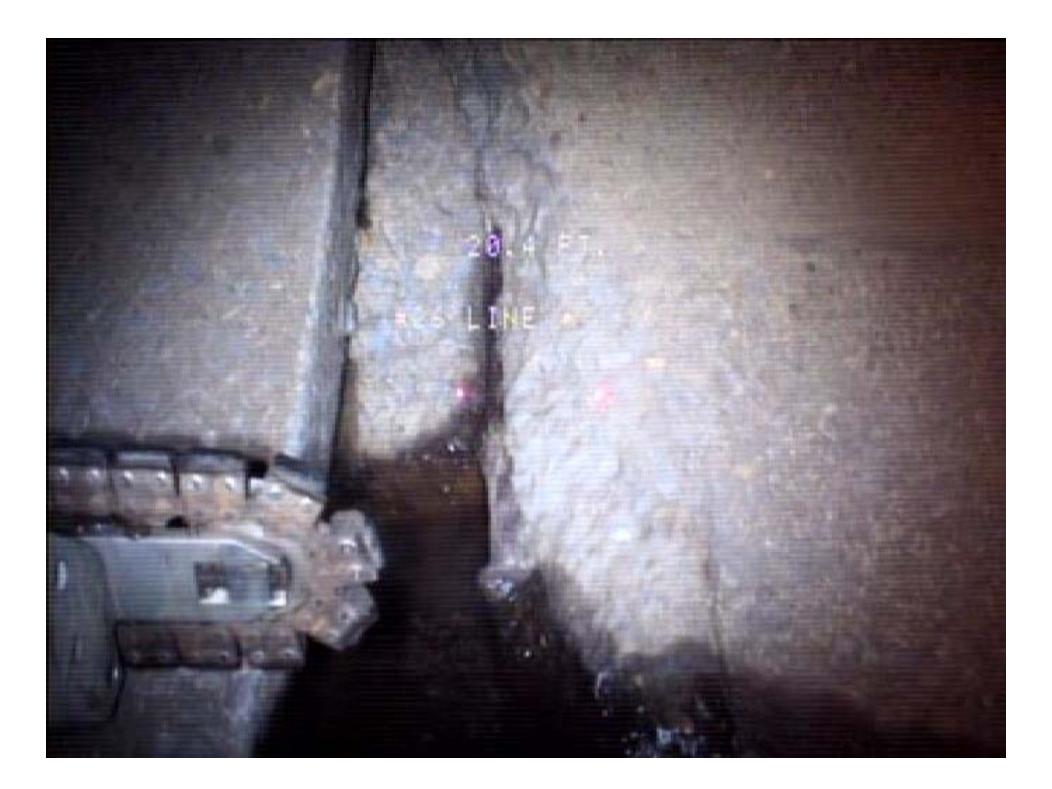
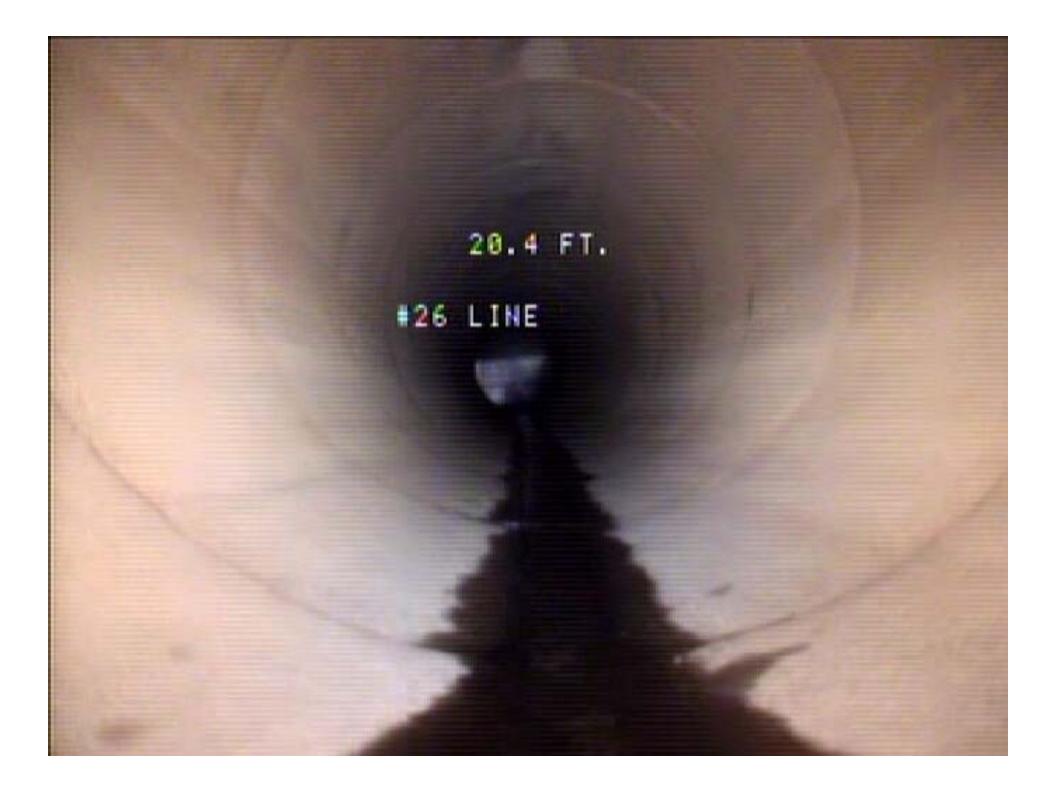
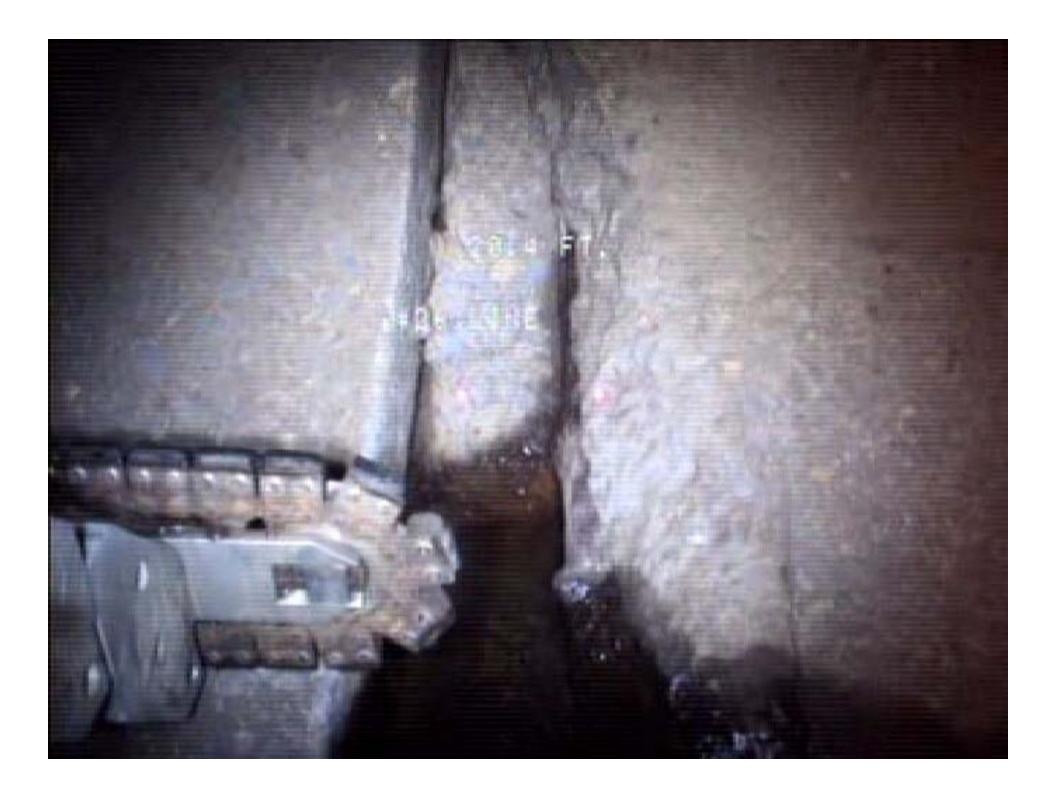
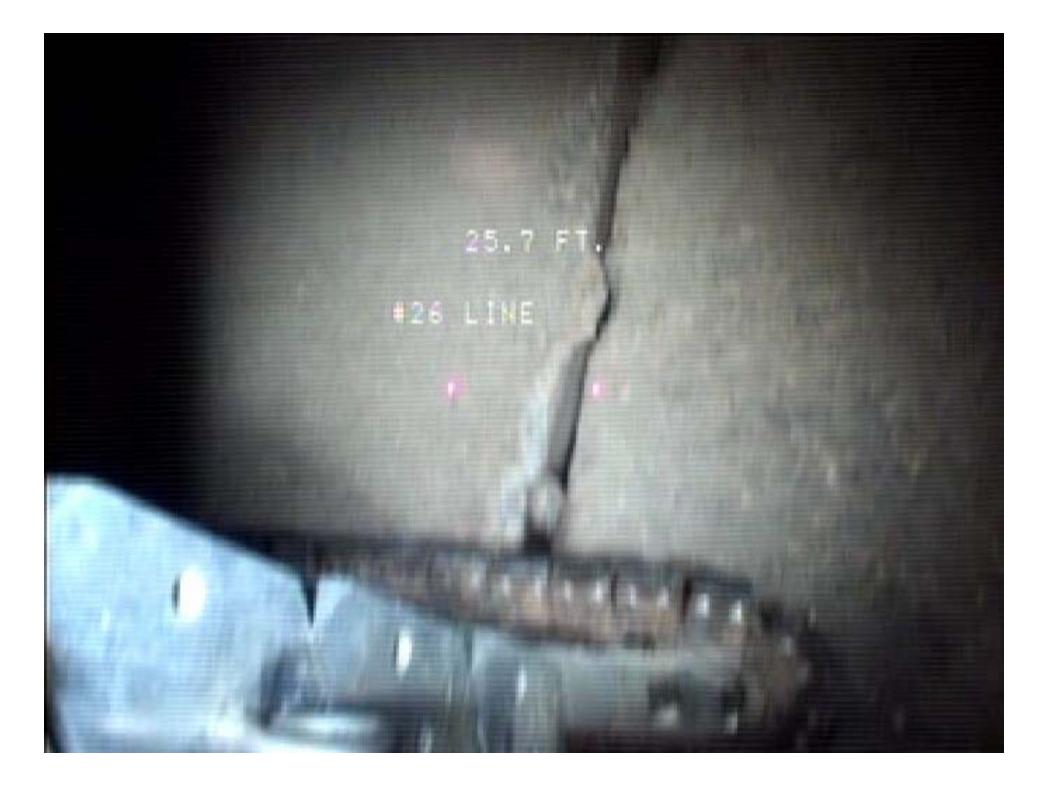
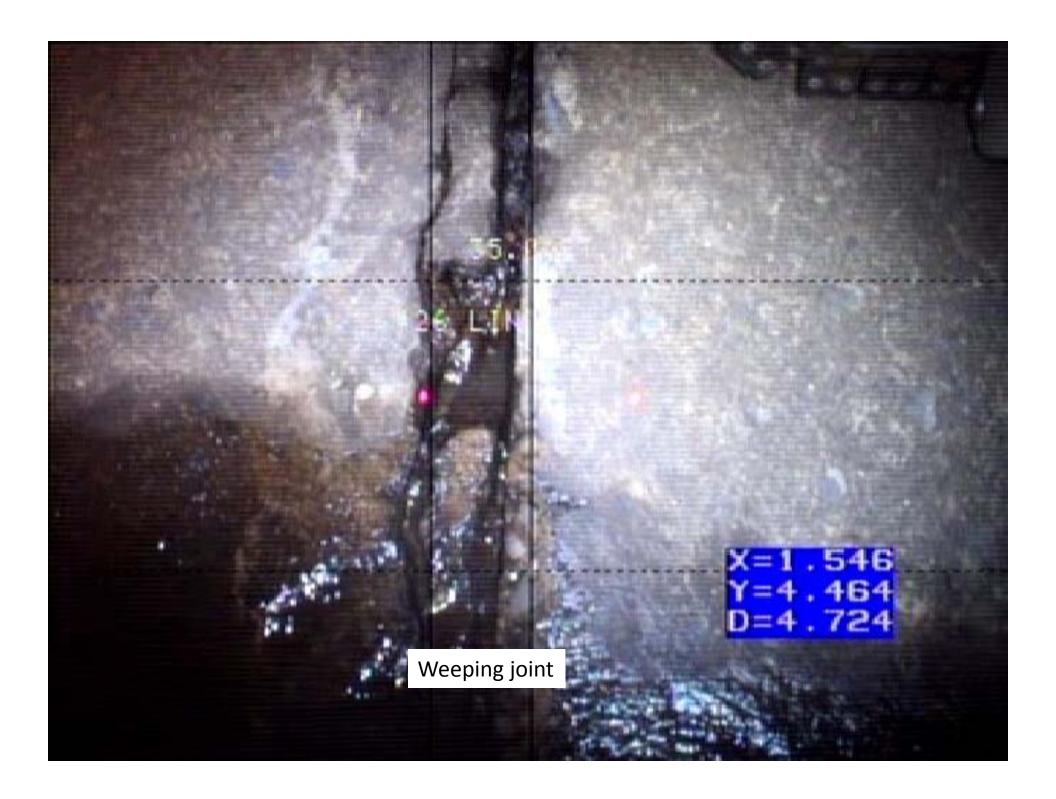
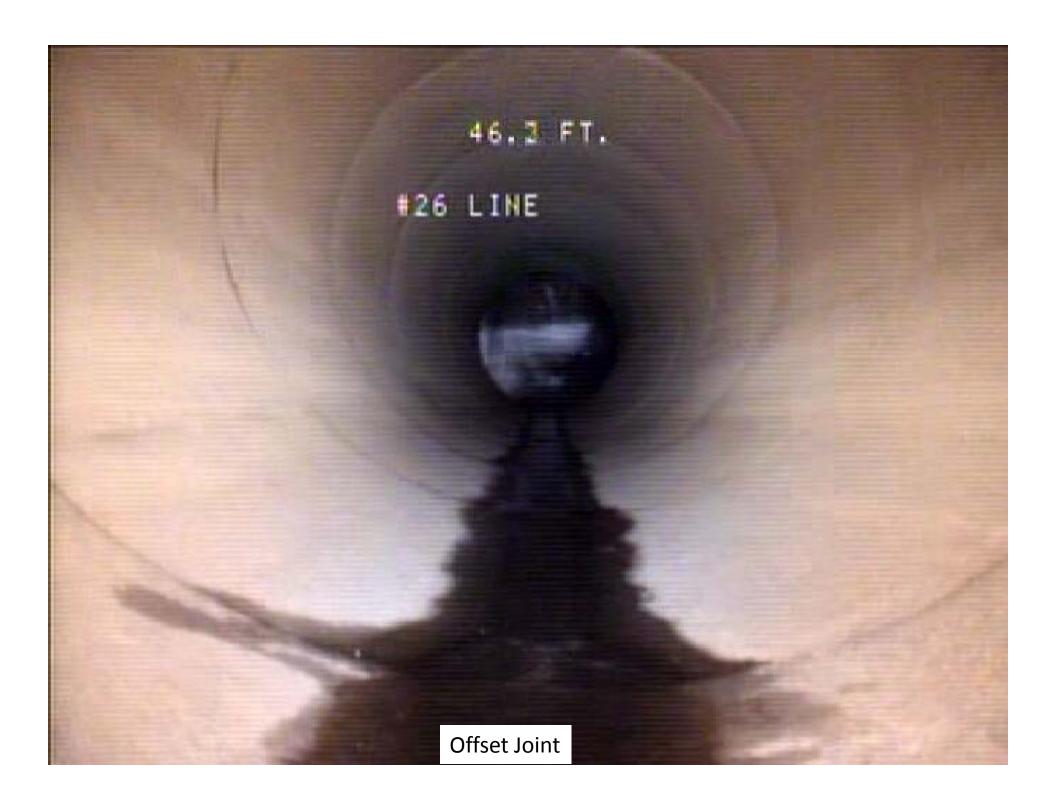
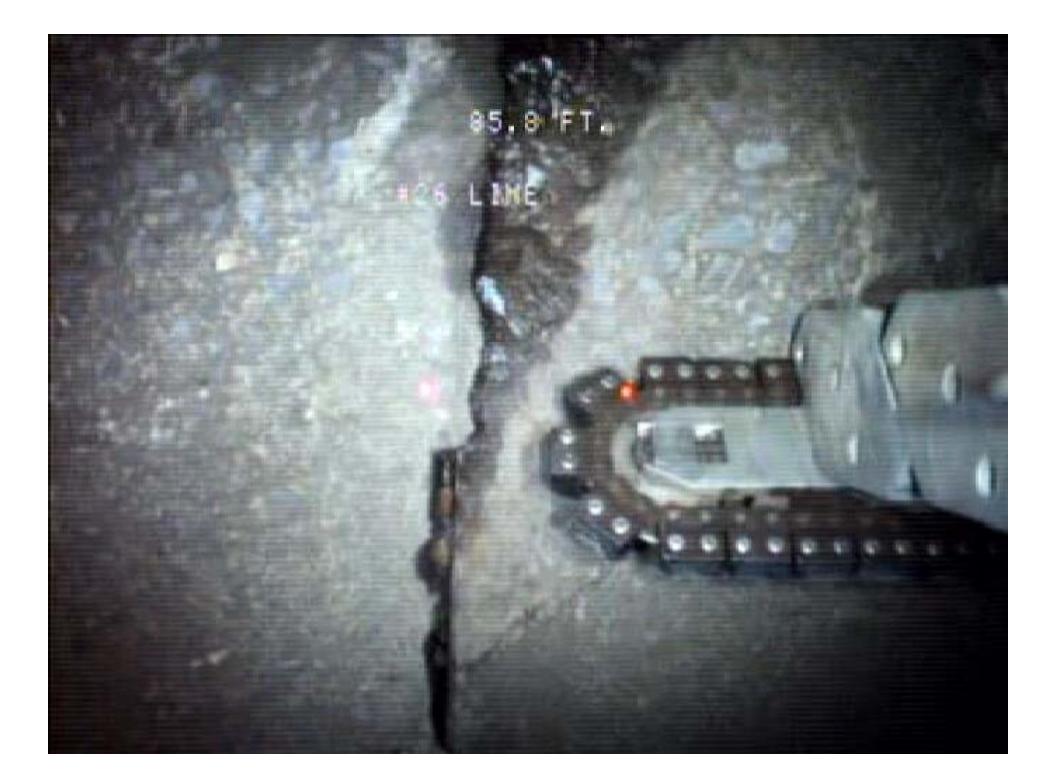
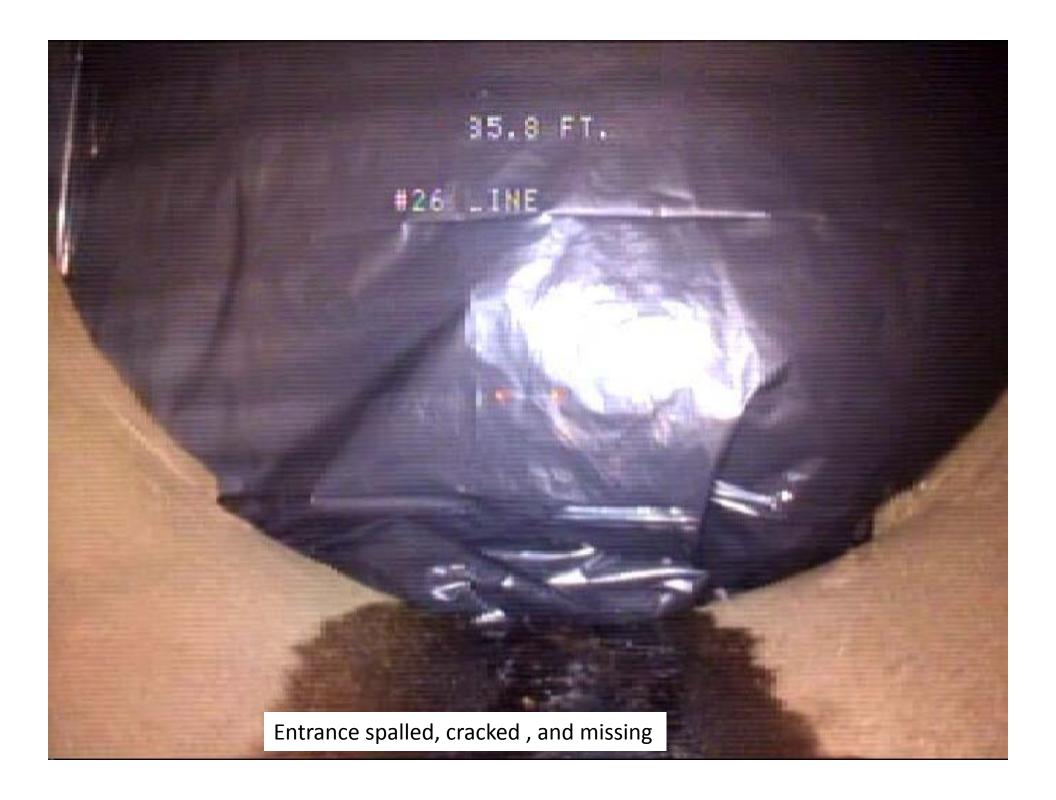
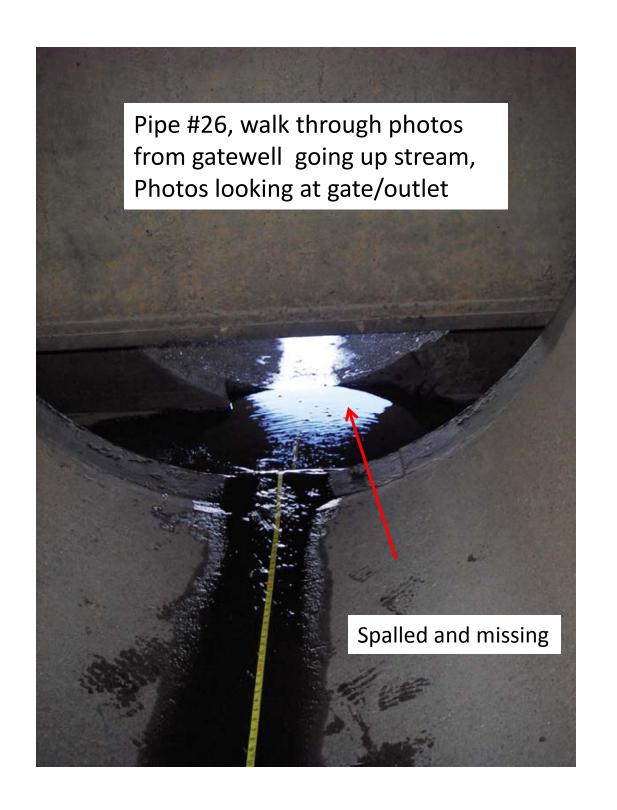
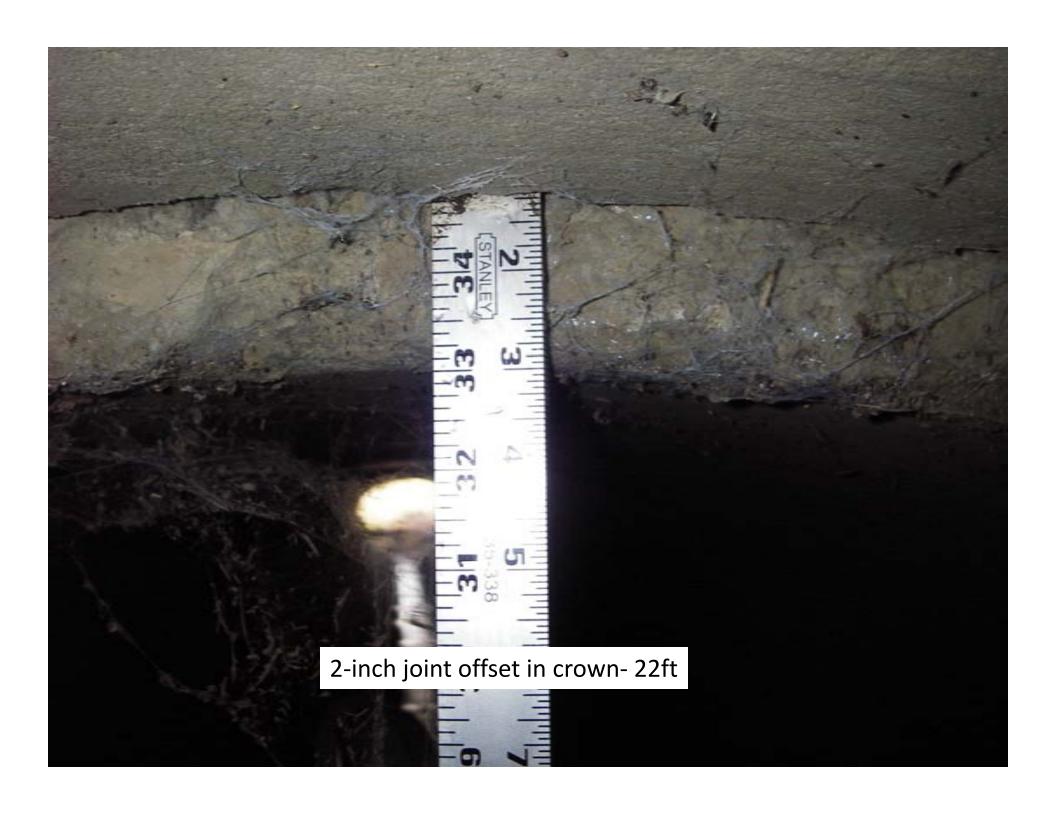
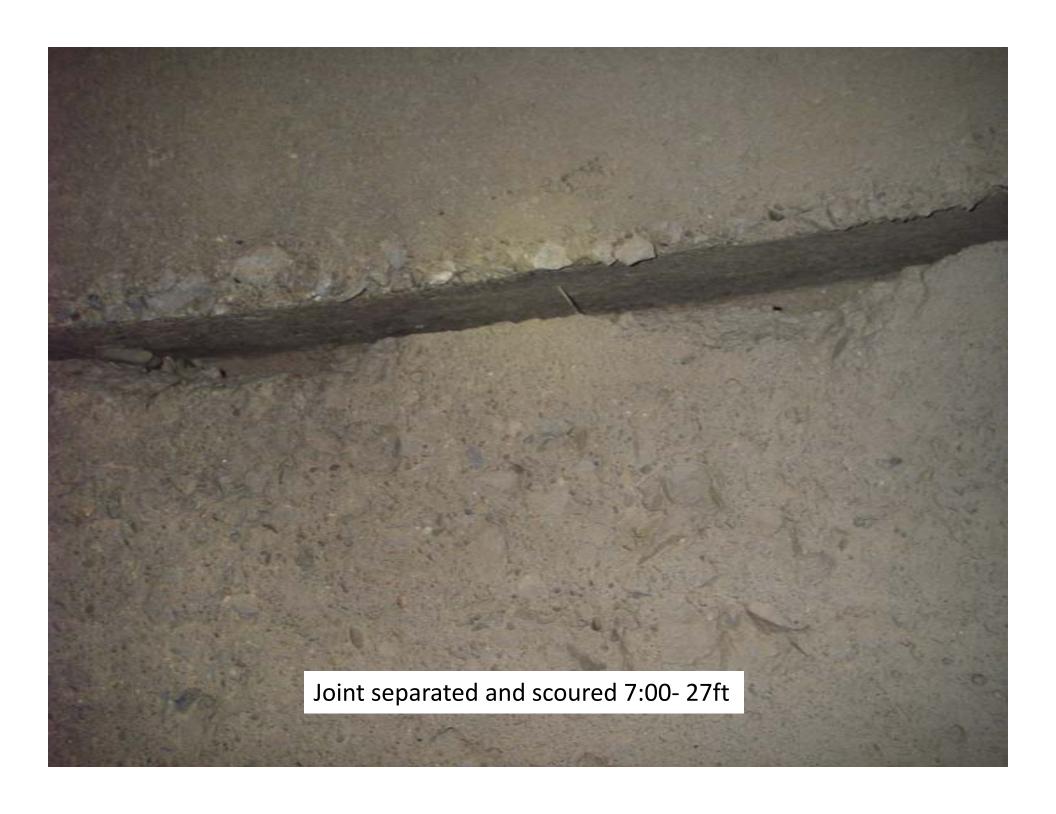
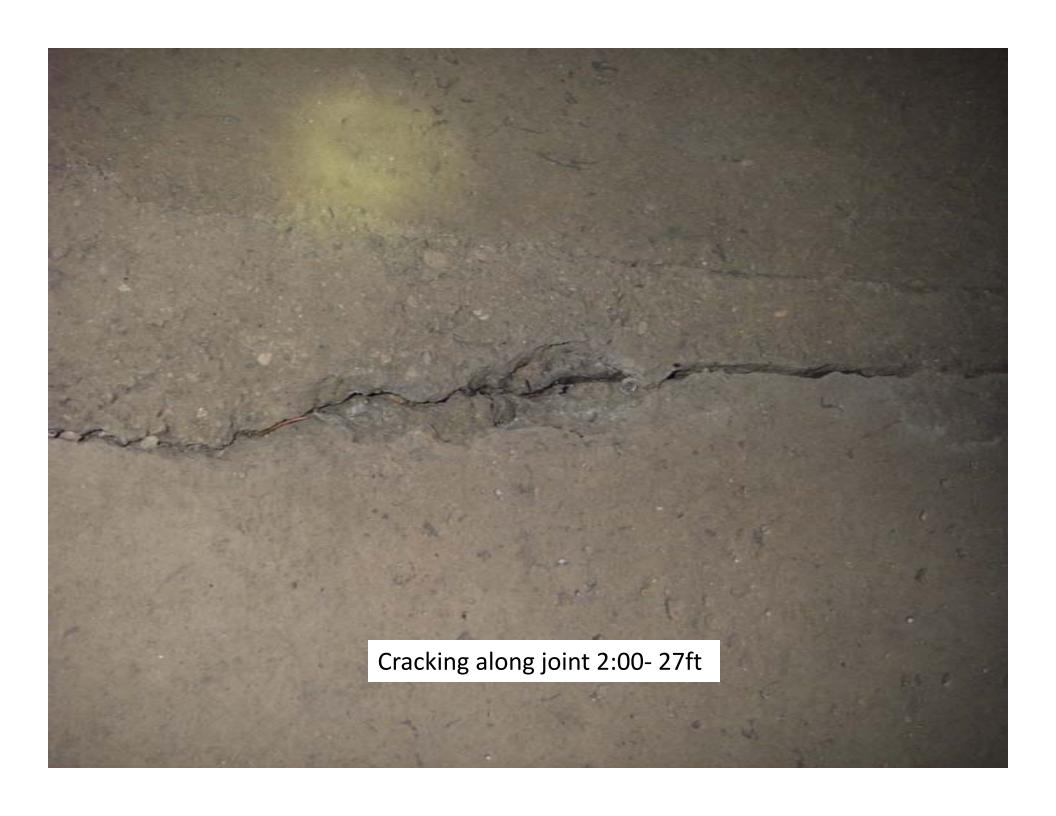
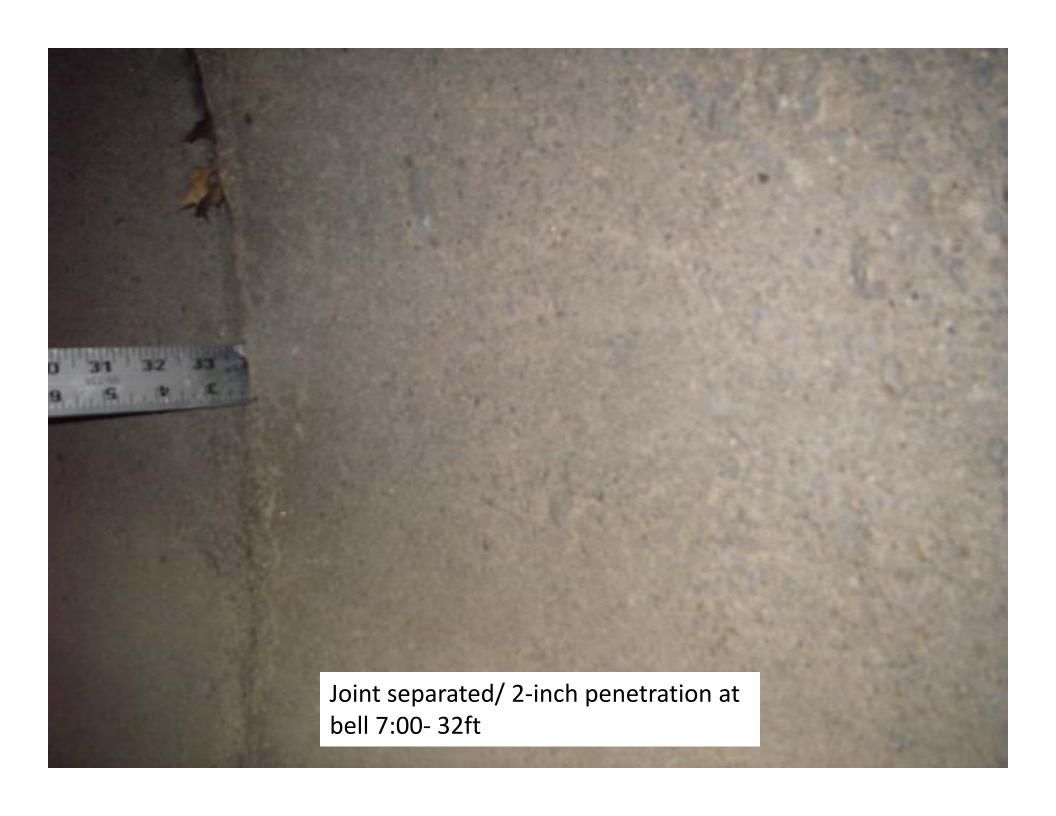
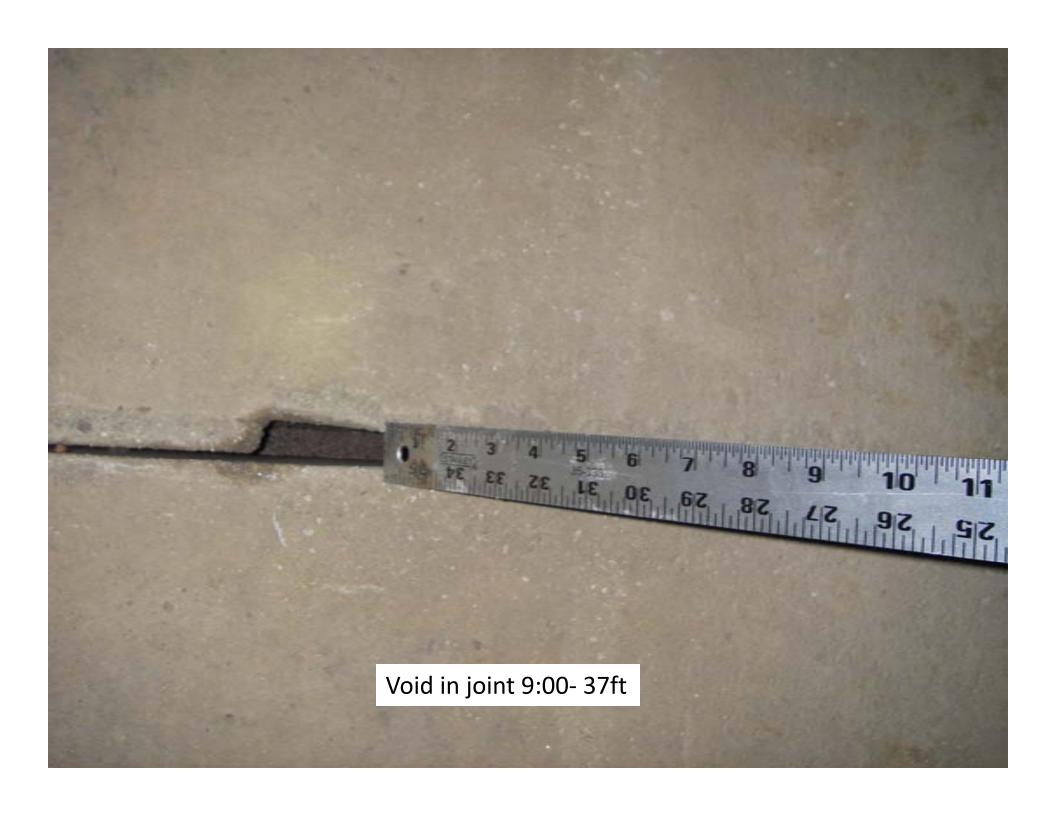
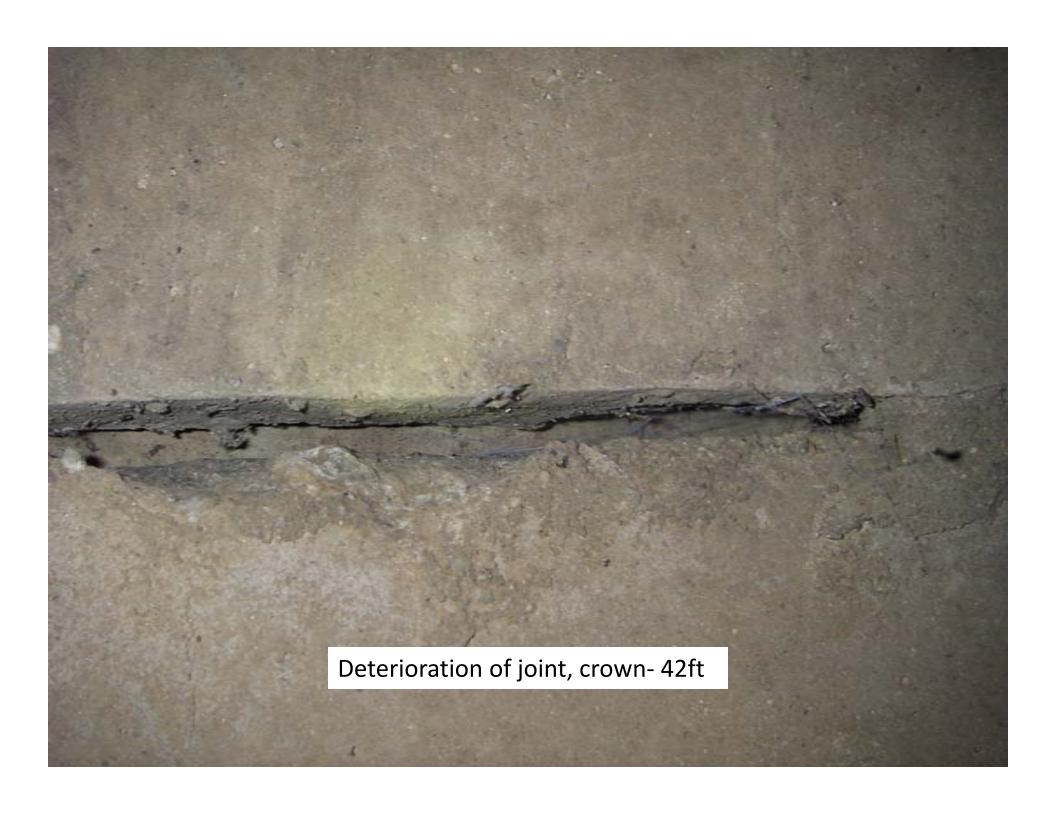
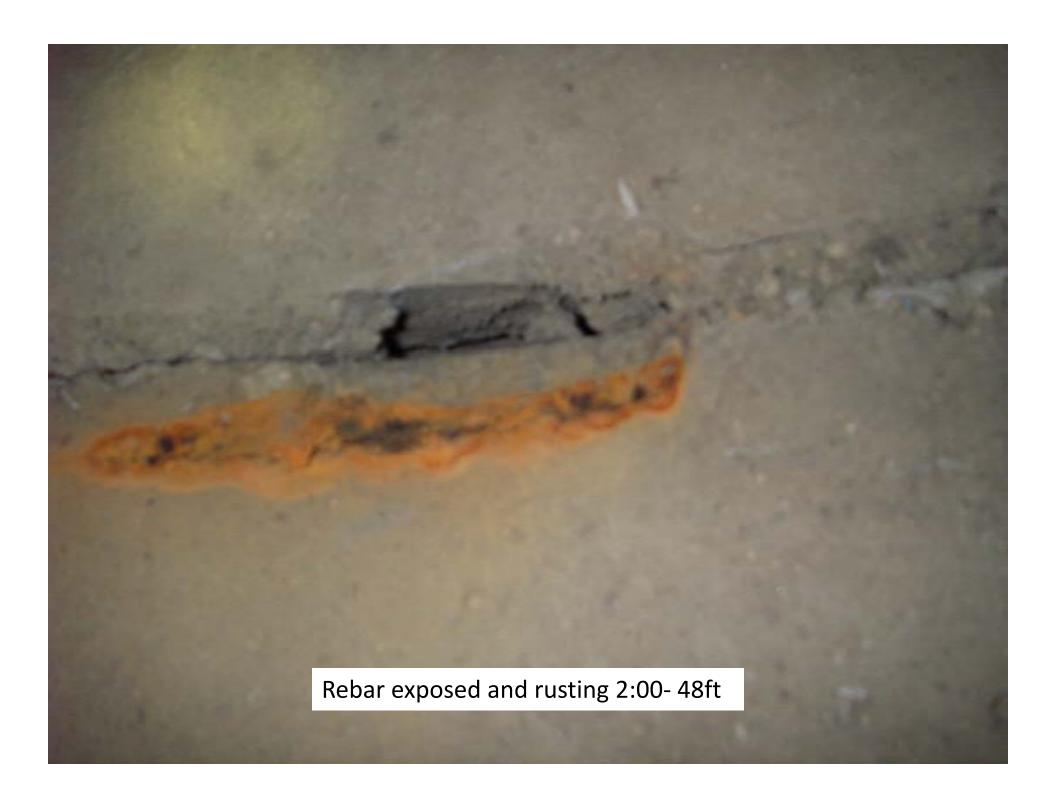
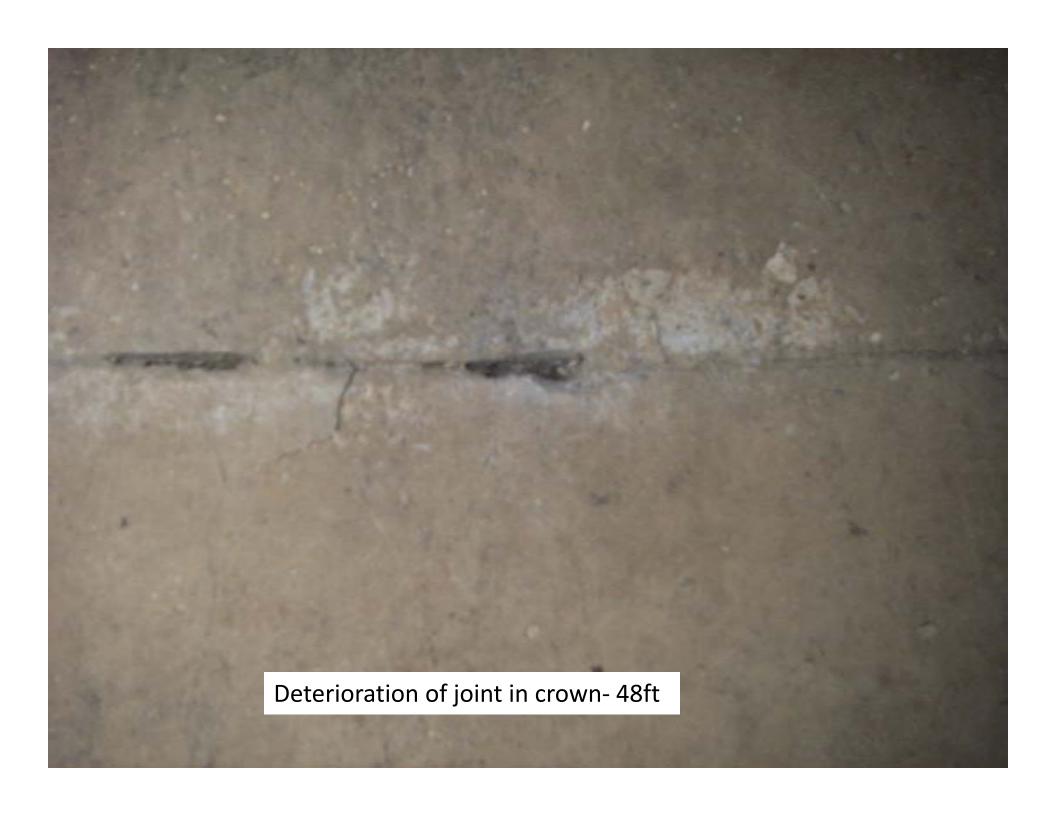
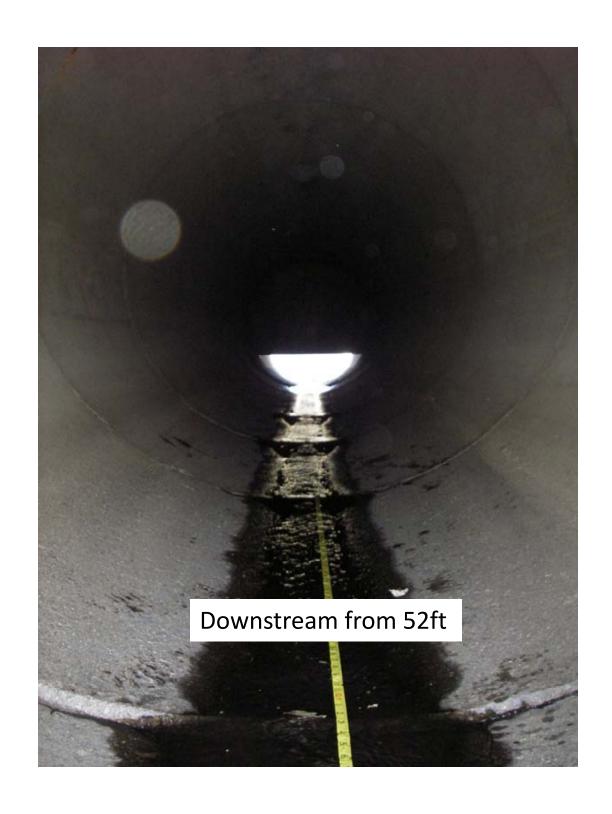
OVERALL CONDITION: NASSCO Grade 5 - Defects required immediate attention

GENERAL INSPECTION FINDING: Several joints offset throughout the structure, several joints broken, moisture present at several joints, pipes starting to show possible distress from water moving outside the structure.

Pipe # 26					
Feet	Defect				
Start-Outlet	Invert of headwall scoured/eroded and missing, 17" across. 4"				
	depth of invert missing				
ft Offset joint, cracked, spalled, scoured					
12ft	Concrete missing from invert of pipe, entrance into gatewell				
21ft	Busted, broken joint. Piece missing from joint/scouring/ 4"				
	joint separation, offset joint , backfill visible				
22ft	Spalling/joint				
35ft	Moisture/water flowing @haunch				
42ft	Deterioration of joint at invert				
46ft	Offset Joint				
52ft	1" offset joint				
57ft	Spalling at joint				
62ft	Seal exposed and being pushed from joint				
67ft	Joint seal deteriorating, moisture present at joint				
67ft	Wet joint left haunch				
73ft	1 1/2" joint separation left haunch, moisture present				
73ft	4" penetration left haunch				
78ft	Scouring of joint at approx. 11 o'clock				
83ft	Spalled/broken invert/moisture present				
88ft	Spalled/broken invert/moisture present

93ft	Large piece of headwall missing at invert of inlet approx. 36"				
	across

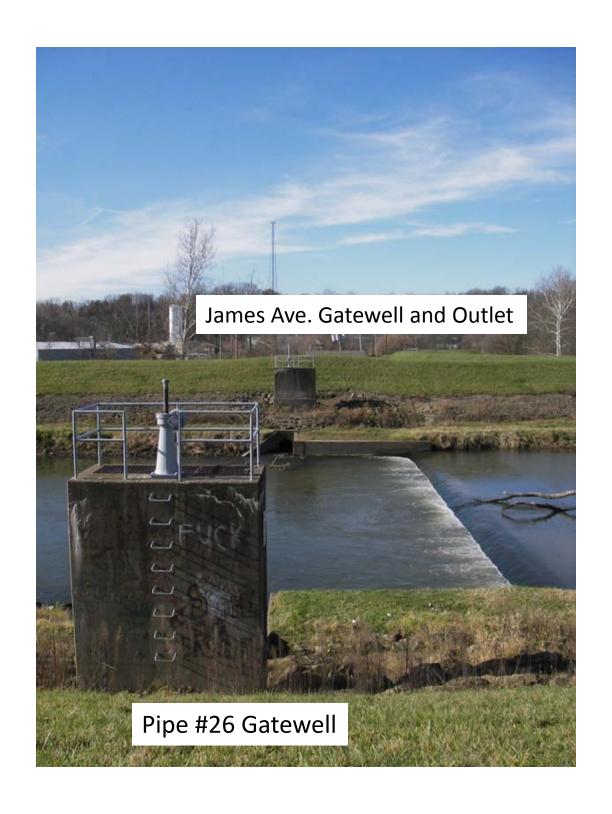
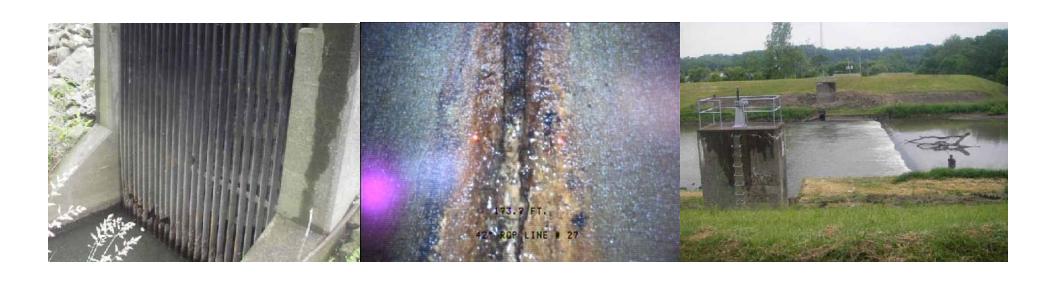
Pipe No. 27 42-Inch RCP Storm Drain/Siphon

OVERALL CONDITION: NASSCO Grade 5 - Defects required immediate attention

GENERAL INSPECTION FINDING: DIP moderately corroded, several stained and leaking joints in RCP pipe. Heavy flow from joint at 173 feet. Radial and diagonal cracking noted in several areas along upstream side of the structure.

Pipe # 27					
Feet	Defect				
Start	DIP Pipe, moderately corroded				
2ft-123ft	DIP				
123ft	DIP to RCP				
127ft	Weeping joint				
141ft	Diagonal/Radial Cracking				
155ft	Radial Cracking				
169ft	Offset Joint				
173ft	Leaking Joint/Gushing/flowing				
175ft	Radial Cracking				
177ft	Staining at joint				
193ft	Diagonal/Radial Cracking				
200ft	Staining/moisture at joint				
251ft	Staining/moisture at joint				
262ft	Diagonal cracking at joint				
266ft	RCP to DIP				
376ft	Gatewell

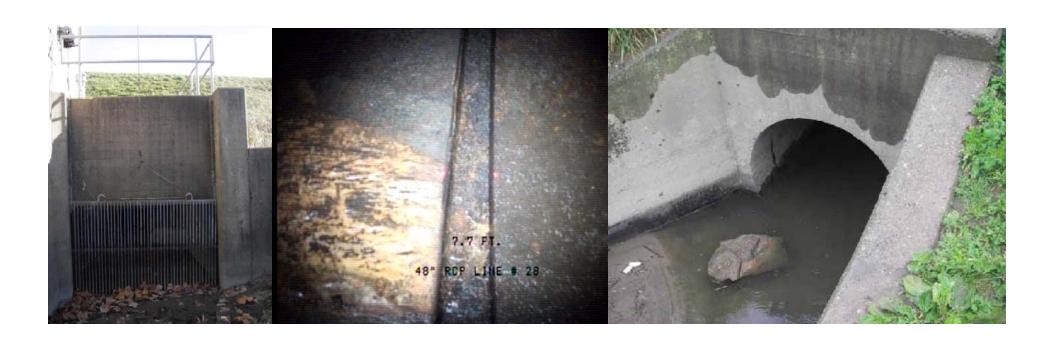
Pipe No. 28 James Avenue Pump Station 48-inch RCP Gravity Outlet

OVERALL CONDITION: NASSCO Grade 4 - Severe defects that will become Grade 5 in near future

Pipe # 28					
Feet	Defect				
7.7ft	Pipe sagging, approx. 2"+ joint separation at 4 o'clock				
23.5ft	Pipe sagging, approx. 1 1/2" joint separation right haunch				
39.4ft	Pipe sagging, 1.3" joint separation at approx. 3 o'clock				
70ft	Weeping joint at approx. 9 o'clock, near gatewell				
76.6ft	Gatewell				
81.5ft	Weeping joint at approx. 3 o'clock				
86.6ft	Weeping joint at approx. 3 o'clock				
91.2ft	Weeping joint				
96 1ft	loint tight

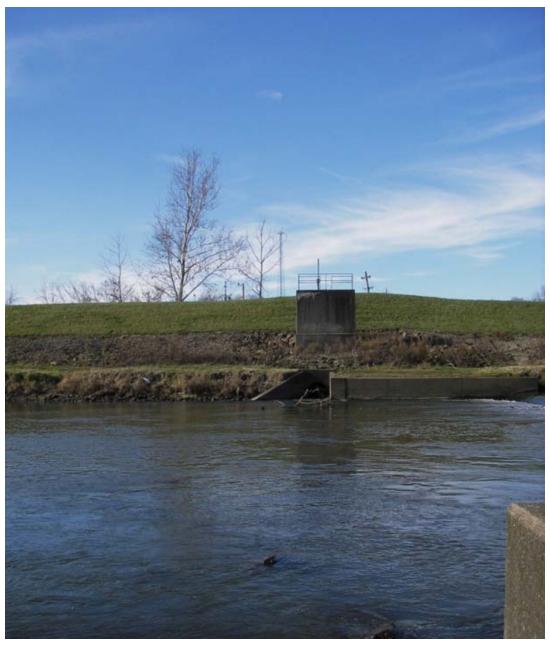
Looking from pipe #26 towards James Avenue

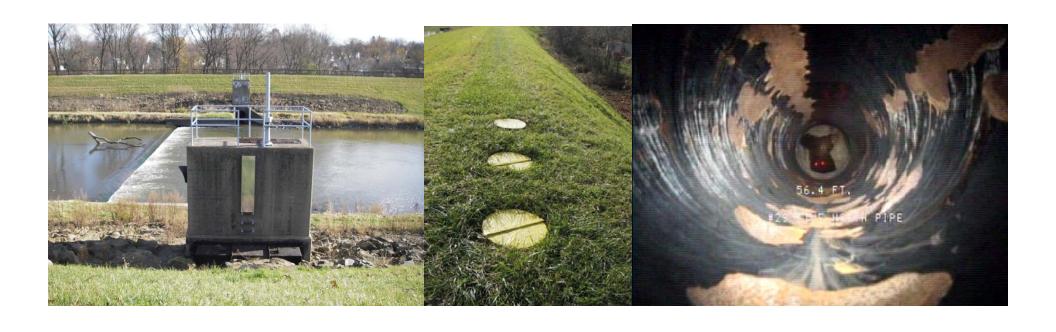
Pipe No. 29, 30, 31 30-Inch DIP Discharge Pipes

OVERALL CONDITION: NASSCO Grade 4: Pipe will probably fail in 5 to 10 years. Pipe rated at a more serious condition due to that it is a pump line going through a levee.

GENERAL INSPECTION FINDING: GENERAL INSPECTION FINDINGS: All three pipes have moderate to severe corrosion at the joints. Bellies have formed in the flat areas of the pipe at the beginning and the end of the runs toward the pump station. Missing protective coating and corrosion was also noted in flat areas and sharp bends. It appears in some sections that point repairs have been made on the protective coating. Recommend air pressure testing to verify integrity of the joints.

Feet	Defect	
0-100 ft	All three pipes have moderate to severe corrosion at the joints. Bellies have formed in the flat areas of the pipe at the beginning and the end of the runs toward the pump station. Missing protective coating and corrosion was also noted in flat areas and sharp bends. It appears in some sections that point repairs have been made on the protective coating. Recommend air pressure testing to verify integrity of the joints.

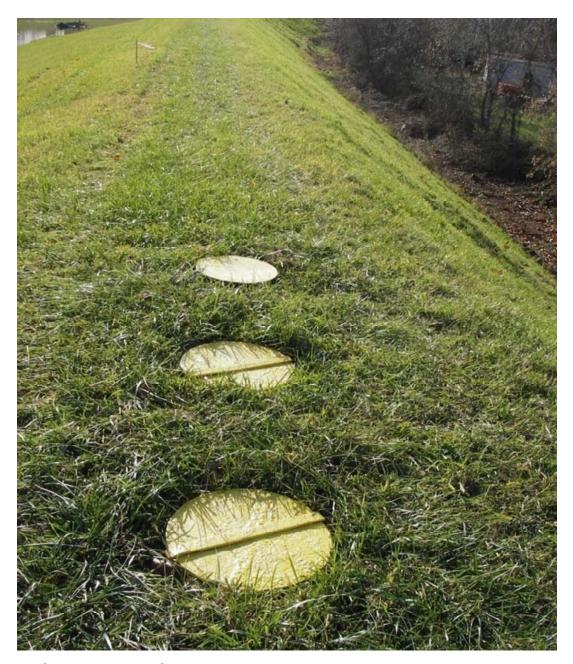
Siphon Breakerss on Levee, James Avenue Pump Station
