Pipes Inspected, Massillon Levee					
Size (Inches)	Material	Length (Feet)	Location					
18	RCP	103	West of RR with Flap Gate					
12	RCP?	175	Could not locate/unknown/does not exist					
42	RCP	95	Culvert through West Bank Levee opposite of Croose Avenue, 1000 ft					
			upstream of Cherry Rd.					
66	RCP	93	Culvert through East Bank Levee near control weir					
42	RCP	360	At inlet to siphon control weir					
			James Avenue Pump Station Gravity Outlet					
			Discharge from James Avenue Pump Station					
		100	Discharge from James Avenue Pump Station					
30	CIP	100	Discharge from James Avenue Pump Station					
			Federal Avenue Pump Station Outlet					
			Federal Avenue Pump Station Outlet					
			Discharge from Federal Avenue Pump Station					
		141	Discharge from Federal Avenue Pump Station					
30	CIP	141	Discharge from Federal Avenue Pump Station					
		120	Sippo Creek Pump Station					
			Discharge from Sippo Creek Pump Station

Army Corp of Engineers Rating Guidelines for Levee Inspection

HUNTINGTON DISTRICT

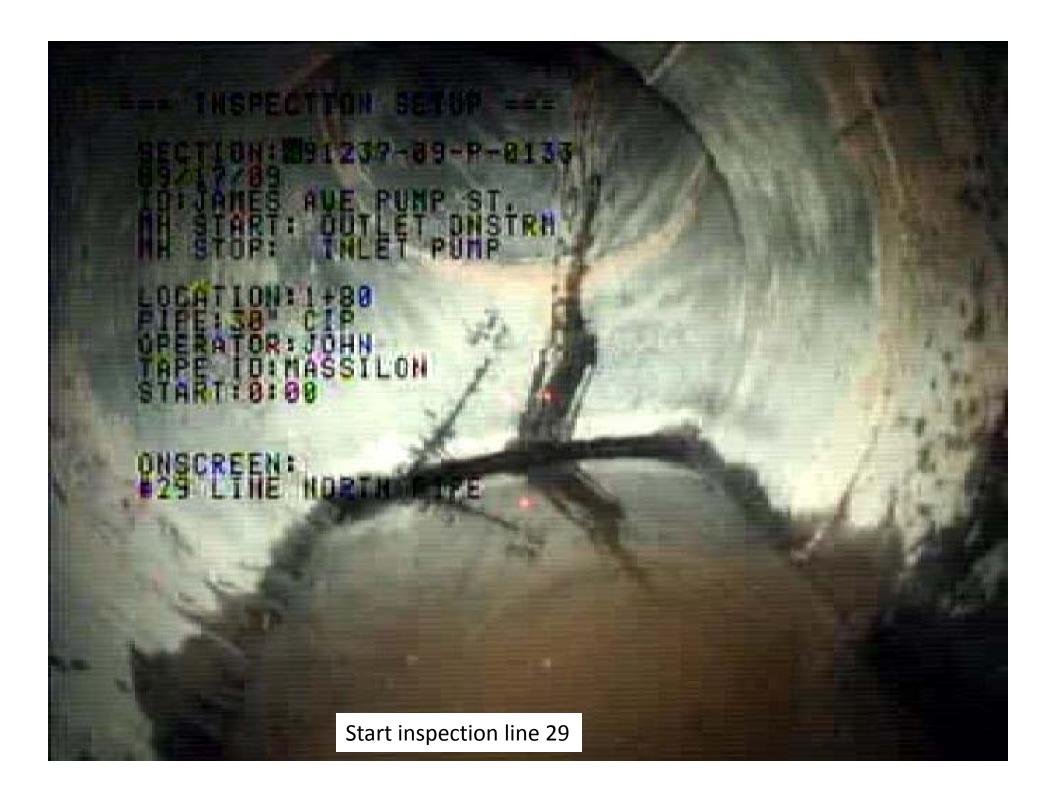
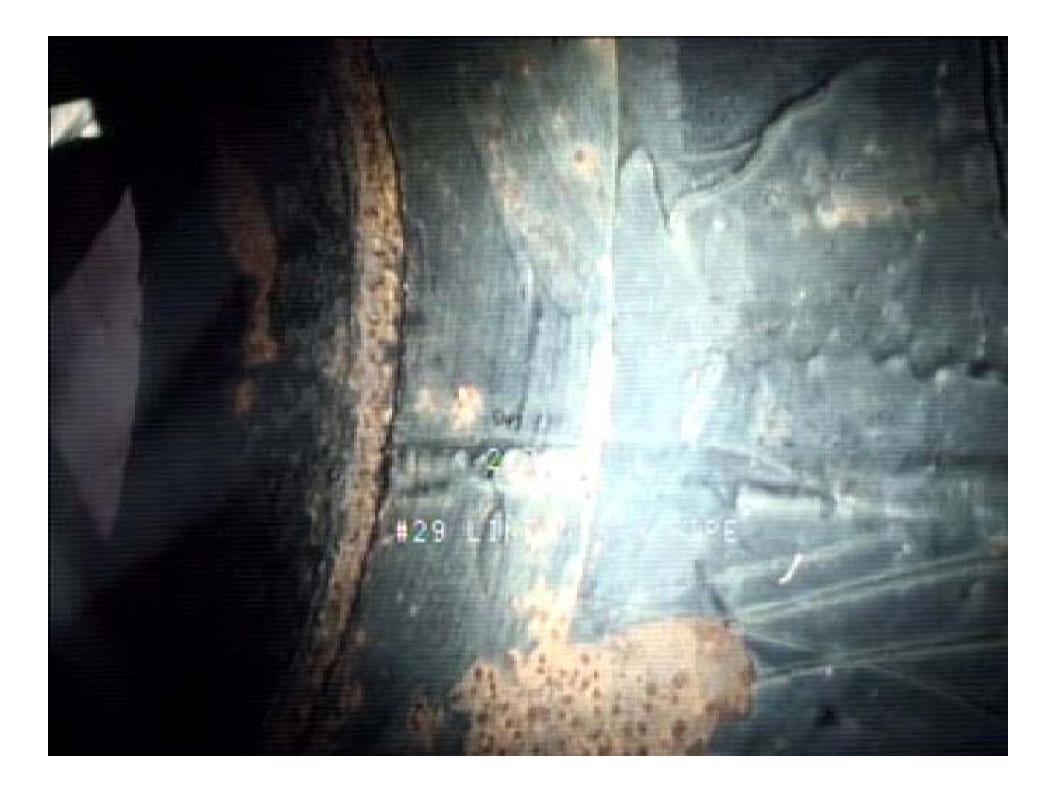
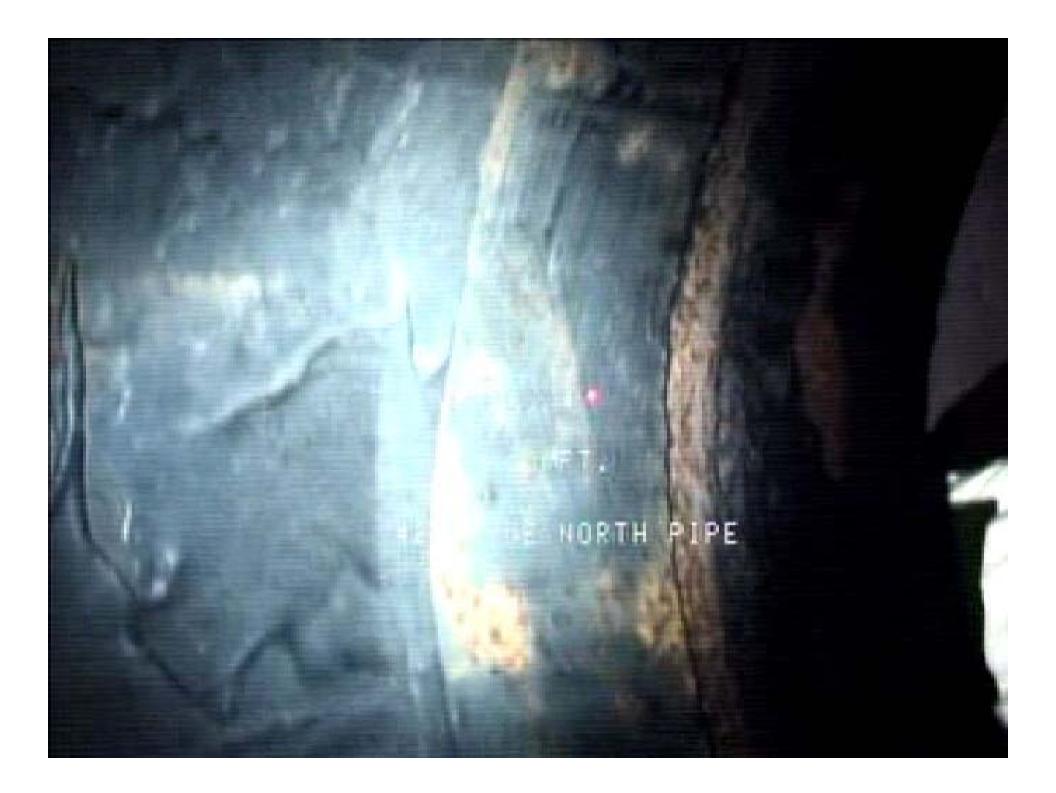
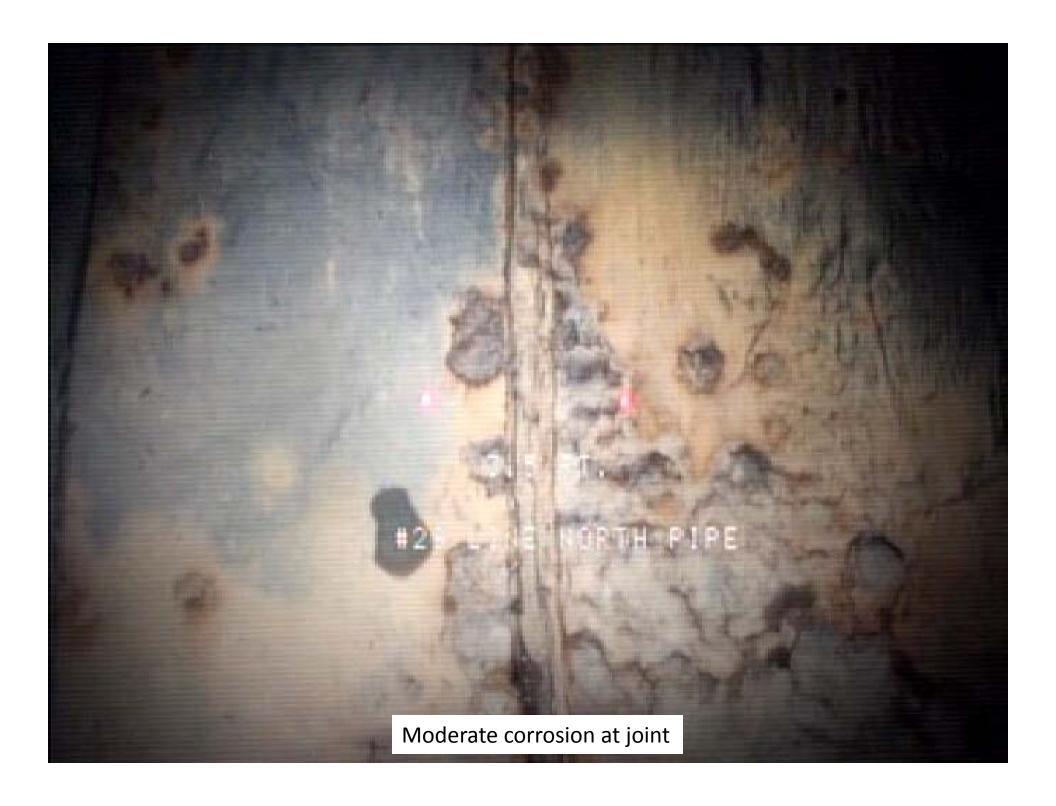
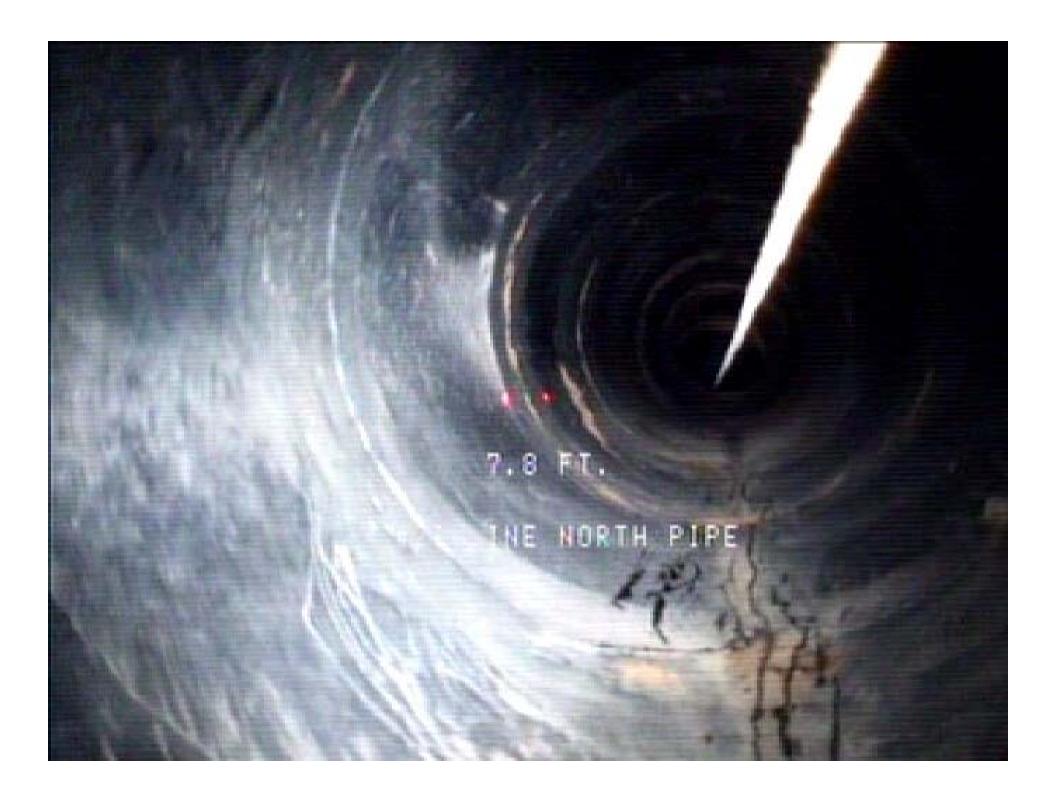
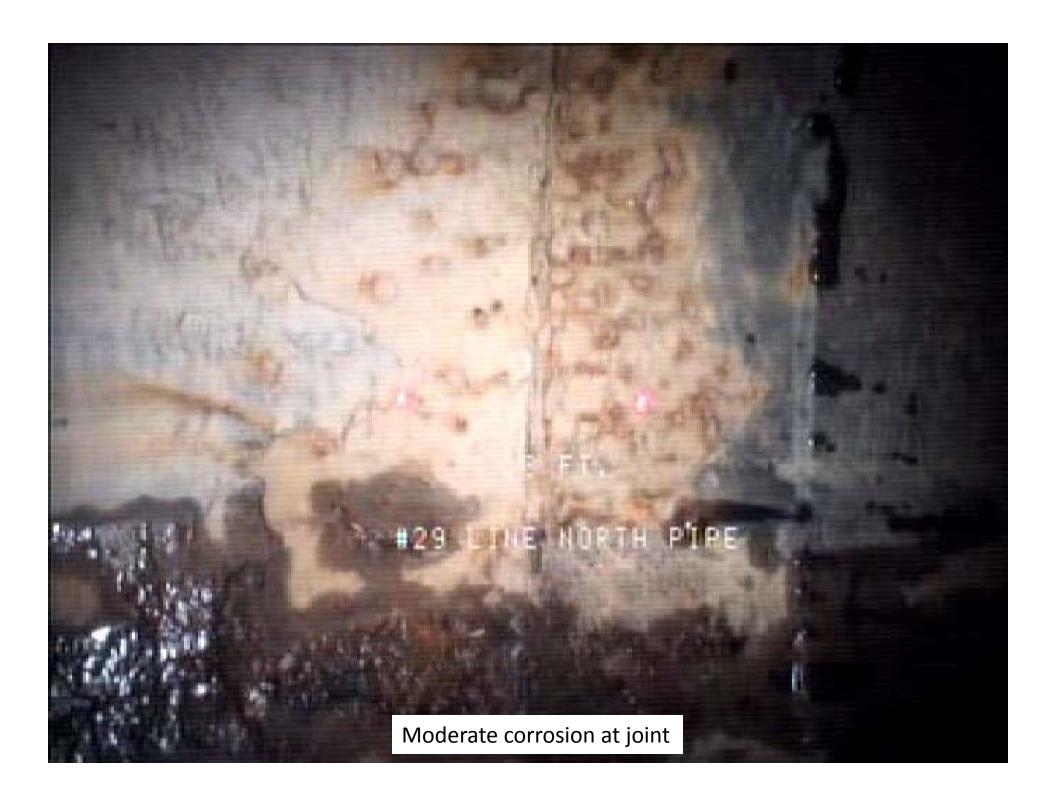
Massillon, Ohio James Avenue Pump Station Pipe #29, North Discharge Pipe

OVERALL CONDITION: NASSCO Grade 4: Pipe will probably fail in 5 to 10 years. Pipe rated at a more serious condition due to that it is a pump line going through a levee.

GENERAL INSPECTION FINDING: GENERAL INSPECTION FINDINGS: All three pipes have moderate to severe corrosion at the joints. Bellies have formed in the flat areas of the pipe at the beginning and the end of the runs toward the pump station. Missing protective coating and corrosion was also noted in flat areas and sharp bends. It appears in some sections that point repairs have been made on the protective coating. Recommend air pressure testing to verify integrity of the joints.

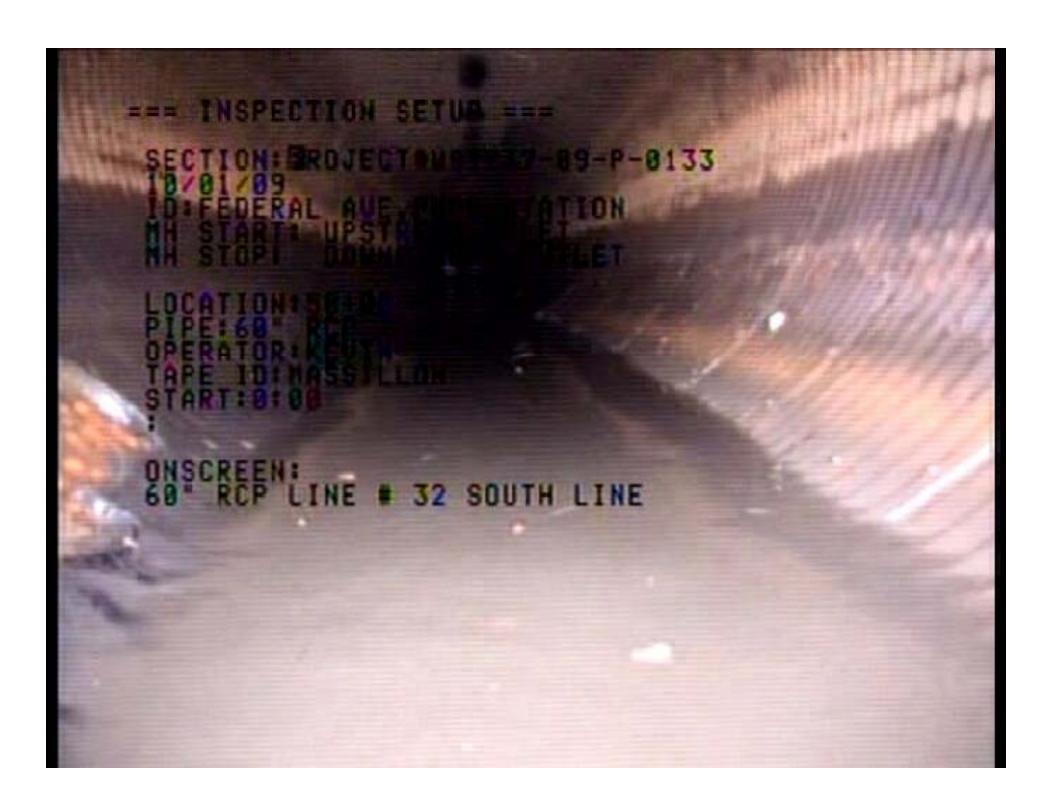
View of entrance at Federal Avenue south pipe

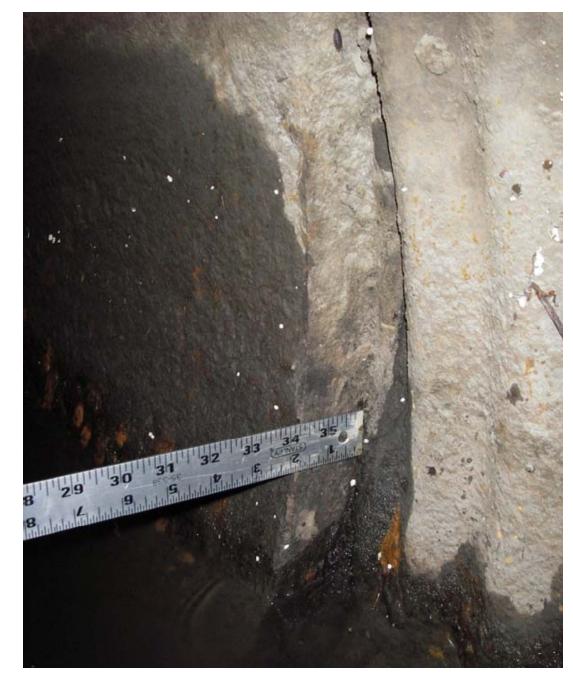
Offset joint at 4:00 where CMP meets RCP (approx. 2")

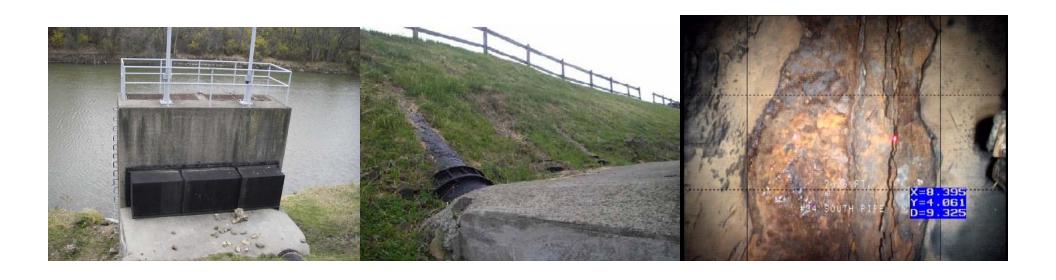
Massillon, Ohio Federal Avenue Pump Station Pipe #34, 35, and 36

OVERALL CONDITION: NASSCO Grade 4: Pipe will probably fail in 5 to 10 years. Pipe rated at a more serious condition due to that it is a pump line going through a levee.

GENERAL INSPECTION FINDINGS: All three pipes have moderate to severe corrosion at the joints. Missing protective coating and corrosion was also noted in flat areas and sharp bends. It appears in some sections that point repairs have been made on the protective coating. Recommend air pressure testing to verify integrity of the joints.

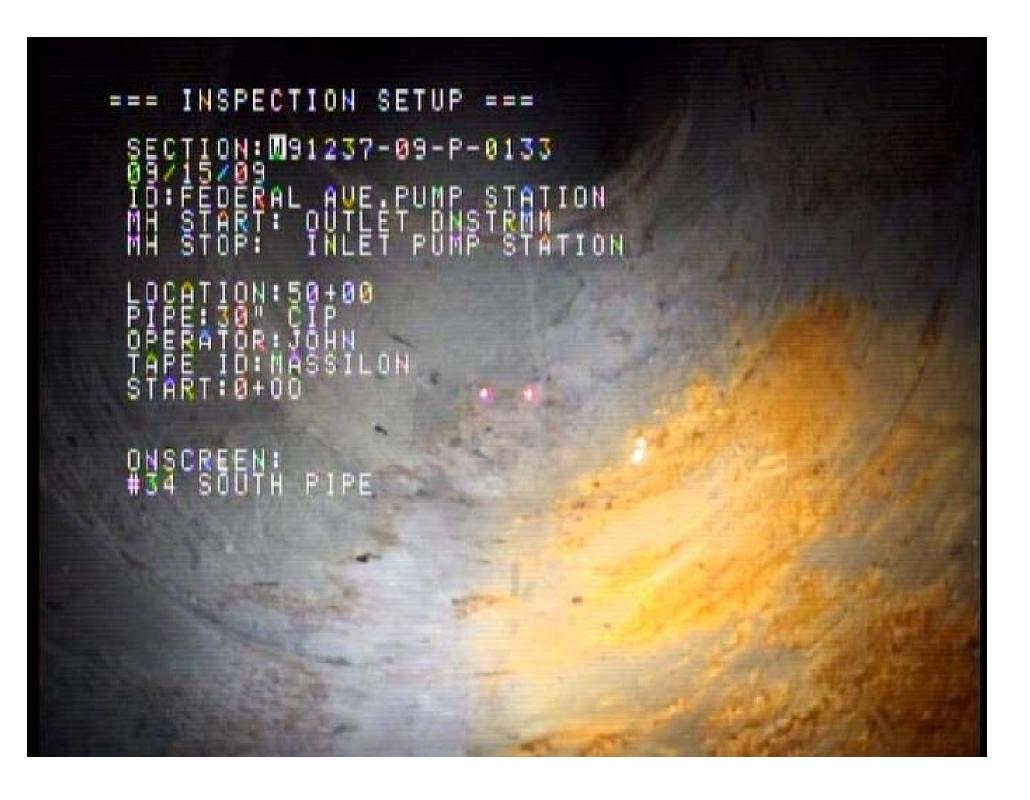
Massillon, Ohio Federal Avenue Pump Station Pipe #34 (South Pipe)

0-141 ft All three pipes have moderate to severe corrosion at the joints. Missing protective coating and corrosion was also noted in flat areas and sharp bends. It appears in some sections that point repairs have been made on the protective coating. Recommend air pressure testing to verify integrity of the	Feet	Defect
joints. *Note: Pipe #35 has severe loss of lining from air-release valve to pump station on the downward grade section of pipe.	0-141 ft	corrosion at the joints. Missing protective coating and corrosion was also noted in flat areas and sharp bends. It appears in some sections that point repairs have been made on the protective coating. Recommend air pressure testing to verify integrity of the joints. *Note: Pipe #35 has severe loss of lining from air-release valve to pump station on the
