Pipes Inspected, Massillon Levee					
Size (Inches)	Material	Length (Feet)	Location					
18	RCP	103	West of RR with Flap Gate					
12	RCP?	175	Could not locate/unknown/does not exist					
42	RCP	95	Culvert through West Bank Levee opposite of Croose Avenue, 1000 ft					
			upstream of Cherry Rd.					
66	RCP	93	Culvert through East Bank Levee near control weir					
42	RCP	360	At inlet to siphon control weir					
			James Avenue Pump Station Gravity Outlet					
			Discharge from James Avenue Pump Station					
		100	Discharge from James Avenue Pump Station					
30	CIP	100	Discharge from James Avenue Pump Station					
			Federal Avenue Pump Station Outlet					
			Federal Avenue Pump Station Outlet					
			Discharge from Federal Avenue Pump Station					
		141	Discharge from Federal Avenue Pump Station					
30	CIP	141	Discharge from Federal Avenue Pump Station					
		120	Sippo Creek Pump Station					
			Discharge from Sippo Creek Pump Station

Army Corp of Engineers Rating Guidelines for Levee Inspection

HUNTINGTON DISTRICT

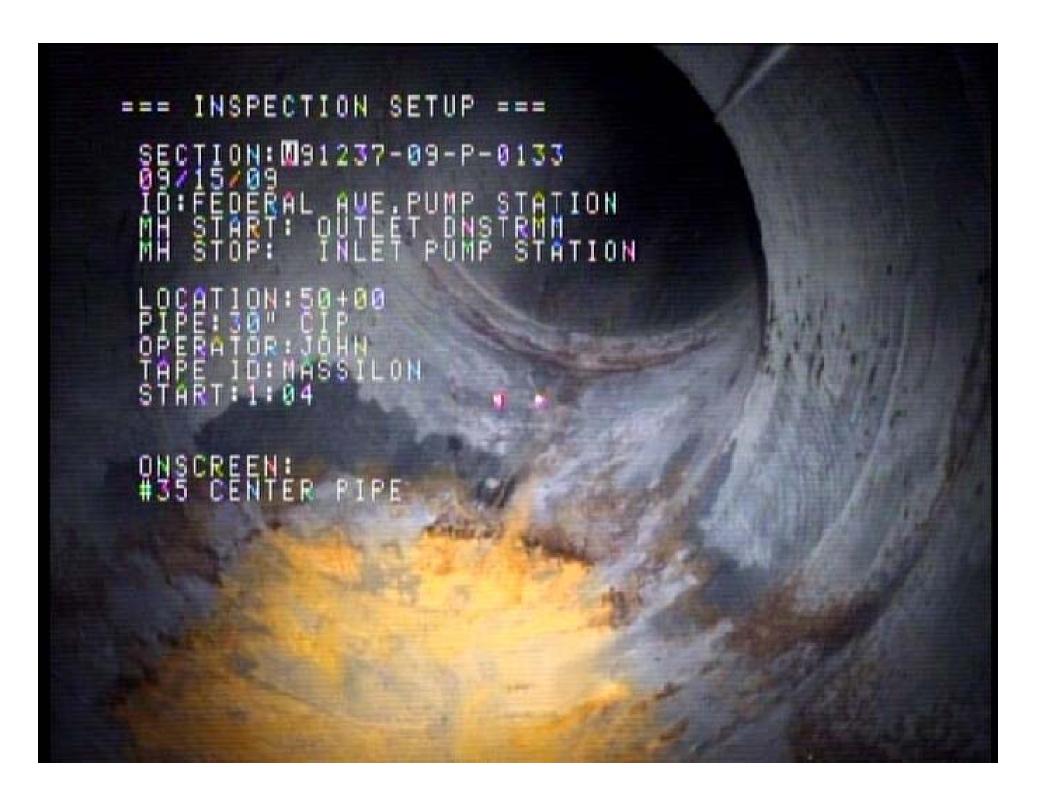
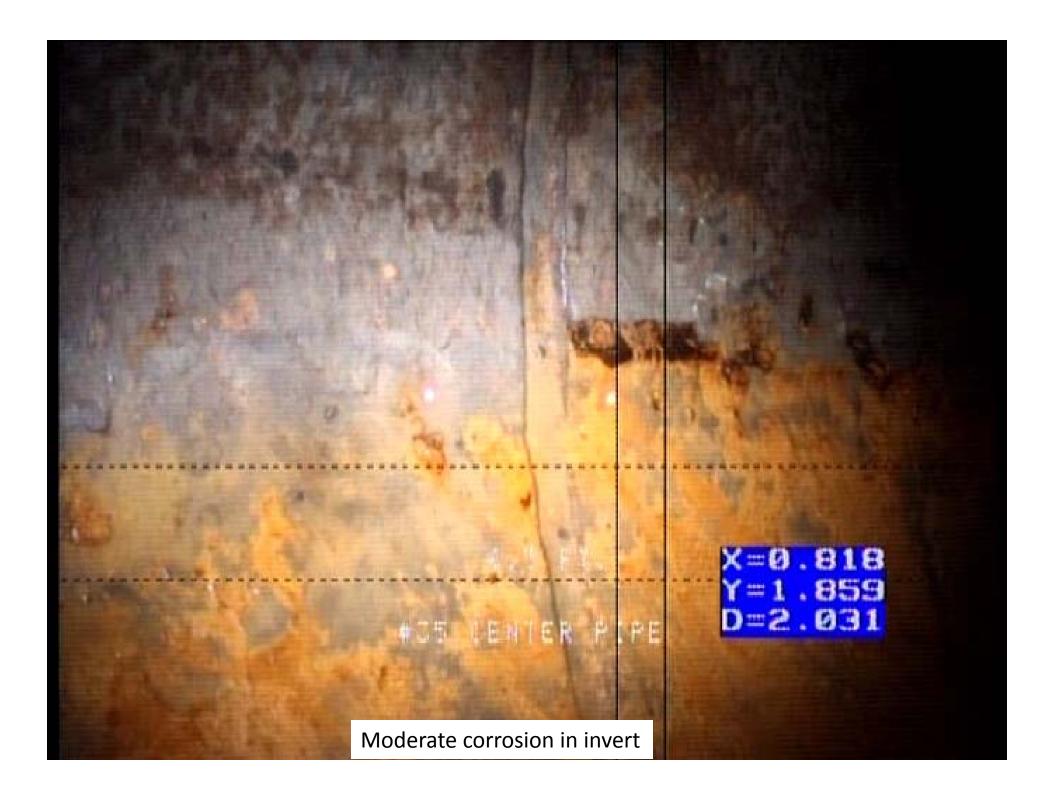
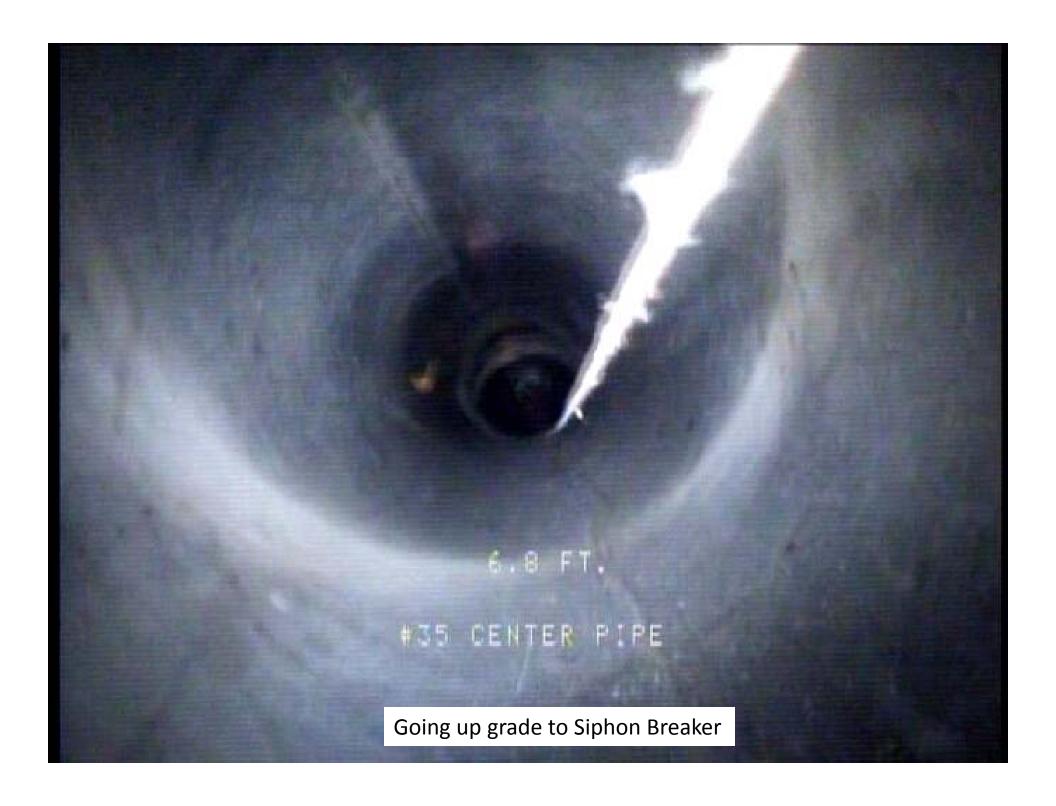
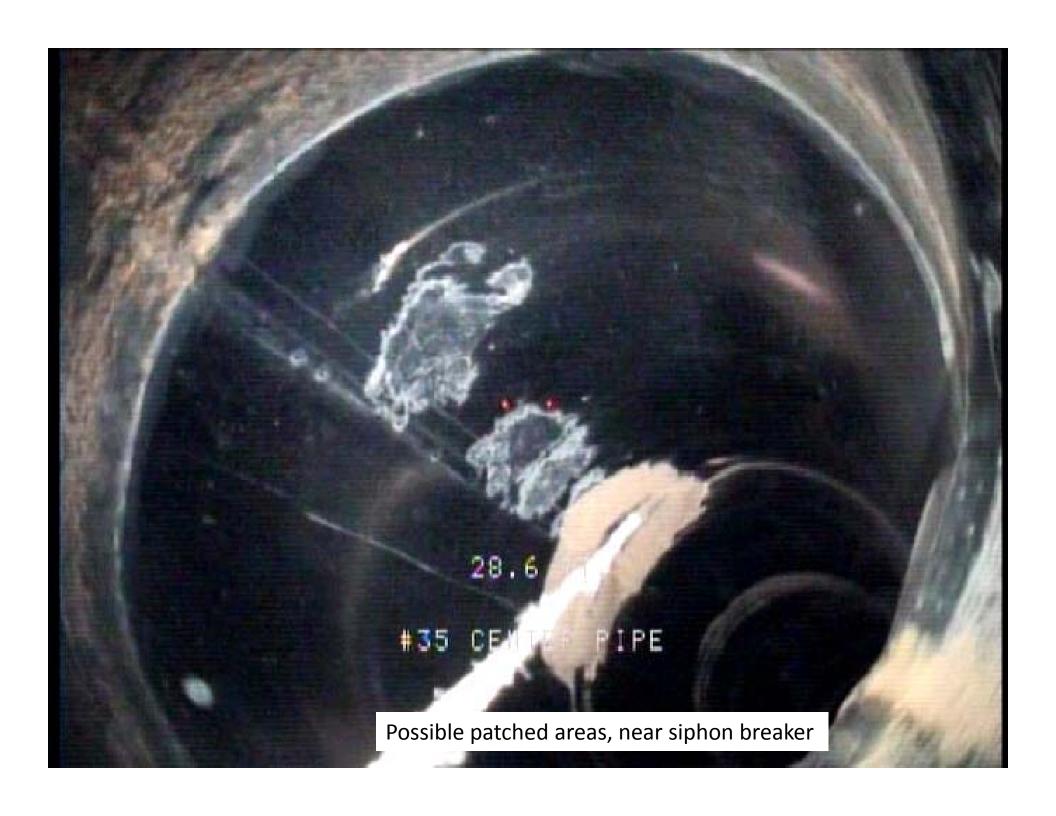
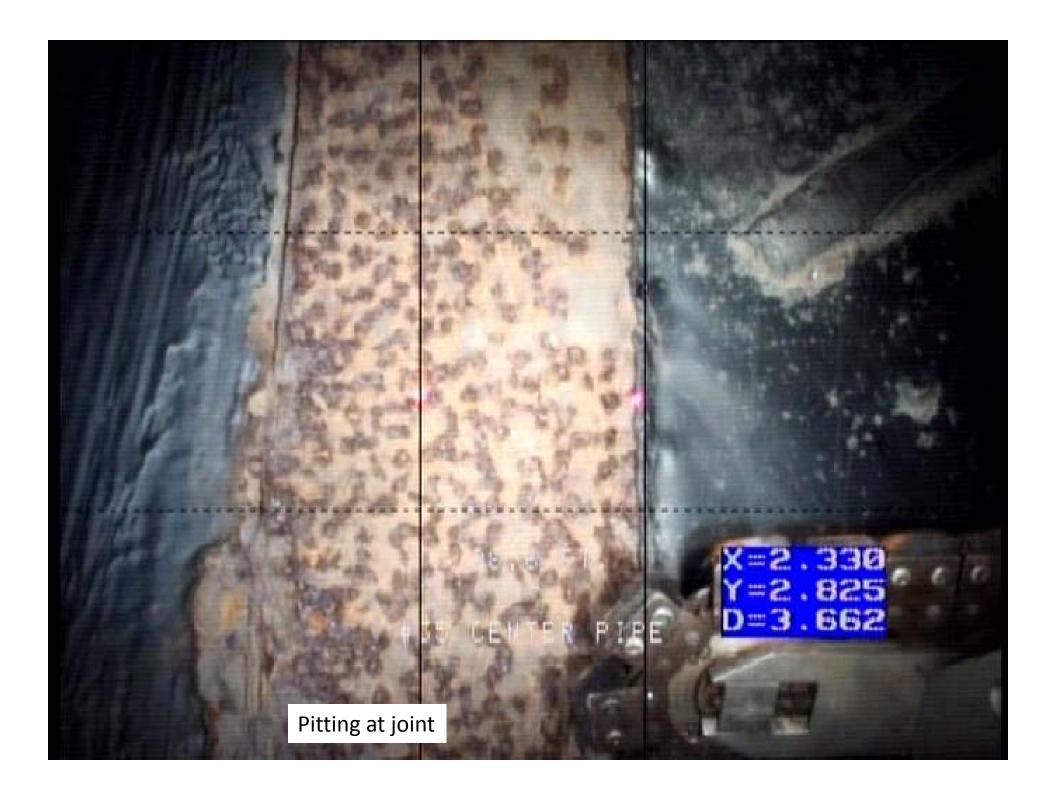
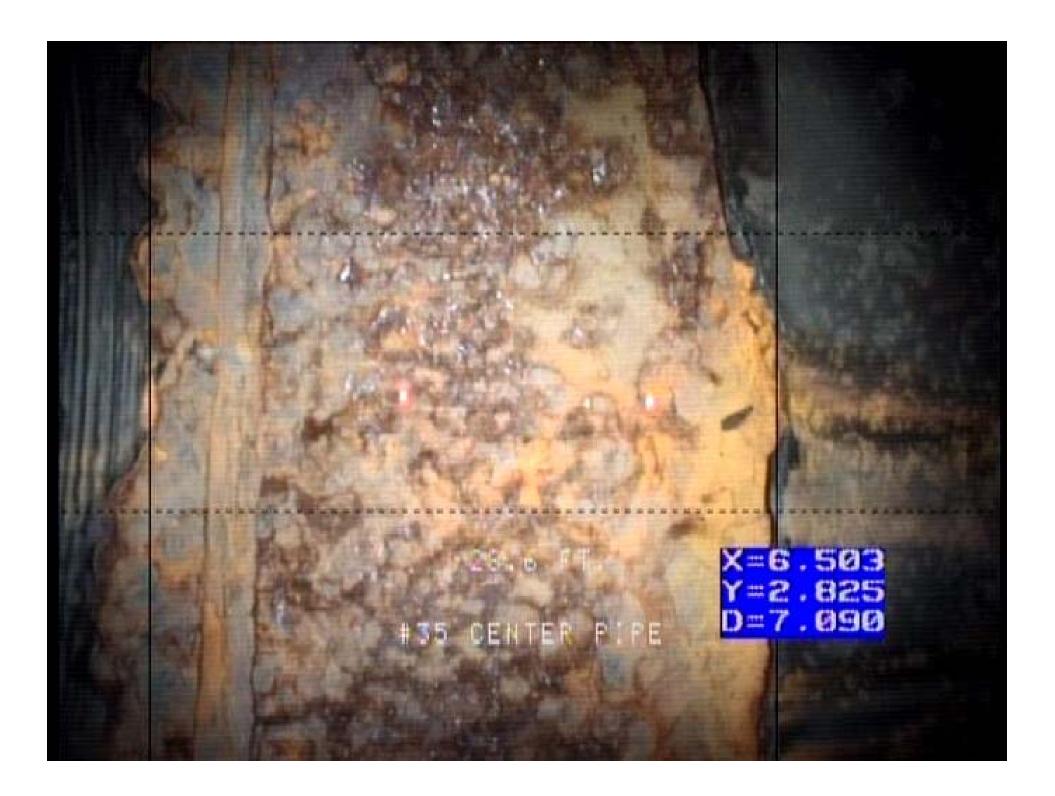
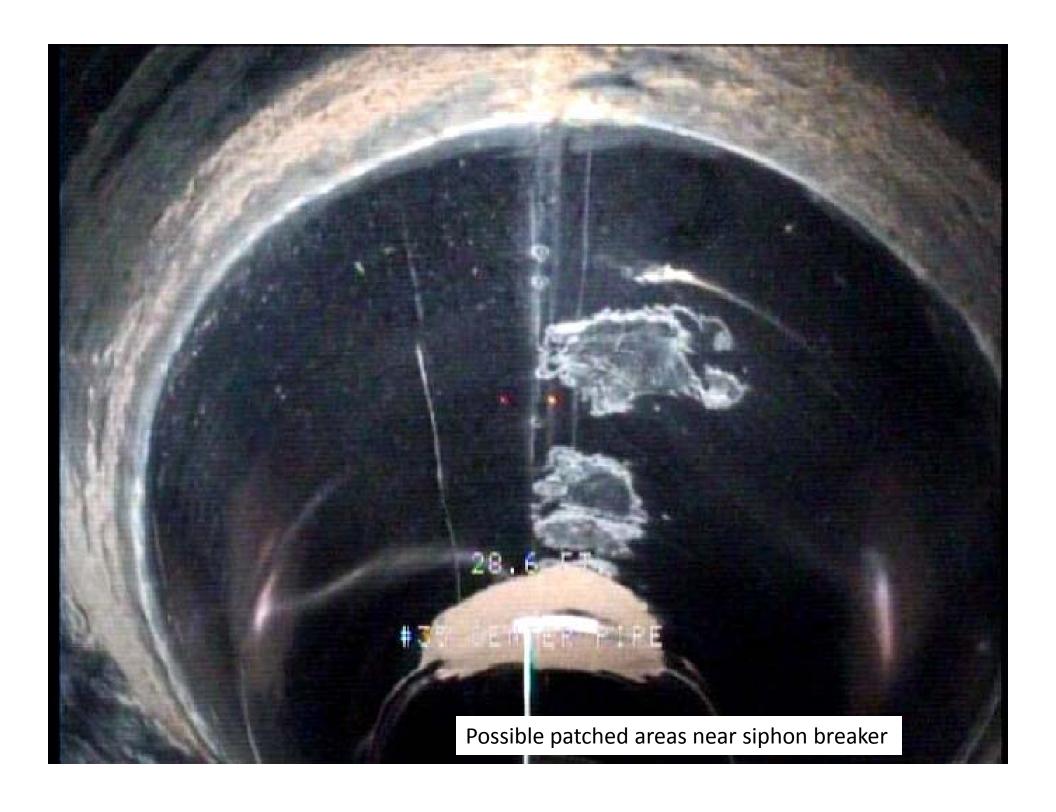
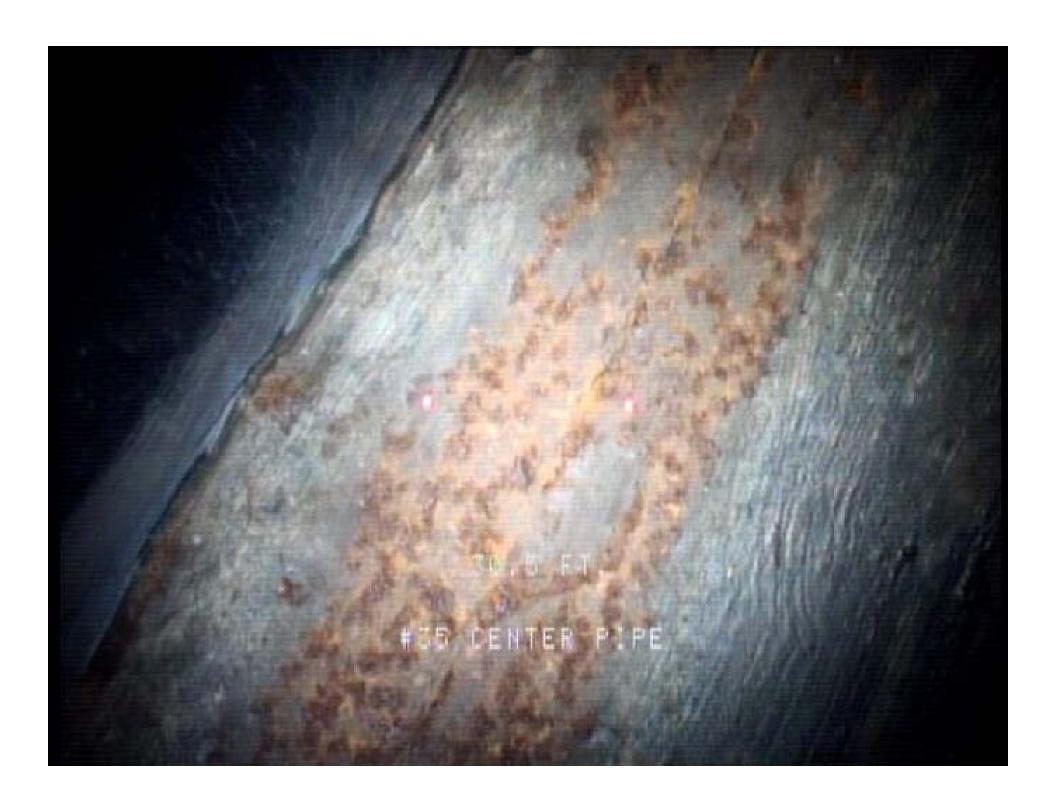
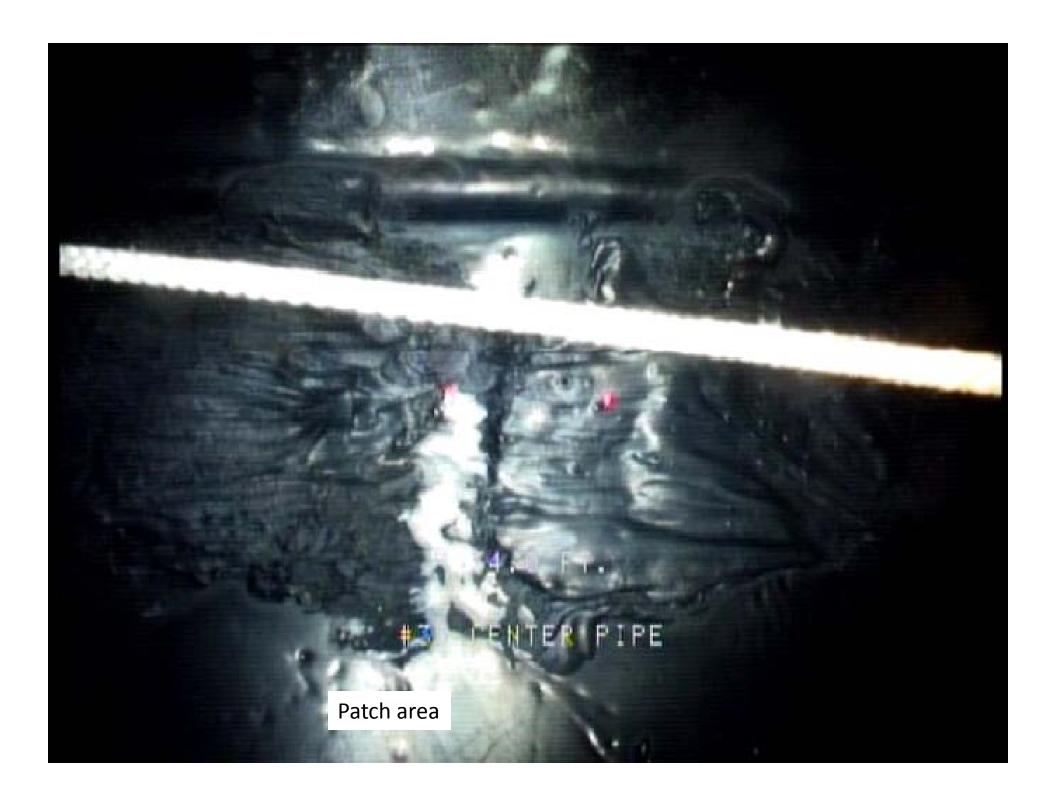
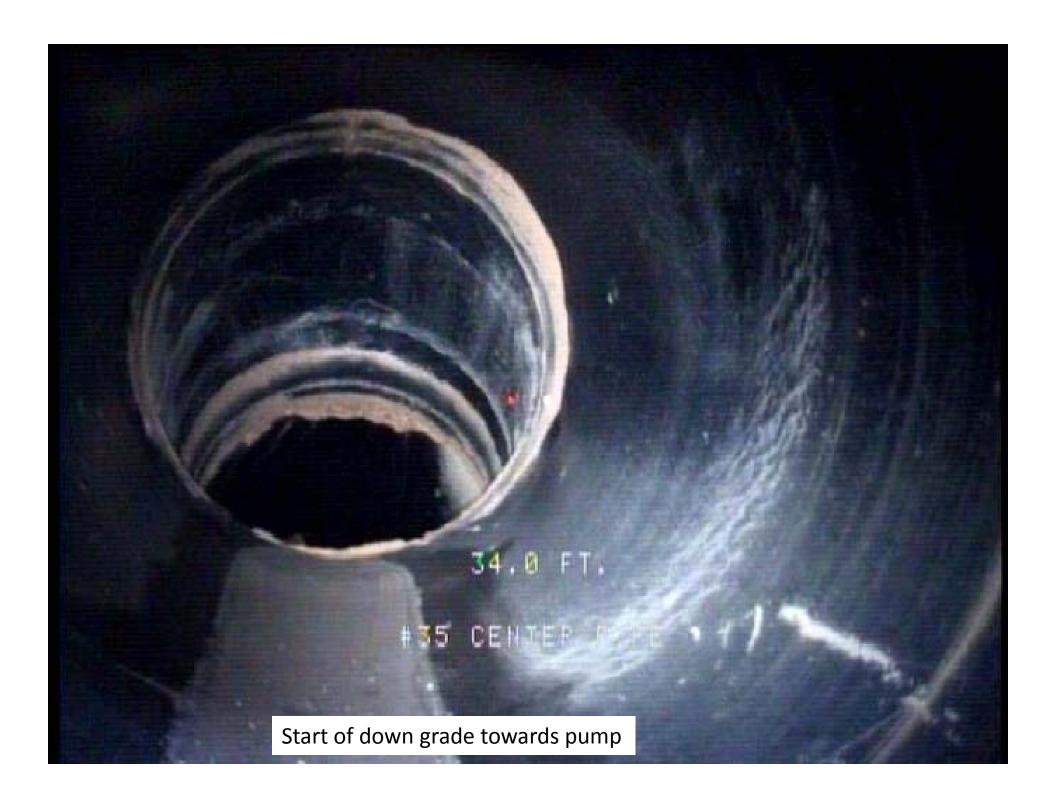
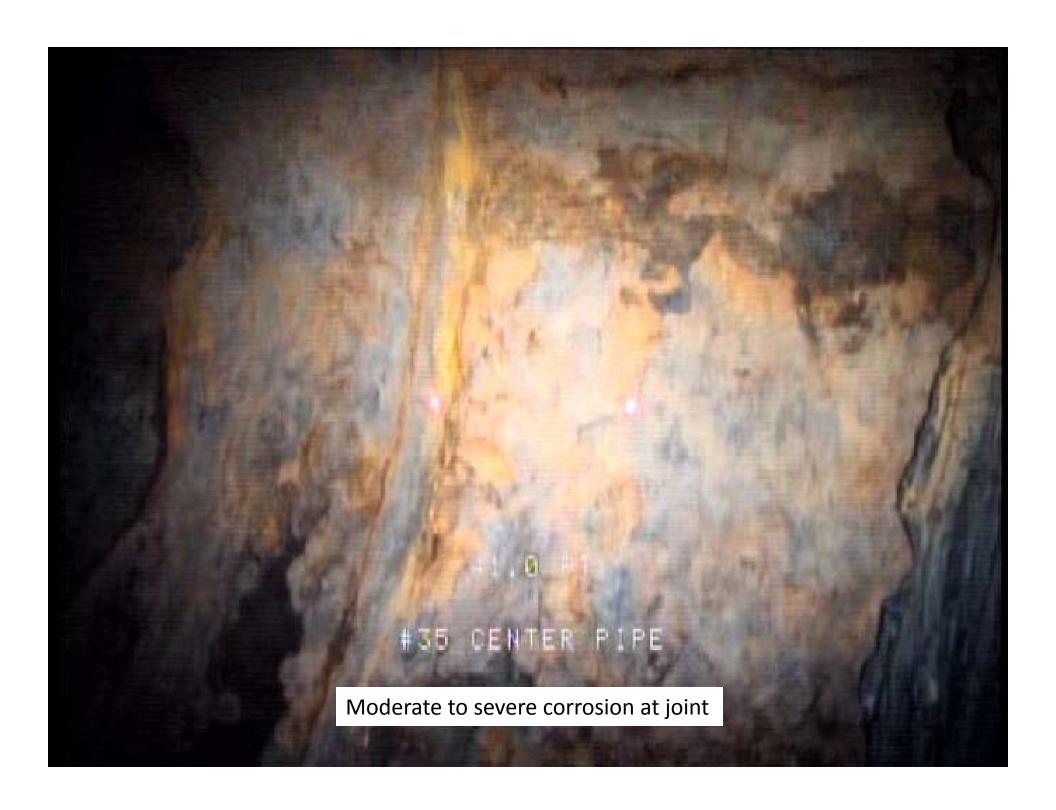
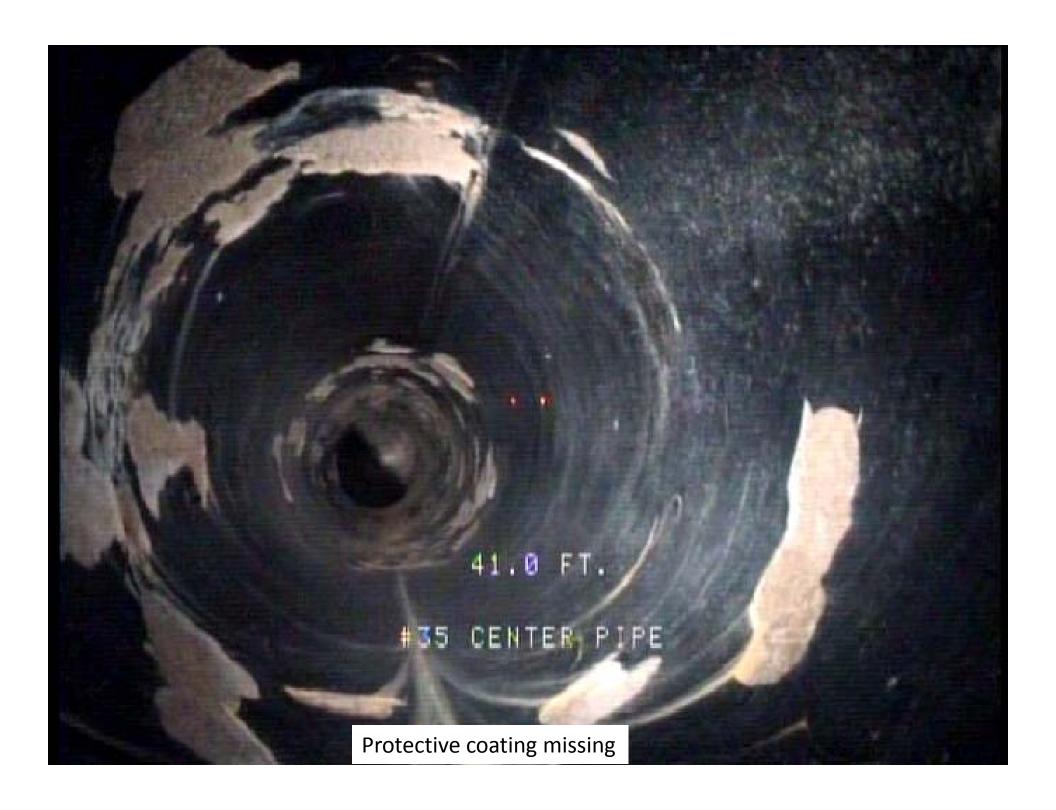
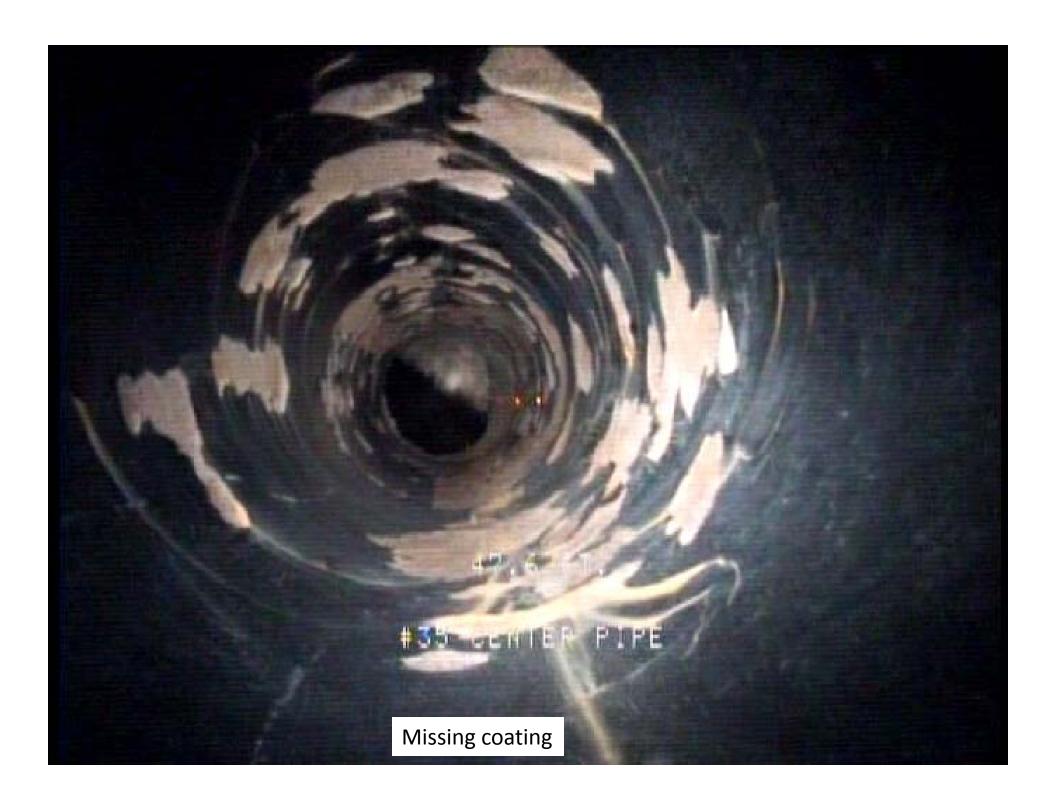
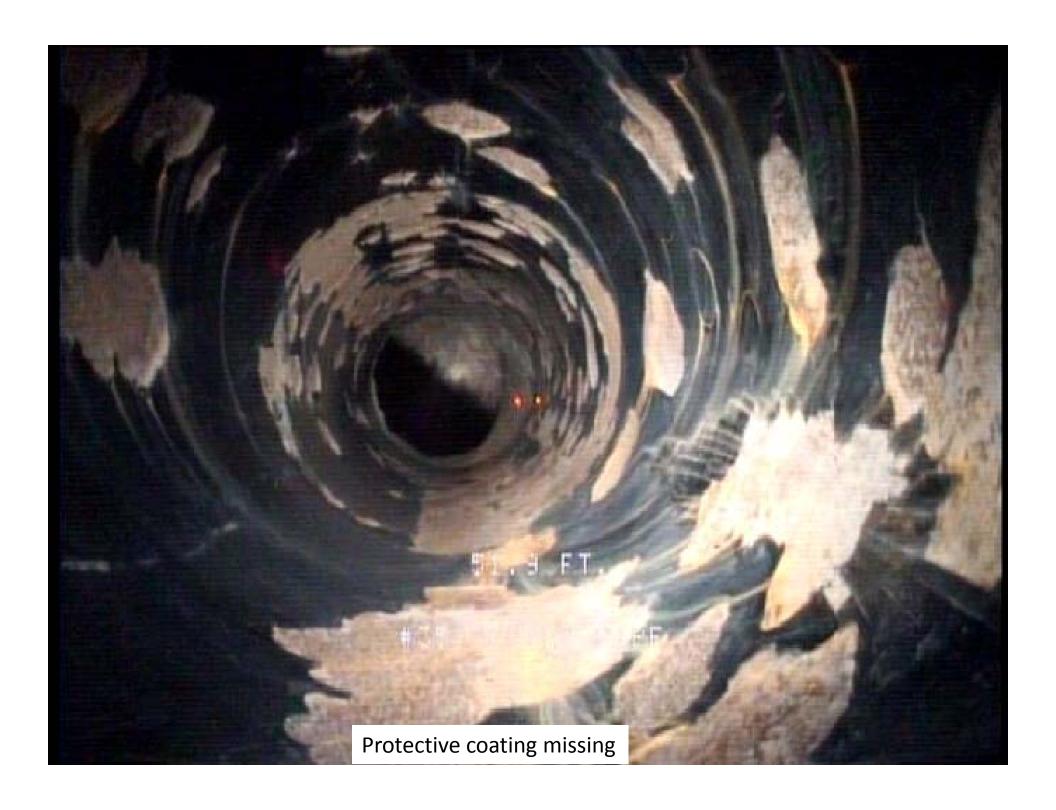
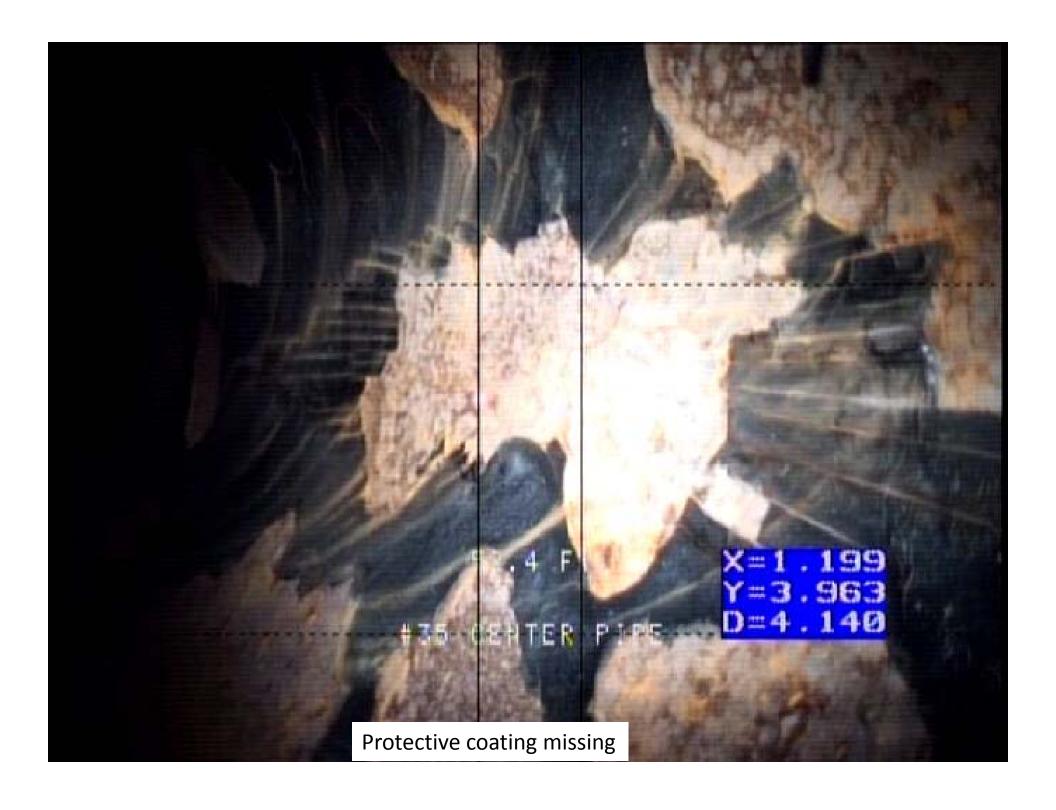
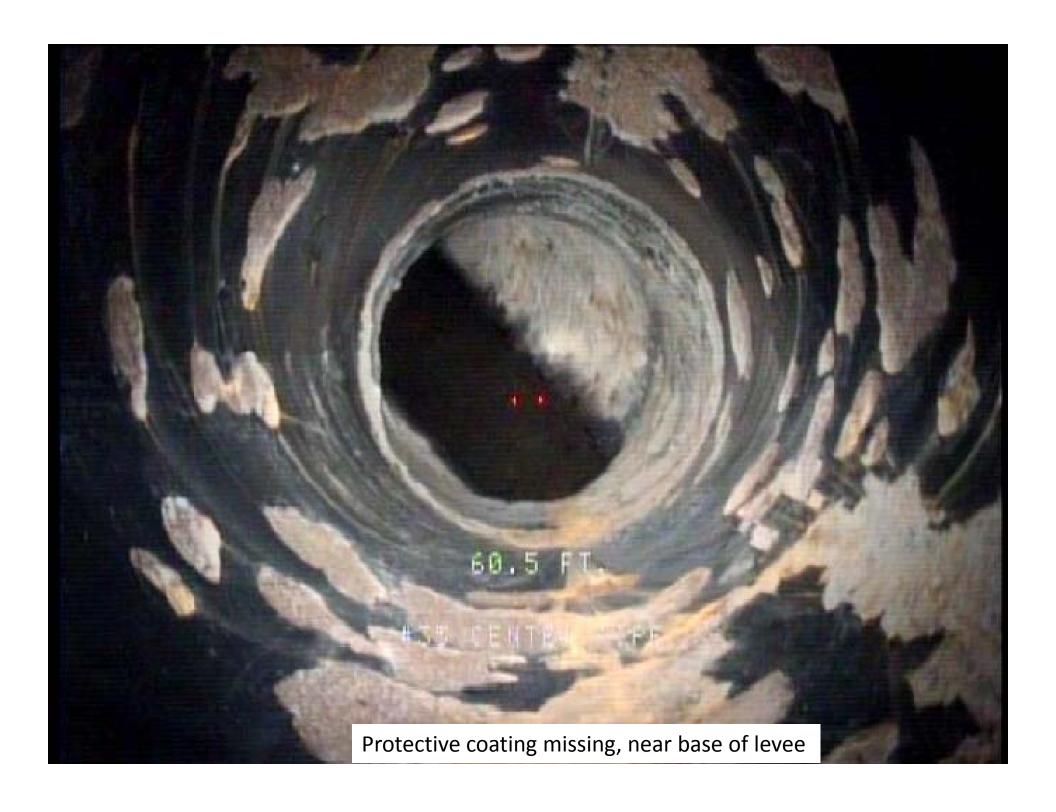
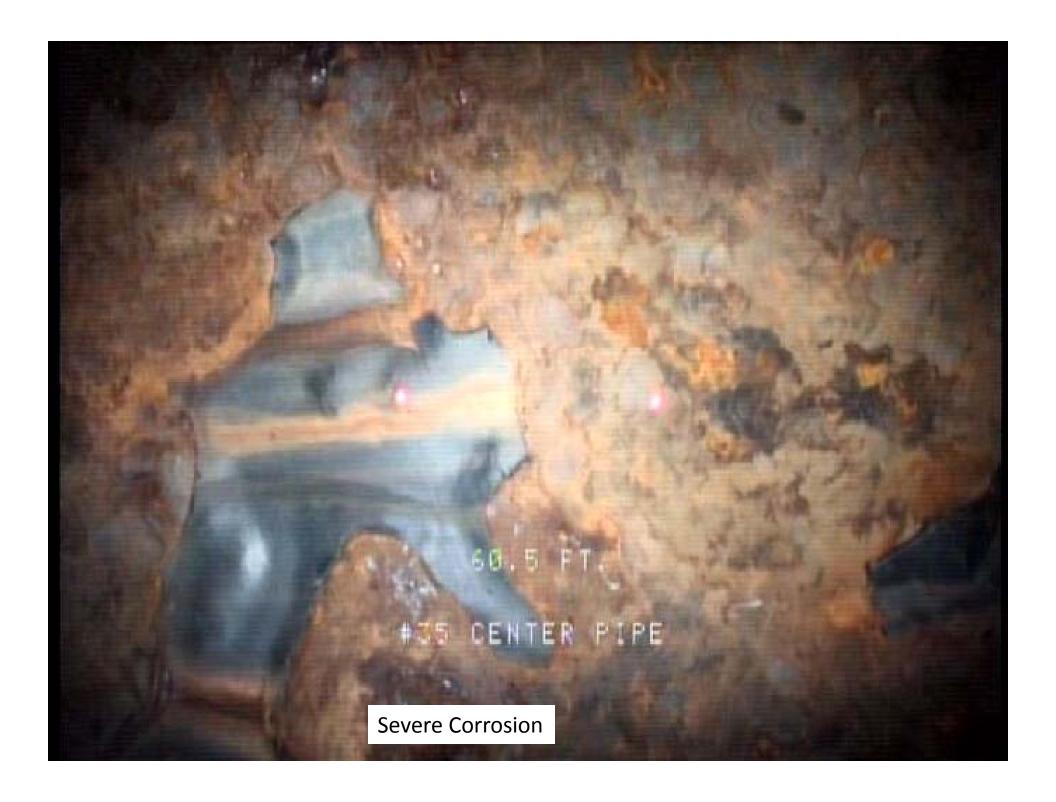
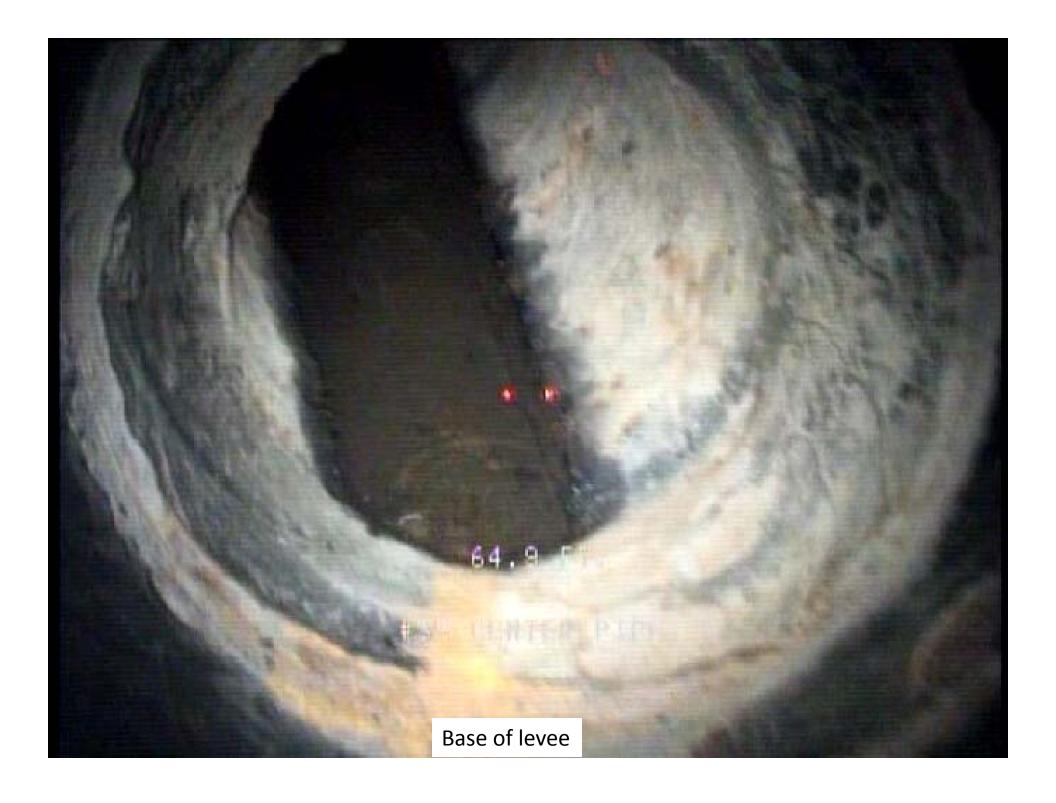
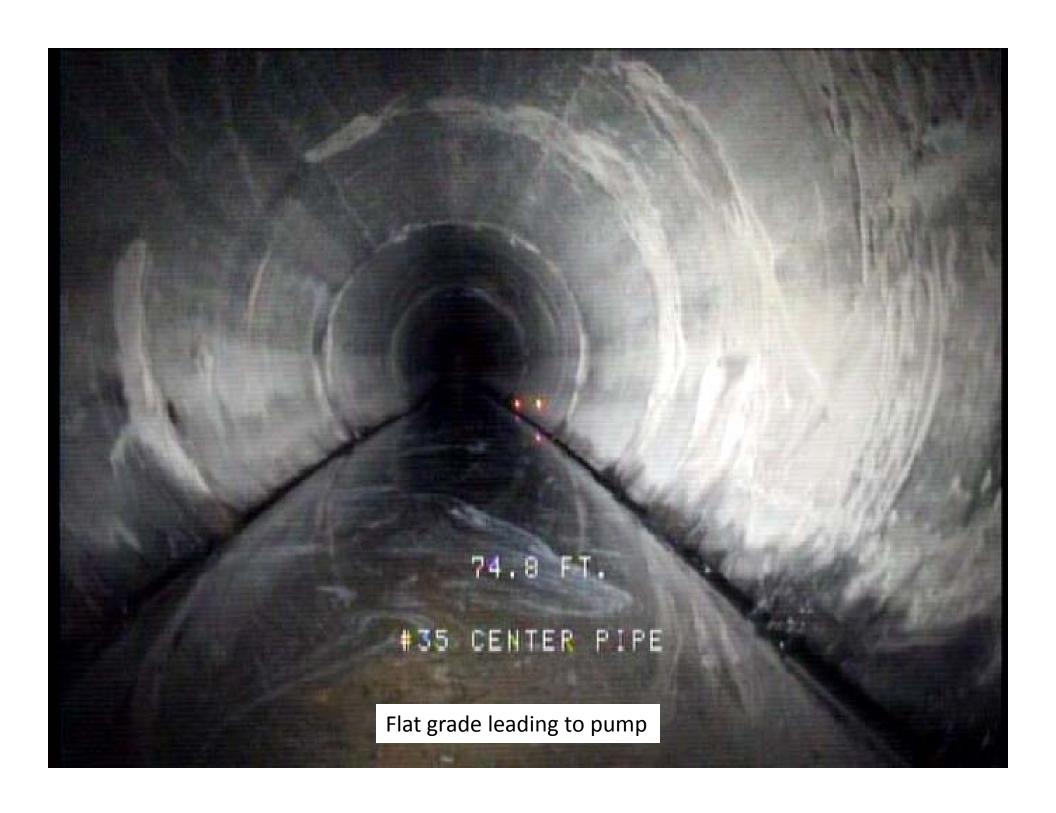
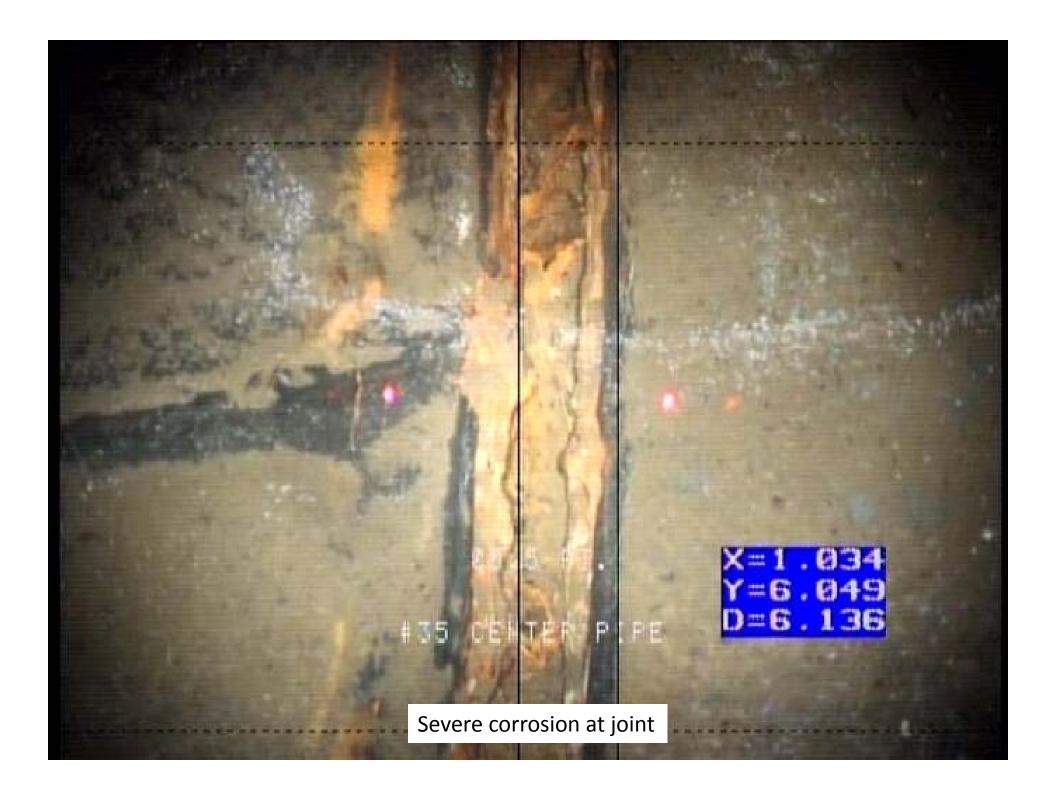
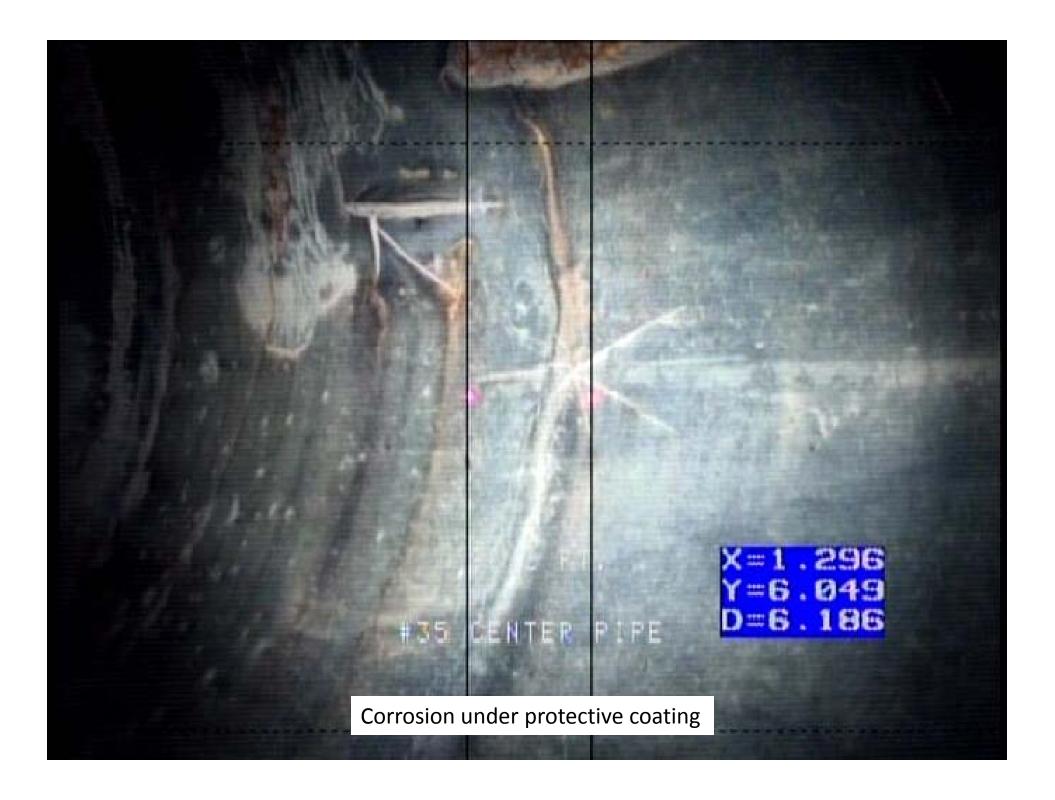
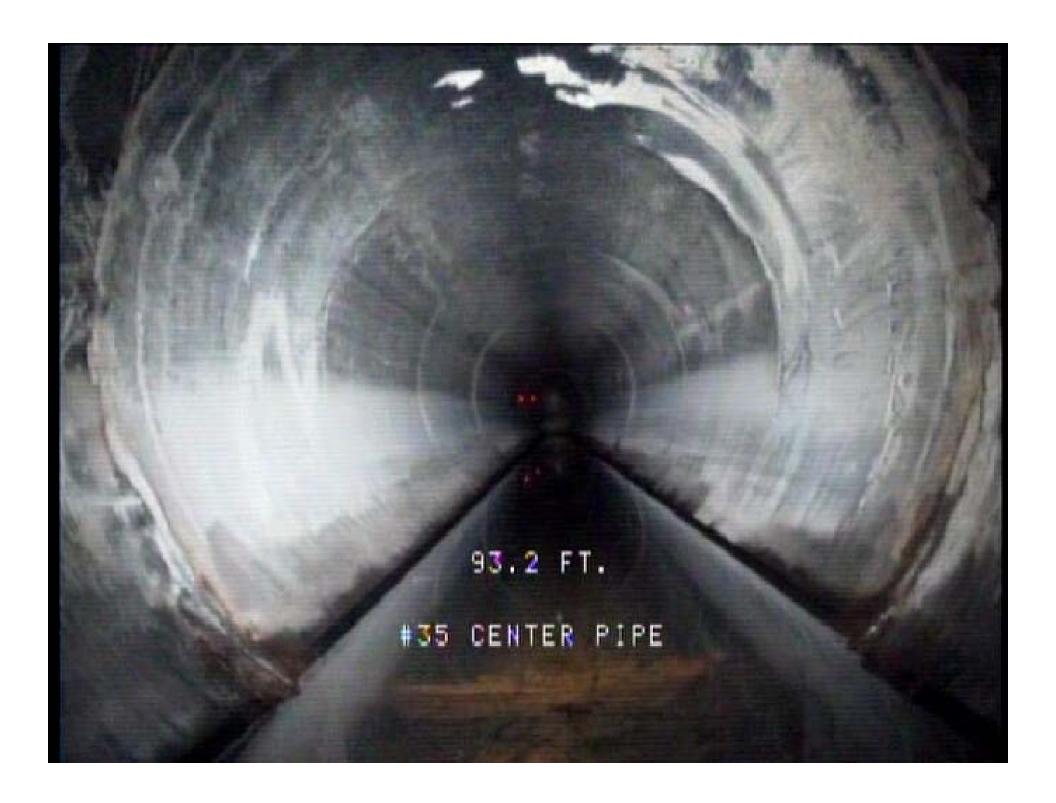
Massillon, Ohio Federal Avenue Pump Station Pipe #35 (Center Pipe)

0-141 ft All three pipes have moderate to severe corrosion at the joints. Missing protective coating and corrosion was also noted in flat areas and sharp bends. It appears in some sections that point repairs have been made on the protective coating. Recommend air pressure testing to verify integrity of the	Feet	Defect
joints. *Note: Pipe #35 has severe loss of lining from air-release valve to pump station on the downward grade section of pipe.	0-141 ft	corrosion at the joints. Missing protective coating and corrosion was also noted in flat areas and sharp bends. It appears in some sections that point repairs have been made on the protective coating. Recommend air pressure testing to verify integrity of the joints. *Note: Pipe #35 has severe loss of lining from air-release valve to pump station on the

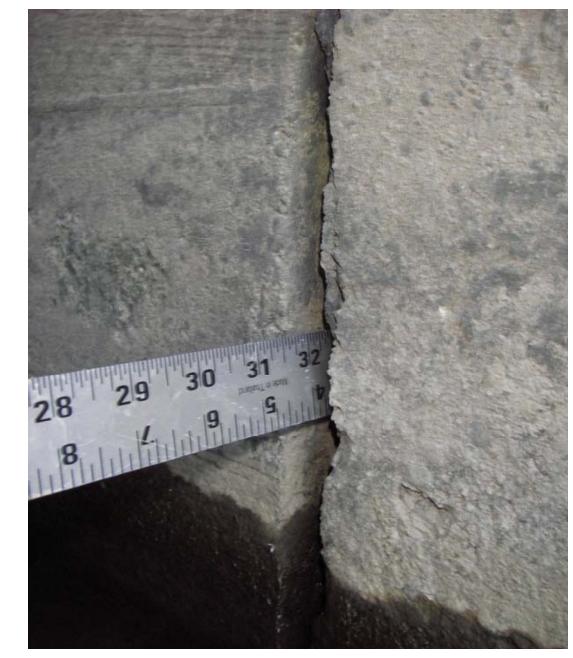
4- inch penetration in right side of box- outlet of box

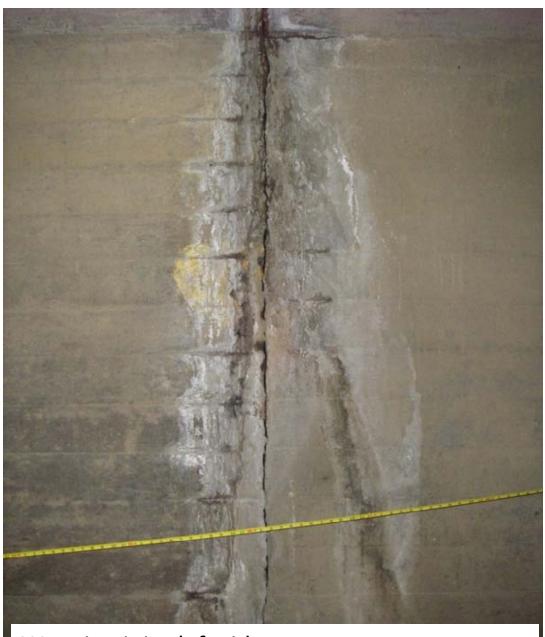
Sippo Avenue 15' X 10' Box #37					
Feet	Defect				
28ft	Spalling at joint				
30ft	Reinforcing steel exposed in crown				
39ft	Reinforcing steel exposed in crown				
56ft	Weeping and stained joint. Rebar exposed from				
	deteriorating joint.				
76ft	Rebar exposed from deteriorating joint .				
83ft	Weeping and stained joint. Rebar exposed from				
	deteriorating joint.				
98ft	Significant weeping and stained joint				
110ft	Weeping and stained joint. Rebar exposed from				
	deteriorating joint.				
118ft	4" scour hole left haunch				
Outlet-Pump Pipes	Invert under water, rough in areas, indicating				
	moderate scour in the invert.

Weeping joint left side, starts upper corner-56ft

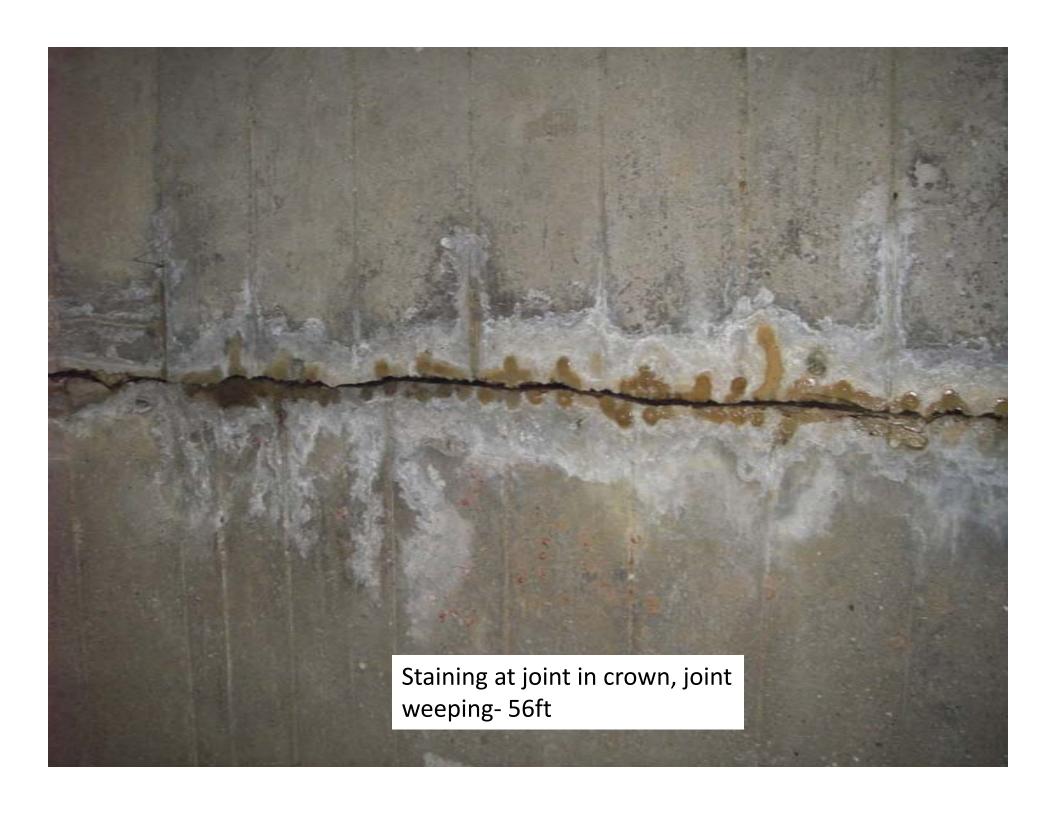
Weeping joint, exposed rebar at right side-56ft

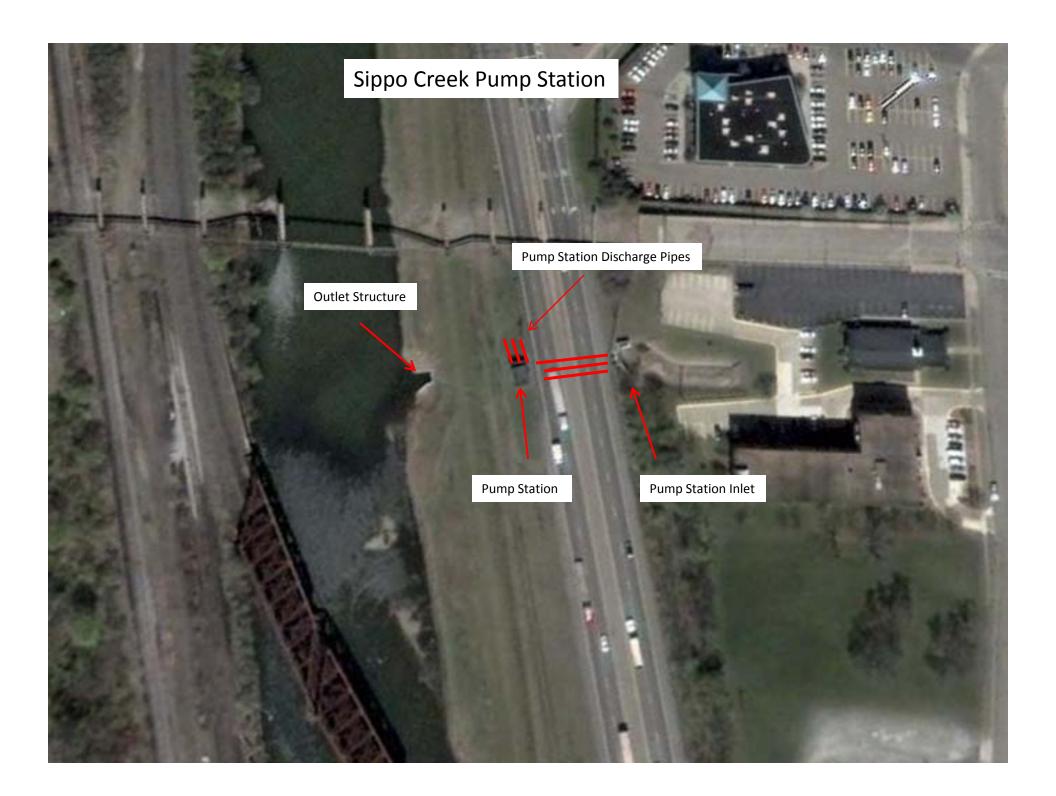
Massillon, Ohio Sippo Creek 24" DIP Pump Pipes Pipe #38, 39, 40

OVERALL CONDITION: NASSCO Grade 4: Pipe will properly fail in 5 to 10 years. Pipe rated at a more serious condition due to that it is a pump line going through a levee.

GENERAL INPECTION FINDINGS: All three pipes have moderate to severe corrosion and rust at the joints and pipe walls. Missing protective coating was predominately around the haunches and inverts of the pipe. Recommend air pressure testing to verify integrity of the joints.

*Note: Pipe #39 (center) at 9.3ft has a severe offset/separated joint with potential leakage.
